# Structural Report

A structural report prepared to inspect the site and appraise the condition of the south front boundary walls.

Property located in Land to west of 2 King's road N17 8NP.

Undertaken by Kenan Taylan(BEng).

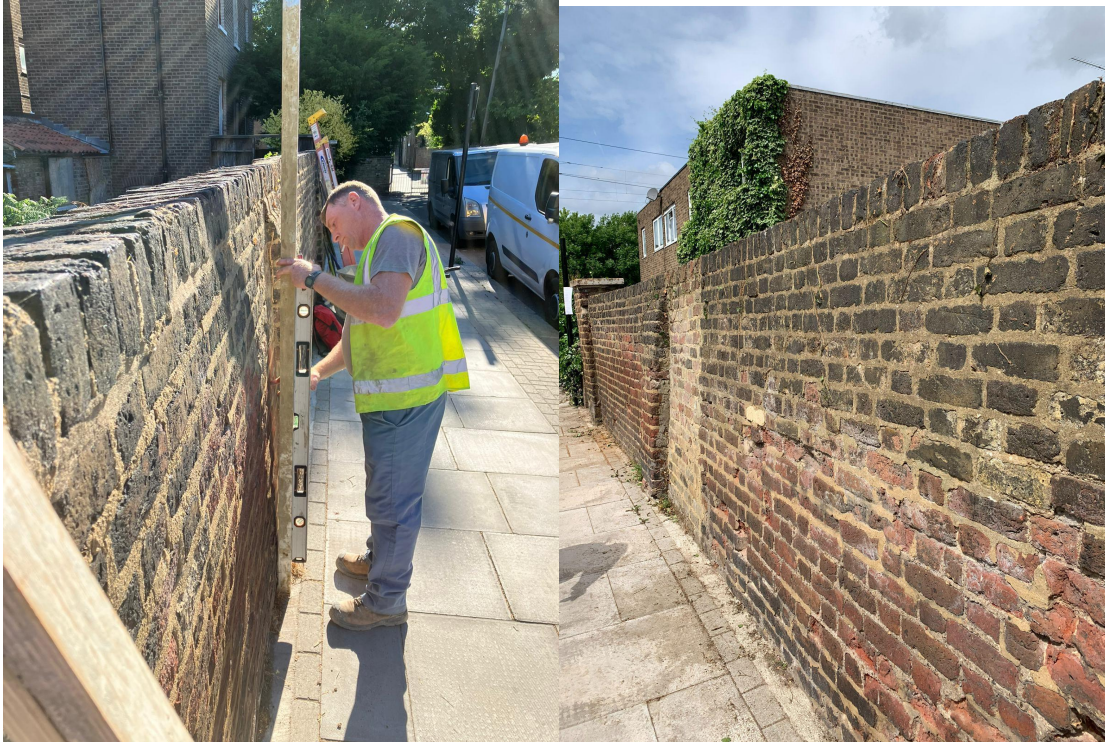
## Image 1 Leaning wall June 2022

The front boundary walls are 215mm thick constructed with London bricks with 1700 mm height with two pier and bricks was collapsed and removed around the centre area. A pier (450x450 mm) to the left hand end forms the return corner to the left hand side wall and a concern as it is currently leaning out into the pavement.

Initially, before work started on 15th July 2022, the front wall was previously horizontally deflected at the top by 100 mm to 130 mm. Due to planning approach and suggestion from the conservation officer the front was to be retain and repair. However, as noted in the previous structural report in the planning application, it's work actually would require rebuilding as the most of the mortar are crumple and the wall was leaning.

It is noted in the previous structural report: “a result of sulphate damage causing the wall to deteriorate. As a result of the initial tree(which is now removed in the site clearance) was pushing against the wall. This is indicating that tree roots are beneath the wall lifting the wall upwards or alternatively shallow foundations to the pier and front wall have suffered from subsidence. Because the effect of tree roots in shrinkable clay is a common occurrence. Especially, the water demand of the trees causes seasonal fluctuations in the clay bearing strata which result in volumetric changes in the ground on which the building and external works are founded. In summer when the water demand of the trees is high the ground shrinks, while in winter when the water demand of the trees is very low the ground swells. These seasonal changes occurring over a long period are commonly responsible for the type of structural movement evident at this property.”

☐ The whole front wall requires rebuilding.

☐ The front wall in its present condition: The safety factors for the stability of the wall have been considerably reduced and vibration from traffic or construction work and a possible increase in wind forces. Thus, the collapse has happened and it is recommended that all of the wall boundary are to be rebuilt as there has been multiple collapse over the years some which are not recorded. The C19 curtilage walls are in a poor condition and are leaning in most areas. It is advisable to rebuild all the C19 walls with the existing bricks (removing any mixed brick which is uncharacteristic with the initial old bricks).

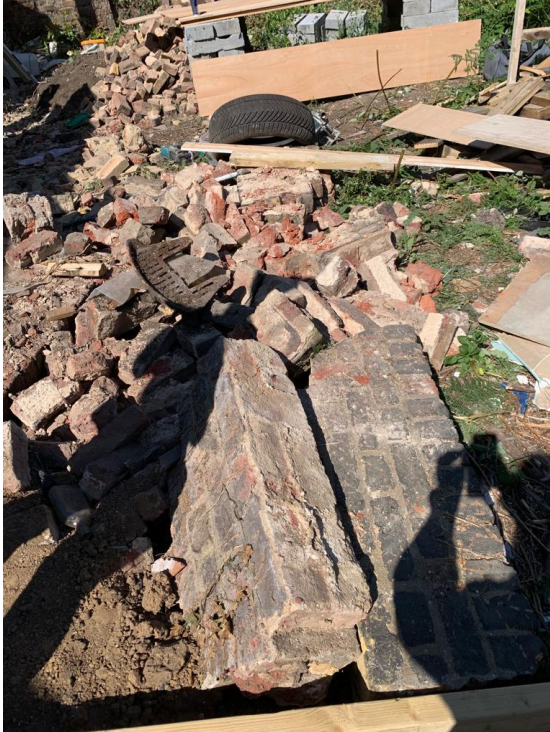
**Image 3 Collapse and to be reclaimed; poor condition wall been brought to ground by contractor due to hazardous concerns. Remaining piers to the southwest are still leaning on to the street.**

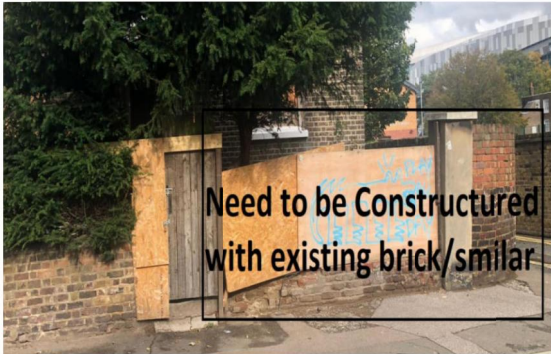
Images Extracts from structural report for planning for listed building

The wall was constructed with brick with 1900 mm height with 250mm width but due to lateral load and ground movement a portion of wall collapsed and deviated laterally more than the permissible deviations for masonry elements tolerances ( BS EN 1996-2:2006). Refer to Images. Most of bed joint for brick wall losing their bonding capacity and the pier was supposed to strengthen wall laterally but unfortunately due to wall movement pier lose functionality.

Need to be Constructured with existing brick/smlar
