**Structural Inspection Report**

**42 Southwood Lane  
Highgate  
London N6 5EB**

Document Reference: 824-22 R01

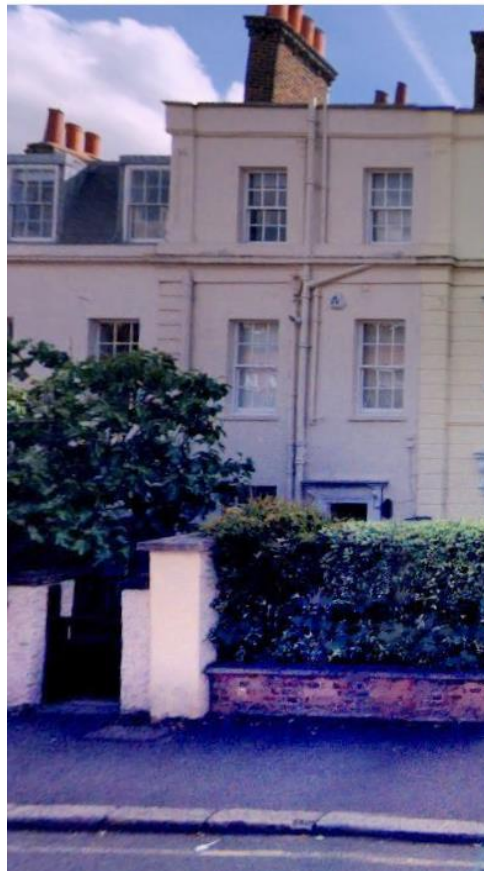
- 2.2.1 The front elevation is Stucco rendered on brickwork and is seen in the photo of the title page to this report.
- 2.2.2 Overall the elevation presents reasonable line and level indicating good historic structural performance particularly with consideration of the buildings age. There are some cracks in the Stucco render but these are considered not to be a significant importance.

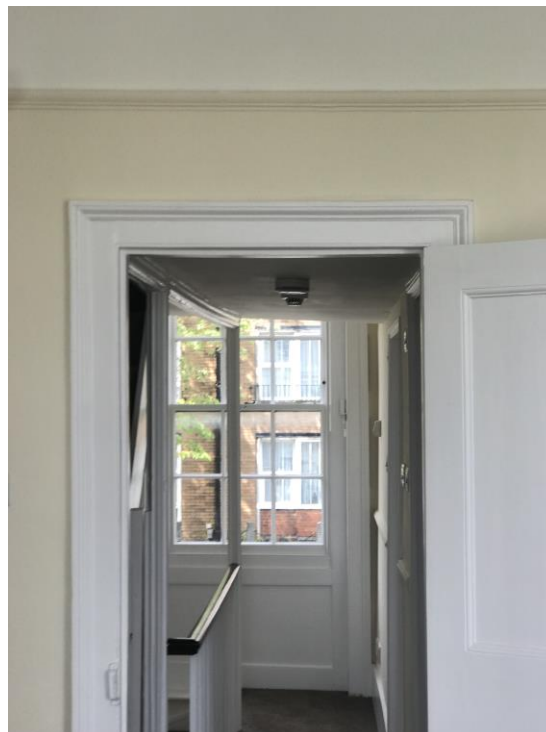
- 2.1.5** The internal inspection of the First floor storey indicated reasonable structural / construction performance around the rear room. However between the central load bearing wall and the front elevation the floor is deformed. This appears to be due to the non original construction of the storage tank service enclosure at high level in the First floor storey. The manner of this construction of this enclosure uses timber propping to from the First floor to support it and consequently the abnormal loading has created abnormal loading deflection. It should be noted that there are a couple of timber props to the edge of the stair well. These are important in maintaining support to the service tank enclosure.

**First Floor Props at edge of stair**  
**Supporting service tank enclosure**

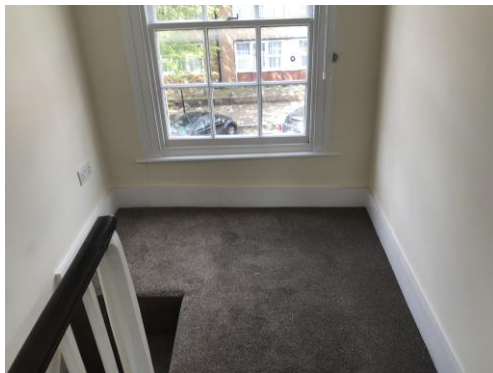
**2.1.7** There is a significant sag in the floor level. This appears to relate to the construction of the service tank enclosure beneath the floor. It was not possible to determine the specific inadequacies or defects that were caused or otherwise created by the supplementary construction of the service tank enclosure because much is hidden from view. Nevertheless the construction of the enclosure severely altered the structural support of the Second floor and it is currently impossible to determine if the inadequacies have achieved a reasonable state of stability.

**Second Floor Stairway Window  
Floor Sag Left to Right**

- 3.1.2** Notwithstanding the general comment of **3.1.1**, the second floor construction is exhibiting significant deformation that appears to relate to the service storage tank enclosure construction at high level in the First floor storey. That supplementary construction appears to have adversely affected the support of the second floor but the detail of that inadequacy is currently hidden from view. It is recommended that an allowance be made to carry out any necessary strengthening to the floor of the second floor once the existing construction is exposed sufficiently.

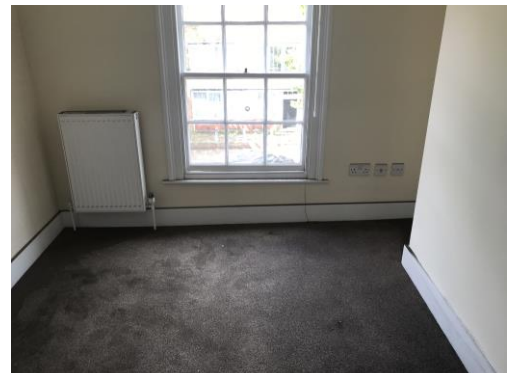
**Second Floor Front Room Window  
Floor Sag Right to Left**

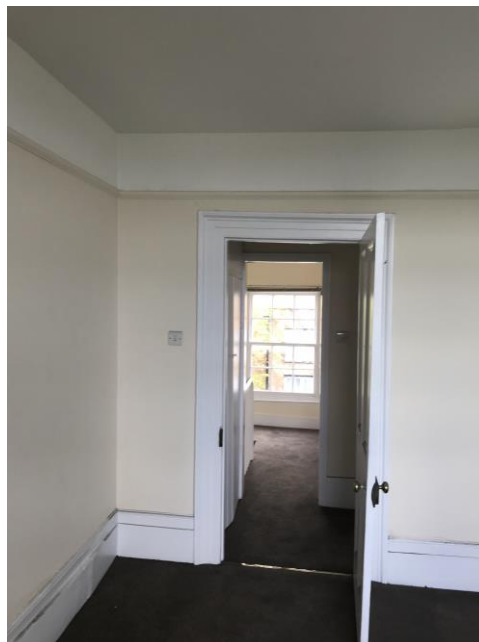
**2.1.8** The deformation of the Second floor is also reflected in the doorframe in the central wall. It is notable that the ceiling line appears to be level. However that ceiling is a modern false ceiling. The original ceiling is above and is the subject of comment in the next section.

**Second floor Deformed Doorway**

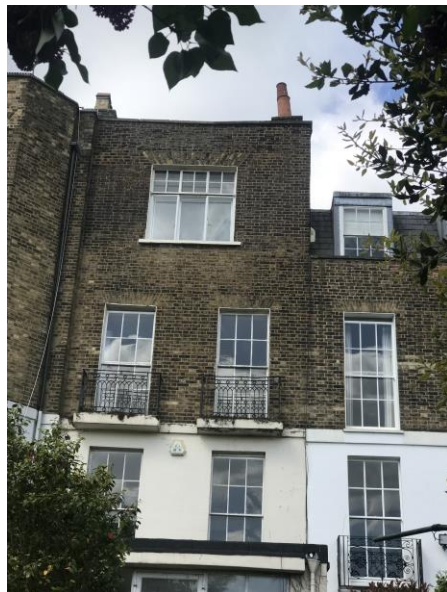
Rear Elevation

- 2.3.1 The rear elevation is plain yellow Stock facing brickwork.
- 2.3.2 Overall this elevation presents reasonable line and level and reasonable structural performance since it was constructed.
- 2.3.3 There is a small degree of sloping deformation of the First Floor window arches indicting a small degree of historic differential downward movement of the wall section between the windows but this is not serious and is a common feature of buildings of this age and form.
- 2.3.4 There is some deterioration of the brickwork at parapet level above the window arch of the Second floor and in the arch itself. This decay should be repaired repointing and resetting bricks if necessary.

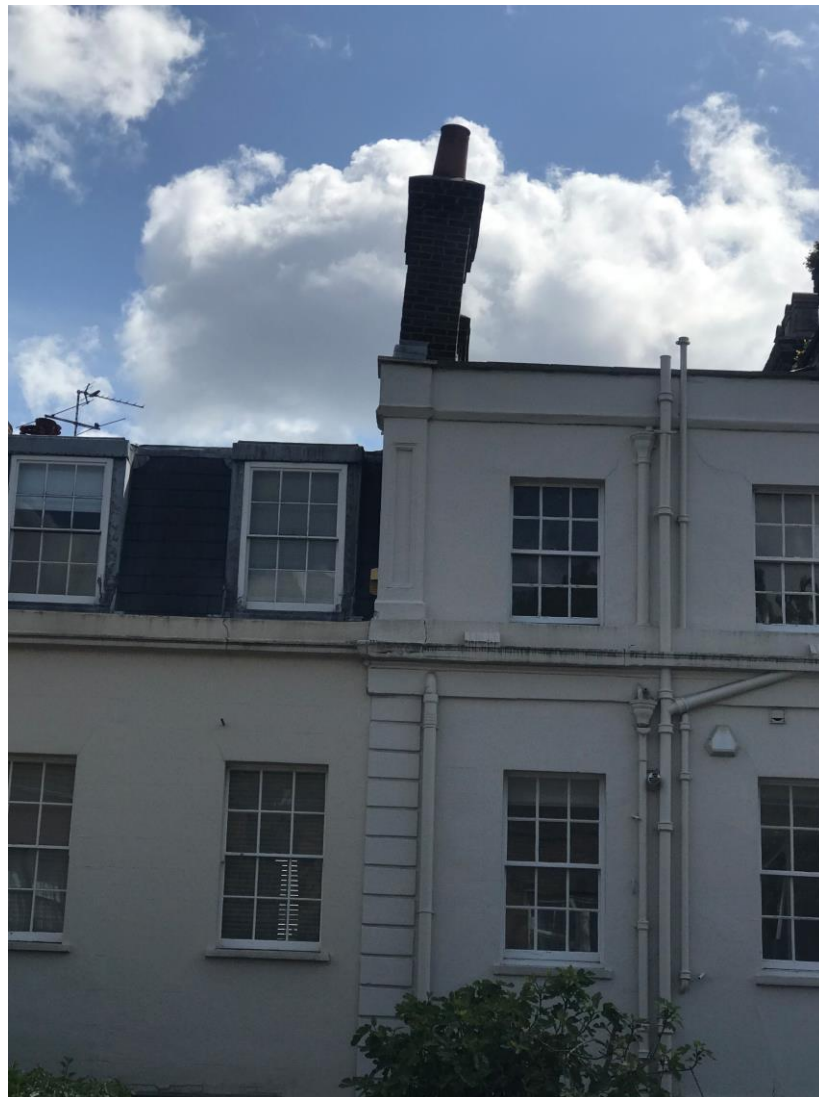
2.4.2 However above a level generally corresponding to the second floor ceiling, the chimney stacks and top section of the wall starts to lean in to the house as the centre of gravity of the chimney and wall construction is offset in that direction. The angle of lean increases with height of the stacks and the total lean has become serious. It is my estimate that the effective centroid of the chimney stack's weight now falls outside the 'middle third' of the plan sectional the base of the stacks. As such I am of the opinion that there is a real potential that the stacks are close to a situation of instability and with the accompanying potential of falling into the building. There is some propping restraint from the roof timber that was real at the time of original construction. However the defects and downward deformation of the roof construction over time has relaxed that restraint but more importantly has probably enhanced the lean progression in the chimney stacks.

Leaning Chimney Stacks

- 3.1.3** The most serious defect is with the leaning chimney stacks on the East Flank / Party Wall. It is strongly recommended that the chimney stacks are rebuilt from second floor ceiling level. In conjunction with this it is also strongly recommended that the roof structure is reconstructed with engineering input in the form of steel beams as well as the typical timbering to establish permanent and effective horizontal restraint to the flank wall and chimney stacks.
