## Highgate School, North Rd, N6 4AY Heritage Statement

Prepared for:  
Highgate School  
Document Date: 27/09/2022  
Report Reference: 2250/01  
Prepared By:  
John Clayton, Clayton Surveying Ltd

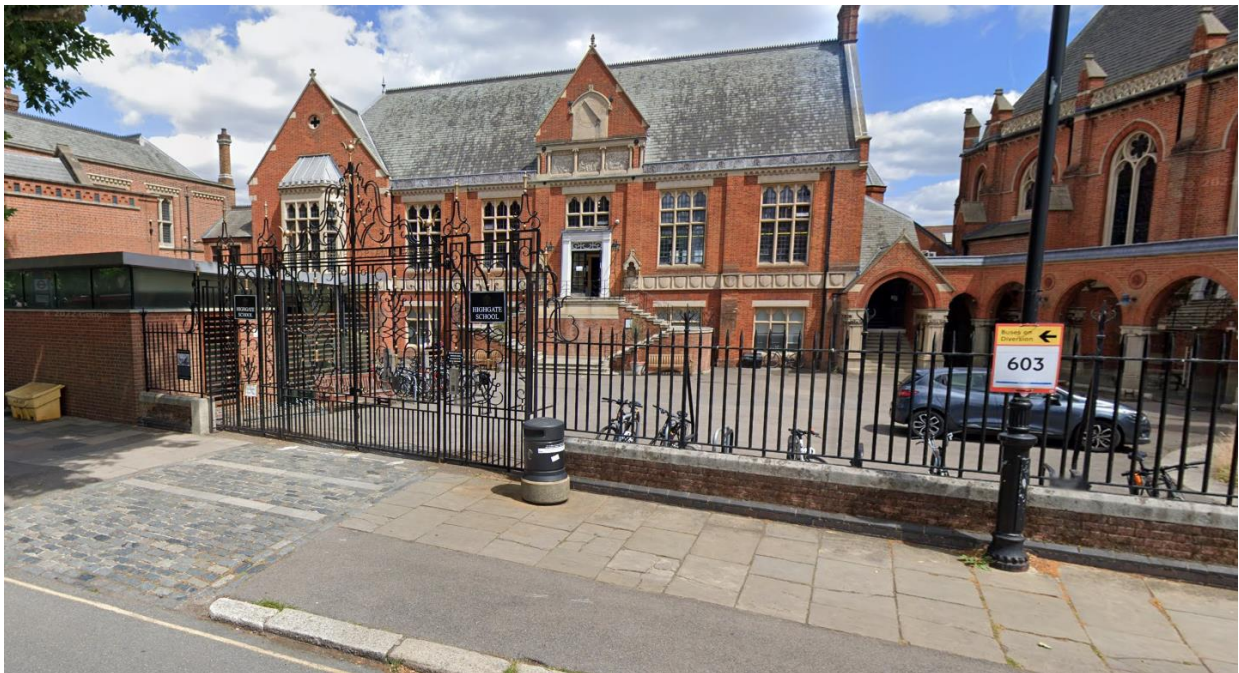
001 – Boundary railings prior to the impact damage

The cast iron railings are secured by iron supports embedded in to the reconstituted Portland stone coping stones and facing brickwork of the low-level wall. The existing coping stones were in reasonable condition prior to the accident, with only minor levels of weathering and general wear and tear visible.

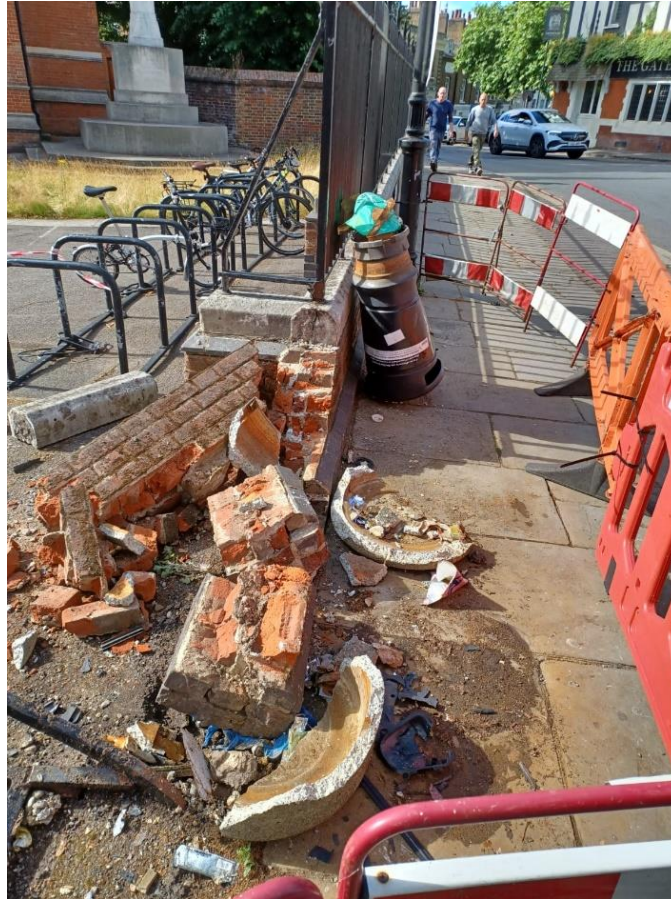
002 – Damaged wall following the vehicle impact

| Element | Defect or Issue | Recommendations |
|---|---|---|
| Brickwork | Brick wall partially demolished in the impact. | <p>The bricks have been tidied away with any sound, undamaged bricks being set aside for re-building. A small number of reclaimed bricks will be required to supplement the retained bricks.</p> <p>Any reclaimed bricks will be required to match the original bricks in terms of size, colour, texture and finish.</p> |
| Stone copings | A localised extent of reconstituted Portland stone copings were damaged in the vehicle impact. | Reconstituted Portland stone copings are to be supplied and installed to match existing. |

| Element | Defect or Issue | Recommendations |
|---|---|---|
| Mortar | Existing mortar needs to be cleaned off bricks before they can be reused. | Hydraulic lime mortar to be used for the rebuilding of the wall and bedding of coping stones. Colour and mortar type to match existing, along with the pointing profile. |

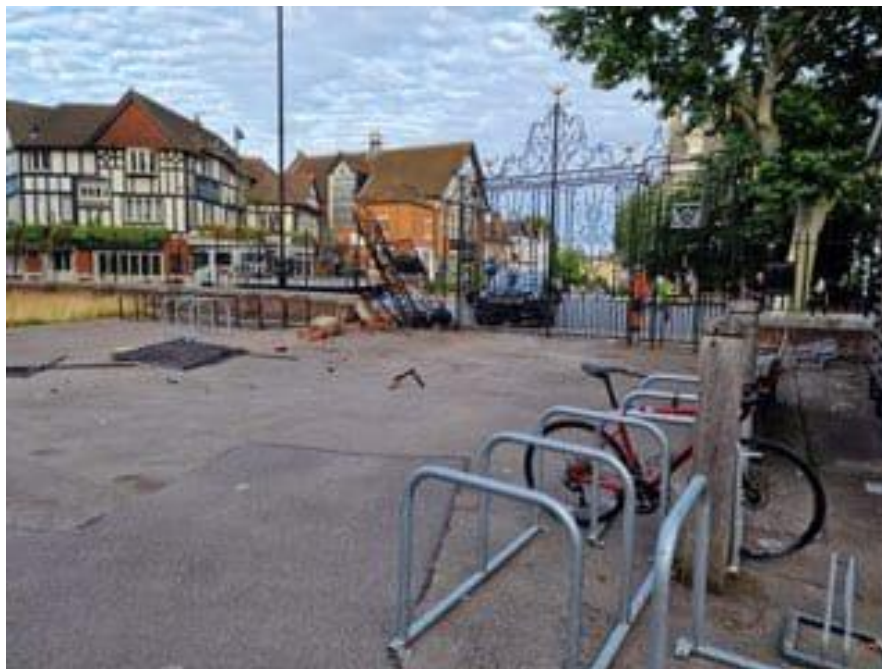
003 – Additional view of the damaged railings

| Element | Defect or Issue | Recommendations |
|---|---|---|
| Iron railings, gates and standards | The metalwork suffered extensive damage in the impact with several sections being damaged beyond repair. | The schools conservation specialist metalwork company, CT Metals, have undertaken a 3D laser scan of the existing railings and gates in order to prepare a fabrication drawing. Replacement cast iron sections are to be fabricated using new grey iron, to ensure the replacement gate and railings match existing in every regard. |

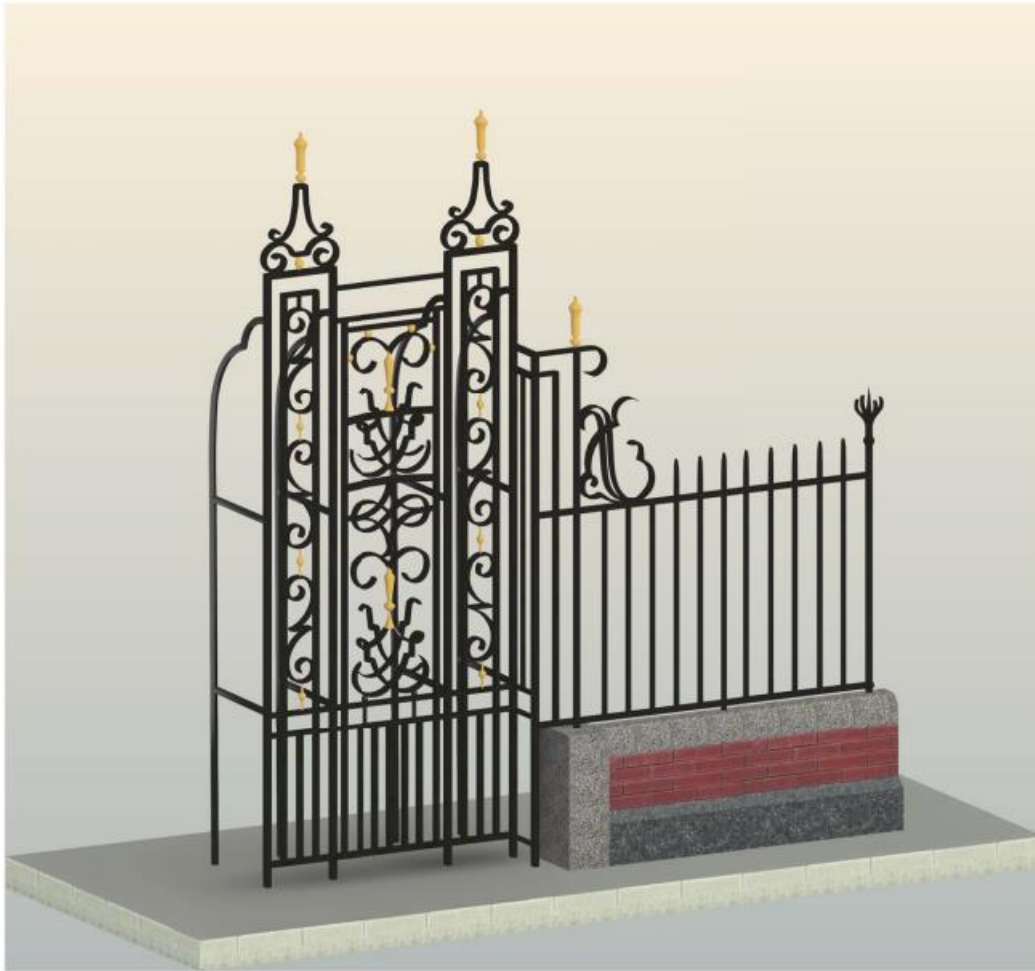
004 – General view of proposed right hand gate support and masonry wall

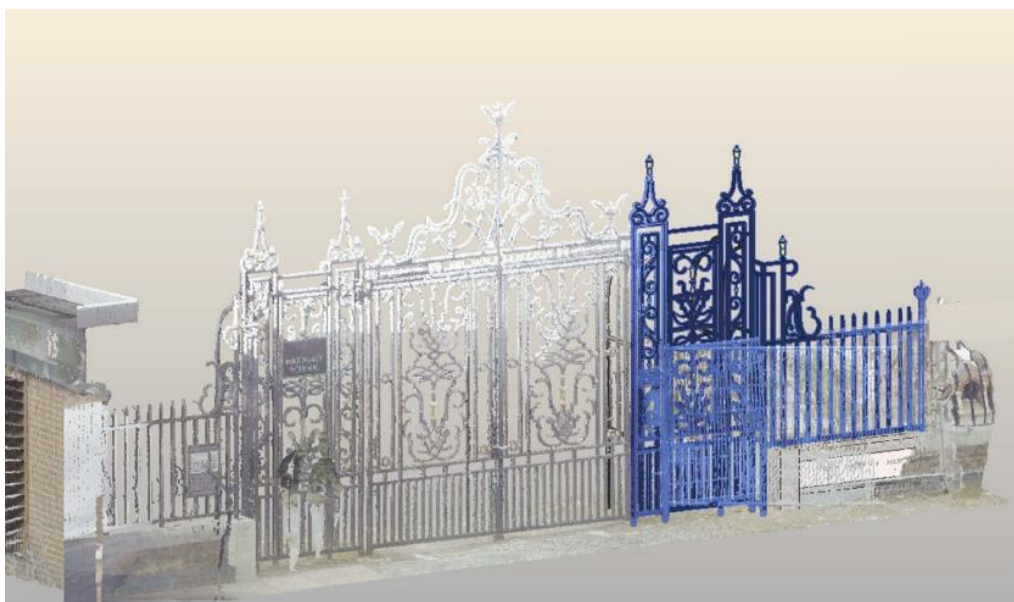
005 – 3D scan showing the damaged metalwork in blue
