# Arboricultural Appraisal

10 Ringwood Avenue, N2 9NS

Report Reference: 207123r\_AA001

Date of inspection: 26<sup>th</sup> of July 2022

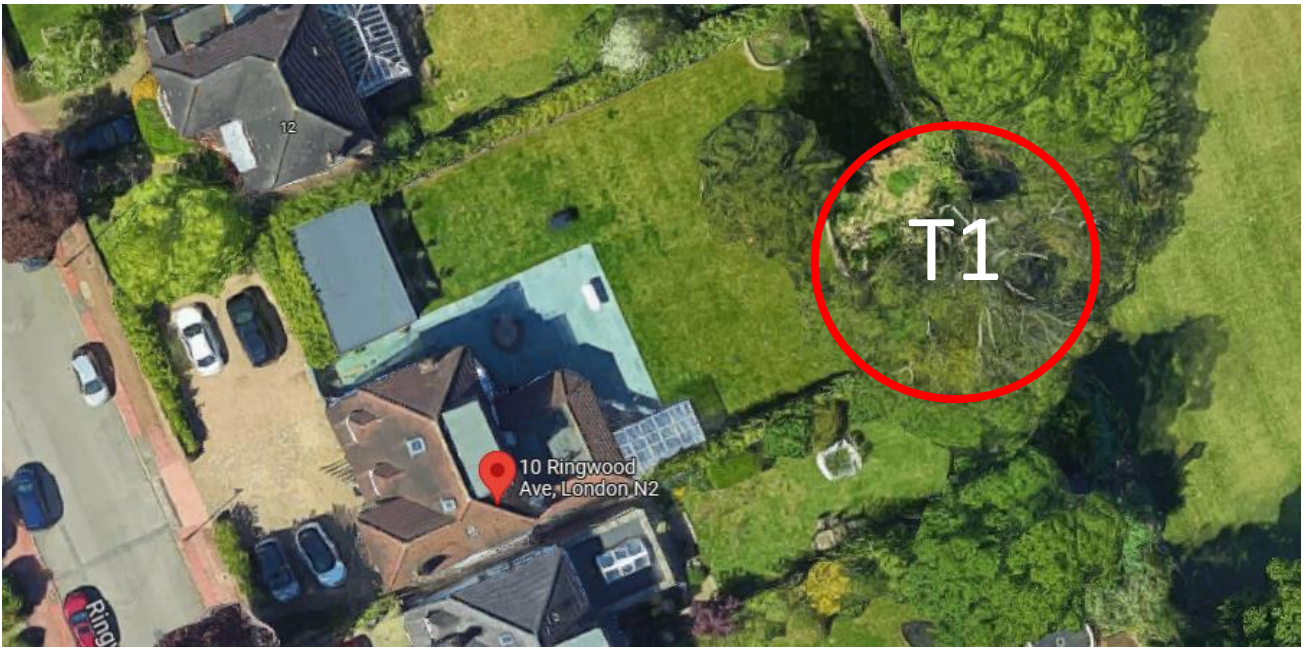
T1 is a mature Oak that situated within the rear garden of 10 Ringwood Ave, on first appearances has a die back ratio of above 80% and looks to be in trouble. There are other Oaks visible in the area some of which also look to be suffering.

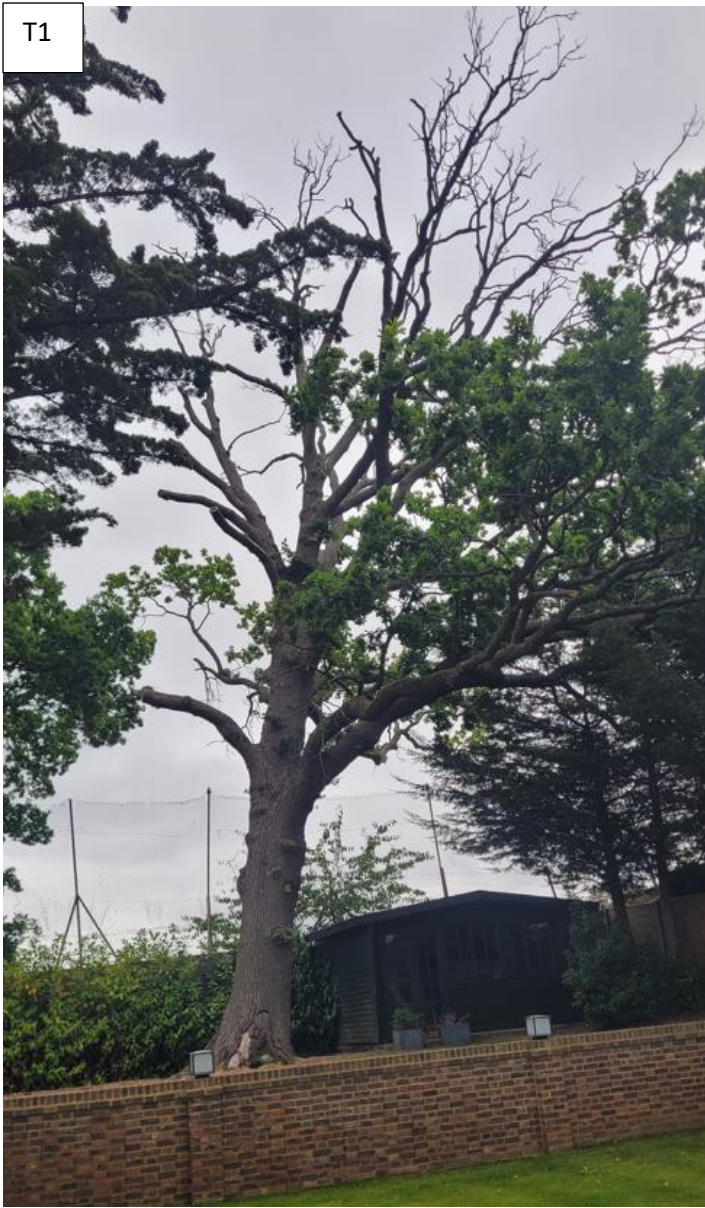
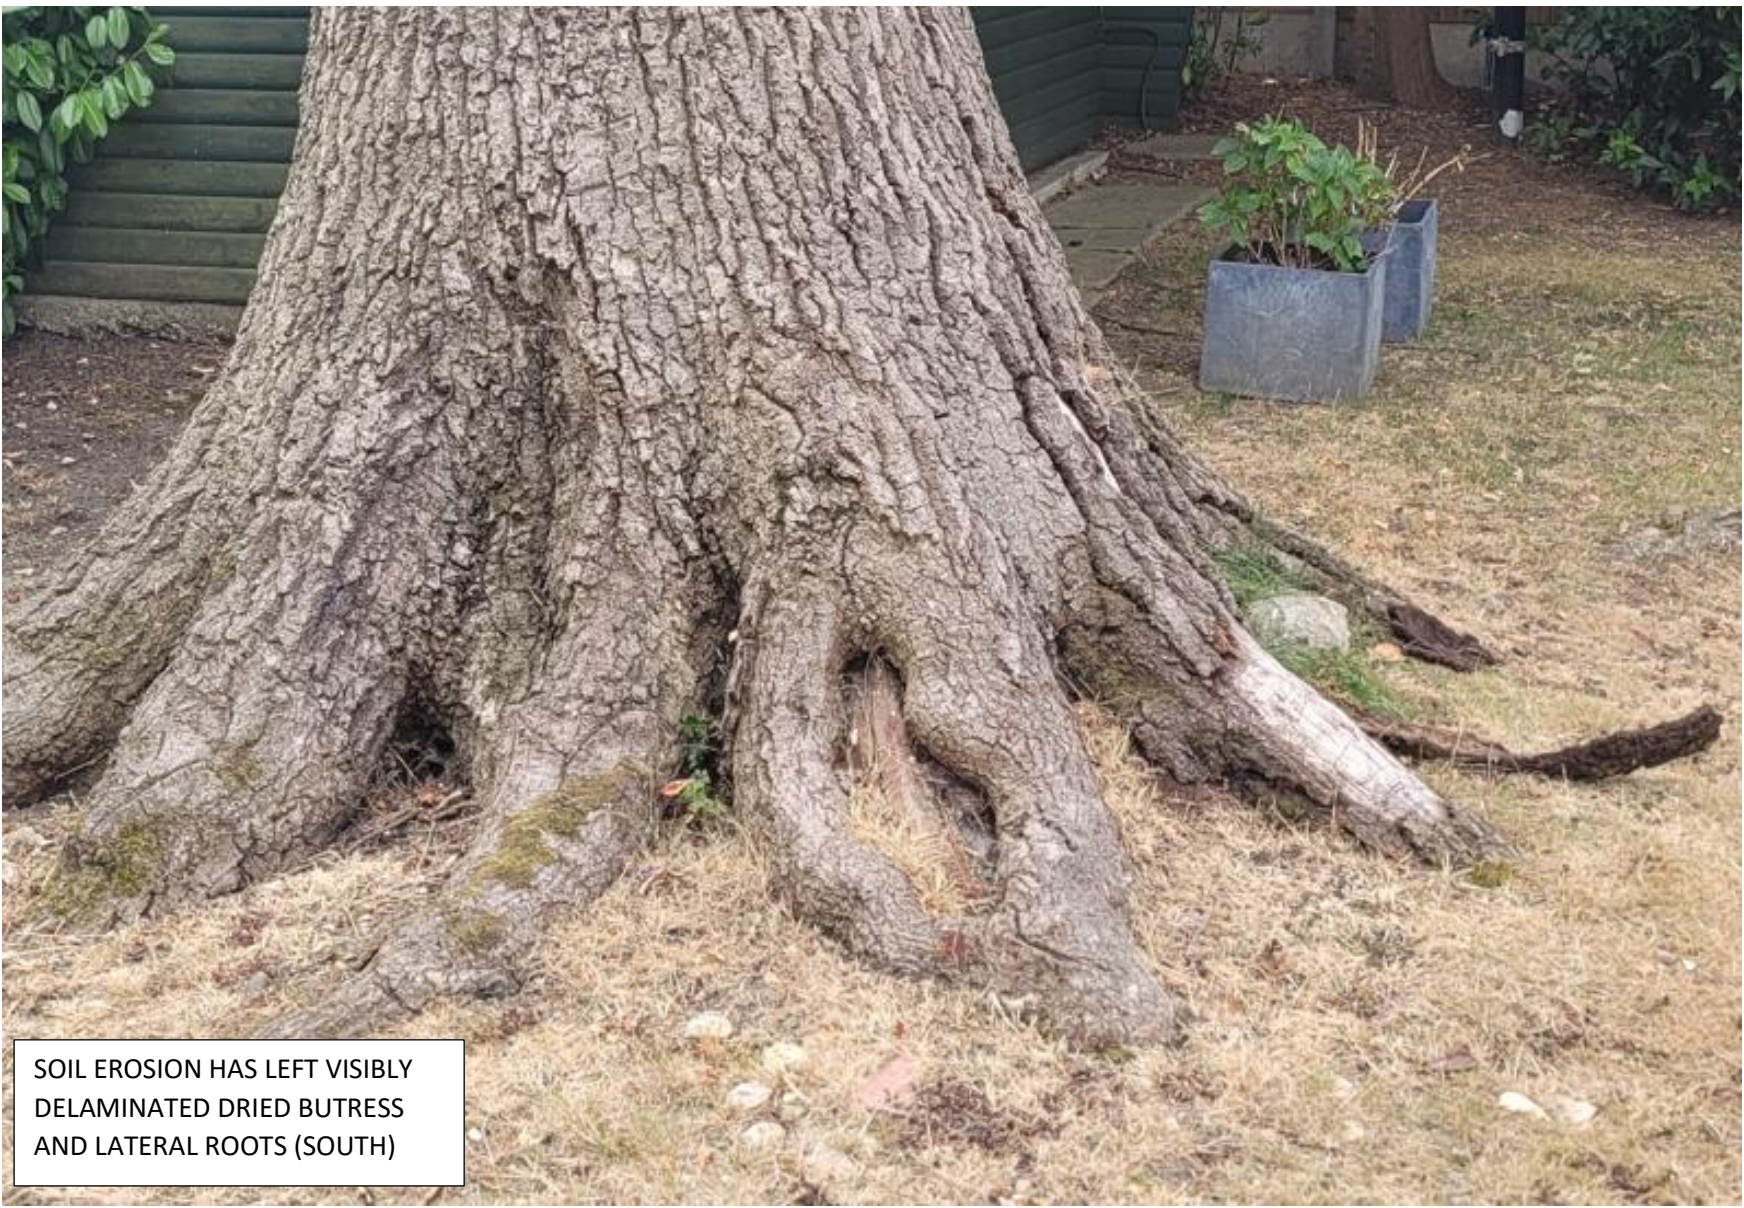
SOIL EROSION HAS LEFT VISIBLY DELAMINATED DRIED BUTRESS AND LATERAL ROOTS (SOUTH)

- 6.1 T1 has a crown die back ratio of 80%
- 6.2 T1 has delaminated buttress and lateral roots and a weak soil structure
- 6.3 T1 has stem delamination and stunted adventitious growth.
- 6.4 T1 has become infected with a parasitic fungal fruiting body that has decayed
- 6.5 T1 has an exapted SULE of up to 5 years
- 6.6 Given the buttress root proliferation, there is also a possibility that direct root interaction has borne an effect on the wall.
- 6.7 T1 would not be classified as a veteran under: Veteran Trees - A Guide to Good Management.
- 6.8 In accordance with The Occupiers Liability Act 1984 (SECTION 5) reasonable measures must be undertaken to ensure that a tree does not have a negative impact upon neighbouring land. This includes property damages or through trespass / nuisance and subsidence.

Remove T1 to ground level as soon as reasonably practicable. All works to be carried out with reference to British Standard 3998, 2010.

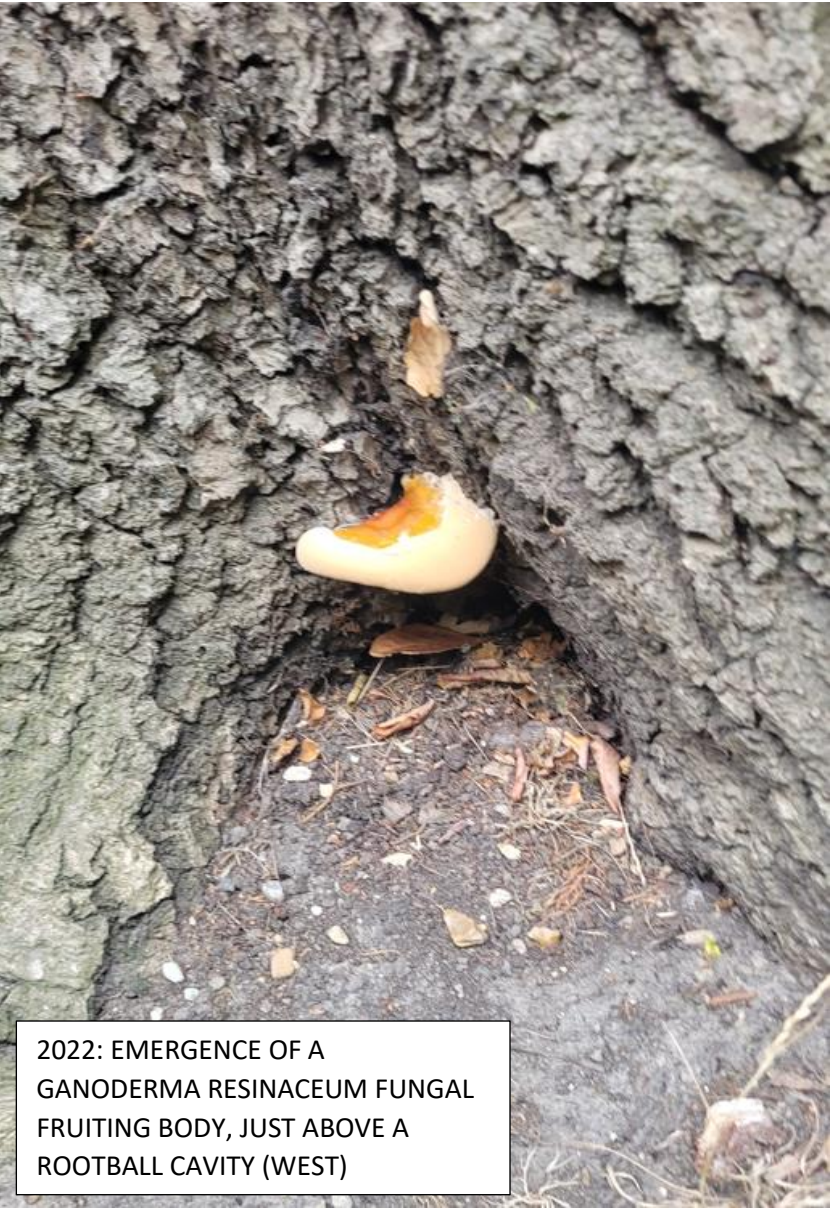
2022: EMERGENCE OF A GANODERMA RESINACEUM FUNGAL FRUITING BODY, JUST ABOVE A ROOTBALL CAVITY (WEST)

T1 is within a spiral of physiological decline that will see no bud production within the next five years. It has a lean towards the adjacent property with dried out and delaminated structural roots contained within an eroded, weak soil profile. It has become infected with a white rot fungus. There is a serious risk of failure, though more likely this specimen will just entrench further and die.

An investigation into the stability of this specimen would be required annually, to determine any further fungal decay through the progression of *G. Resinaceum*, which is parasitic fungi known to destabilise through the consumption of lignin. D.Lonsdale suggests that *G. Resinaceum* can decay more extensively due to its parasitic nature, resulting in a greater consumption of cellulose in addition to lignin, which can lead to windthrow and/or stem fracture (*Principles of Tree Hazard Management, P107*). This constant investigation would be a draconian and costly imposition placed upon a tree that has outlasted its preservation status, as it would just be waiting for the tree to die before Tree Preservation Order (TPO) relevance is no longer a factor.

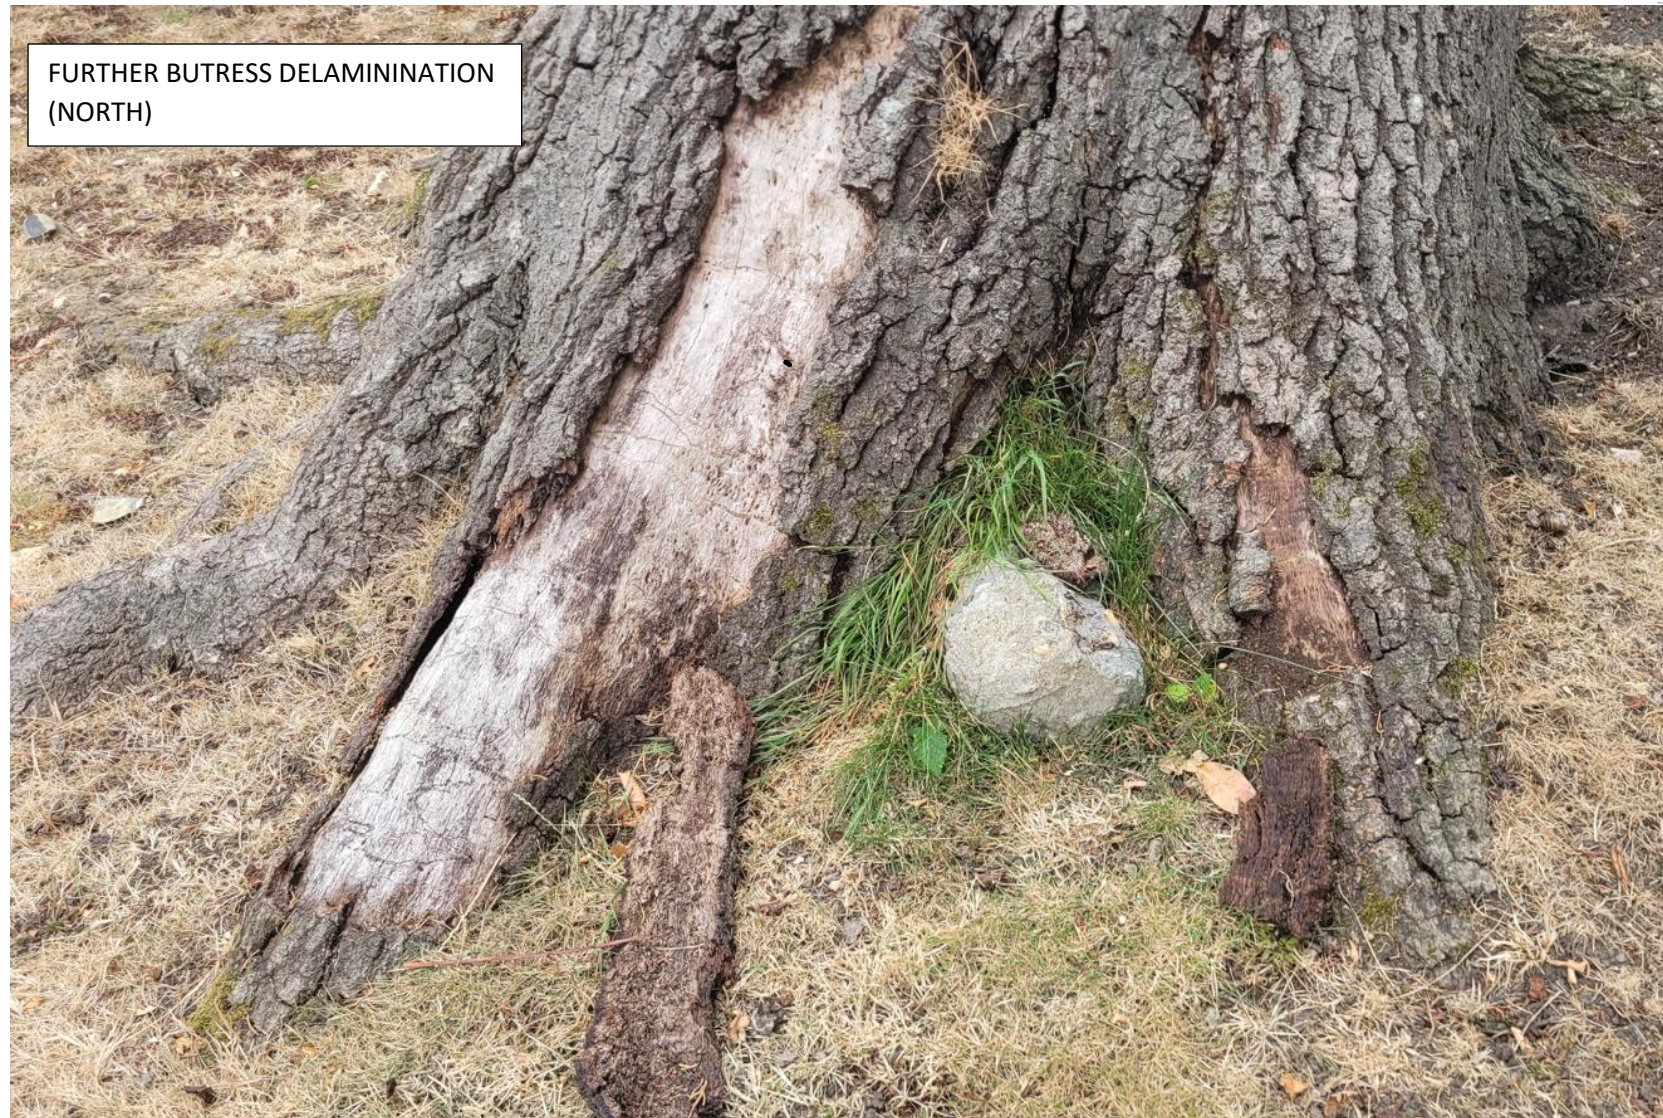
FURTHER BUTRESS DELAMINATION  
(NORTH)

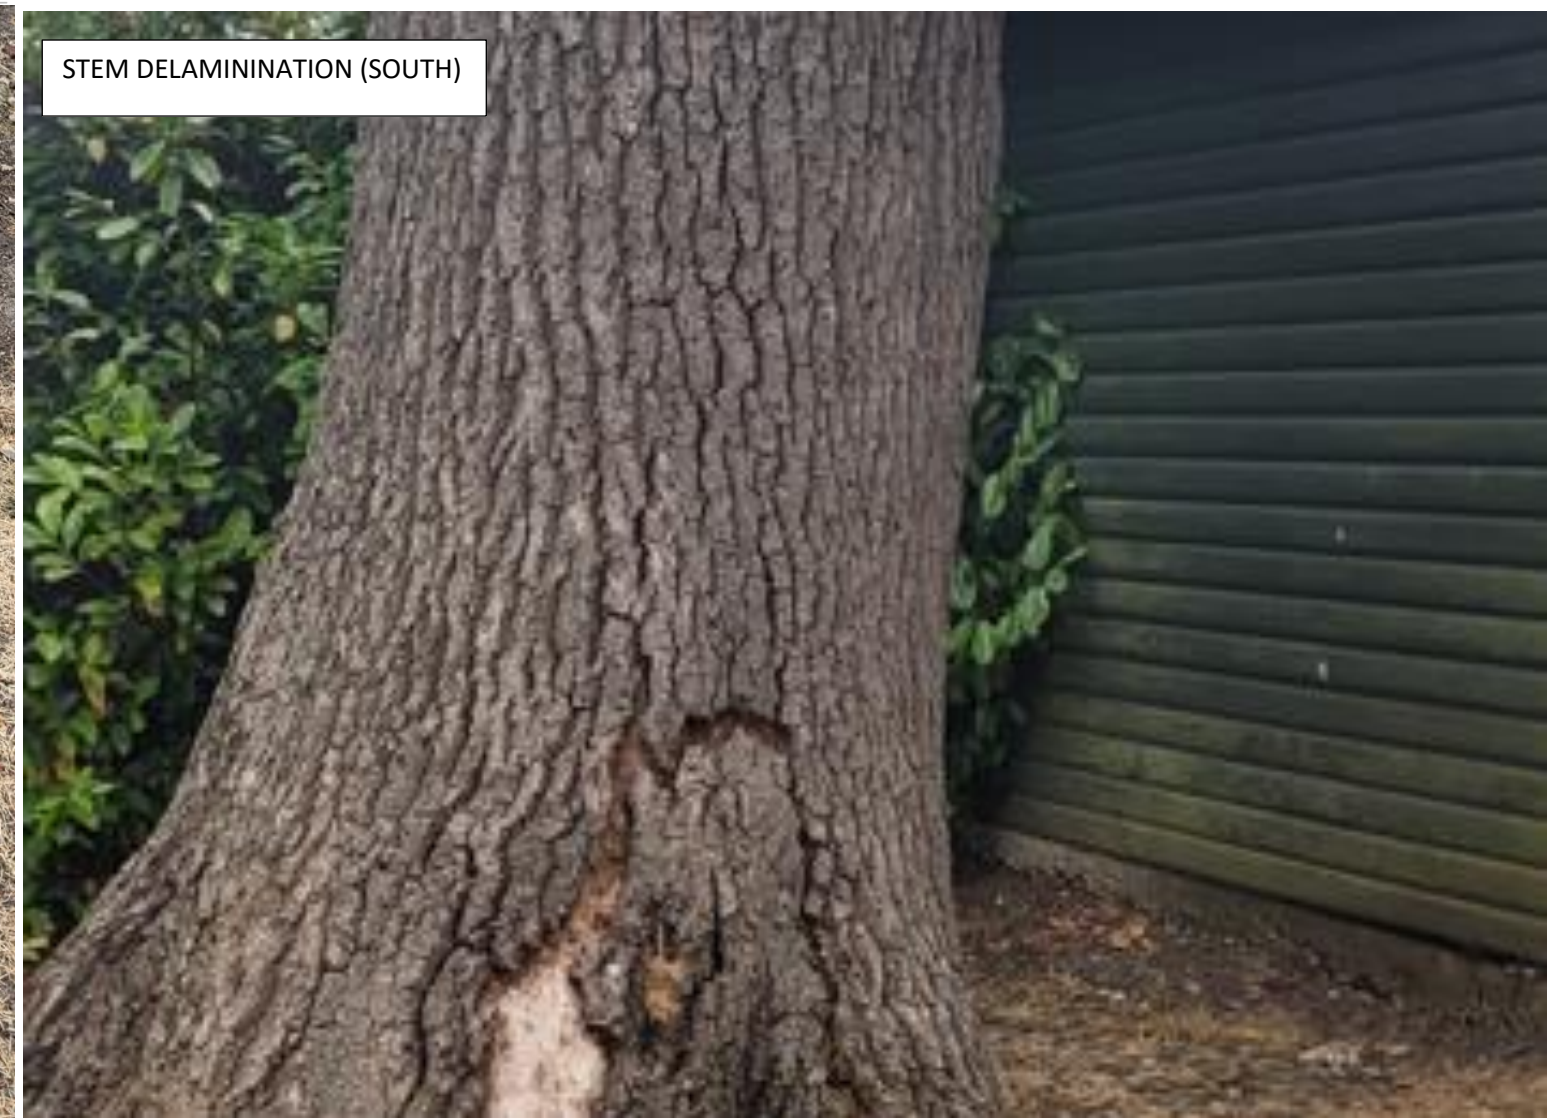
STEM DELAMINATION (SOUTH)

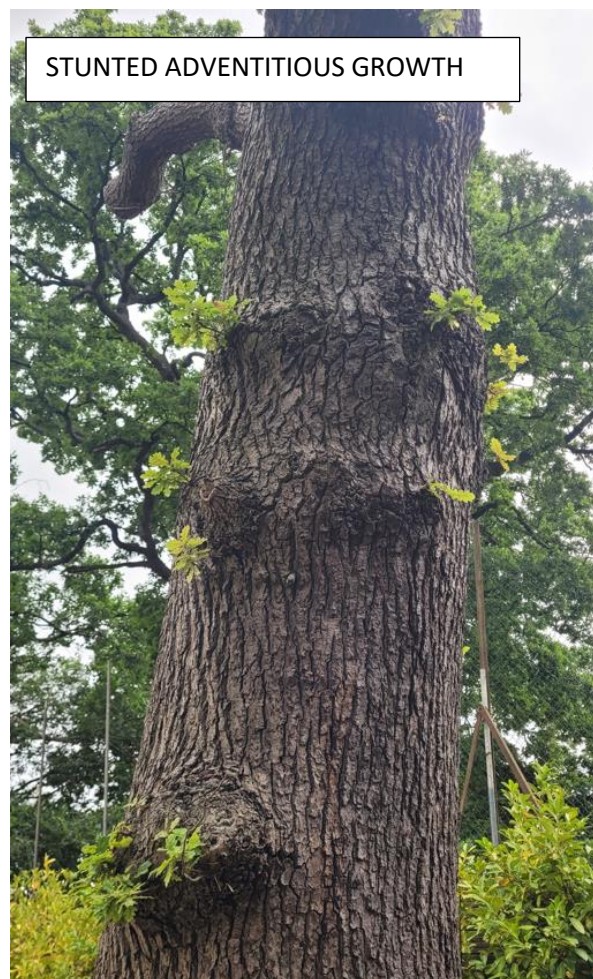
STUNTED ADVENTITIOUS GROWTH

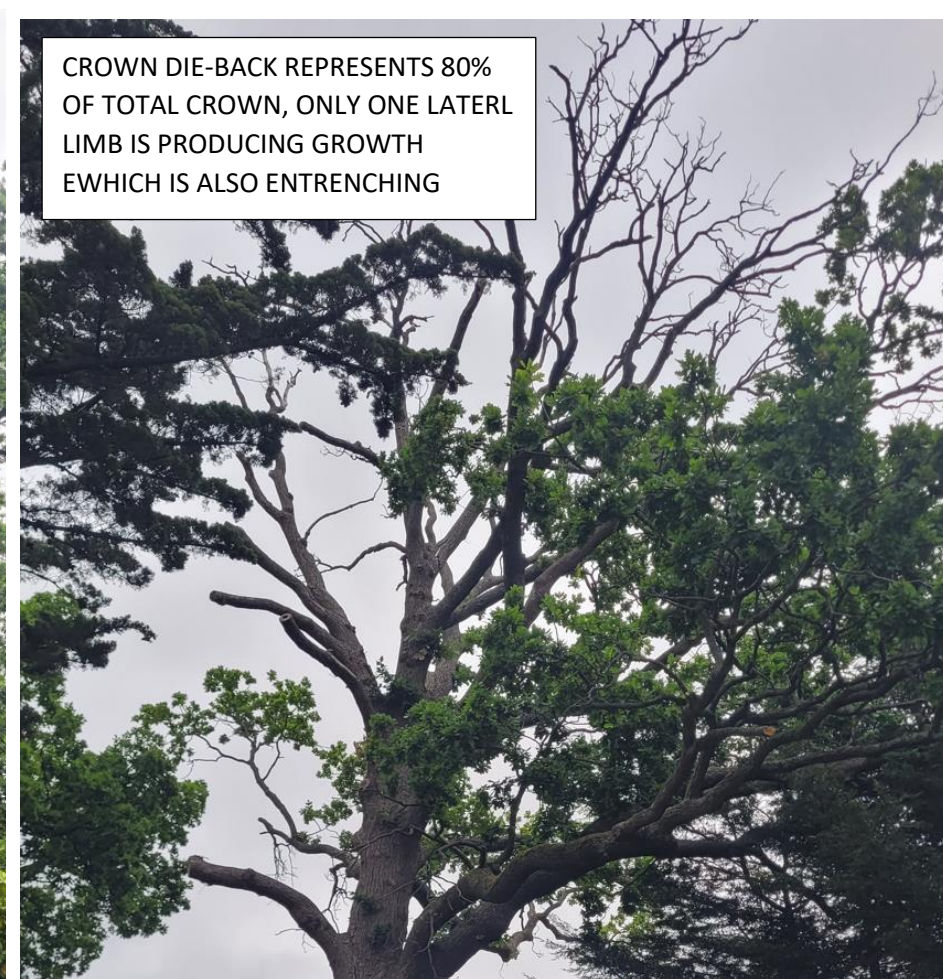
CROWN DIE-BACK REPRESENTS 80%  
OF TOTAL CROWN, ONLY ONE LATERL  
LIMB IS PRODUCING GROWTH  
EWHICH IS ALSO ENTRENCHING
