# Arboricultural Appraisal Report

## Subsidence Damage Investigation at:

135 Dukes Avenue  
London  
N10 2QD

| MWA REF: | SUB220720-10313Rev01 |

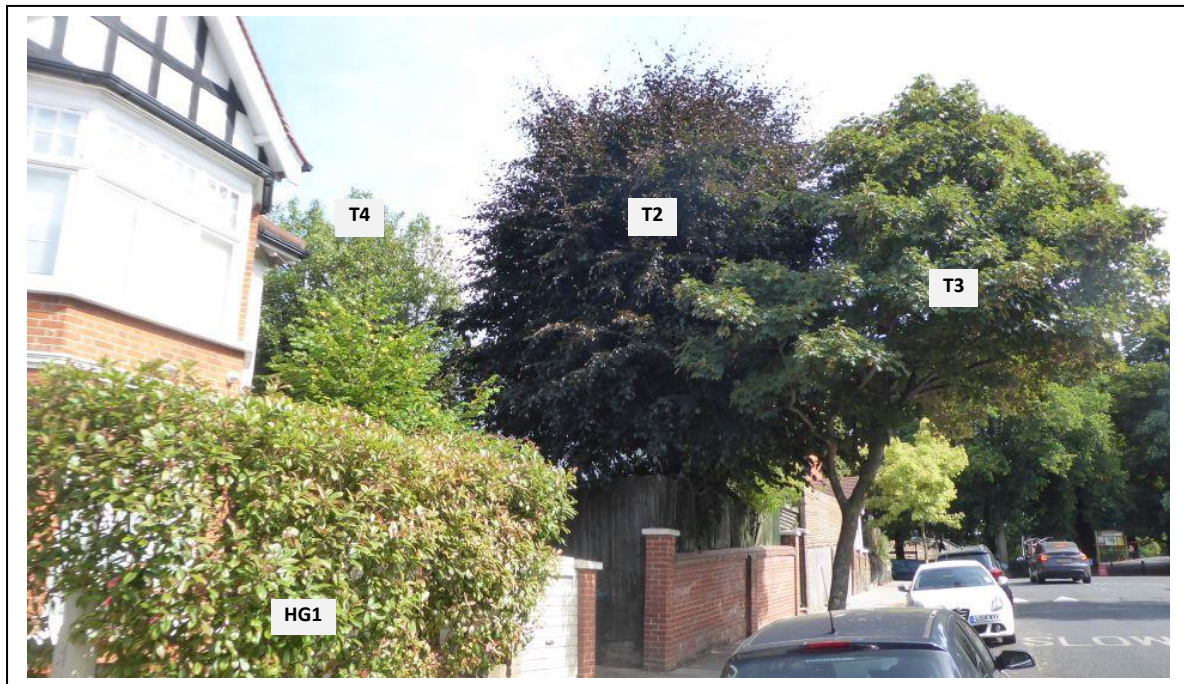
Roots were observed to a depth of 1.5m bgl in TP/BH1, to 0.75m bgl in TP/BH2 and to 1.0m bgl in TP/BH3, and recovered samples have been positively identified (using anatomical analysis) as *Fagus* spp. and broadleaved species, too juvenile for positive identification [possibly also *Fagus* spp.]; the origin of which will be T2 Beech, confirming its influence on the soils below the foundations.

View of T2 Beech and T3 Maple, with HG1 Photinia hedgerow to foreground and T4 Pear visible beyond

| Tree No. | Species | Ht (m) | Dia (mm) | Crown Spread (m) | Dist. to building (m) | Age Classification | Ownership |
|---|---|---|---|---|---|---|---|
| Recommendation | | Remove (fell) to near ground level and treat stump to inhibit regrowth. | | | | | |

| Tree No. | Species | Ht (m) | Dia (mm) | Crown Spread (m) | Dist. to building (m) | Age Classification | Ownership |
|---|---|---|---|---|---|---|---|
| Recommendation | | Re-prune to previous points and thereafter re-prune on a triennial cycle to maintain at reduced dimensions.<br>- or -<br>Remove (fell) to near ground level and treat stump to inhibit regrowth if evidence confirms its involvement | | | | | |
| Recommendation | | Re-prune to previous points at approx. 5.0m and thereafter re-prune on a triennial cycle to maintain at reduced dimensions.<br>- or -<br>Remove (fell) to near ground level and treat stump to inhibit regrowth if evidence confirms its involvement. | | | | | |

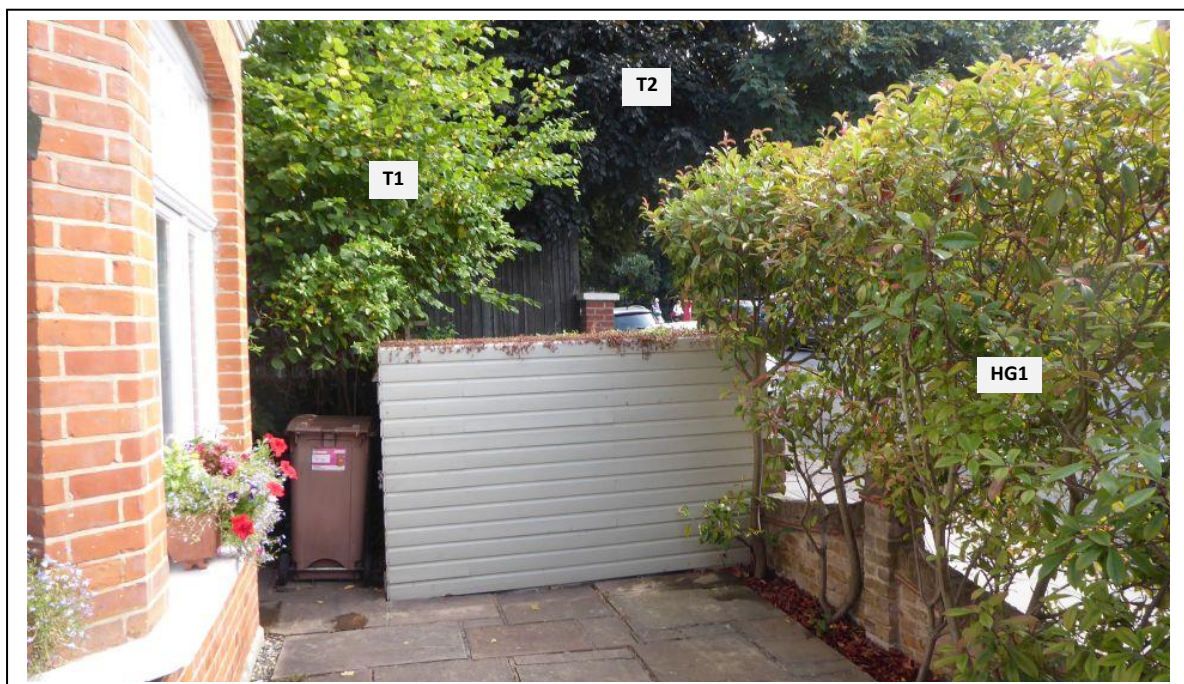
Irrespective of the identification of recovered root samples, the roots of the T1 Hazel will also be present below foundation level in proximity to the area of movement/damage and contributing to the influence of soil moisture and volumes. T3 Maple and T4 Pear may also be involved however, the degree of their involvement is difficult to fully assess while the influence of the much larger T2 Beech remains.

View of T1 Hazel and HG1 Photinia hedgerow with T2 Beech visible beyond

| Tree No. | Species | Ht (m) | Dia (mm) | Crown Spread (m) | Dist. to building (m) | Age Classification | Ownership |
|---|---|---|---|---|---|---|---|
| Recommendation | | Remove (fell) all to near ground level and treat stump to inhibit regrowth. | | | | | |

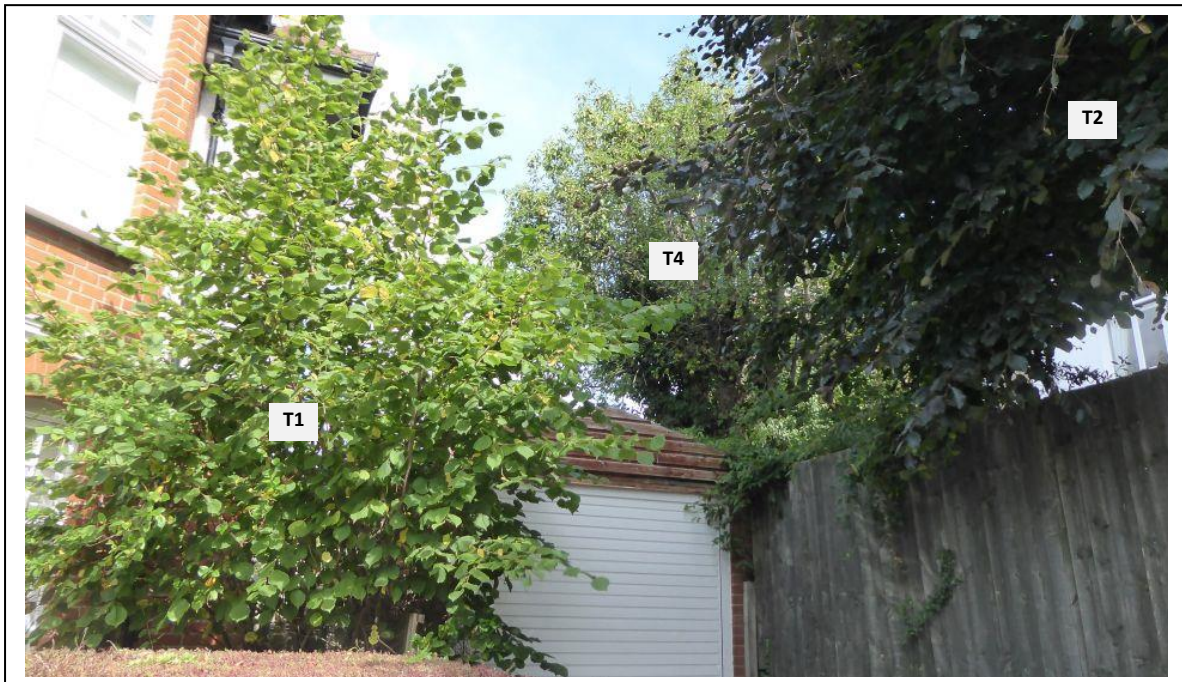
View of T1 Hazel to foreground, with T2 Beech to right of frame and T4 Pear visible beyond

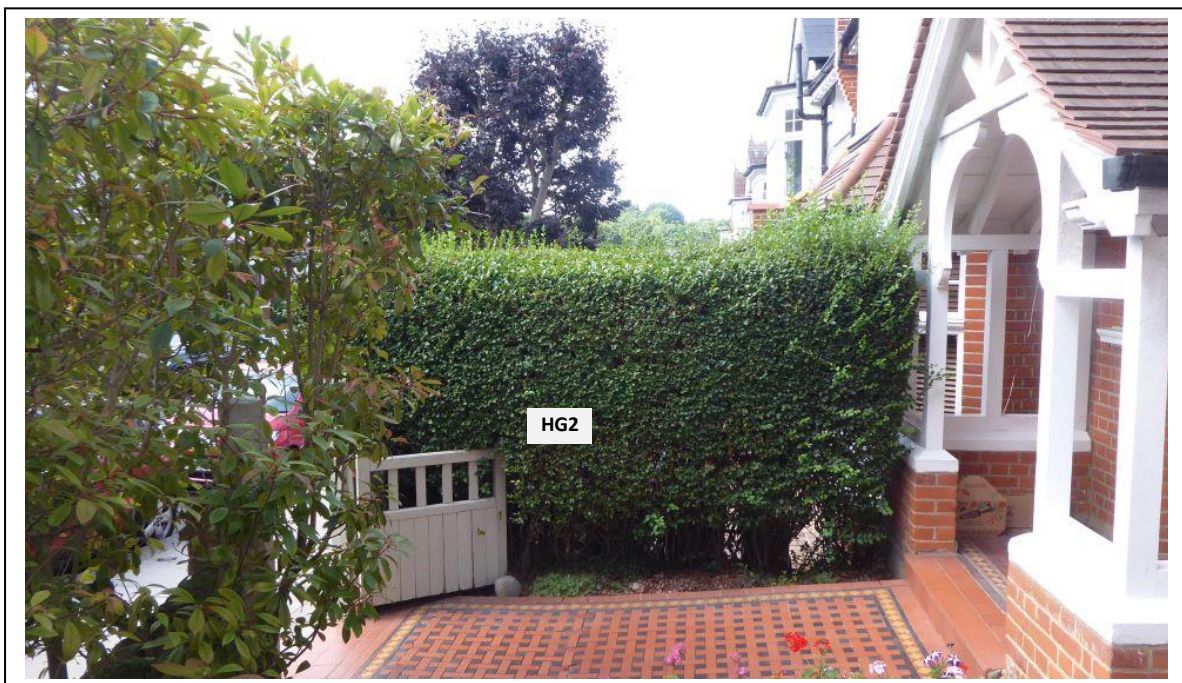
View of HG2 Privet hedgerow

| Tree No. | Species | Ht (m) | Dia (mm) | Crown Spread (m) | Dist. to building (m) | Age Classification | Ownership |
|---|---|---|---|---|---|---|---|
| Recommendation | | Cut back width to leave hedge no wider than 0.5m and trim on an annual cycle thereafter to maintain at broadly reduced dimensions. | | | | | |
