BS 5837:2012 Tree Survey, Arboricultural Impact Assessment and Tree Constraints/Protection Plan  
Including Method Statement

# 219 Philip Lane, London N15 4HL

Report Reference: 120922/RP/PL  
Tree Constraints and Root Protection Plan: AA01TCPP/PL

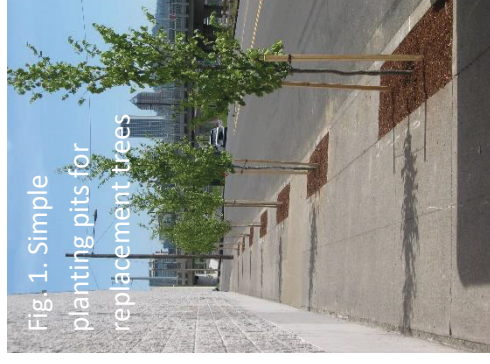
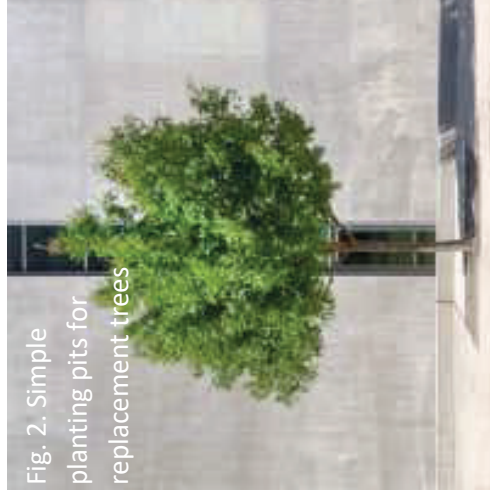
6.2 There are 3 initial tree removals proposed **T2, T3** and **T5**. All these trees are very low quality and are not conducive to the final use of the area. The garden will need to be accessed by people with special needs and so ease of entry and low obstacles is paramount. The replacement trees will need to be suitable safety wise and be able to flourish with straightforward maintenance. These can be placed in areas near to original planting and planting holes can be left in the concrete with the option of a porous covering over the open planting pit. (*See right photo 1 & 2*)

7.3 **Initial tree works:** There are three tree removals proposed **T2, T3** and **T5**. These can be removed before works begin and replacement trees can be planted after.

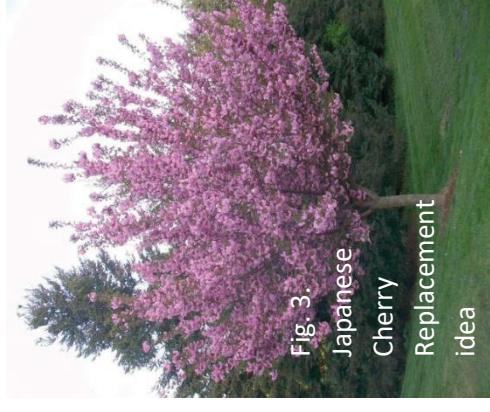
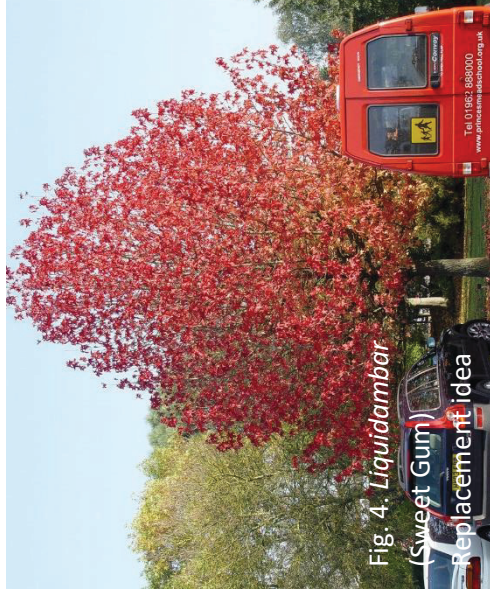
6.3 The proposed tree removals consists of 2 cherries and 1 apple tree. These could be replaced by more ornamental trees with lower maintenance and less falling debris. The two cherries could be replaced by non-fruiting ornamental cherries such as the Japanese cherry of which there are many varieties. With maybe a non-native replacement for the apple such as the sweet gum (*Liquidambar*) which has brilliant autumn colour giving a contrasting background to the area. The Sweet Gum is easy to grow and drought tolerant. (*See right photo 3 & 4*)

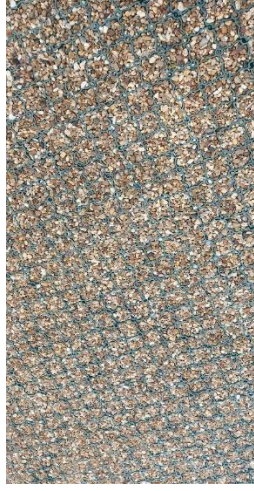
6.4 **Potential Root Damage:** According to the drawing, the resurfacing will impact on to the RPA of **T5**. This is a third-party tree and so it will be imperative to protect the root system of this tree. The tree is a category 'A' tree which means it will have 40 years

plus to contribute to the landscape. Mitigation will consist of laying no concrete within this area and laying a porous layer for water and protection with access. One idea would be to place a cellular confinement system for ground protection with gravel as the substrate or just gravel on it own.
