# Arboricultural Consultancy for Aviva

| Insured | Miss Nava Orstein | Address | 112 Mount View Road, London, N4 4JX | | |
| Report Date | 16/06/2021 | | | | |

**Scope of Report:** To survey the property and determine significant vegetation contributing to subsidence damage, make recommendation for remedial action and assess initial mitigation and recovery prospects. The survey does not make an assessment for decay or hazard evaluation.

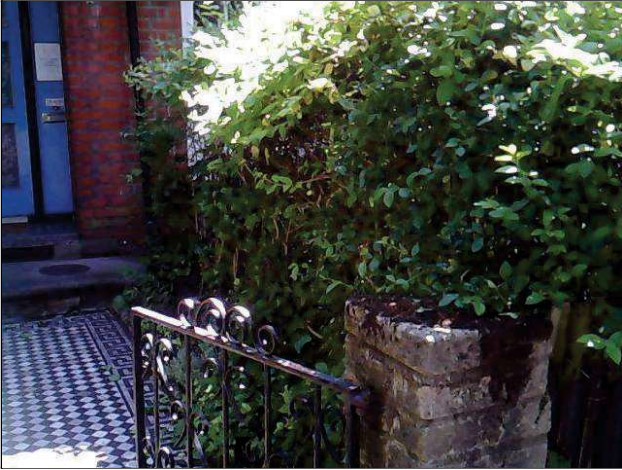
H1 - Mixed species hedge

| Tree No. | Species | Age Cat | Approx. Height (m) | Distance to Building (m) * | Ownership | Action | Requirement |
|---|---|---|---|---|---|---|---|
| H1 | Mixed species hedge | 1 | 2 | 1.3 | C - Insured | Action to avoid future risk | Maintain at broadly current dimensions by way of regular pruning. Hedge comprises Honeysuckle, Ivy and Privet |

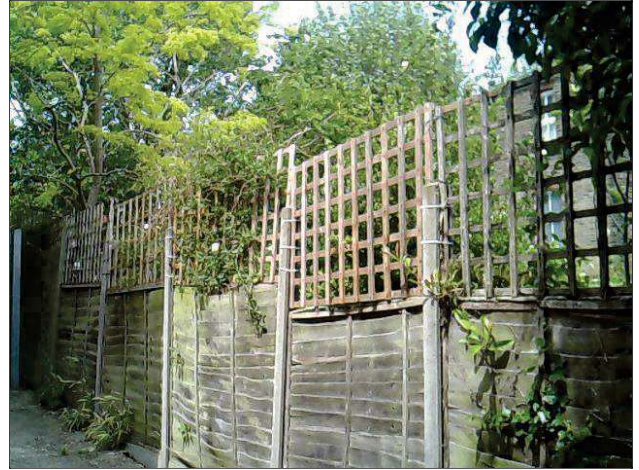
SG2 - Mixed species shrubs

| Tree No. | Species | Age Cat | Approx. Height (m) | Distance to Building (m) * | Ownership | Action | Requirement |
|---|---|---|---|---|---|---|---|
| SG2 | Mixed species shrubs | 1 | 3 | 3.5 | A - Third Party | No action | No works. Including Rose, Pyracantha, Holly and Jasmine |

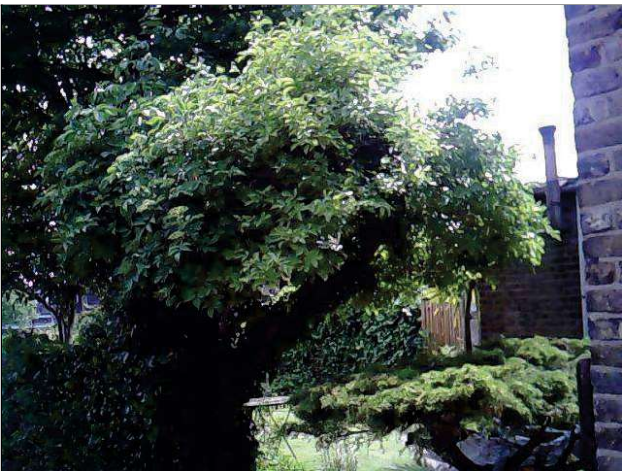
T7 - Elder

Our survey of the site identified the London Plane (T2), False Acacia (T5), Elder (T7) and Cherry (T8), given their position relative to the damage it is our opinion that the roots identified will emanate from this vegetation.

| Tree No. | Species | Age Cat | Approx. Height (m) | Distance to Building (m) * | Ownership | Action | Requirement |
|---|---|---|---|---|---|---|---|
| T7 | Elder | 1 | 3.2 | 4.2 | C - Insured | Remove | Remove close to ground level and treat stump to inhibit regrowth. |

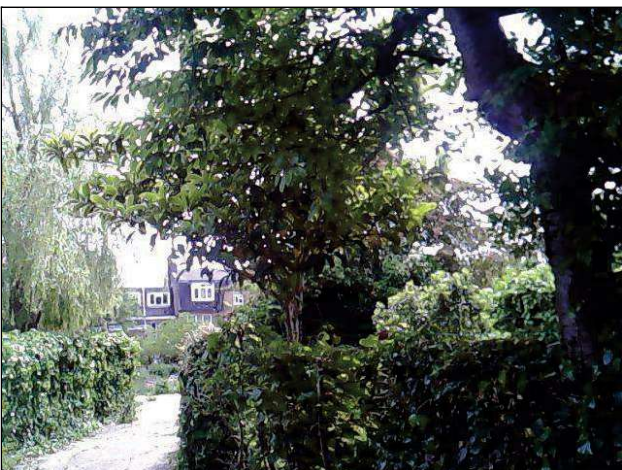
T9 - Loquat

| Tree No. | Species | Age Cat | Approx. Height (m) | Distance to Building (m) * | Ownership | Action | Requirement |
|---|---|---|---|---|---|---|---|
| T9 | Loquat | 1 | 4.2 | 10 | C - Insured | No action | No works. |

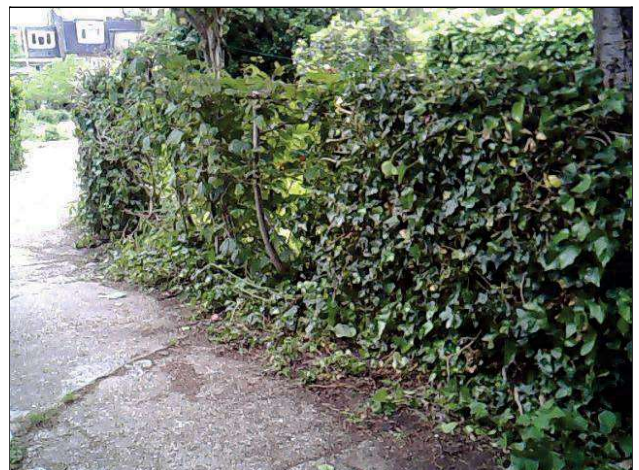
H2 - Mixed species hedge

| Tree No. | Species | Age Cat | Approx. Height (m) | Distance to Building (m) * | Ownership | Action | Requirement |
|---|---|---|---|---|---|---|---|
| H2 | Mixed species hedge | 1 | 1.6 | 4.4 | C - Insured | Action to avoid future risk | Maintain at broadly current dimensions by way of regular pruning. Hedge includes Ivy, Pyracantha, Sycamore, Ash and Cherry |

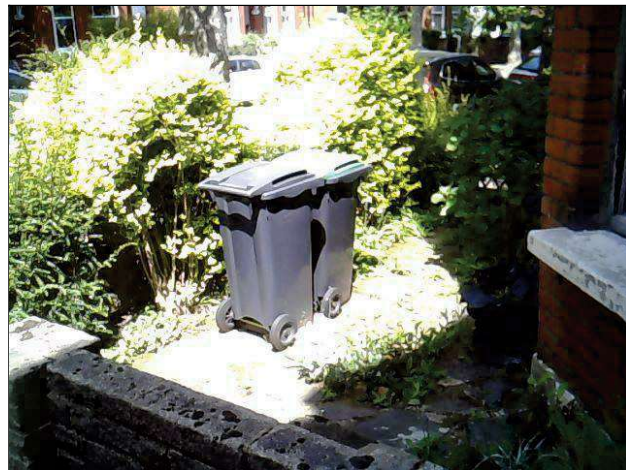
SG1 - Mixed species shrubs

| Tree No. | Species | Age Cat | Approx. Height (m) | Distance to Building (m) * | Ownership | Action | Requirement |
|---|---|---|---|---|---|---|---|
| SG1 | Mixed species shrubs | 1 | 2 | 2 | C - Insured | No action | No works. Lonicera, Privet, Holly, Hydrangea and Fuchsia |

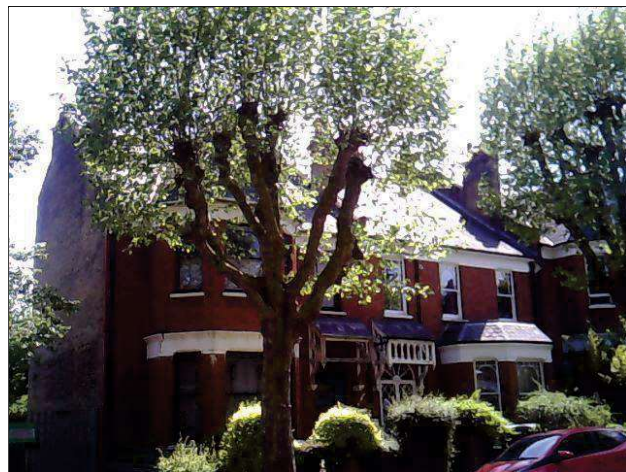
T2 - Plane (London)

The size and proximity of the above vegetation is consistent with the location of damage; accordingly, we have identified their collective / cohesive influence as the primary cause of the subsidence damage.

| Tree No. | Species | Age Cat | Approx. Height (m) | Distance to Building (m) * | Ownership | Action | Requirement |
|---|---|---|---|---|---|---|---|
| T2 | Plane (London) | 1 | 11 | 4.8 | B - Local Authority | Remove | Remove close to ground level; do not treat stump due to translocation risk. Where such a risk exists, we advise that any emergent regrowth is removed annually. |

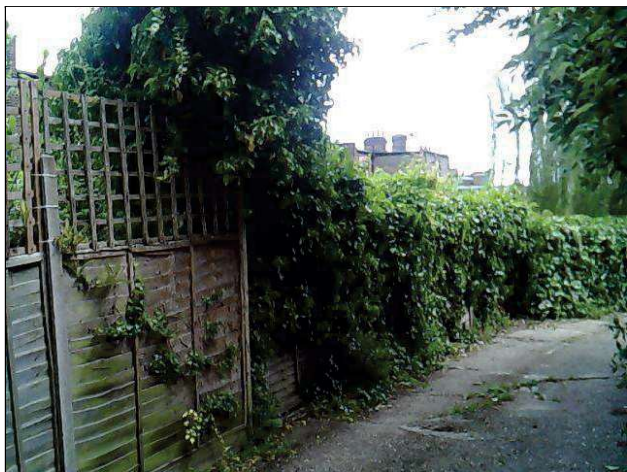
C1 - Ivy

| Tree No. | Species | Age Cat | Approx. Height (m) | Distance to Building (m) * | Ownership | Action | Requirement |
|---|---|---|---|---|---|---|---|
| C1 | Ivy | 1 | 3.5 | 5.3 | E - Boundary Veg (ownership to be confirmed) | No action | No works. |
