# Geotechnical Survey Report

FSI Ref: 24247  
Issue Date: May 2022

Risk Address: 135 Dukes Avenue  
Haringey  
London  
N10 2QD

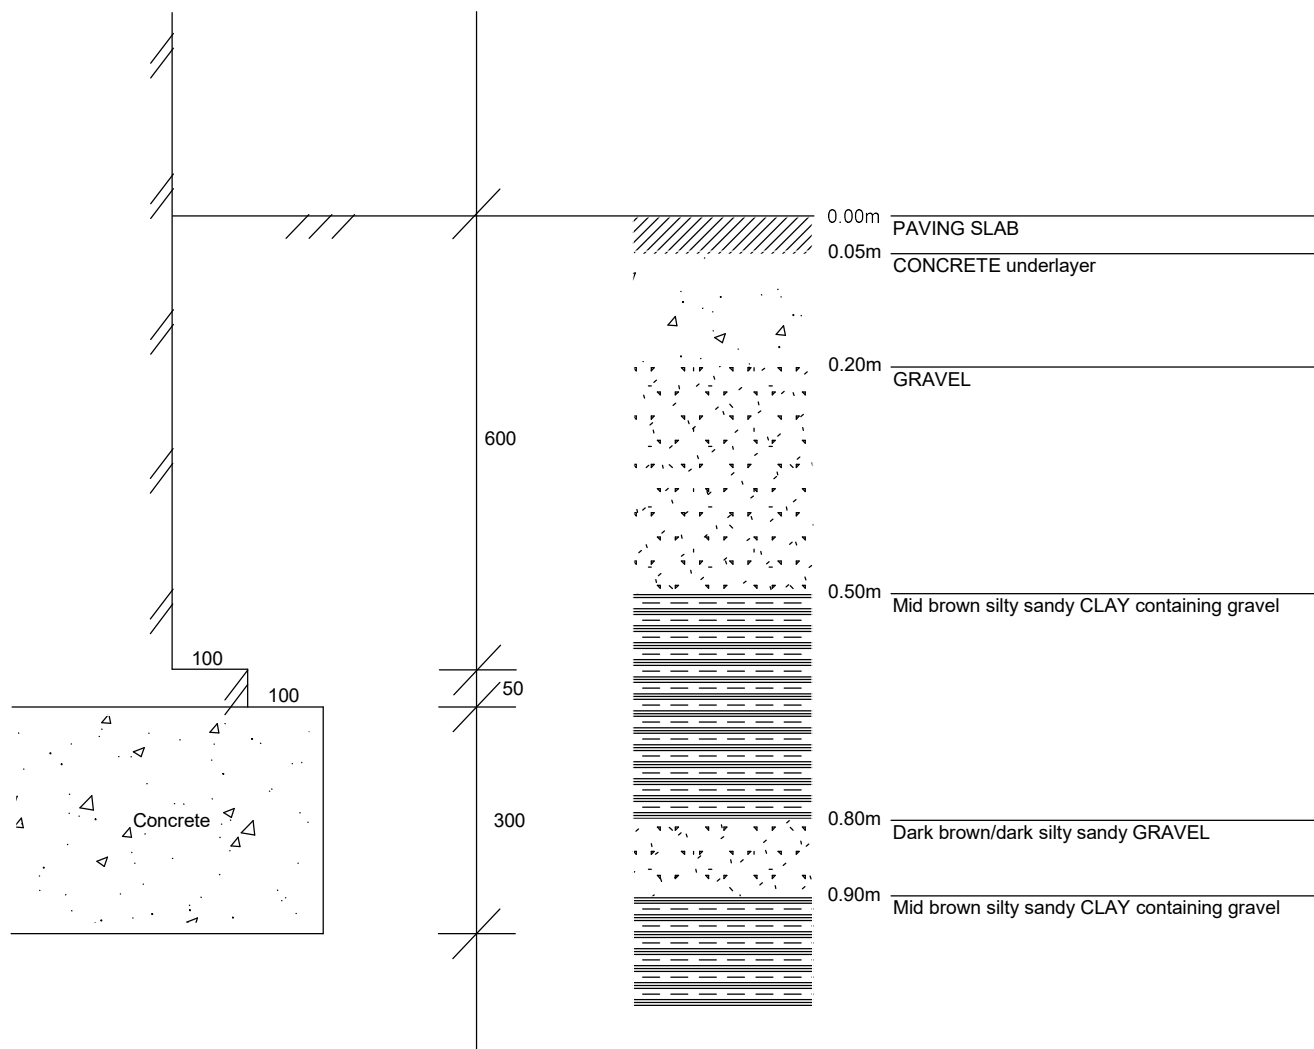
## TRIAL PIT 1

D1 @ F.L. (0.95m)

V = 72-74kPa

Founding strata: Mid brown silty sandy CLAY containing gravel

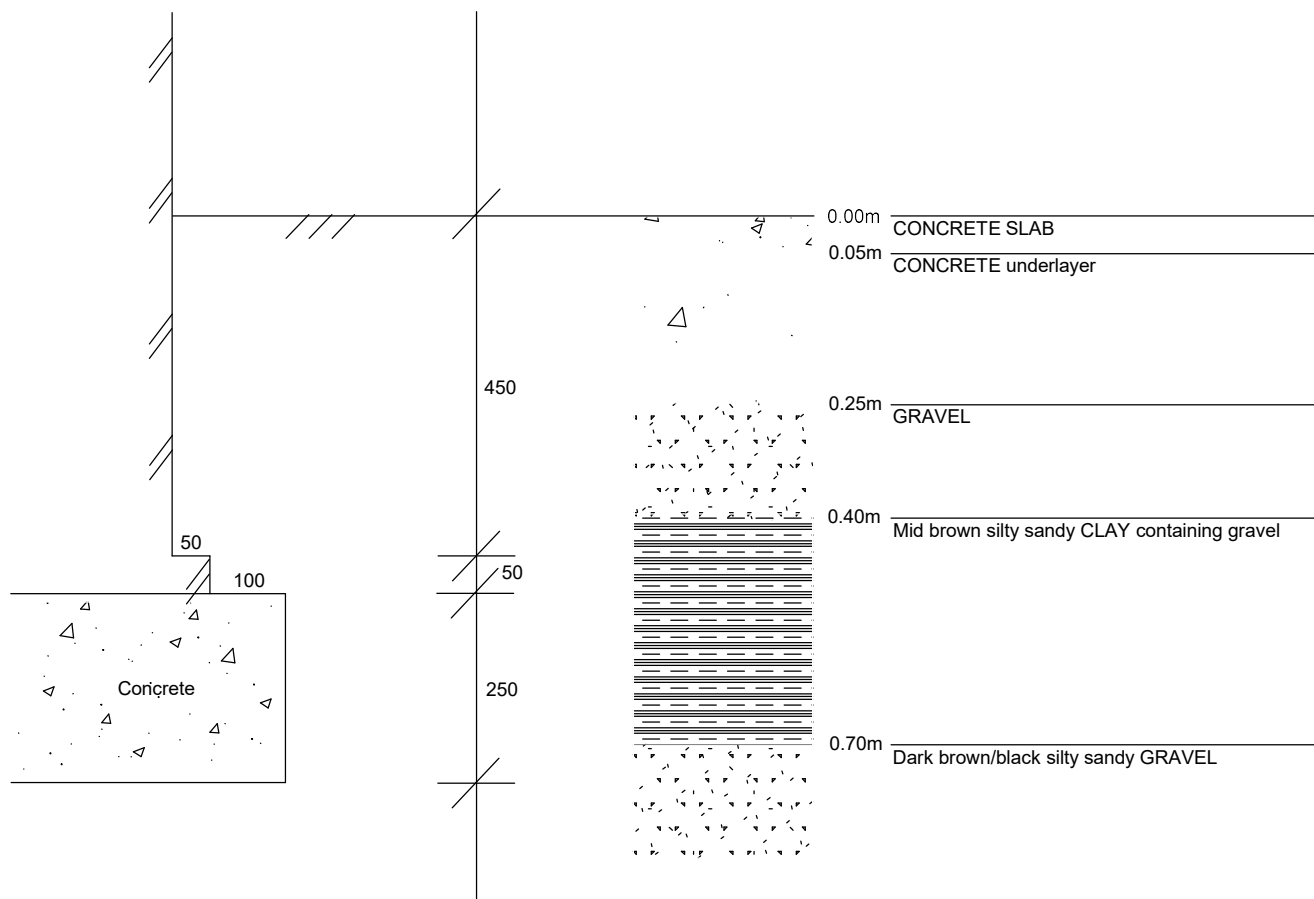
## TRIAL PIT 2

D1 @ F.L. (0.75m)

V = 66-68kPa

Founding strata: Dark brown/black silty sandy GRAVEL

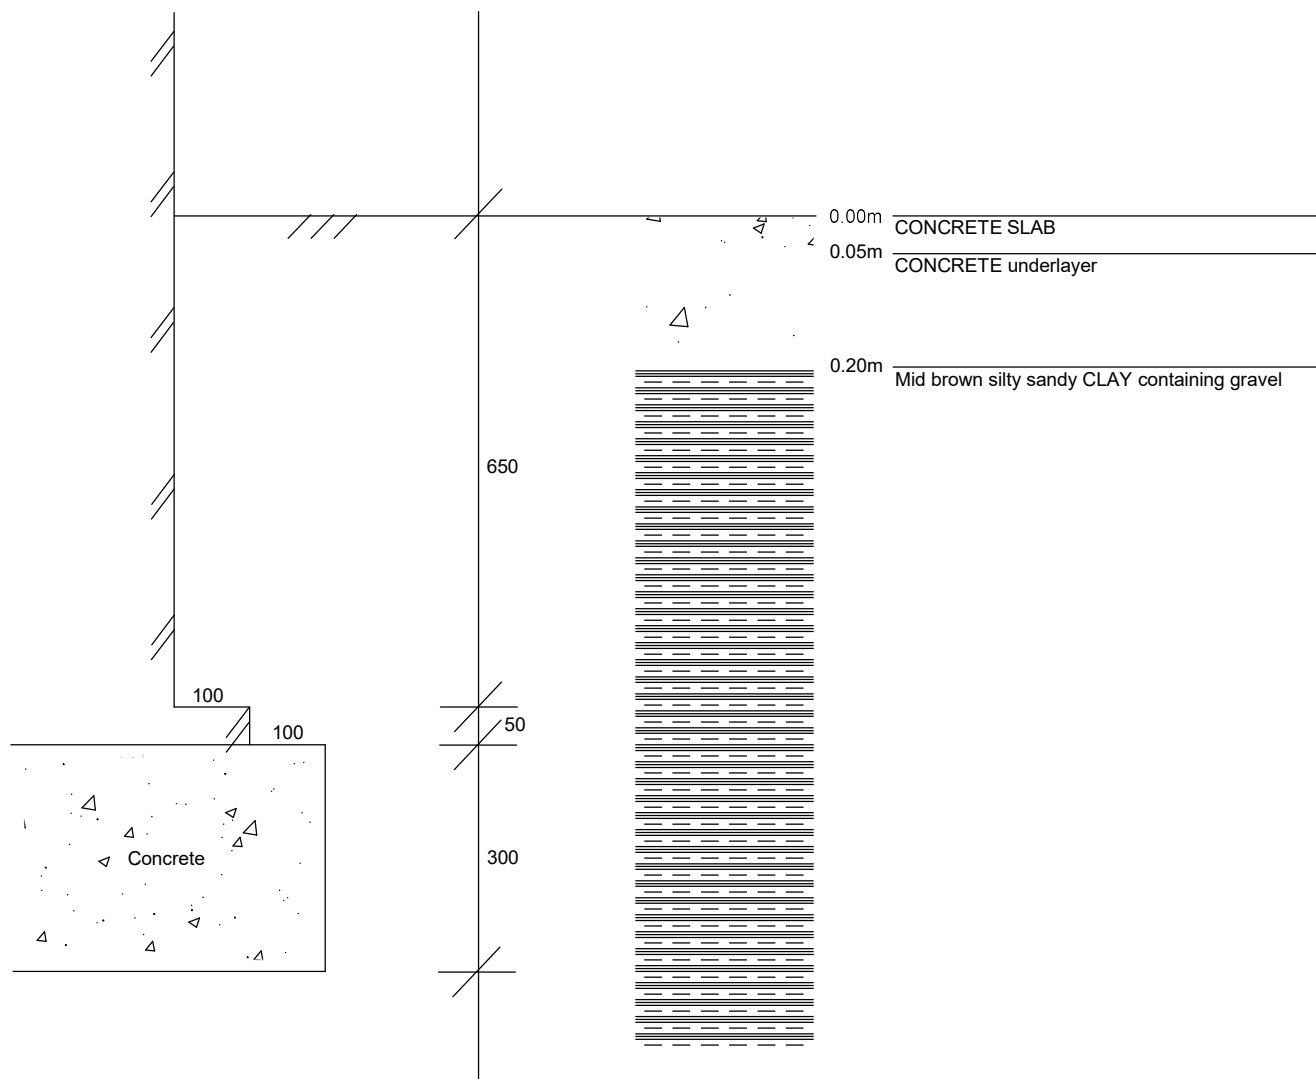
## TRIAL PIT 3

D1 @ F.L. (1.00m)

V = 68-70kPa

Founding strata: Mid brown silty sandy CLAY containing gravel
