## **Heritage Statement**

**120 Crouch Hill  
Crouch End  
London  
N8 9DY**

October 2022

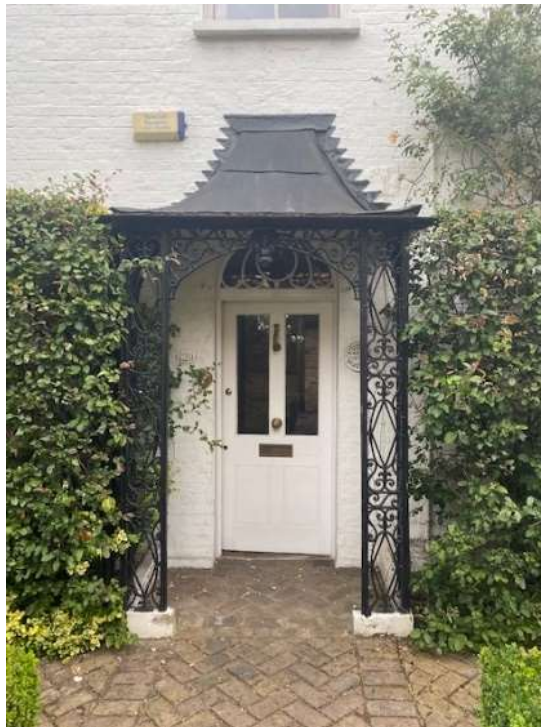
Image 4 – Front porch as existing

### 6.2 The existing porch canopy structure is in very poor condition due to the following issues:-

- The canopy structure was poorly installed in the first instance, it does not align with the center point of the front door. We also understand that the porch is not an original feature of the building. The current owner has been informed that there was originally a Juliet balcony above the door.

- Localized differential movement and uneven ground causing twisting and distortion of the porch canopy structure (As can be seen on the plan view drawing Ref:CS-SW-20456A-03). It should also be noted that during the current owner's occupation of the building, 5nr. silver birches have been removed from the front garden and replaced with less water-consuming Amelanchier Snowy Mespilus trees to protect the property from damage due to swelling and shrinkage of the clay subsoil.

- The cast in-situ concrete plinth has repeatedly spalled around stanchions despite local repairs. The porch has no foundations and is therefore prone to a greater degree of movement than the main property.

- Paint covering to stanchions, frieze and spandrels is peeling, exposing underlying metal which is at risk of corrosion. Many layers of paint have obscured some of the detailing.

- The current porch canopy is supported by a cast iron armature which provides insufficient support. This has lead to the canopy hood sagging at the base of the hood causing rainwater to pond before it can reach the cast iron perimeter gutter.

6.4 Whilst full replacement of the canopy structure had been considered due to the underlying structural issues associated with the main structure (as alluded to by previous planning applications), the current owner is looking to carefully and elegantly reconfigure the subsiding plinths and the floor area that supports the porch and undertake the following restoration works:-

- Replace the existing dilapidated concrete cast in-situ plinths with natural stone plinths (to match existing height). Length of plinths to be reduced to match the width of the stanchions. New flange plate to be fixed to the base of the stanchions so that they can be mechanically fixed to the stones and decorated to match sanctions.

- Retain and strip off many layers of black paint from the cast iron sections of the stanchions and re-coat to match existing colour (black). Twisted stanchions may also need to be carefully re-shaped back into position so that they can be fixed to the stone plinths at right angles as shown on proposed plan drawings Ref:CS-SW-20456A-01 to 03).

- Remove and discard of painted copper canopy
- Provide new preformed canopy armature to match profile of new hood as show in drawings Ref:CS-SW-20456A-01 to 03.

- Install new code 4 lead hood and stepped flashing. Flashing to be tucked into mortar joints of external brick wall and re-pointed using lime based mortar. All to match profile of new armature as shown on drawings Ref:CS-SW-20456A-01 to 03. External walls to be made good and redecorated to match existing (white masonry paint). The lead will be treated with patination oil to achieve a dark grey appearance, as it is understood not to be beneficial to paint lead.

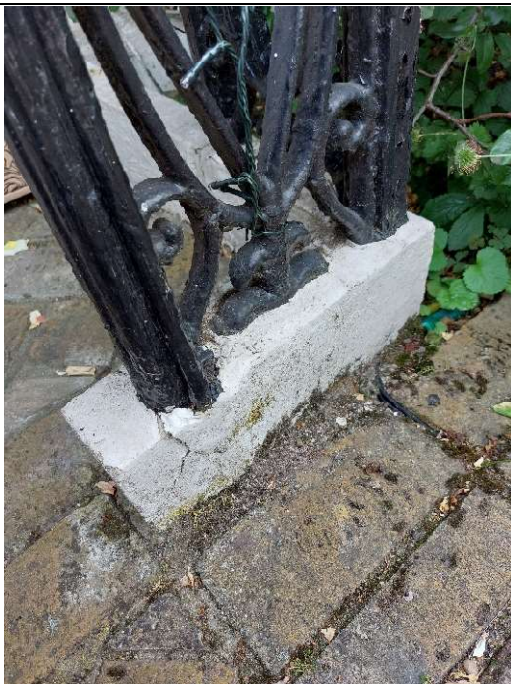
**Image 5. Concrete plinths spalling around existing sanctions due to water ingress cause by freeze thaw.**

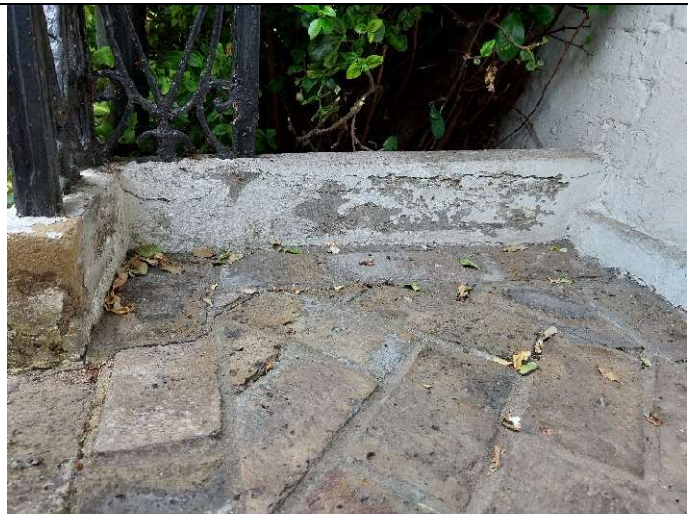
**Image 6. Further evidence of seasonal movement of the ground directly in front of the porch causing the plinth to crack and the canopy structure to sink and twist on the left hand side.**

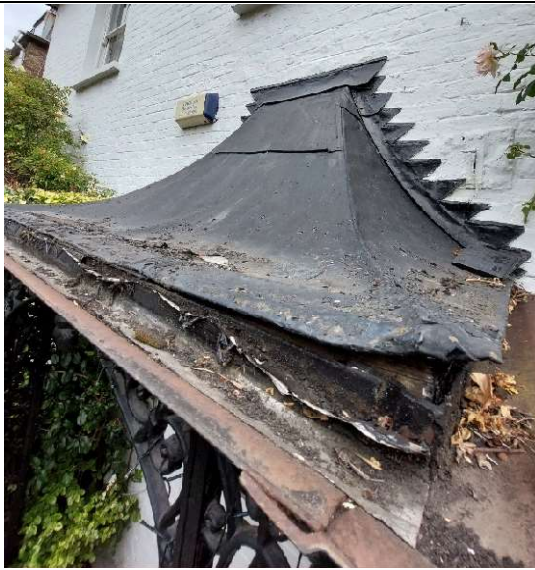
**Image 7. Poorly executed temporary flashing repairs to gutter/fascia abutment. Cast Iron gutter in poor condition, joints have failed.**

- Remove and set aside existing cast iron ogee perimeter gutters, brackets and downpipes serving porch canopy. Carry out restoration works including; Rubbing down rusted sections back to bare metal, treat with rust converter, prime with red oxide rust treatment, apply Bondarust primer and fully redecorate with gloss black bituminous paint. Re-seal joints using Hargreaves foundry jointing kit.

- Reinstall refurbished Ogee Gutters, Brackets and Cast Iron Downpipes fixing back to decorated timber hardwood fascia boards.

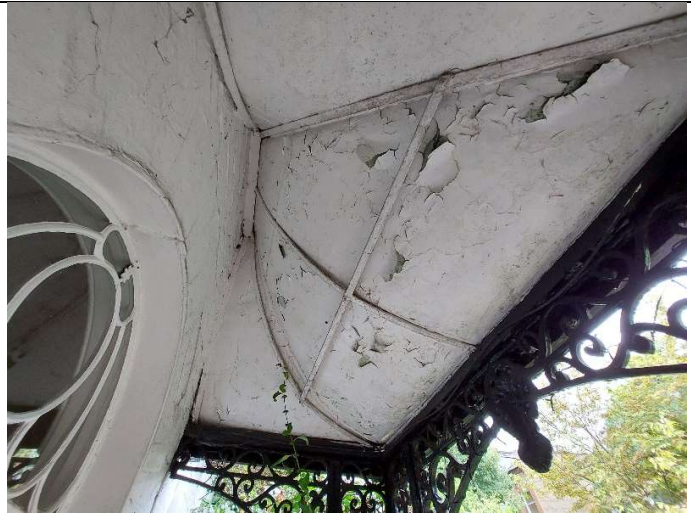
**Image 8. Insufficient support provided by existing armature causing the existing canopy to sag on the lower section.**

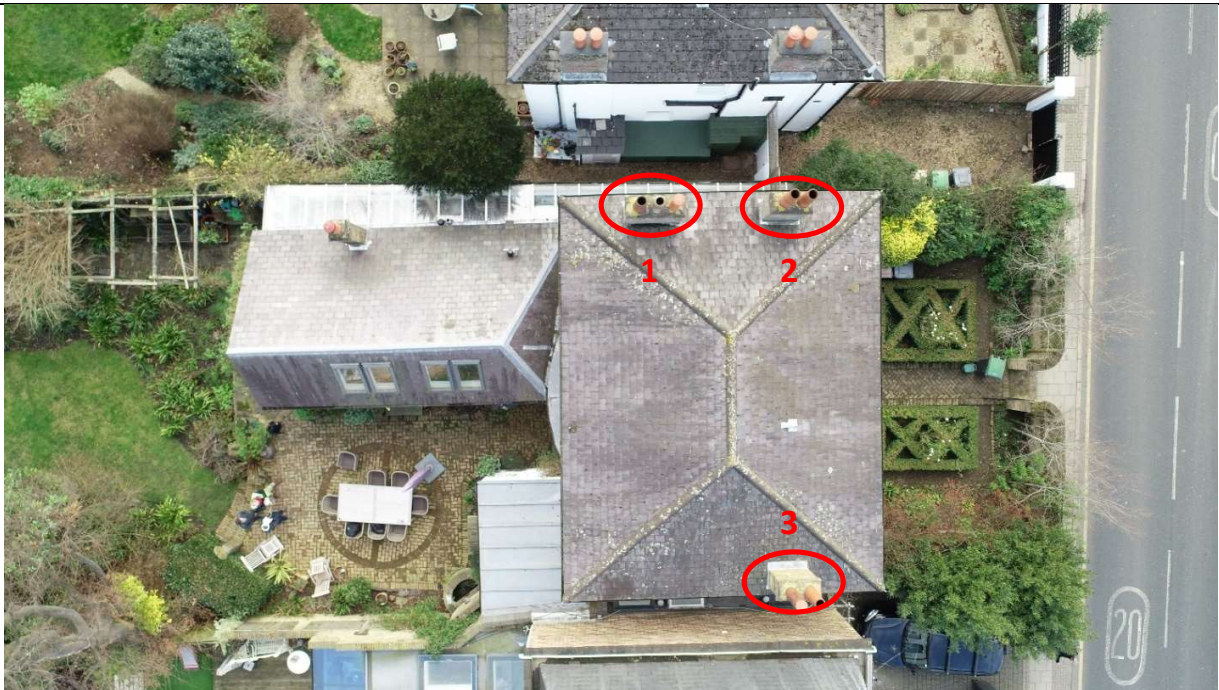
6.6 There are 3 existing chimney stacks serving the main roof structure, some chimneys are still in use and others are redundant. However none have been fitted with ventilation flues or rain cowls to protect them from water ingress and animal infestation.

**Image 9. Main roof layout with 3nr Chimneys requiring repairs circled in red**

6.8 Subject to further survey, it is proposed to install reclaimed clay ventilation flues or new rain cowls to each open chimney pot (6nr in total) to reduce the risk of rain water ingress and animal infestation. Whilst these new cowls are being added, the general condition of the chimneys is to be assessed and it may also be necessary to undertake further critical repair work to the chimneys including:-

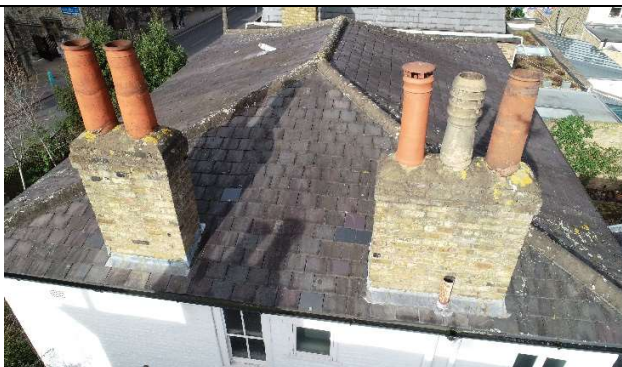
**Image 10. Chimneys 1 & 2** Slightly distorted lead detailing. Note: slates have been cut to suit the dimensions of the chimney stack and where tiles are extending off the junction with the flashing, cut tiles have been pieced in rather than using an extended tile (ie. slate and a half) which in turn will lead to movement and potentially water ingress.

- Re-flaunching around chimneys and re-pointing angle bead on brick ledge to minimize water penetration into the brickwork.
  - It is proposed to introduce new code 5 lead secret gutters around the base of the chimneys whilst also addressing the issue of the mismatching roof tiles sizes used during previous repairs. Works to introduce the new lead secret gutters will generally involve:-

- Reinstate slate tiles allowing to re-size tiles as required to avoid smaller `cut to size` tiles.
    - Laying new code 5 lead secrete gutter, with front apron, side flashings and a back gutter with cover flashings (saddles). All in accordance with accordance with Lead Sheet Training Academy Guidance.

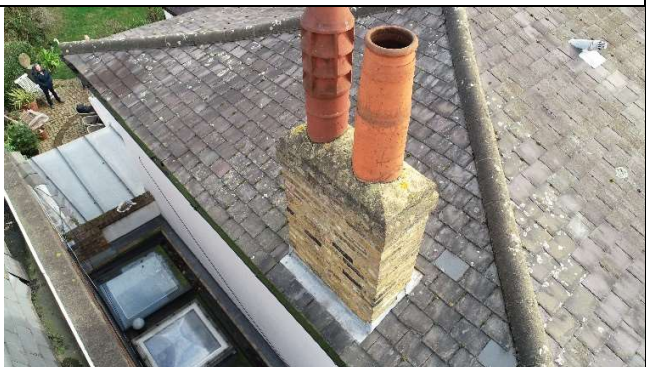
**Image 11. Flaunching of Chimney Stack 3** which is cracked and fractured and suffering from algae growth

- 
- Rake off any excess moss and lichen growth from the mortar joints and re-point using lime based mortar.
  - Removing and replacing and cracked/damaged clay chimney pots on a like for like basis.

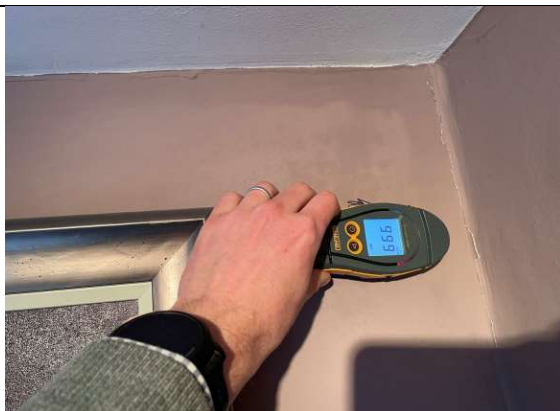
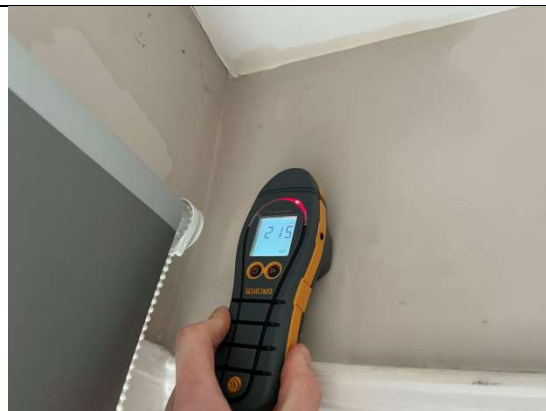
- 6.7 Internally, there are issues with water ingress around the base of the chimneys. This has caused staining to the ceilings and walls within the upstairs bedrooms following heavy rainfall. Previous repairs and repointing to the chimneys has failed to resolve the water ingress.

Images 12 & 13- Typical view of staining in Bedrooms 1 & 2 with positive moisture readings being taken on the return of the chimney breasts in both rooms

- Opening up around the perimeter of the chimney structures, review condition of roof timbers and carry out repairs in accordance with BRE guidance

- Lay new gutter boards and introduce timber support to the back gutter lead work. Adequate support will prevent the lead work becoming depressed and/or sagging and causing potential weather ingress issues.
