## **Heritage Statement**

**120 Crouch Hill  
Crouch End  
London  
N8 9DY**

October 2022

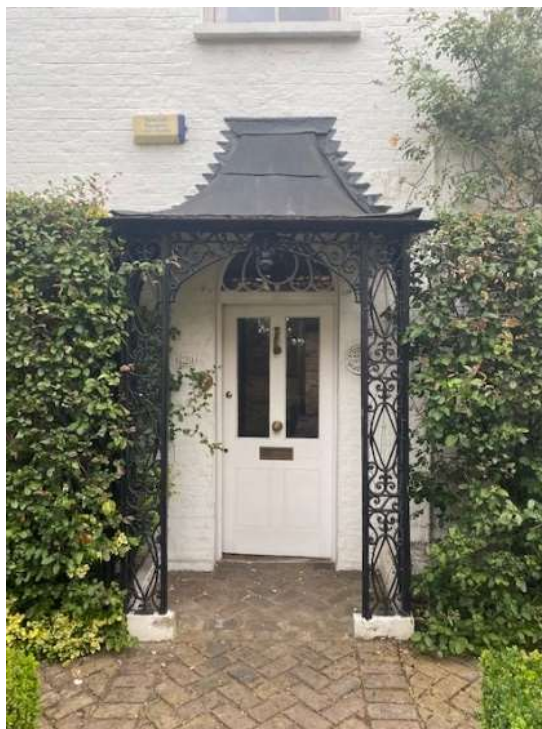
Image 4 – Front porch as existing

### 6.2 The existing porch canopy structure is in very poor condition due to the following issues:-

- The canopy structure was poorly installed in the first instance, it does not align with the center point of the front door. We also understand that the porch is not an original feature of the building. According to the previous owner, there was originally a Juliet balcony above the door.

- Localized differential movement and uneven ground causing twisting and distortion of the porch canopy structure (As can be seen on the plan view drawing Ref:CS-SW-20456A-03). It should also be noted that during the current owners occupation of the building, 5nr. silver birches have been removed from the front garden and replaced with less water consuming trees.

- Cast in situ concrete plinth is spalling around stanchions. The canopy has no foundations therefore prone to greater degree of movement.
- Paint covering to stanchions, frieze and spandrels is peeling, exposing underlying metal which is at risk corrosion.

- Current porch canopy is supported by a cast iron armature which provides insufficient support. This has lead to the canopy hood sagging at the base of the hood causing rainwater to pond before it can reach the cast iron perimeter gutter.

- Replace the existing dilapidated concrete cast in situ plinths with natural stone plinths (to match existing height). Length of plinths to be reduced to match the width of the stanchions. New flange plate to be fixed to the base of the stanchions so that they can be mechanically fixed to the stones and decorated to match sanctions.

- Retain and strip off many layers of black paint from the cast iron sections of the stanchions and re-coat to match existing colour (black). Twisted stanchions may also need to be carefully re-shaped back into position so that they can be fixed to the stone plinths at right angles as shown on proposed plan drawings Ref:CS-SW-20456A-01 to 03).

- Remove and set aside existing cast iron ogee perimeter gutters, brackets and downpipes serving porch canopy. Carry out restoration works including; Rubbing down rusted sections back to bare metal, treat with rust converter, prime with red oxide rust treatment, apply Bondarust primer an fully redecorate with gloss black bituminous paint. Re-seal joints using Hargreaves foundry jointing kit.

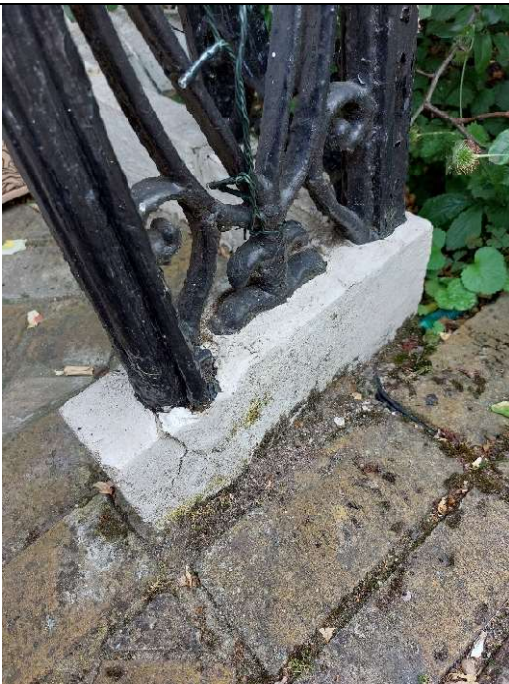
**Image 5. Concrete plinths spalling around existing sanctions due to water ingress cause by freeze thaw.**

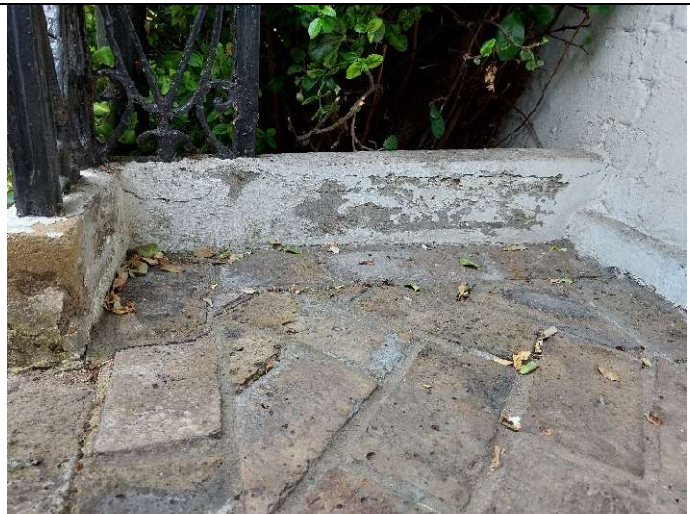
**Image 6. Further evidence of seasonal movement of the ground directly in front of the porch causing the plinth to crack and the canopy structure to sink and twist on the left hand side.**

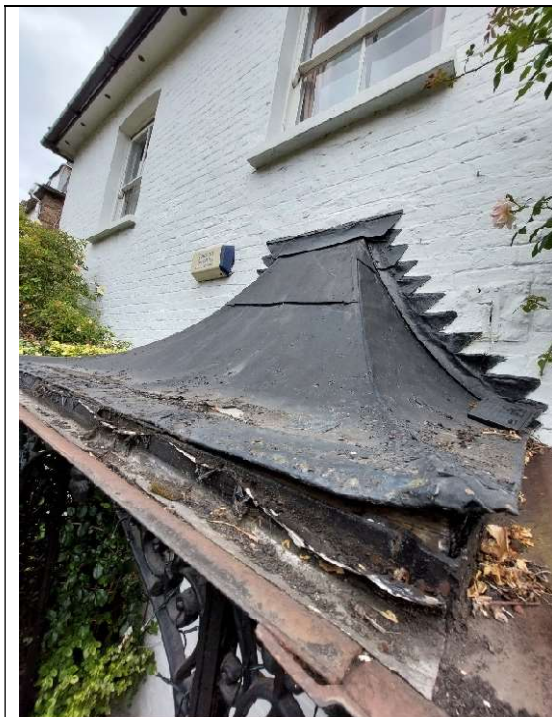
**Image 7. Poorly executed temporary flashing repairs to gutter/fascia abutment. Cast Iron gutter in poor condition, joints have failed.**

- Relace rotten timber fascia to the canopy with new hardwood fascias. (Primed and decorated to match colour of stanchions - Black)
- Remove the existing lead flashings and make good external wall ready to receive new re-positioned (centered) porch canopy structure.

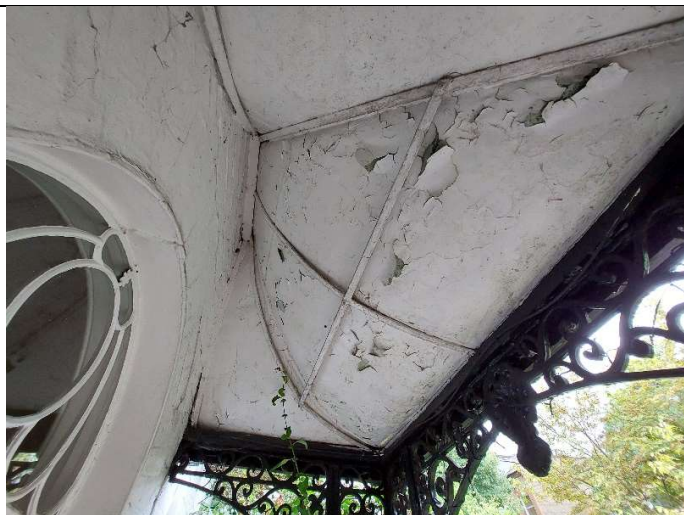
**Image 8. Insufficient support provided by existing armature causing the existing canopy to sag on the lower section.**

- Remove and discard of painted copper canopy
- Provide new preformed canopy armature to match profile of new hood as show in drawings Ref:CS-SW-20456A-01 to 03.

- Install new code 4 lead hood and stepped flashing. Flashing to be tucked into mortar joints of external brick wall and re-pointed using lime based mortar. All to match profile of new armature as shown on drawings Ref:CS-SW-20456A-01 to 03. External walls to be made good and redecorated to match existing (white masonry paint).
- Reinstall refurbished Ogee Gutters, Brackets and Cast Iron Downpipes fixing back to decorated timber hardwood fascia boards.

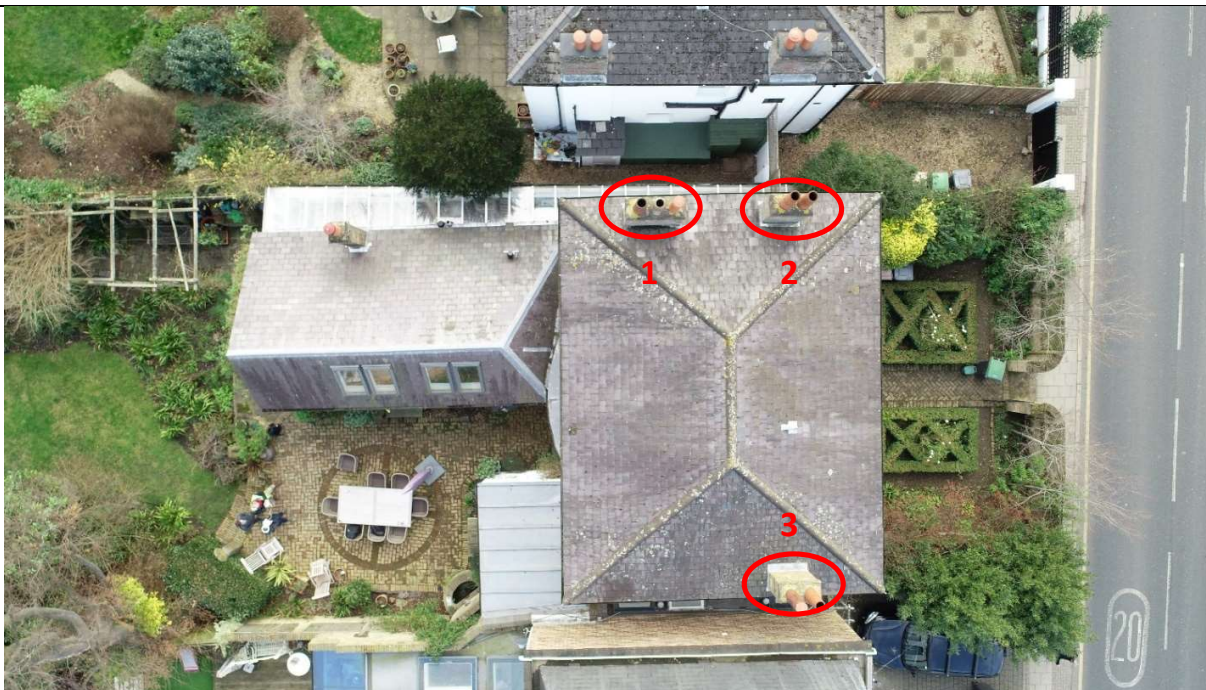
- 6.6 There are 3 existing chimney stacks serving the main roof structure, some chimneys are still in use and others are redundant. However none have been fitted with ventilation flues or rain cowls to protect them from water ingress and animal infestation.

**Image 9. Main roof layout with 3nr Chimneys requiring repairs circled in red**

6.8 Subject to further survey, it is proposed to install reclaimed clay ventilation flues or new rain cowls to each open chimney pot (6nr in total) to reduce the risk of rain water ingress and animal infestation. Whilst these new cowls are being added, the general condition of the chimneys is to be assessed and it may also be necessary to undertake further critical repair work to the chimneys including:-

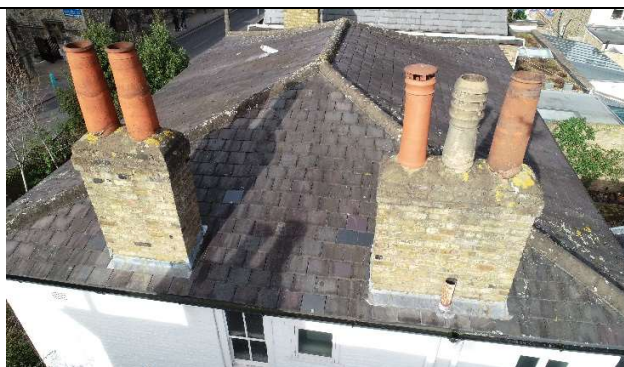
**Image 10. Chimneys 1 & 2 Slightly distorted lead detailing. Note: slates have been cut to suit the dimensions of the chimney stack and where tiles are extending off the junction with the flashing, cut tiles have been pieced in rather than using an extended tile (ie. slate and a half) which in turn will lead to movement and potentially water ingress.**

- Lay new gutter boards and introduce timber support to the back gutter lead work. Adequate support will prevent the lead work becoming depressed and/or sagging and causing potential weather ingress issues.
- Reinstall slate tiles allowing to re-size tiles as required to avoid smaller 'cut to size' tiles.
- Laying new code 5 lead secret gutter, with front apron, side flashings and a back gutter with cover flashings (saddles). All in accordance with accordance with Lead Sheet Training Academy Guidance.

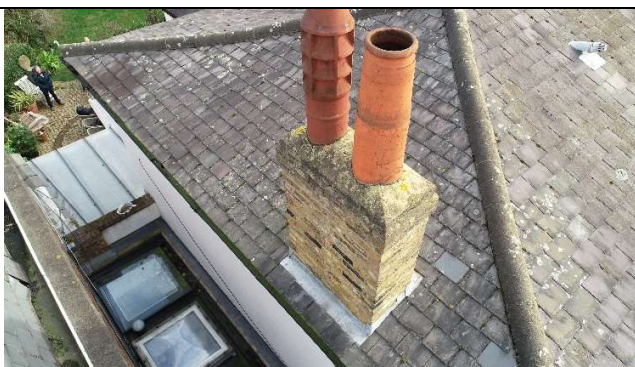
**Image 11. Flaunching of Chimney Stack 3 which is cracked and fractured and suffering from algae growth**

- Rake off any excess moss and lichen growth from the mortar joints and re-point using lime based mortar.
- Removing and replacing and cracked/damaged clay chimney pots on a like for like basis.
- Re-flaunching around chimneys and re-pointing angle bead on brick ledge to minimize water penetration into the brickwork.
- It is proposed to introduce new code 5 lead secret gutters around the base of the chimneys whilst also addressing the issue of the mismatching roof tiles sizes used during previous repairs. Works to introduce the new lead secret gutters will generally involve:-
- Opening up around the perimeter of the chimney structures, review condition of roof timbers and carry out repairs in accordance with BRE guidance

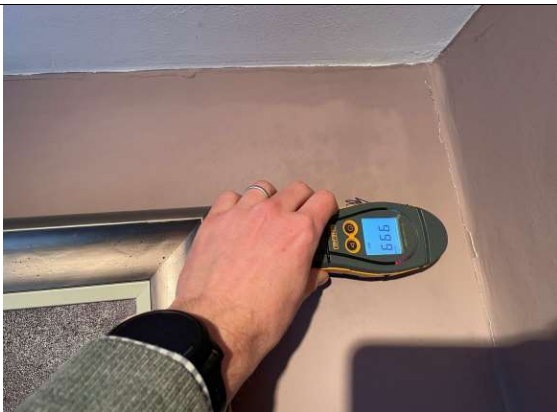
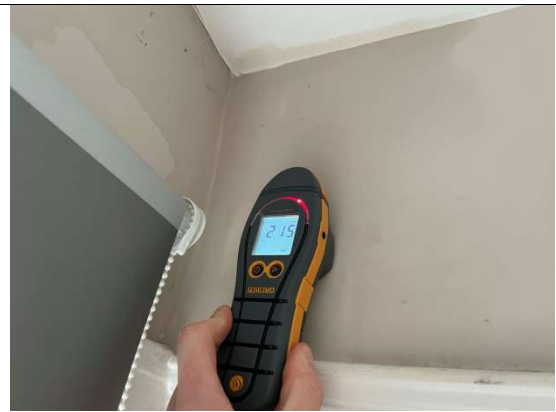
- 6.7 Internally, there are issues with water ingress around the base of the chimneys. This has caused staining to the ceilings and walls within the upstairs bedrooms following heavy rainfall.

**Images 13 & 14- Typical view of staining in Bedrooms 1 & 2 with positive moisture readings being taken on the return of the chimney breasts in both rooms**
