**CCTV REPORT FOR: 15 STANHOPE GARDENS  
LONDON  
N6 5TT**

**Insured:** Miss Z Watt  
**Reference:** 212706

**Site Visit:** 13-Apr-22  
**Report Date:** 03-May-22

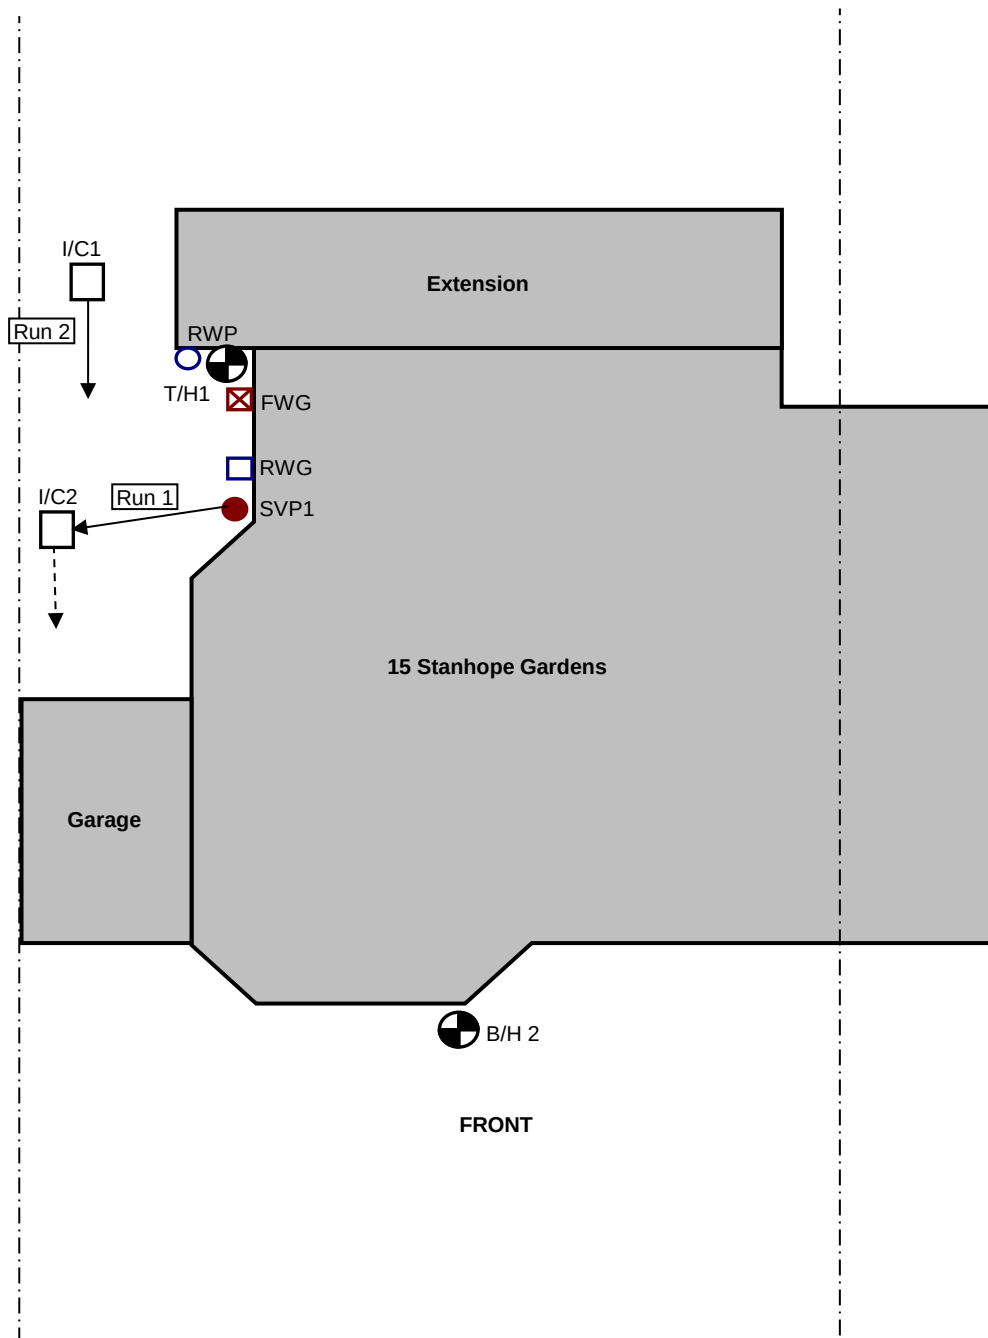
**Note: Runs shown in red have been adopted by the local water authority.**

**RUN: 1** Pipe Dia. (mm): 100 System: Foul Water Made of: Plastic  
From: SVP1 Inv (m): - Downstream To: I/C 2 Inv (m): -

| Metres | Faults / Defects | Remarks |
|---|---|---|
| 3.50 | No Visible Defects | At I/C 2 |

**RUN: 2** Pipe Dia. (mm): 100 System: Foul Water Made of: Glazed Clay  
From: I/C1 Inv (m): 1.20 Downstream To: Unknown Inv (m): -

| Metres | Faults / Defects | Remarks |
|---|---|---|
| 0.50 | | Unable to proceed blockage |

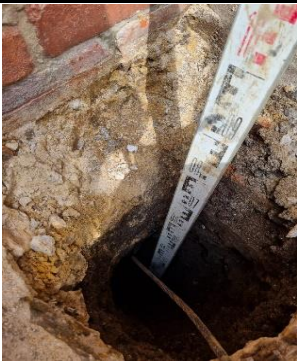
| Location: <b>Junction house and extension</b> | T/H No. <b>1</b> |

| Depth (m) | Soil Descriptions<br><i>(NB: Field crew description only)</i> | Test Type | Depth (m) | |
|---|---|---|---|---|
| 0.80 | Stiff brown mottled grey CLAY | P.P. 2.5 | 0.800 | |
| 4.00 | End of Borehole | P.P. 2.5 | 1.000 | |

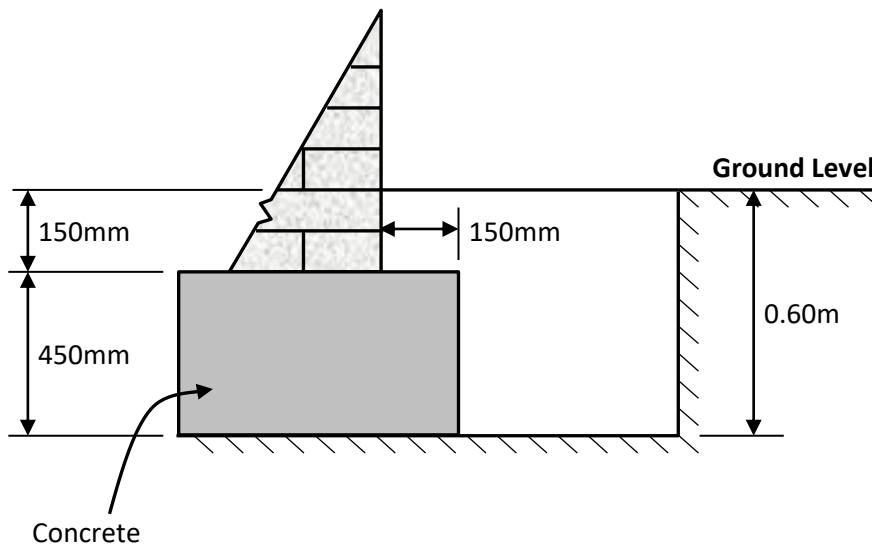
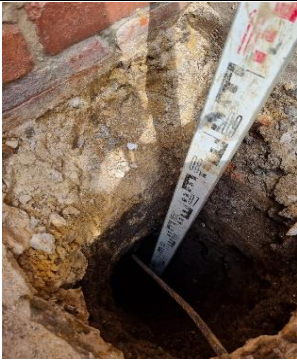
**Extension Foundation Cross Section (Not to Scale)**

| From 0.9m |
| Down to 2.0m |
| up to 1mm diameter |
| None observed on site |
| Hole at instructed depth |

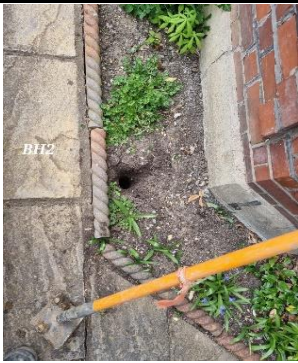
| Location: <b>Remote - Front of bay</b> | B/H No. <b>2</b> |

| <b><u>Bore Hole only</u></b> | Roots Depth & Diameter:<br>None observed on site<br><br><br><br><br>Water Depth Hit & Rise:<br>None observed on site<br><br><br><br>Reason for Termination :<br>Encountered obstruction<br><br><br><br> |

| Depth (m) | Soil Descriptions<br><small>(NB: Field crew description only)</small> | Test Type | Depth (m) | |
|---|---|---|---|---|
| 0.80 | Soft brown CLAY | P.P. 0.0 | 0.800 | |
| 1.00 | Firm brown slightly gravelly CLAY | P.P. 1.5 | 1.000 | |
| 1.50 | Firm brown CLAY | P.P. 2.5 | 1.500 | |
| 2.50 | End of Borehole | P.P. 3.5 | 2.000 | |
