# Arboricultural Consultancy for Smithers Purslow

Date: 05/07/2022

Property: 15 Stanhope Gardens, London, N6 5TT

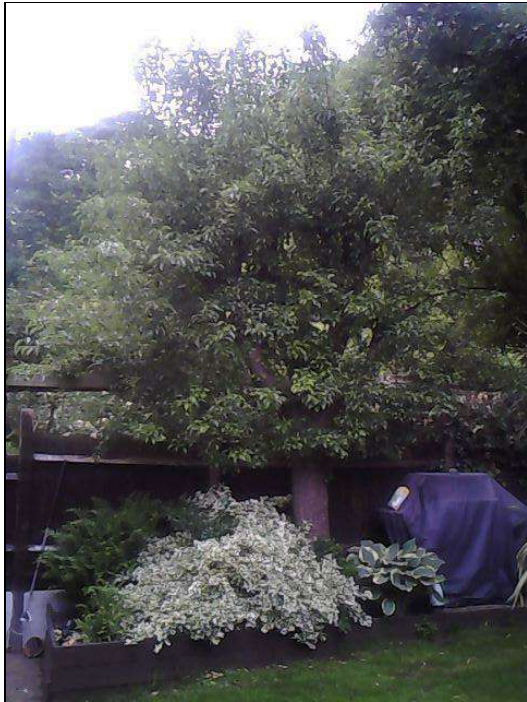
T3 - Pear

| Tree No. | Species | Age Cat | Approx. Height (m) | Distance to Building (m) * | Ownership | Action | Requirement |
|---|---|---|---|---|---|---|---|
| T3 | Pear | 2 | 5.1 | 3.2 | C - Insured | Action to avoid future risk | Subject to regular management; maintain at current dimensions by way of regular pruning. |

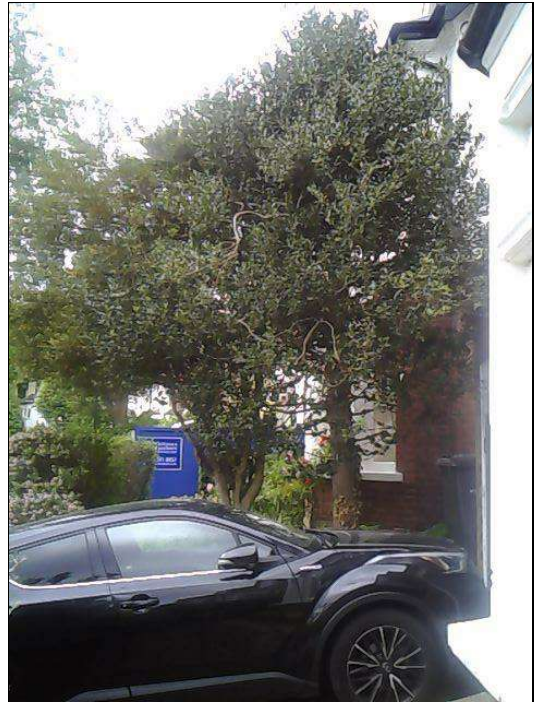
SG2 - Mixed species group

| Tree No. | Species | Age Cat | Approx. Height (m) | Distance to Building (m) * | Ownership | Action | Requirement |
|---|---|---|---|---|---|---|---|
| SG2 | Mixed species shrubs: Buxus & Holly. | 1 | 5.8 | 1.2 | A - Third Party | Action to avoid future risk | Maintain at current dimensions by way of regular pruning. |

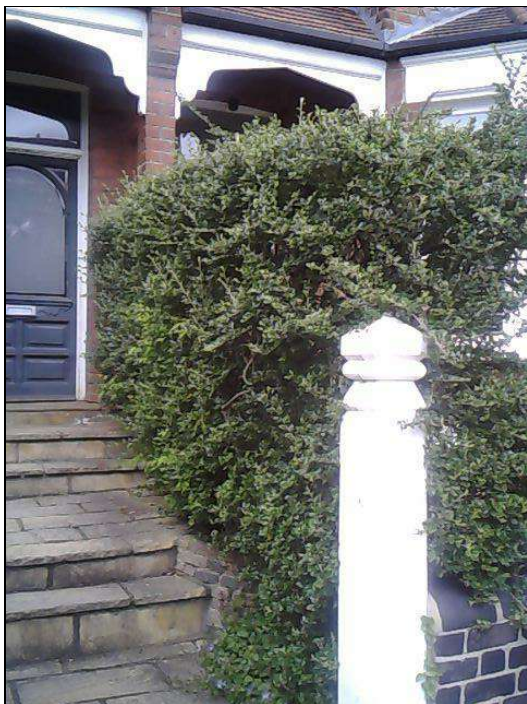
H1 - Cotoneaster

| Tree No. | Species | Age Cat | Approx. Height (m) | Distance to Building (m) * | Ownership | Action | Requirement |
|---|---|---|---|---|---|---|---|
| H1 | Cotoneaster | 1 | 2.2 | 0.6 | E - Boundary Veg (ownership to be confirmed) | Action to avoid future risk | Subject to regular management; maintain at current dimensions by way of regular pruning. |

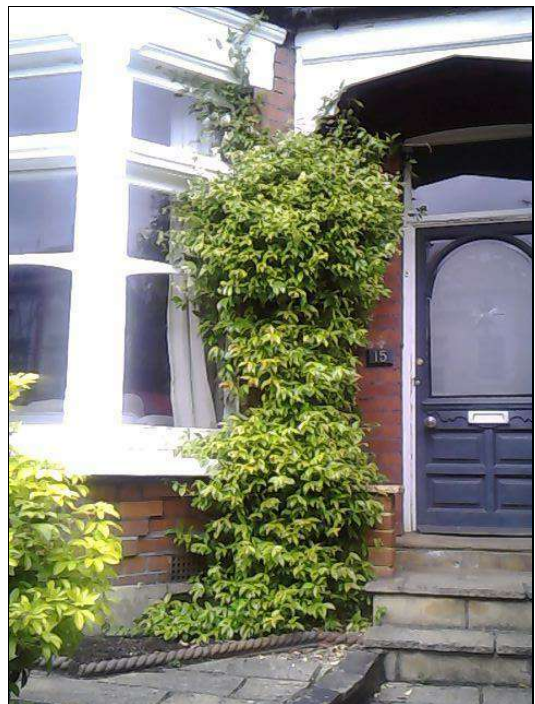
C1 - Jasmine

| Tree No. | Species | Age Cat | Approx. Height (m) | Distance to Building (m) * | Ownership | Action | Requirement |
|---|---|---|---|---|---|---|---|
| C1 | Star Jasmine | 1 | 3.3 | 0 | C - Insured | Action to avoid future risk | Subject to regular management; maintain at current dimensions by way of regular pruning. |

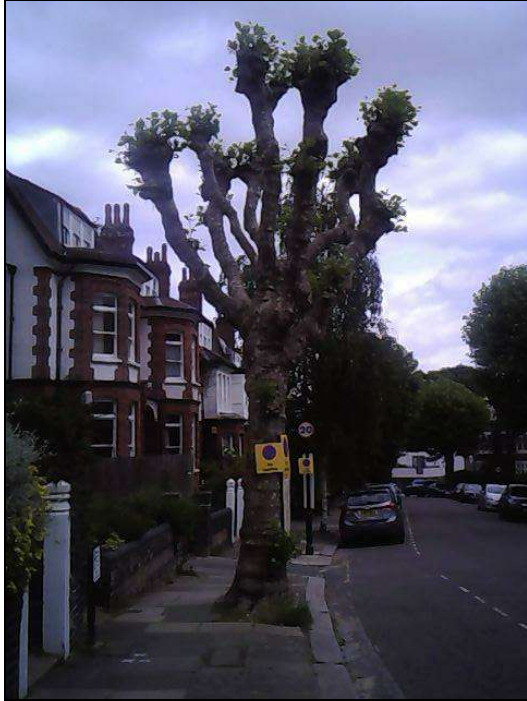
T4 - Plane (London)

| Tree No. | Species | Age Cat | Approx. Height (m) | Distance to Building (m) * | Ownership | Action | Requirement |
|---|---|---|---|---|---|---|---|
| T4 | Plane (London) | 1 | 7.2 | 6.4 | B - Local Authority | Action to avoid future risk | Recently pollarded: maintain at reduced dimensions by re-pruning back to points of previous reduction on a 3 year cycle. |

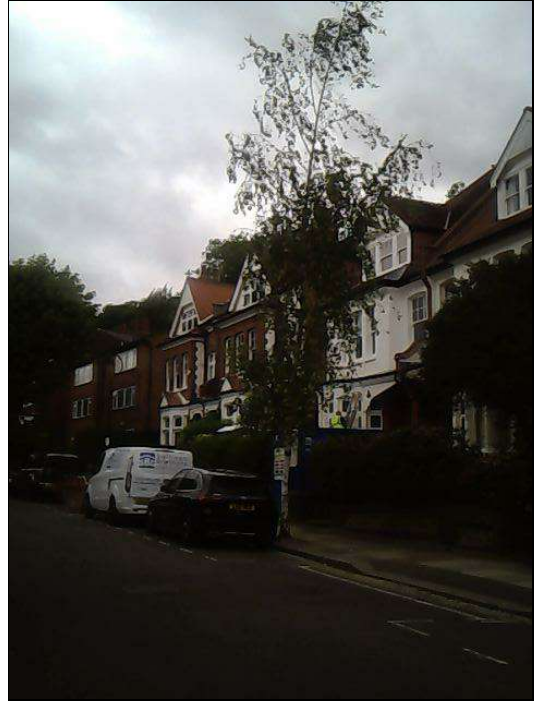
T5 - Birch (Silver)

| Tree No. | Species | Age Cat | Approx. Height (m) | Distance to Building (m) * | Ownership | Action | Requirement |
|---|---|---|---|---|---|---|---|
| T5 | Birch (Silver) | 1 | 13 | 8.2 | B - Local Authority | Action to avoid future risk | Do not allow to exceed current dimensions by way of regular pruning. |

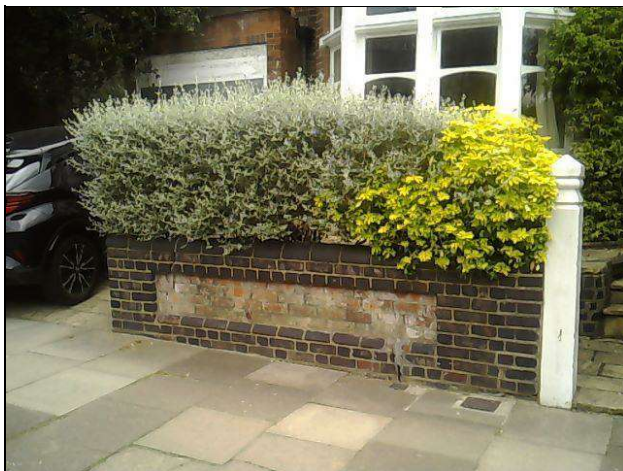
SG3 - Mixed species shrubs

| Tree No. | Species | Age Cat | Approx. Height (m) | Distance to Building (m) * | Ownership | Action | Requirement |
|---|---|---|---|---|---|---|---|
| SG3 | Mixed species shrubs | 1 | 1.6 | 2.9 | C - Insured | Action to avoid future risk | Maintain at broadly current dimensions by way of regular pruning. |

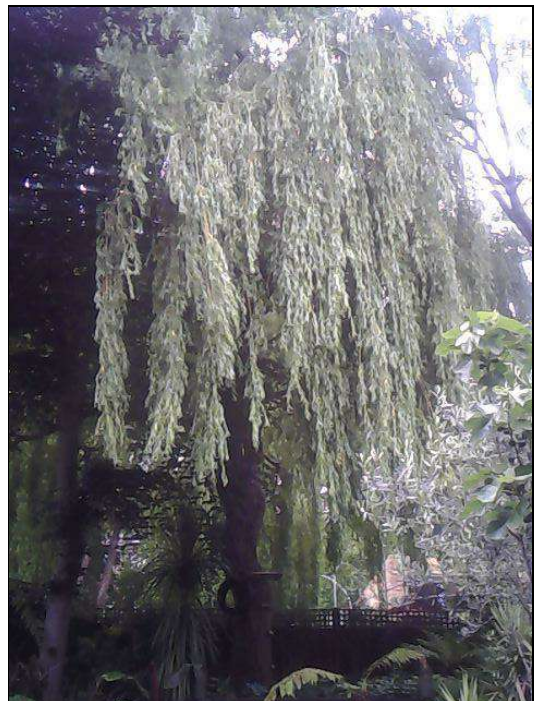
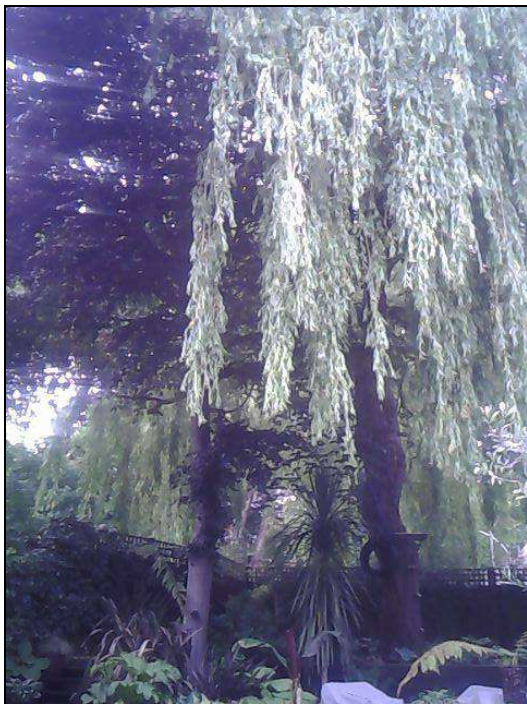
T1 - Willow (Weeping)

Our survey of the site identified the Willow (T1), given its position relative to the damage and the absence of any plausible alternative, it is our opinion that the roots identified in TH1 will, on balance of probability, emanate from this tree and accordingly we have identified it as the principal cause of the subsidence damage.

| Tree No. | Species | Age Cat | Approx. Height (m) | Distance to Building (m) * | Ownership | Action | Requirement |
|---|---|---|---|---|---|---|---|
| T1 | Willow (Weeping) | 2 | 16.8 | 12.4 | C - Insured | Remove | Remove close to ground level and treat stump to inhibit regrowth. |

Consequently, complete removal of T1 & T2 will offer the most certain arboricultural solution likely to restore long-term stability.

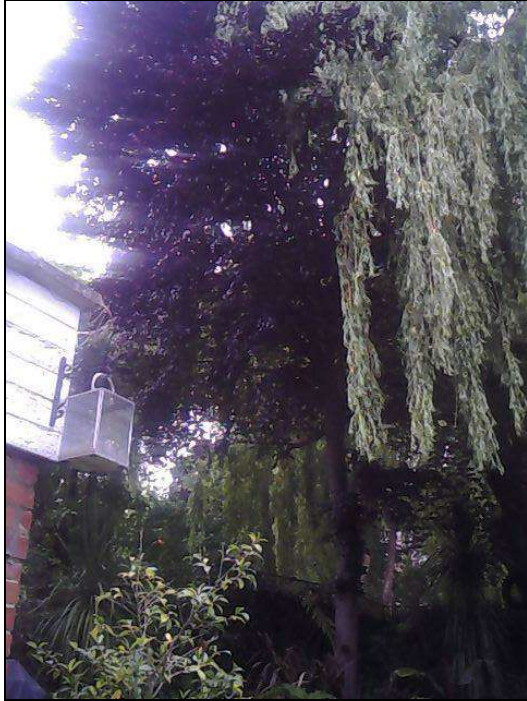
T2 - Beech (CopperPurple)

However, whilst not positively implicated by root analysis, the Beech (T2) cannot be discounted as contributing to the overall level of soil drying proximate to the area of damage and is therefore also considered to retain a contributory influence, albeit in a limited / secondary capacity when compared to T1.

| Tree No. | Species | Age Cat | Approx. Height (m) | Distance to Building (m) * | Ownership | Action | Requirement |
|---|---|---|---|---|---|---|---|
| T2 | Beech (Copper/Purple) | 1 | 14.5 | 9.8 | C - Insured | Remove | Remove close to ground level and treat stump to inhibit regrowth. |

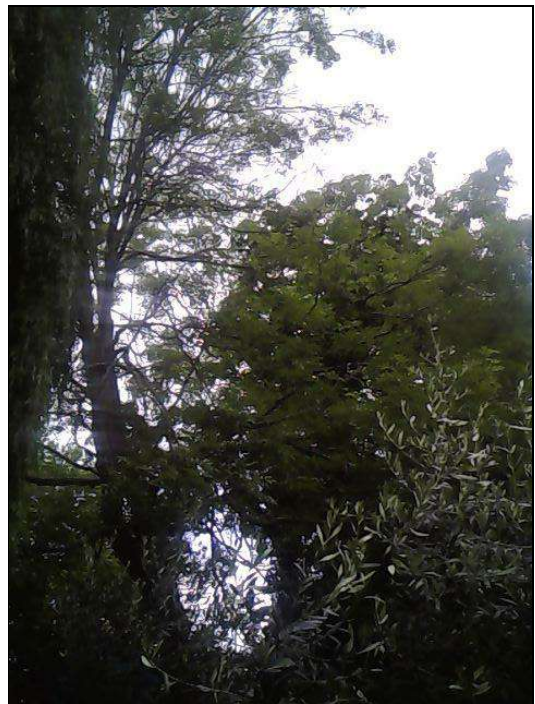
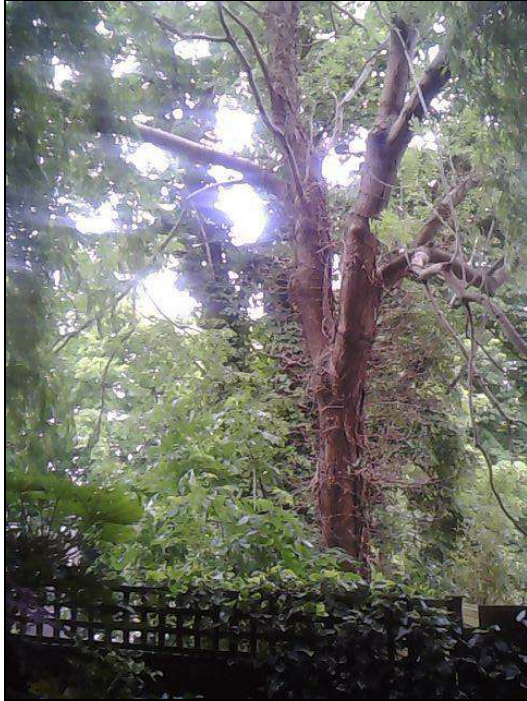
TG1 - Mixed species group

| Tree No. | Species | Age Cat | Approx. Height (m) | Distance to Building (m) * | Ownership | Action | Requirement |
|---|---|---|---|---|---|---|---|
| TG1 | Mixed Species Group | 2 | 18.5 | 15.8 | C - Insured | Action to avoid future risk | Crown reduce overall canopy of Ash by 30% (minimum) to achieve a crown volume reduction in line with BRE IP7/06. Maintain at reduced dimensions by re-pruning back to points of previous reduction on a strict 2-3 year cycle. Maintain Horse Chestnut at broadly current dimensions by way of regular pruning. |

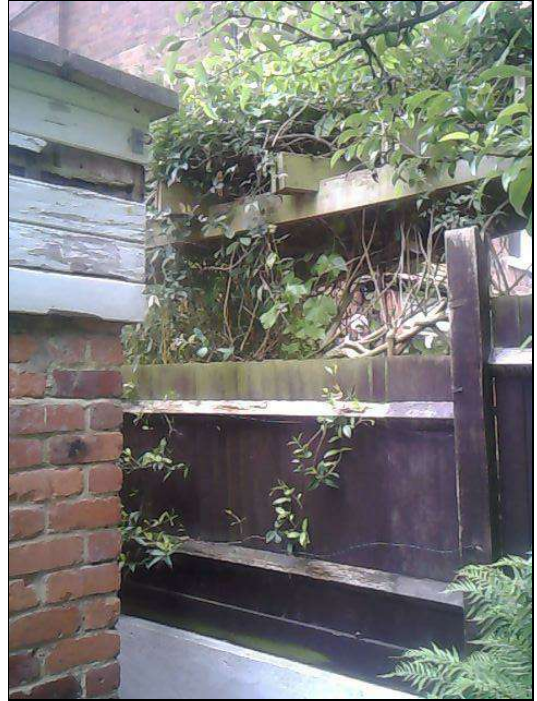
CG1 - Mixed species group

| Tree No. | Species | Age Cat | Approx. Height (m) | Distance to Building (m) * | Ownership | Action | Requirement |
|---|---|---|---|---|---|---|---|
| CG1 | Mixed species climbers: includes Bamboo, Clematis, Lonicera and Vitis. | 1 | 3.4 | 1 | A - Third Party | Action to avoid future risk | Maintain at broadly current dimensions by way of regular pruning. |

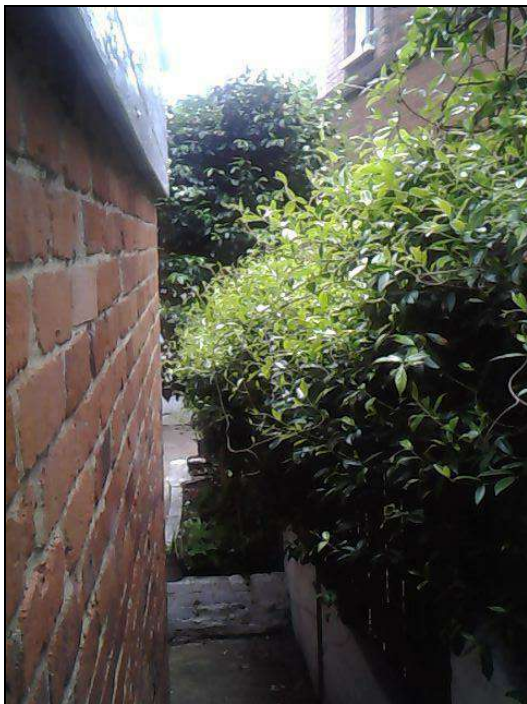
SG1 - Mixed species shrubs

| Tree No. | Species | Age Cat | Approx. Height (m) | Distance to Building (m) * | Ownership | Action | Requirement |
|---|---|---|---|---|---|---|---|
| SG1 | Mixed species shrubs: Camelia and Star Jasmine (located in raised planter but base unknown). | 1 | 3.7 | 2 | C - Insured | No action | No works. |
