## ASBESTOS DEMOLITION SURVEY

| Site | Cranwood, 100 Woodside Avenue, Muswell Hill, London, N10 3JA |
| Survey reference | J050727 |

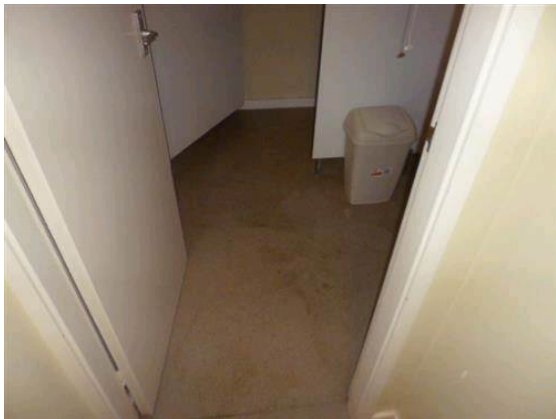
| | Item Reference | | J050727 #9 |

| <b>Comments:</b> Chrysotile found in adhesive & floor tile | |

| <b>Recommended Action</b> | Remove |

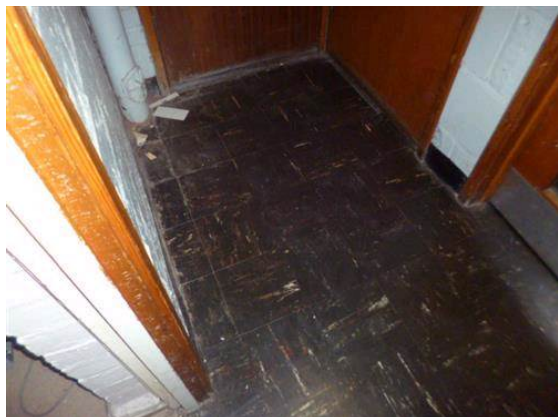
| Item Reference | J050727 #64 |

**Recommended Action** Remove  
**Comments:** Chrysotile found in adhesive & floor tile

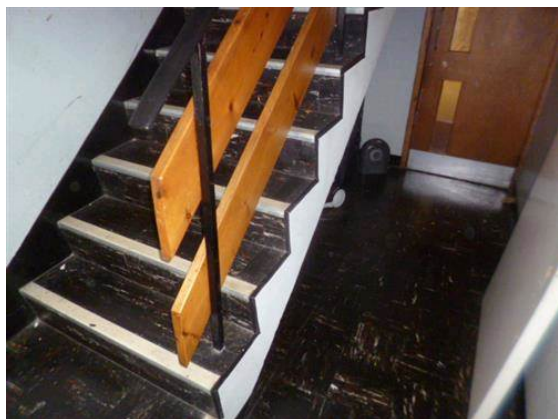
| Item Reference | J050727 #65 |

**Recommended Action** Remove  
**Comments:** Chrysotile found in adhesive & floor tile
