# Design & Access Statement for repairs to Pier and Wall on Land Adjacent to no.86 Southwood Lane, N6 5SY

16th October 2022

Ref: SHERCO\_RP\_01 (Rev A)

**Client:** Southwood House Estates Residents Company Limited (SHERCO)

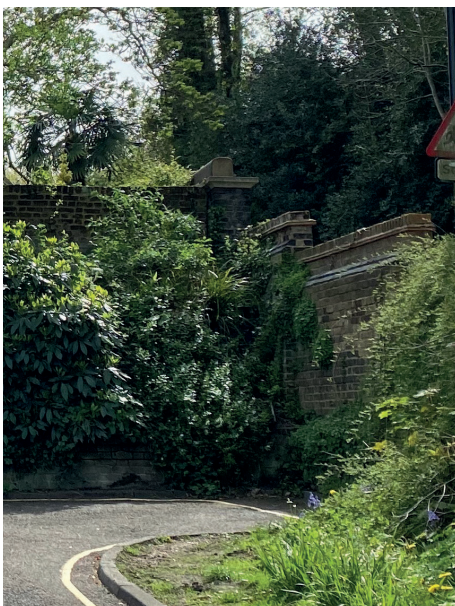
**Figure 2 - View from Service Road Looking South (Existing condition)**

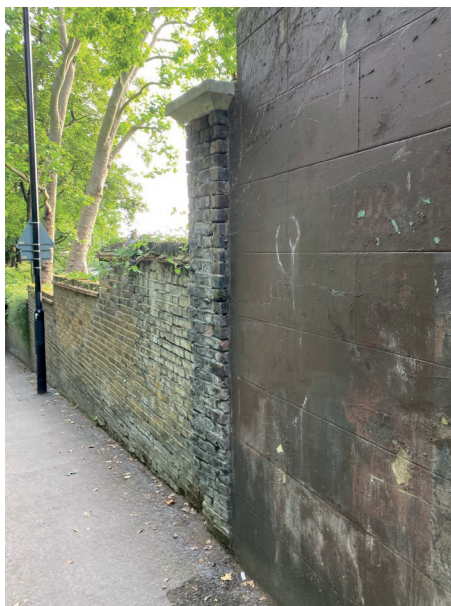
**Figure 3 - View from Southwood Lane Looking North (Existing condition)**

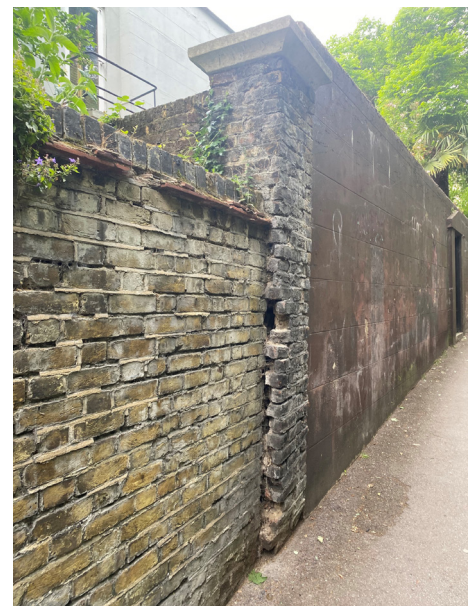
**Figure 4 - View from Southwood Lane Looking South (Existing condition)**

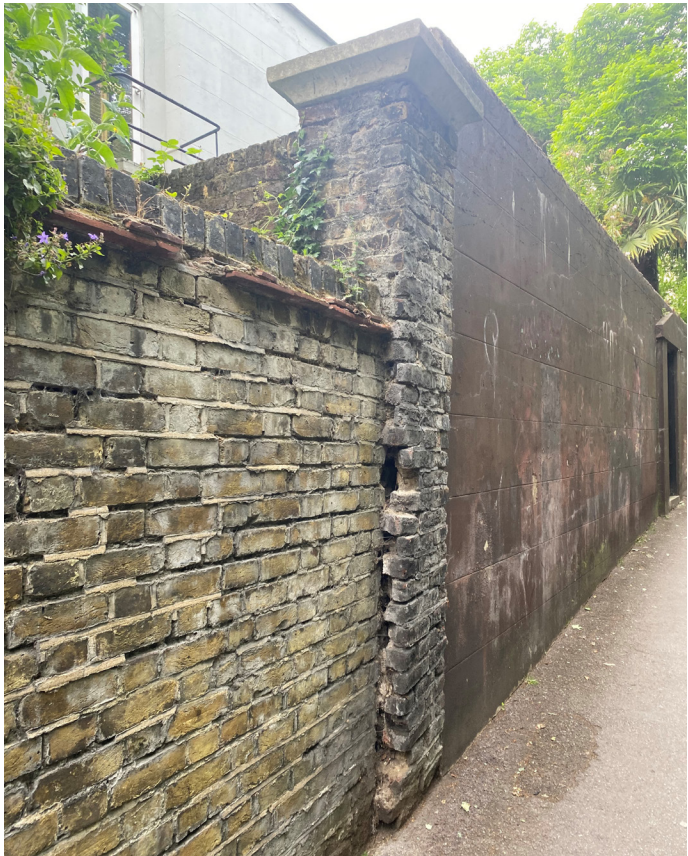
Figure 6 - View from Southwood Lane Looking South (Existing condition)

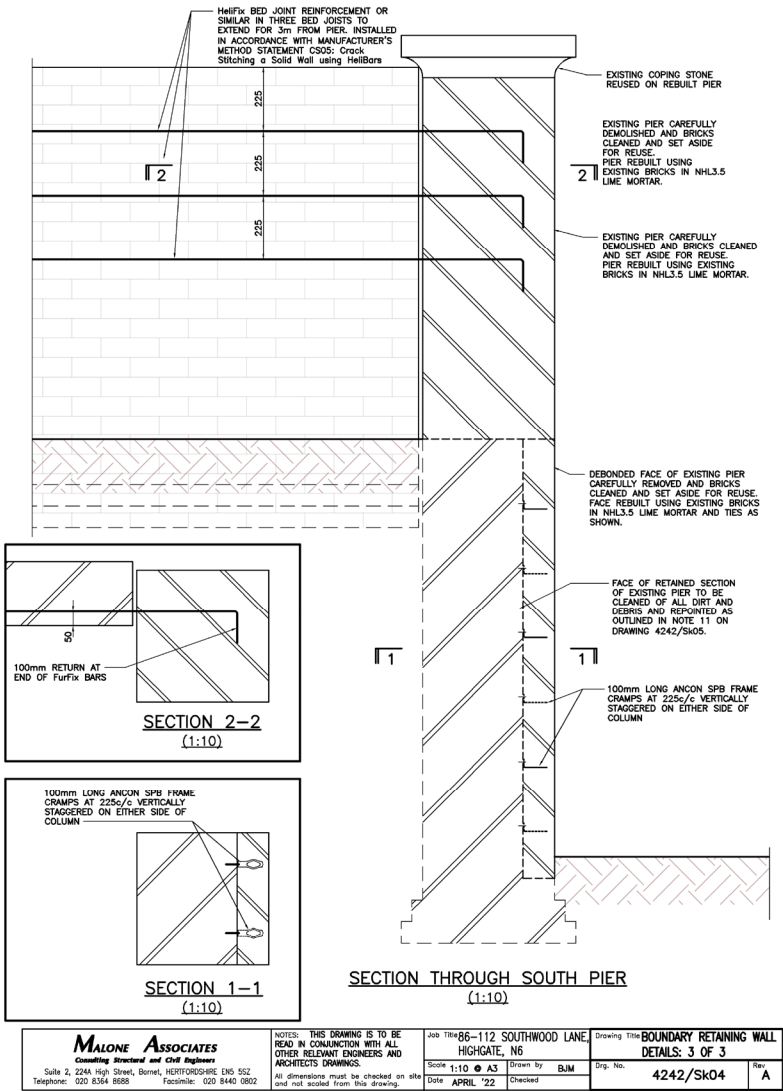
Figure 7 - Extract of drawing 4242/SK04  
This drawing summarises the repairs to the pier

These works are a shared responsibility between SHERCO and the adjoining owner of Highstone House given that they fall on a party fence wall boundary line. They involve the careful dismantling of the upper portion of the pier, the rebuilding of the lower facing course of brickwork and the reinstatement of the upper portion of the pier once the lower section is rebuilt. As is noted in drawings DWG-05 & 4242/SK04, the existing coping stone and all brickwork are proposed to be reused in the reinstatement works.

A Lime mortar will be used in keeping with the original design and all anchors and tie rods/helibars will be concealed behind mortar as far as is practicably possible. The design repair proposals therefore preserve and enhance the original character of the pier as well as making it structurally sound.

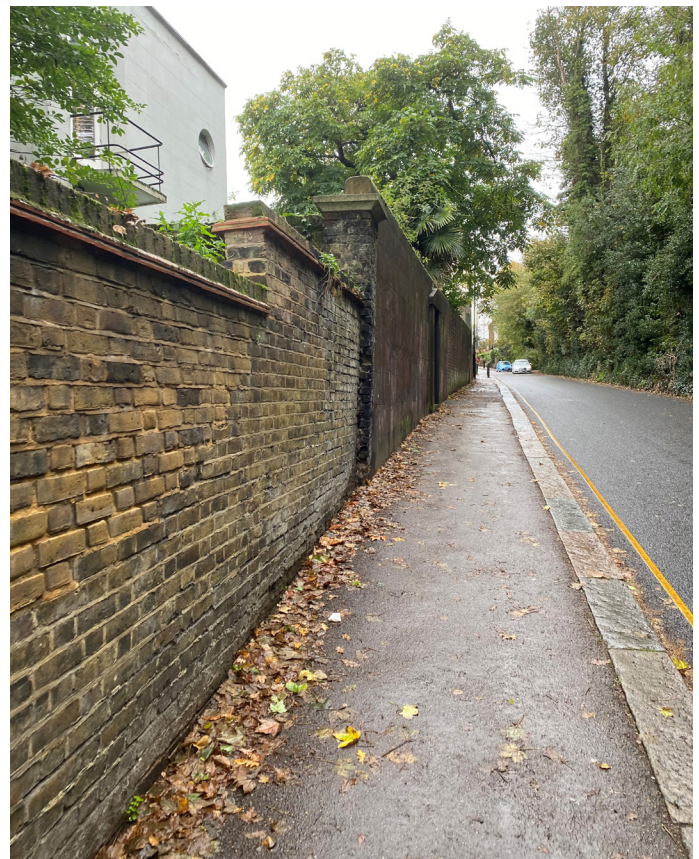
As noted in Malone Associates structural report, repointing of the entire wall is strongly advised. In their survey they identified numerous sections of the wall that had loose or missing mortar and that this problem was worse at the base of the wall.

They noted that if this repointing was not carried out it could lead to a significant deterioration of the condition of the wall in future. SHERCO will undertake to repoint the Pier and the area of Wall where the strengthening works are required.

**Figure 10 – View from Southwood Lane**  
*Looking South showing loose or missing mortar in wall*

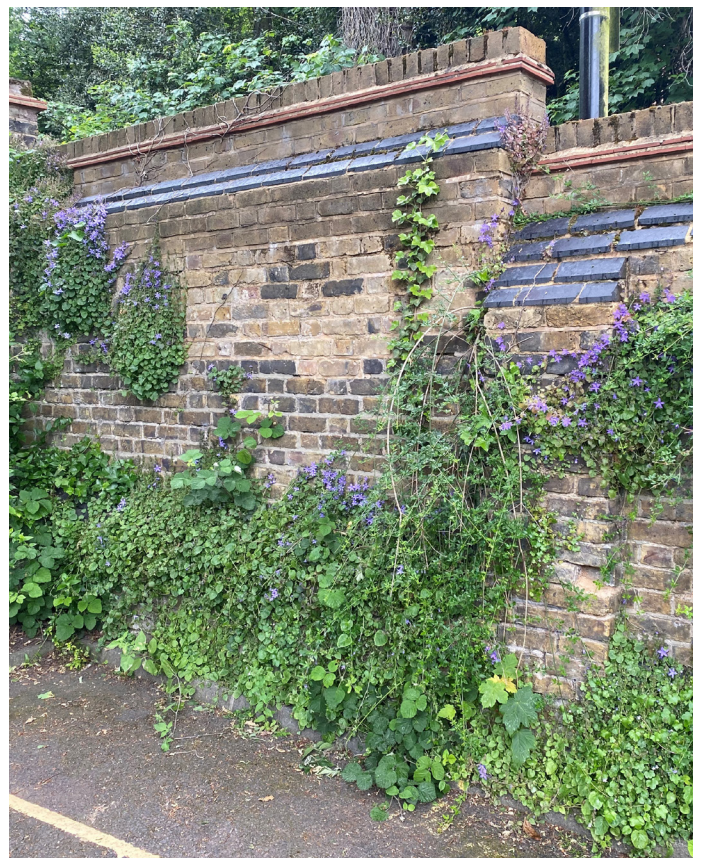
**Figure 11 – View from Service road (accessing 86 – 112 Southwood Lane)**  
*Looking West showing loose or missing mortar in wall*

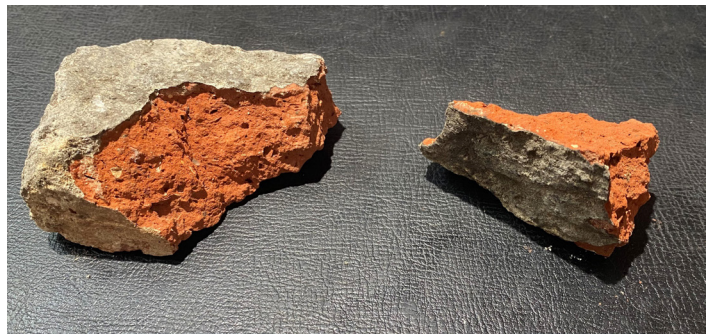
A request was made at pre application stage for further details of any replacement bricks proposed. SHERCO therefore obtained a sample of the existing brick (figure 12) and determined that this was a heavily weathered soft red and through enquiries with the London Reclaimed Brick Merchants has found a proposed replacement from their weathered multi-stock range (figure 13). As it is anticipated that only a small number of replacement bricks will be needed it will be made a requirement that the most weathered soft reds are hand selected from batches to allow for the closest possible match to existing.

**Figure 12- Samples of existing facing bricks from Pier**  
*There is a very significant deposit of grey weathering on all exposed surfaces*

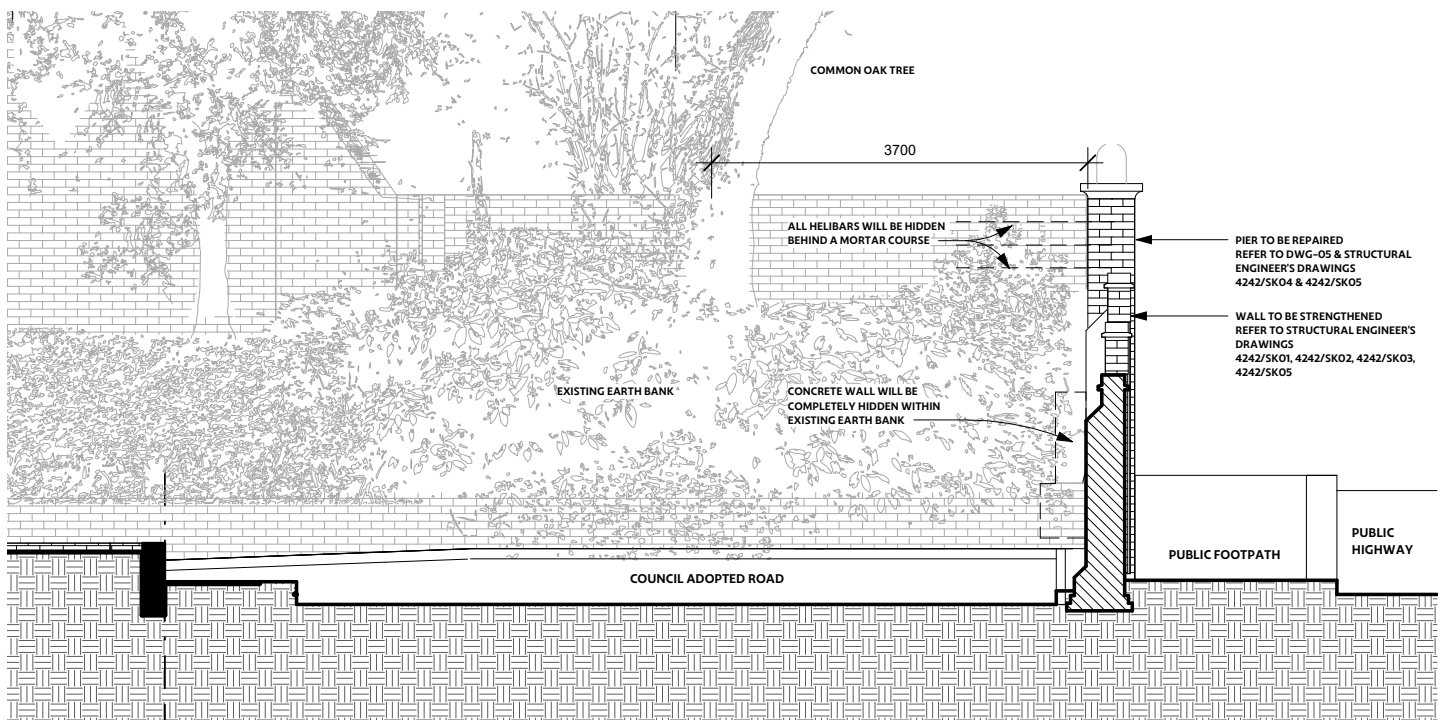
Figure 14- North Elevation (DWG-04)  
Showing the Oak tree and how the proposed works maintain the existing character and height of the pier and wall.
