| PROJECT | | | EXISTING AND PROPOSED<br>PIER AND WALL REPAIRS | |
| SHERCO | | DRAWING NUMBER<br>DWG-05 DETAIL OF PIER | | |

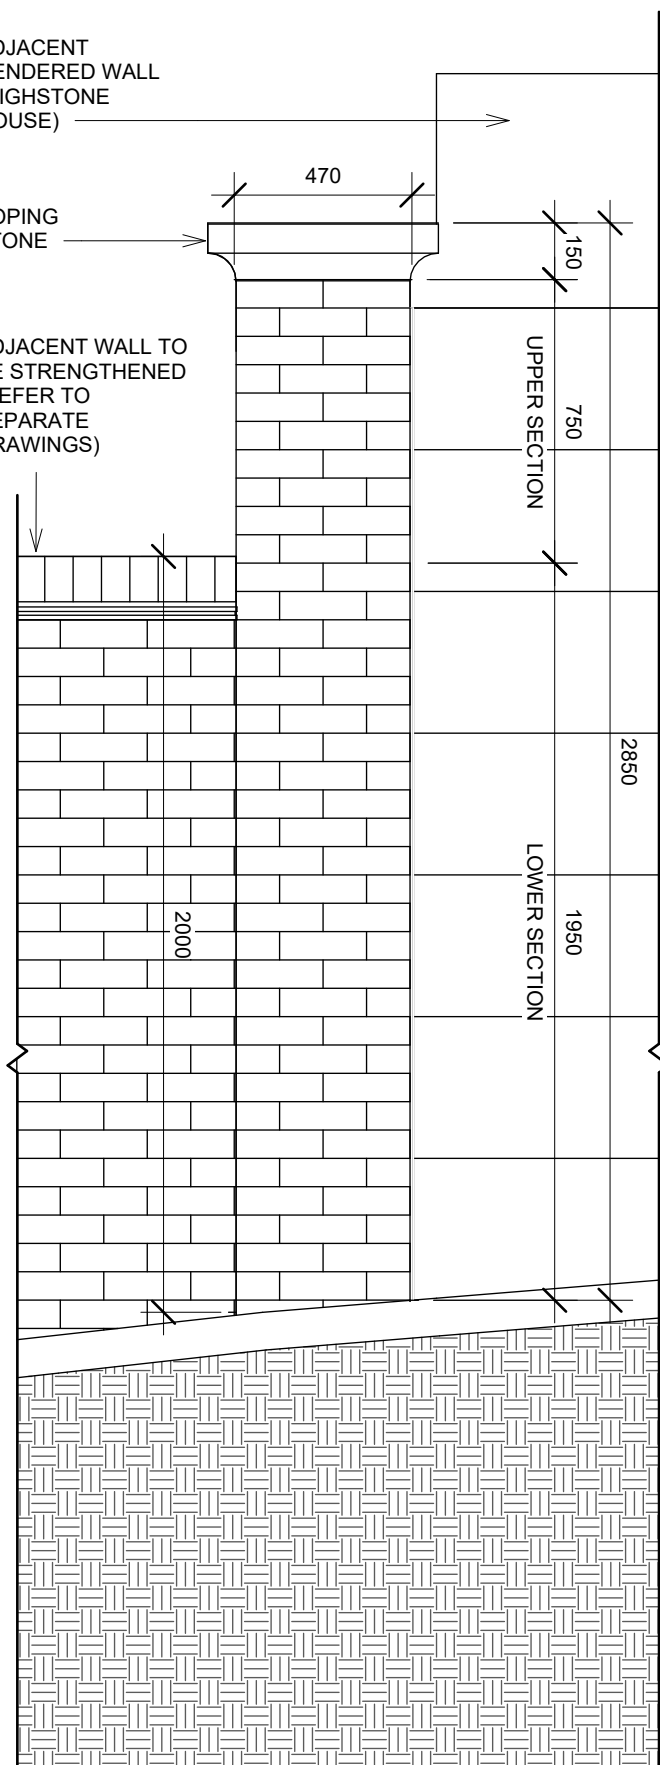
ADJACENT WALL TO  
BE STRENGTHENED  
(REFER TO  
SEPARATE  
DRAWINGS)

**SUGGESTED SEQUENCE OF REPAIR WORKS  
(TO BE AGREED WITH CONTRACTOR)**

- CAREFULLY REMOVE COPING STONE AND STORE FOR REUSE
- CAREFULLY TAKE DOWN THE FULL CROSS-SECTION OF PIER BRICKWORK LABELLED 'UPPER SECTION' WITH BRICKS LIGHTLY CLEANED AT JOINTS AND SET ASIDE FOR REUSE.
- CAREFULLY TAKE DOWN THE EXISTING 4" DEBONDED BRICKWORK FACE LABELLED 'LOWER SECTION' WITH BRICKS LIGHTLY CLEANED AT JOINTS AND SET ASIDE FOR REUSE.
- REBUILD LOWER SECTION FACING BRICKS WITH EXISTING BRICKWORK (EXISTING WEATHERED FACE TO BE EXPOSED) FOLLOWING STRUCTURAL ENGINEER'S DRAWINGS 4242/SK04 & 4242/SK05. AS ADDITIONAL BRICKS ARE REQUIRED TO REPLACE MISSING ONES, SOURCE FROM WEATHERED MULTI-STOCK RANGE BY LONDON RECLAIMED BRICK MERCHANTS TO MATCH EXISTING.
- REBUILD UPPER SECTION OF ENTIRE PIER CROSS-SECTION OF BRICKWORK (WEATHERED FACE TO BE EXPOSED) FOLLOWING STRUCTURAL ENGINEER'S DRAWINGS 4242/SK04 & 4242/SK05
- REINSTATE COPING STONE

ALL MORTAR USED TO BE AS SPECIFIED BY STRUCTURAL ENGINEER IN DRAWINGS 4242/SK04 & 4242/SK05

ALL WEATHERING TO THE EXSITING BRICKS MUST NOT BE REMOVED TO PRESERVE THEIR EXISTING CHARACTER.

EXISTING WEATHERED BRICKS ARE TO BE PRIORITISED FOR VISUALLY PROMINENT AREAS SUCH AS WEST FACE TO HIGHWAY AND NORTH UPPER FACE TOWARDS HIGHWAY. REPLACEMENT RECLAIMED BRICKS TO BE USED AT INTERFACE WITH EXISTING HIGHSTONE HOUSE WALL (TO SOUTH) AND UPPER SECTION OF LANDSCAPED EARTH BANK (TO EAST) WHERE THEY ARE LESS VISIBLE. REFER ALSO TO DRAWING DWG-02 FOR FURTHER DETAILS OF ABOVE MENTIONED LOCATIONS.
