## Omega Works B FRA and SUDS Strategy

Issue P02

| Report Number: | OMB-EOC-RP-001 |

This Flood Risk Assessment has been prepared by Eckersley O'Callaghan (EOC) on behalf of D Haus in support of the planning application for the proposed works at Omega Works B, 167 Hermitage Road, London, N4 1NA, in the London Borough of Haringey.

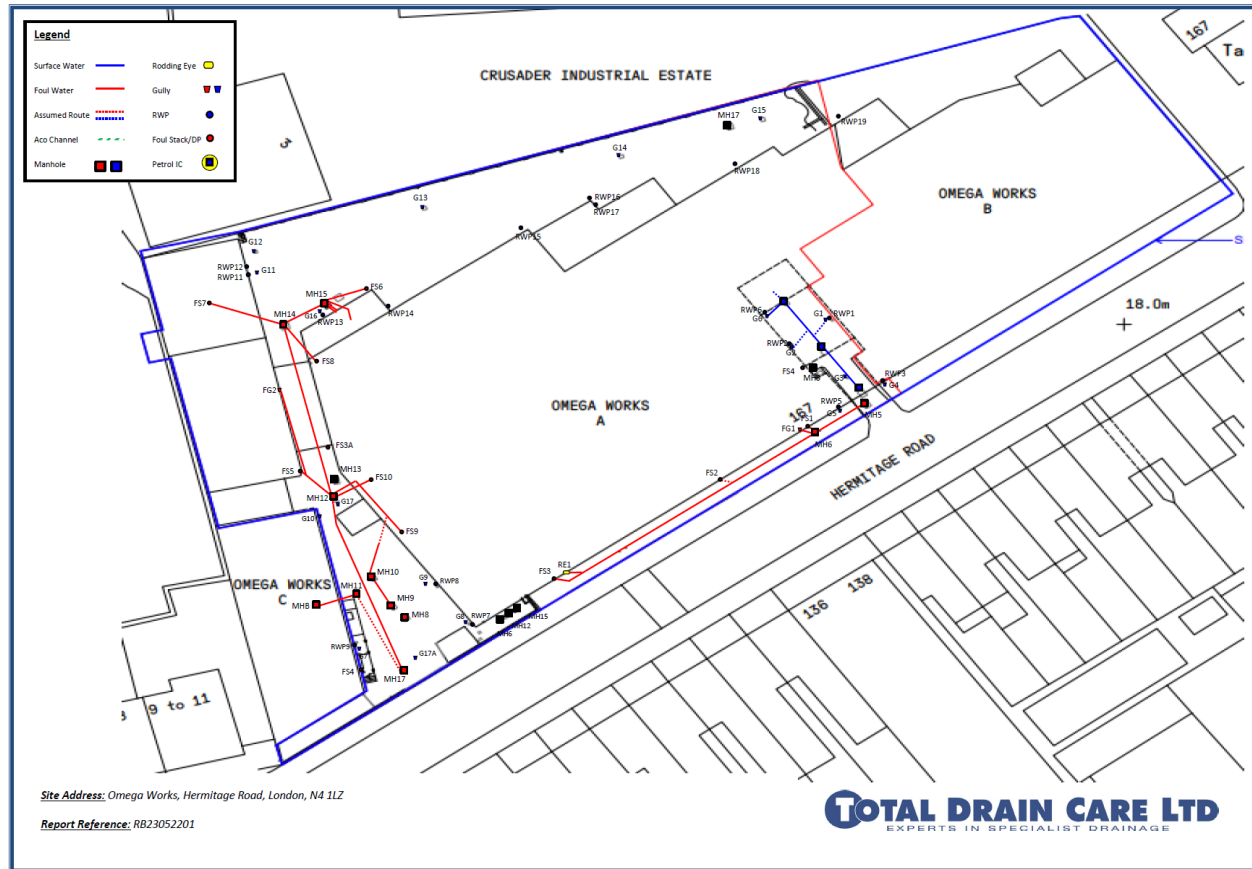
Figure 3 Below Ground Drainage Survey

A CCTV survey has been completed and indicates that the current drainage system is a gravity fed combined system, connecting into the sewer on Hermitage Road between Omega Works A and Omega Works B sites. There appears to be no connection from the site to the surface water sewer at the north of the site.

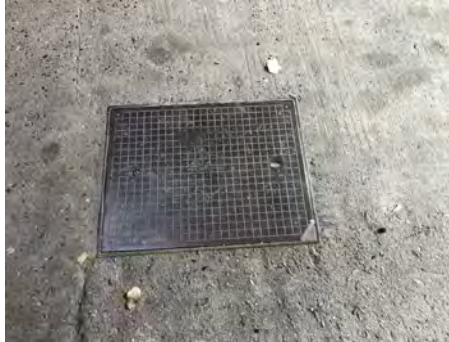
**MH1:** Existing manhole cover is broken in the bottom right corner in the below image. To prevent further damage to the cover we would recommend this to be broken out and replaced with a medium duty manhole cover measuring at 600mmx450mm.

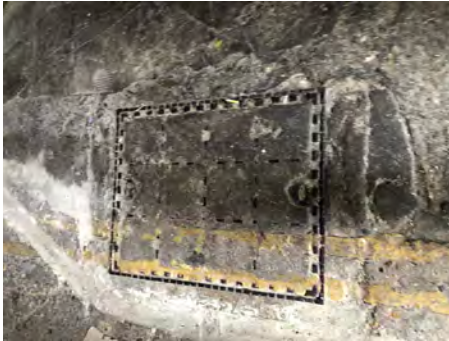
**MH2:** We were unable to survey this manhole as it was seized shut. We recommend that this manhole cover is replaced with a new medium duty 600x450mm medium duty cover and frame.

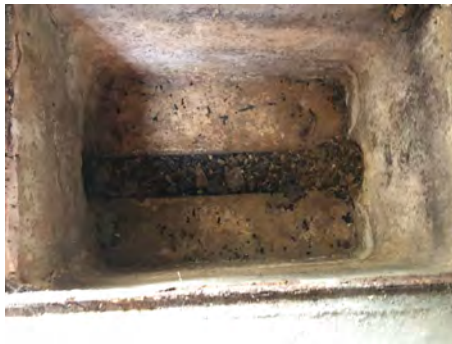
**MH3:** This manhole could not be surveyed due to a very heavy build up of silt within the chamber, blocking all connections. We would recommend the chamber to be cleaned in order to carry out this survey.

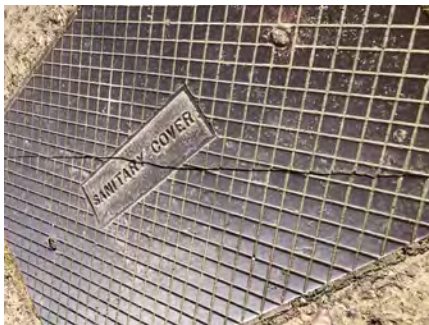
**MH4:** We could not lift this manhole to survey due to a large crack across the entire cover; raising this cover posed a risk of causing further damage and leaving the chamber completely exposed. We recommend a new D400 1000x700mm cover and frame.

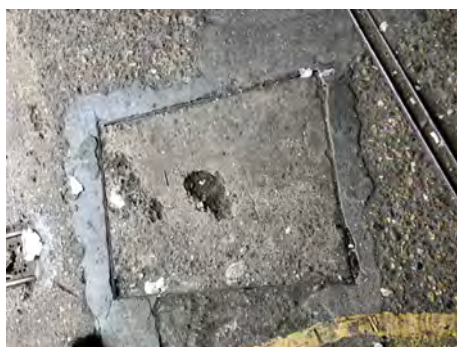
**MH5:** We were unable to lift this manhole due to defective keyholes filled with concrete. We recommend a replacement D400 1000x750mm cover and frame.

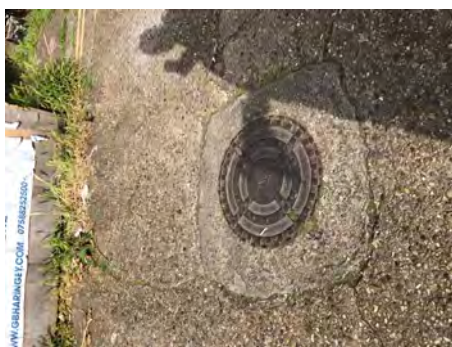
**MH7:** We were unable to survey this manhole due to the cover being seized. We recommend a replacement D400 500mm circular cover and frame in order to carry out the survey and gain access in future if required.

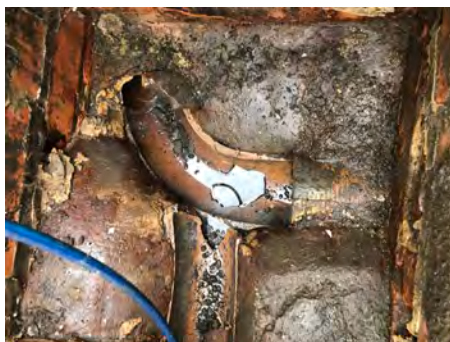
**MH10:** Upon gaining entry to this manhole we discovered that a large amount of the pipework within the chamber is broken. This can cause blockages and further damage to the pipework if not repaired. We recommend this to be removed and replaced to prevent any further damage.

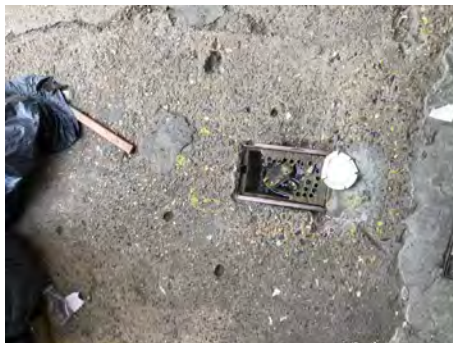
**G1, G2 & G6:** We could not survey these gullies due to the grates being seized shut. In order to survey and gain future access we recommend these to be replaced. 100mm squared grates.

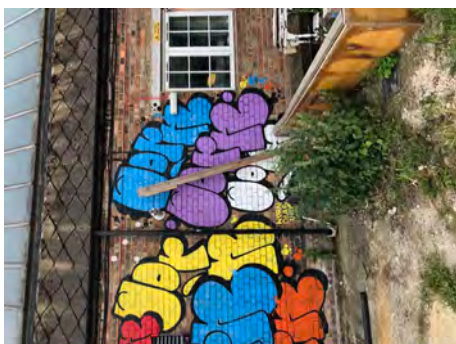
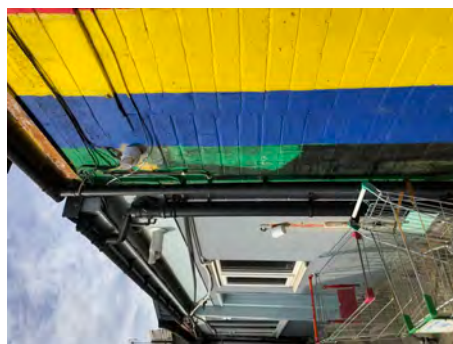
**RWP1,2,3,4,7,8,9,10,11,12,14,15,16,17,18 & 19:** All of these rainwater pipes are unable to be surveyed as they discharge above ground and spill on the floor into nearby gullies.
