# Edmanson's Close Almshouses Tottenham

## Structural Inspection Report

| Job Number: | 28740 |

| January 2020 | 1 | For Information |

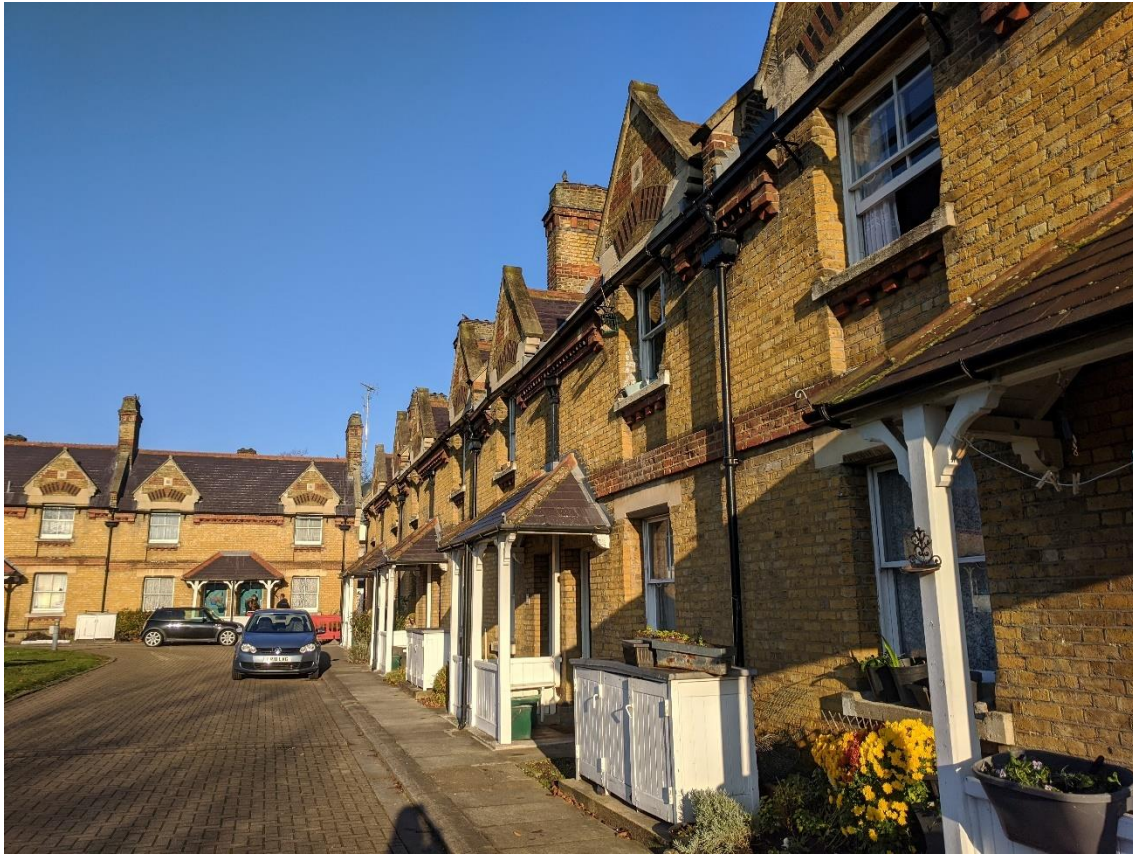
Photograph 1 - Front view of existing Almshouses

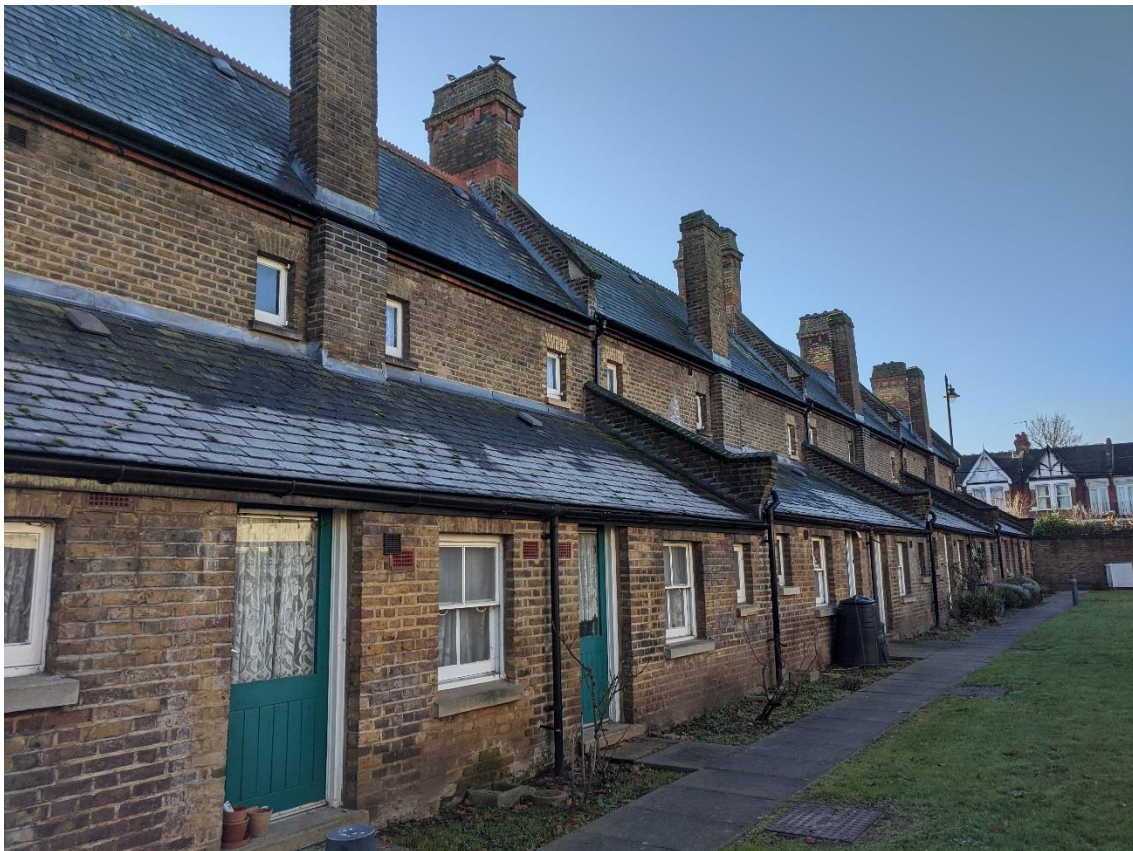
Photograph 2 - Rear view of existing Almshouses

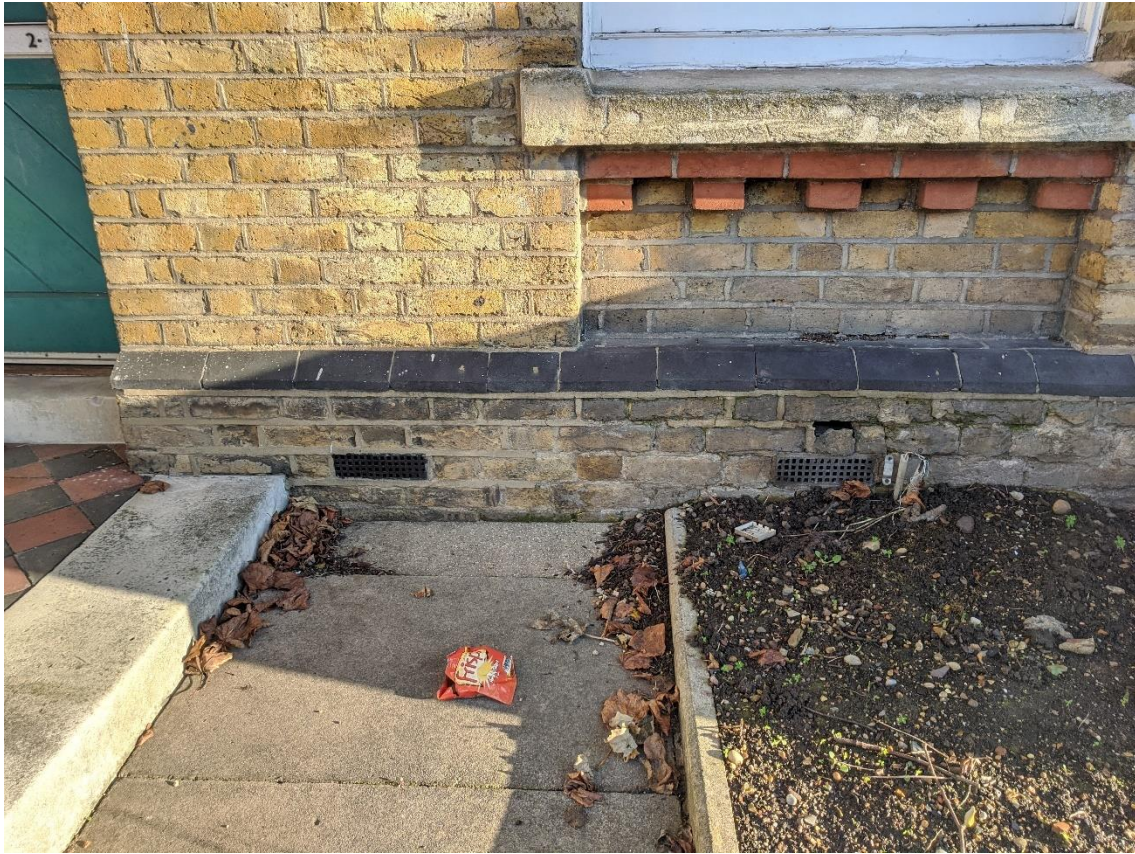
Photograph 3 - Air bricks to Almshouses front elevation

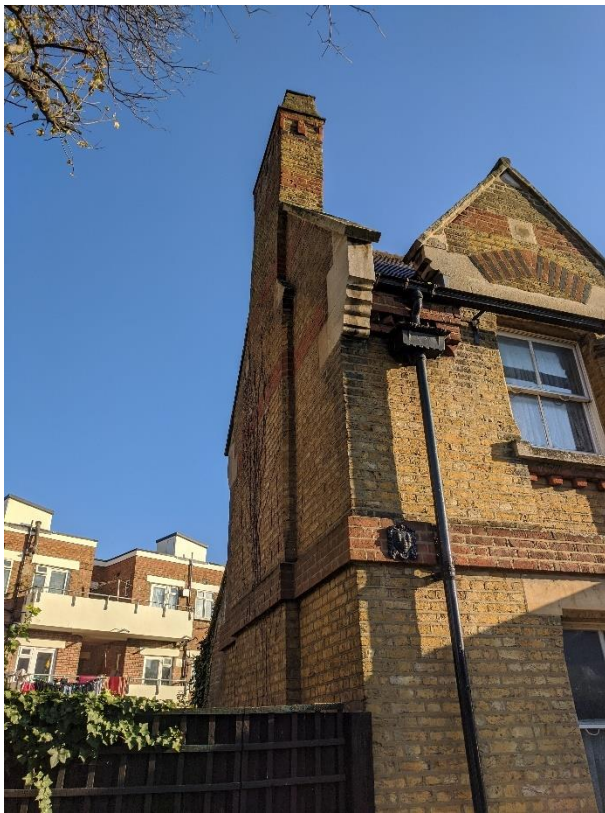
Photograph 4 - Gable wall to Almshouse

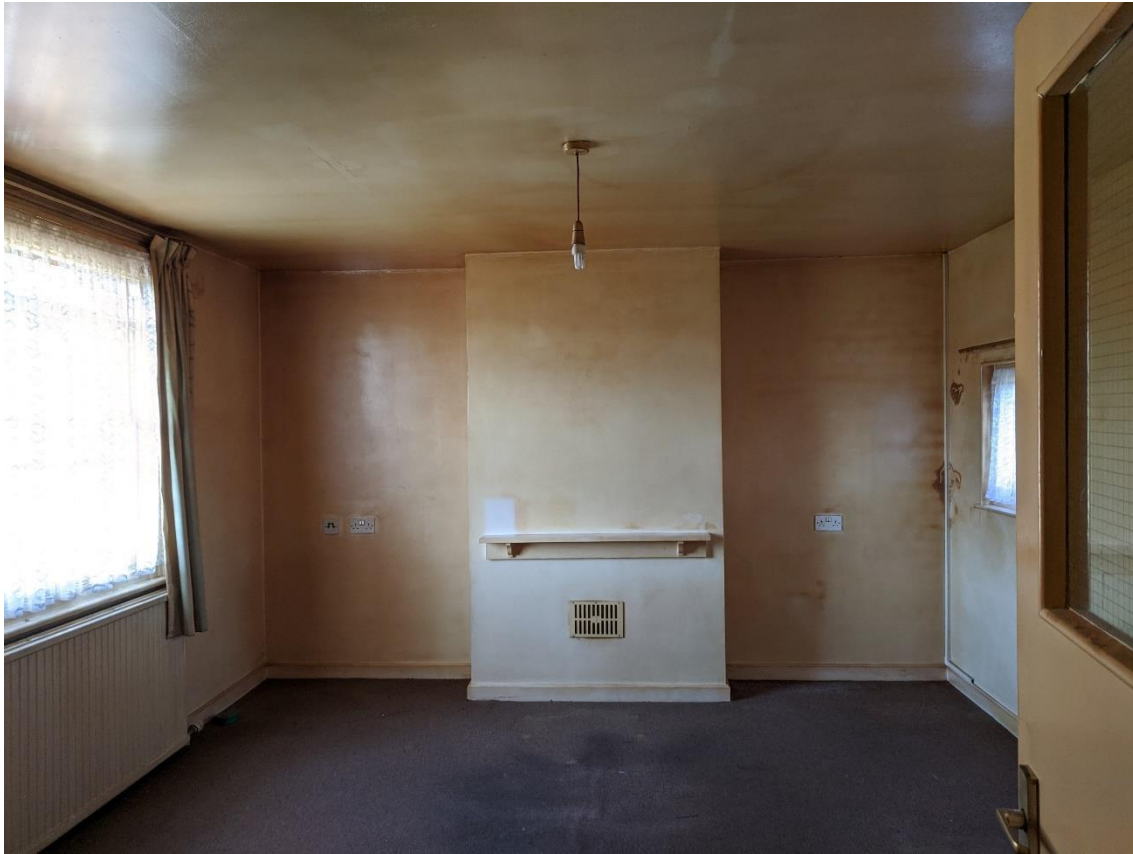
Photograph 5 - Internal condition of 1st floor Almshouse with boarded fire place (No 19)

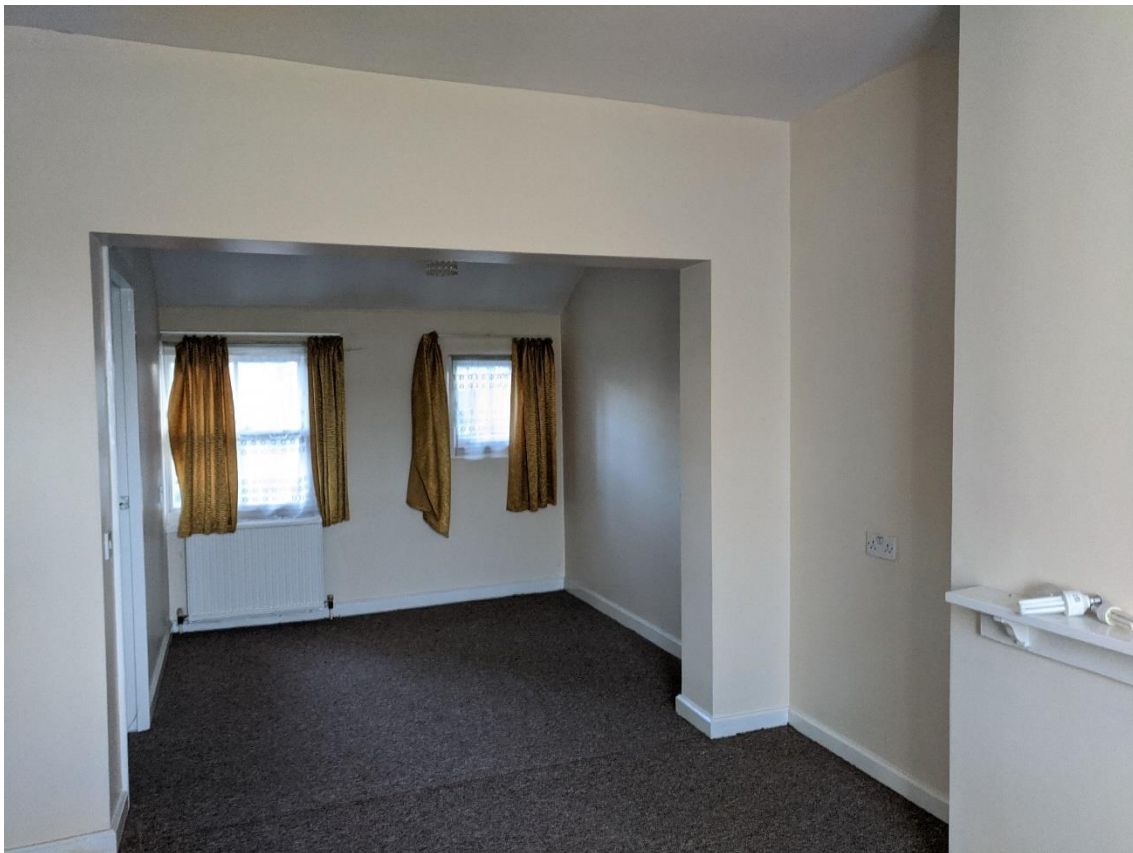
Photograph 6 - Internal condition of ground floor Almshouse (No 25)

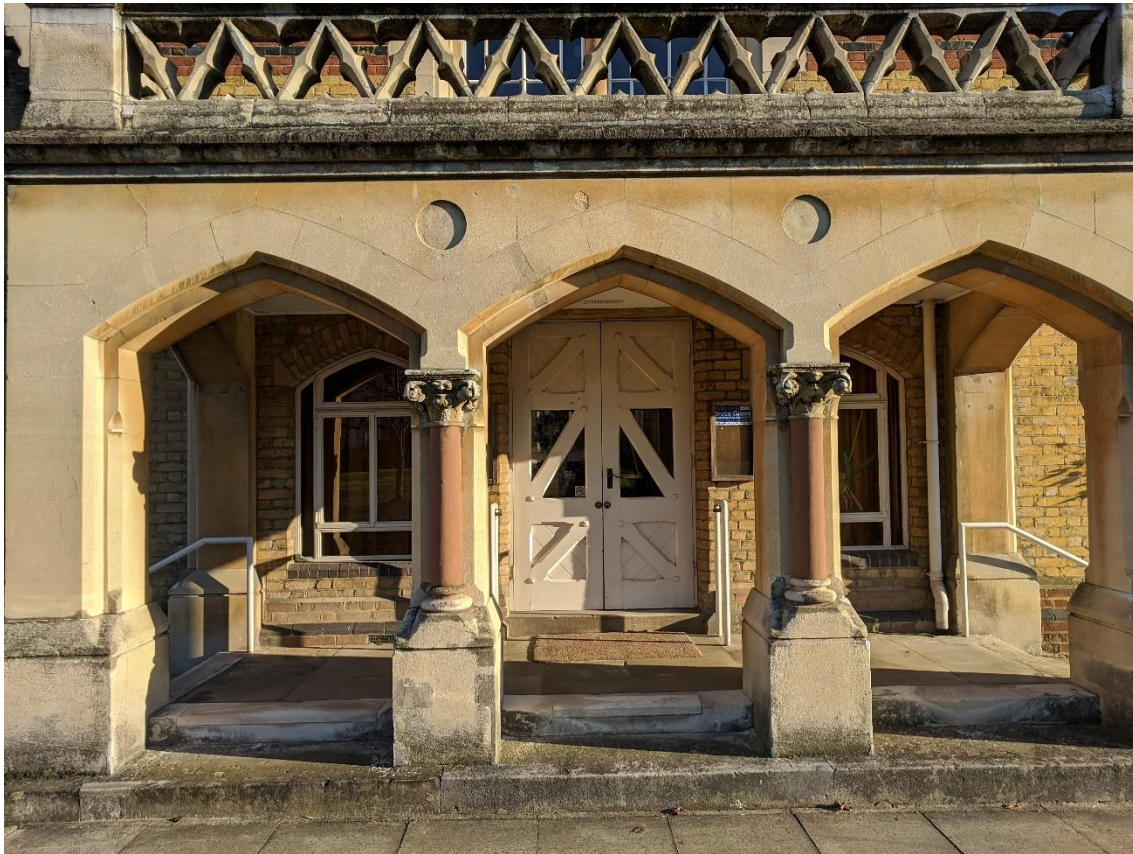
The visual inspection of the existing Almshouses and chapel has not highlighted anything of concern from a structural viewpoint. The external brickwork is in a good condition and shows no signs of movement or cracking. The stone portico to the chapel shows signs of weathering at the base of the columns but is not of structural concern. Some local repairs and cleaning of the stonework may be required to the parapet for aesthetic reasons.

Photograph 7 - Stone portico entrance to Chapel

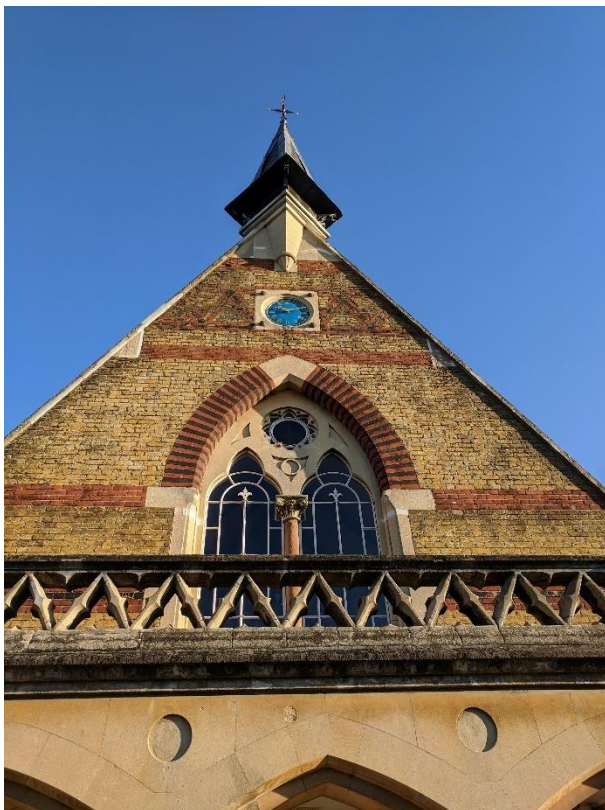
Photograph 8 - Front elevation of Chapel

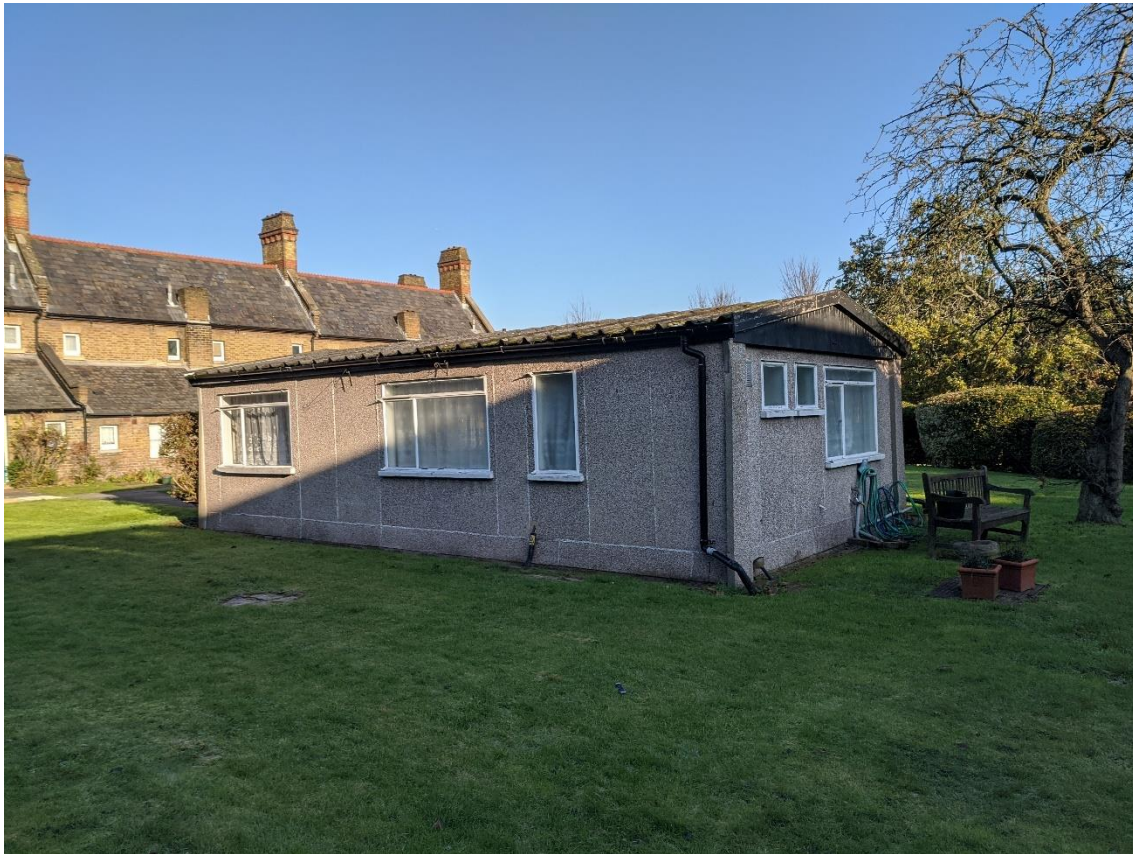
Photograph 9 - 1970's single storey laundry room

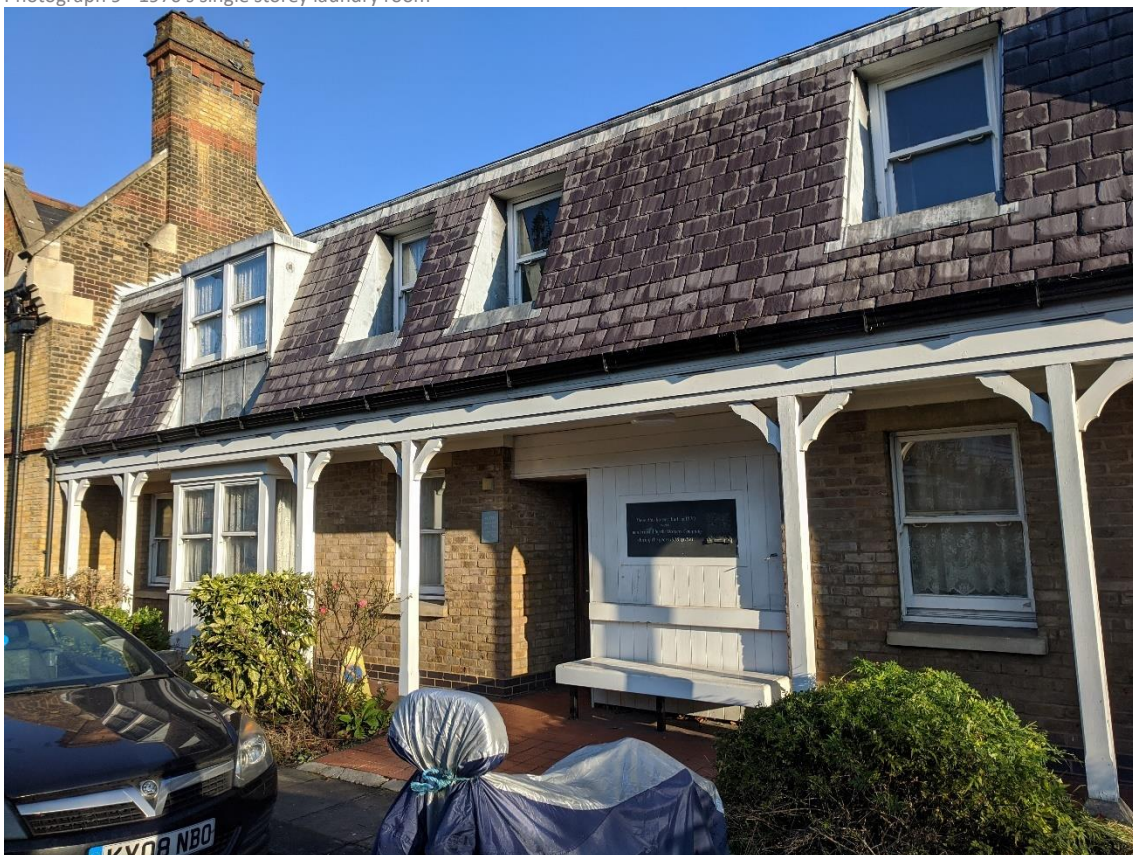
Photograph 10 - 1970's infill accommodation block

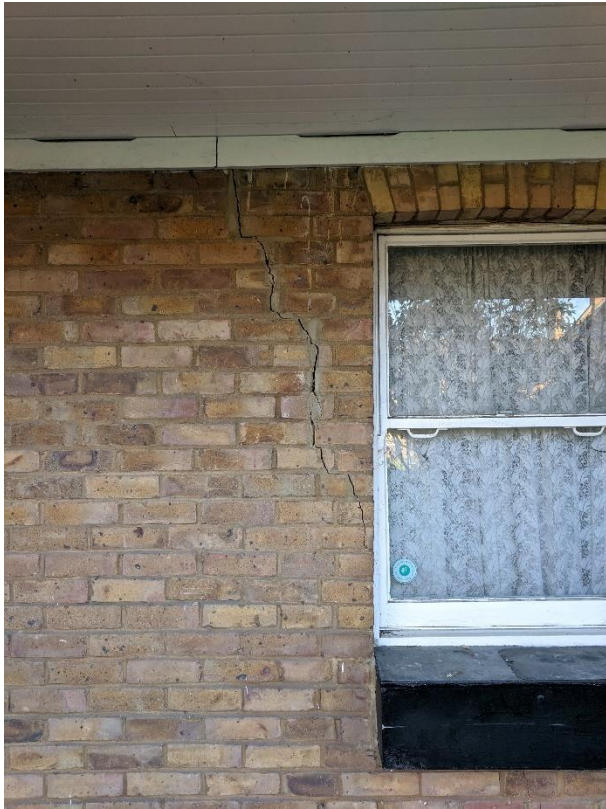
Some cracking is present to the external wall of the 1970's infill block. This is referenced in Photograph 11 in Appendix B. We were informed by the estate manager that this had occurred in the past year and that an adjacent tree has recently been removed. London Clay, which is present on the site, is typically classified as highly shrinkable. This means it has a high potential to change volume due to fluctuations in water content. The water content of the clay can be influenced by trees as well as climatic conditions. When a structure is built within the zone of influence of a tree then the foundations need to be sufficiently deep so they are not affected by seasonal fluctuations in the volume of the clay which can lead to building movements. This is likely to be the cause of the movement in the 1970's building and it is likely the building is founded on shallow spread footings which are not deep enough to overcome the movement in the clay. This building is proposed to be demolished so remedial work is not necessary. The foundations for the new building will need to consider the soil conditions and the proximity of existing and proposed trees.

Photograph 11 - Cracking to external wall of 1970's infill block

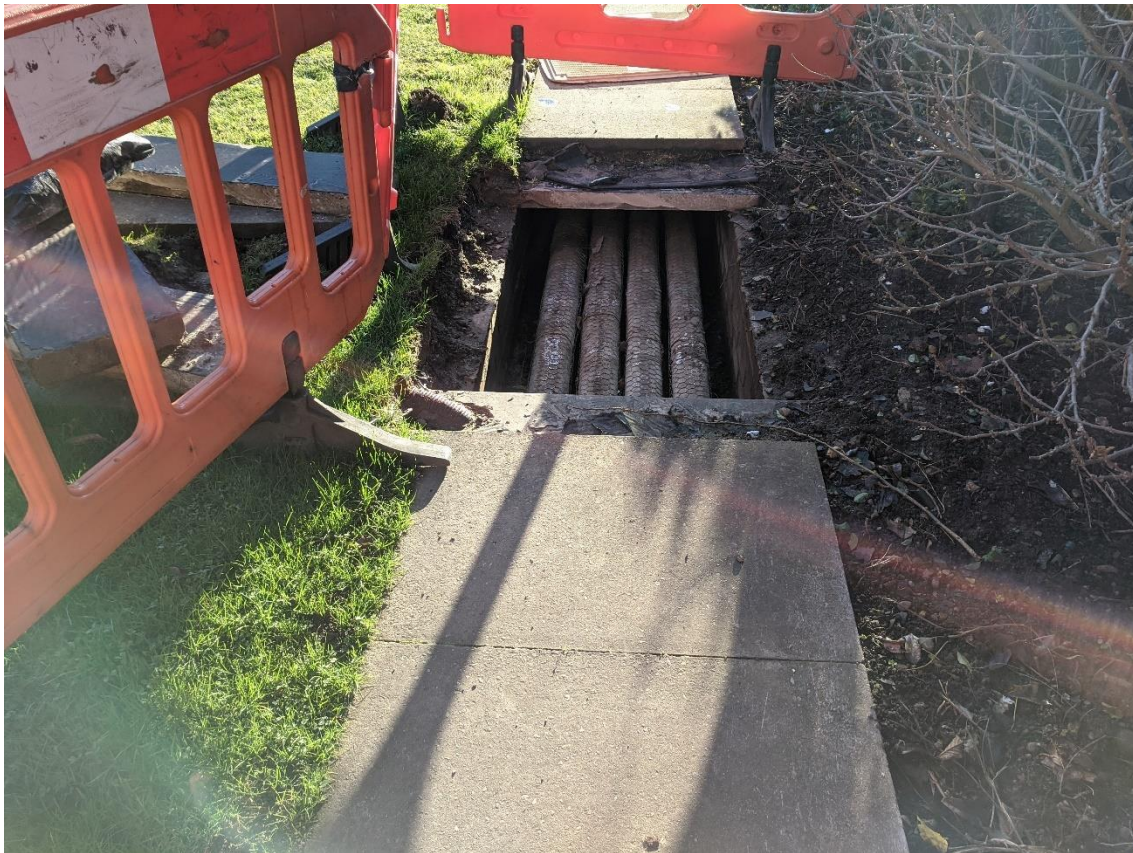
Whilst our inspection was being carried out some maintenance work was happening on the external services. The existing Almshouses are serviced through an external trench to the rear of the houses. This is shown in Photograph 12 in Appendix B. If the service trench will be re-used to service the refurbished Almshouses then its location will need to be considered and accounted for in the foundation design of the extensions.

Photograph 12 - External service trench under existing footpath
