OLD SCHOOL COURT  
TOTTENHAM, NI7 6LY

REPORT INTO INVESTIGATION OF DEFECTS CAUSED BY DAMP AT  
FLATS 1, 2, 24 AND 25 OLD SCHOOL COURT

March 2022

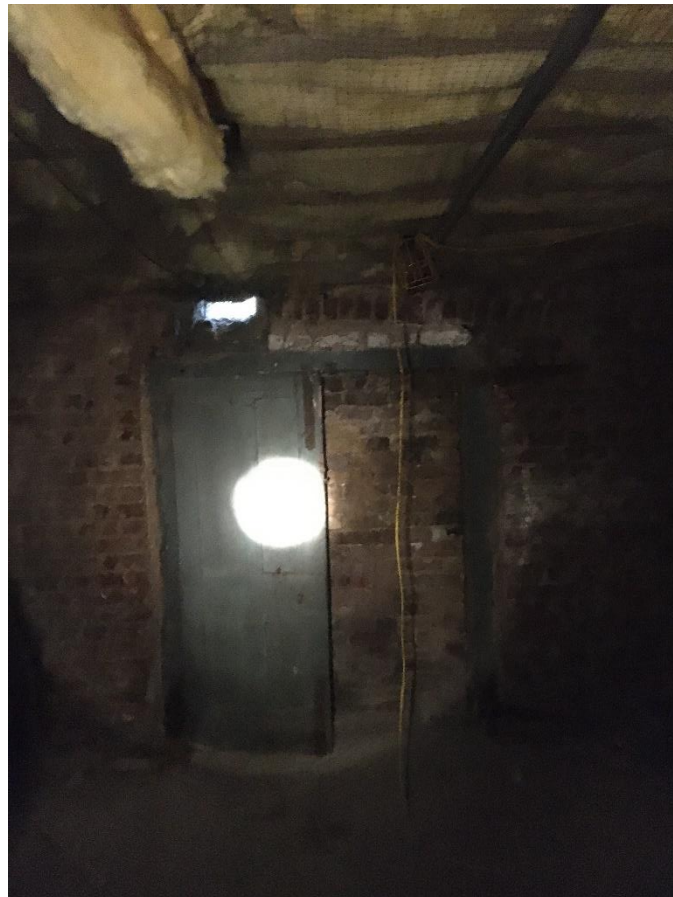
On this first visit I noted that there is evidence of former windows and/or door openings through the basement external walls, all of which have been built up solid in brick, precluding all air/light and access to the basement spaces. One former opening below 26 retains a crude shallow wooden cupboard, the frame of which is rotten. This cupboard is in the place of what was probably a doorway. Above it is a ventilation grille, approx. 230x230 iron grid. This is the only vent opening to be found at the basement spaces.

*The blocked up opening (initially window by seemingly later made into a doorway) below 23. There is no daylight into this space. The cupboard is just discernible and the glare from the ventilator above it.*

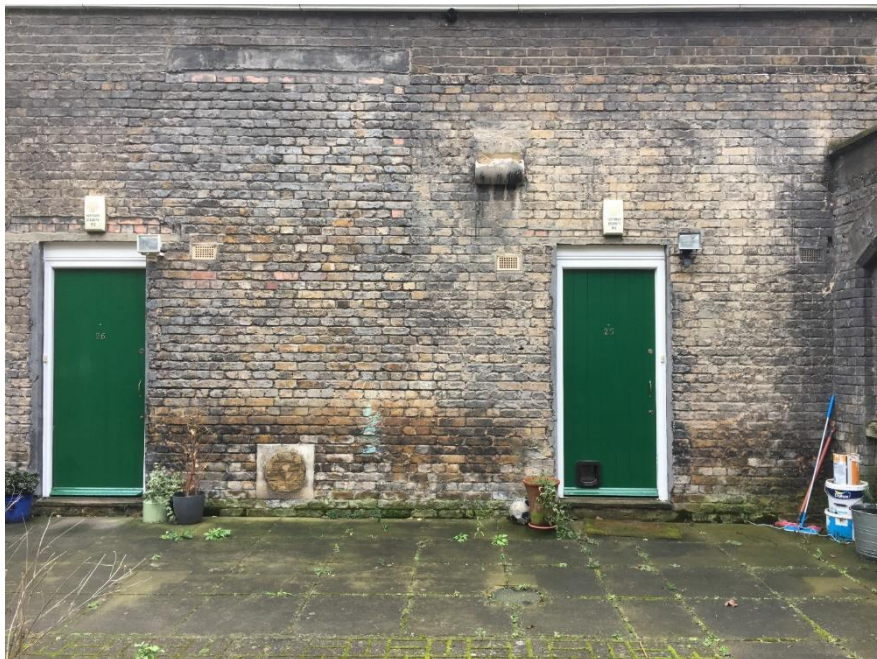
*Door to Flat 25 on the right and 26 on the left. Note a) the high level stone corbel that originally supported the roof of a passage, b) the stone head of a former window opening, c) the darkened brickwork (approx. bottom 12 courses) indicating very wet brickwork. Bathrooms are on the opposite side of the wall.*

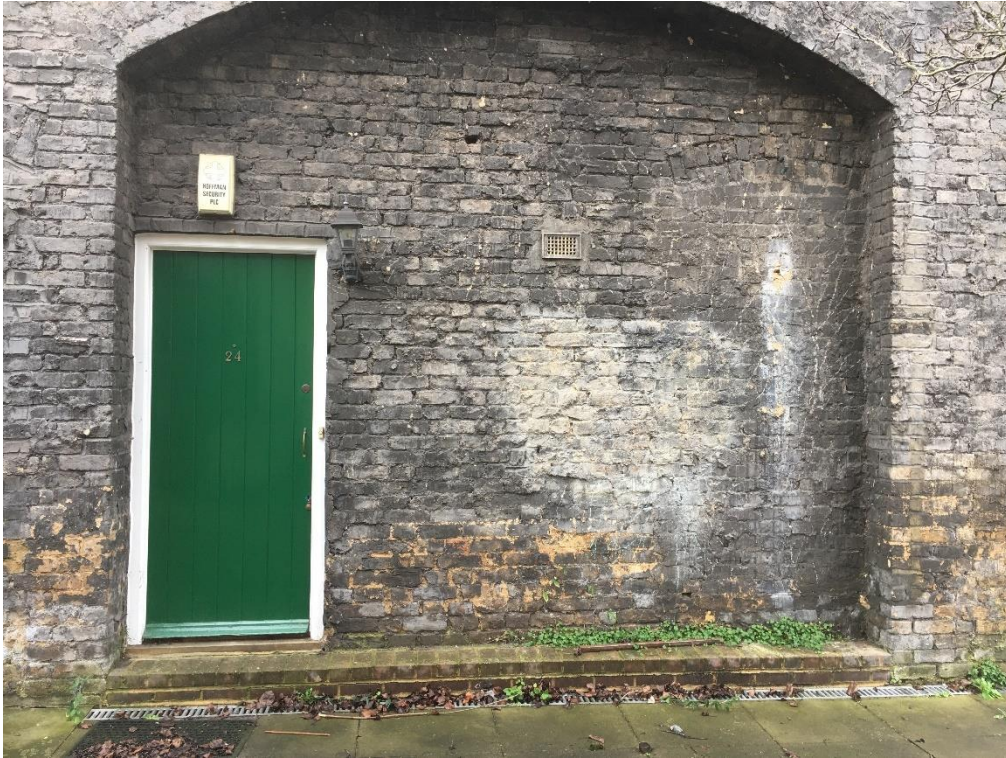
*Wall to 24. The entrance door is set within brickwork that forms a recess from the principal wall face. The wall could be thin, 9 inches, because it originally was internal. All the brickwork has been painted with a grey colour-wash. The header arch to the right hand side is where there was a former door. Observe the plants at the raised brick upstand and the Acco drain at wall base. To the right and left of the door salt damage is causing disruption of the surfaces – a sign of bad rising damp.*

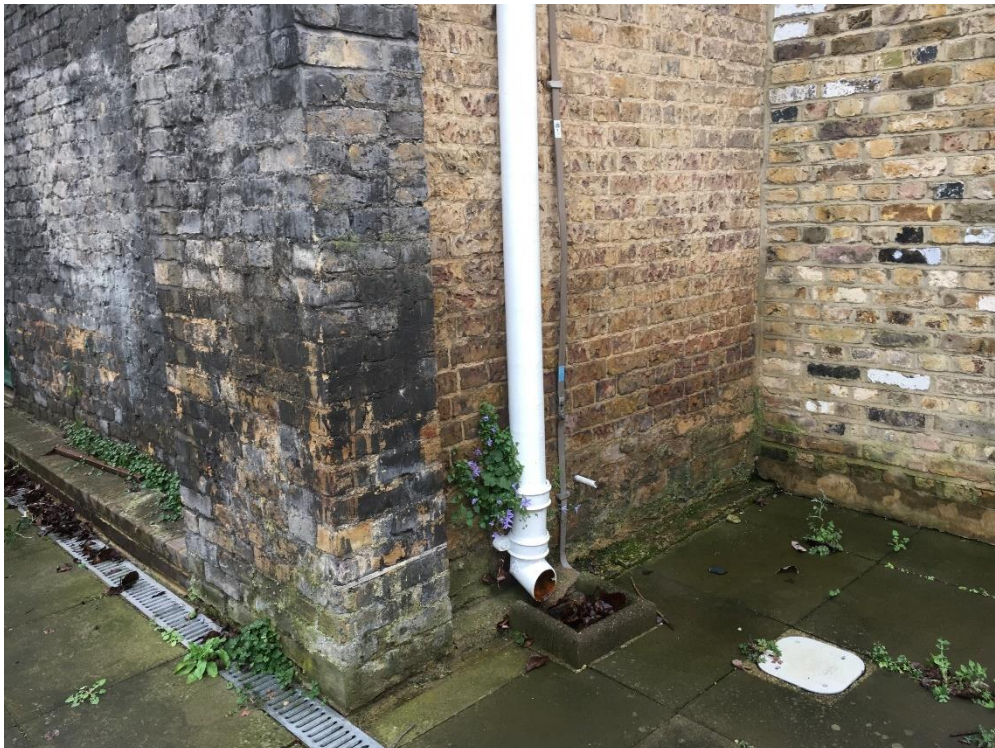
*Corner of 24. (The wall that supports the downpipe is the bathroom end wall. The saturation of the wall is marked by the colour change. Also note plant growth. There is no problem with the downpipe.*

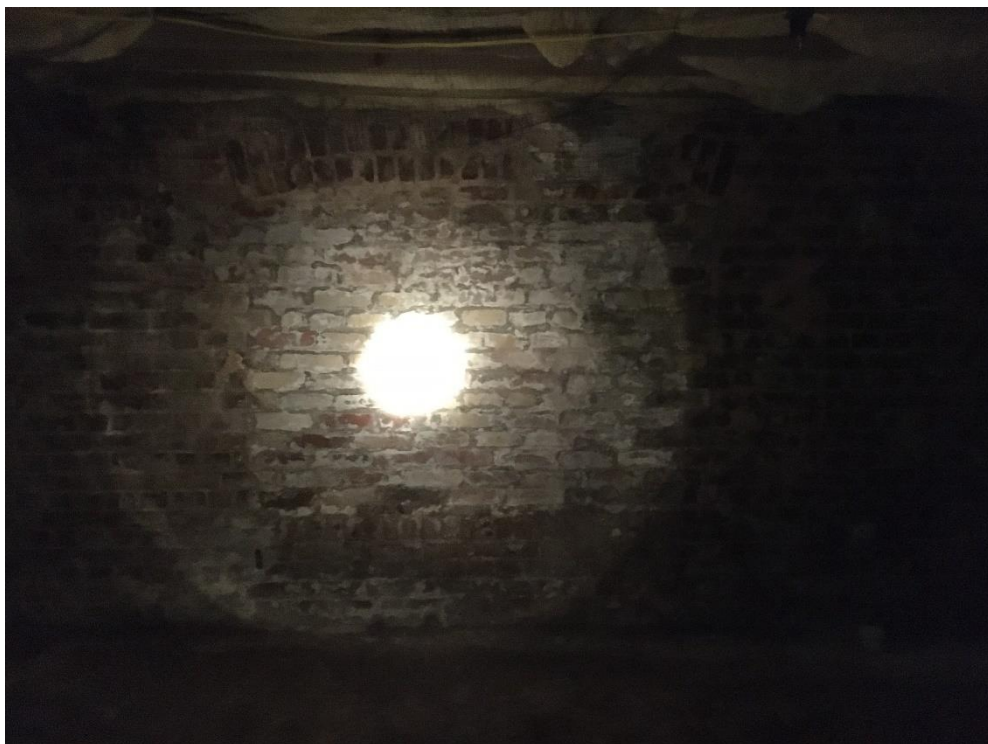
*Blocked window below 26 central courtyard side. The arched brick head and the brick on edge cill of the original window are visible. All the basement windows below 24, 25 and 26 were blocked.*

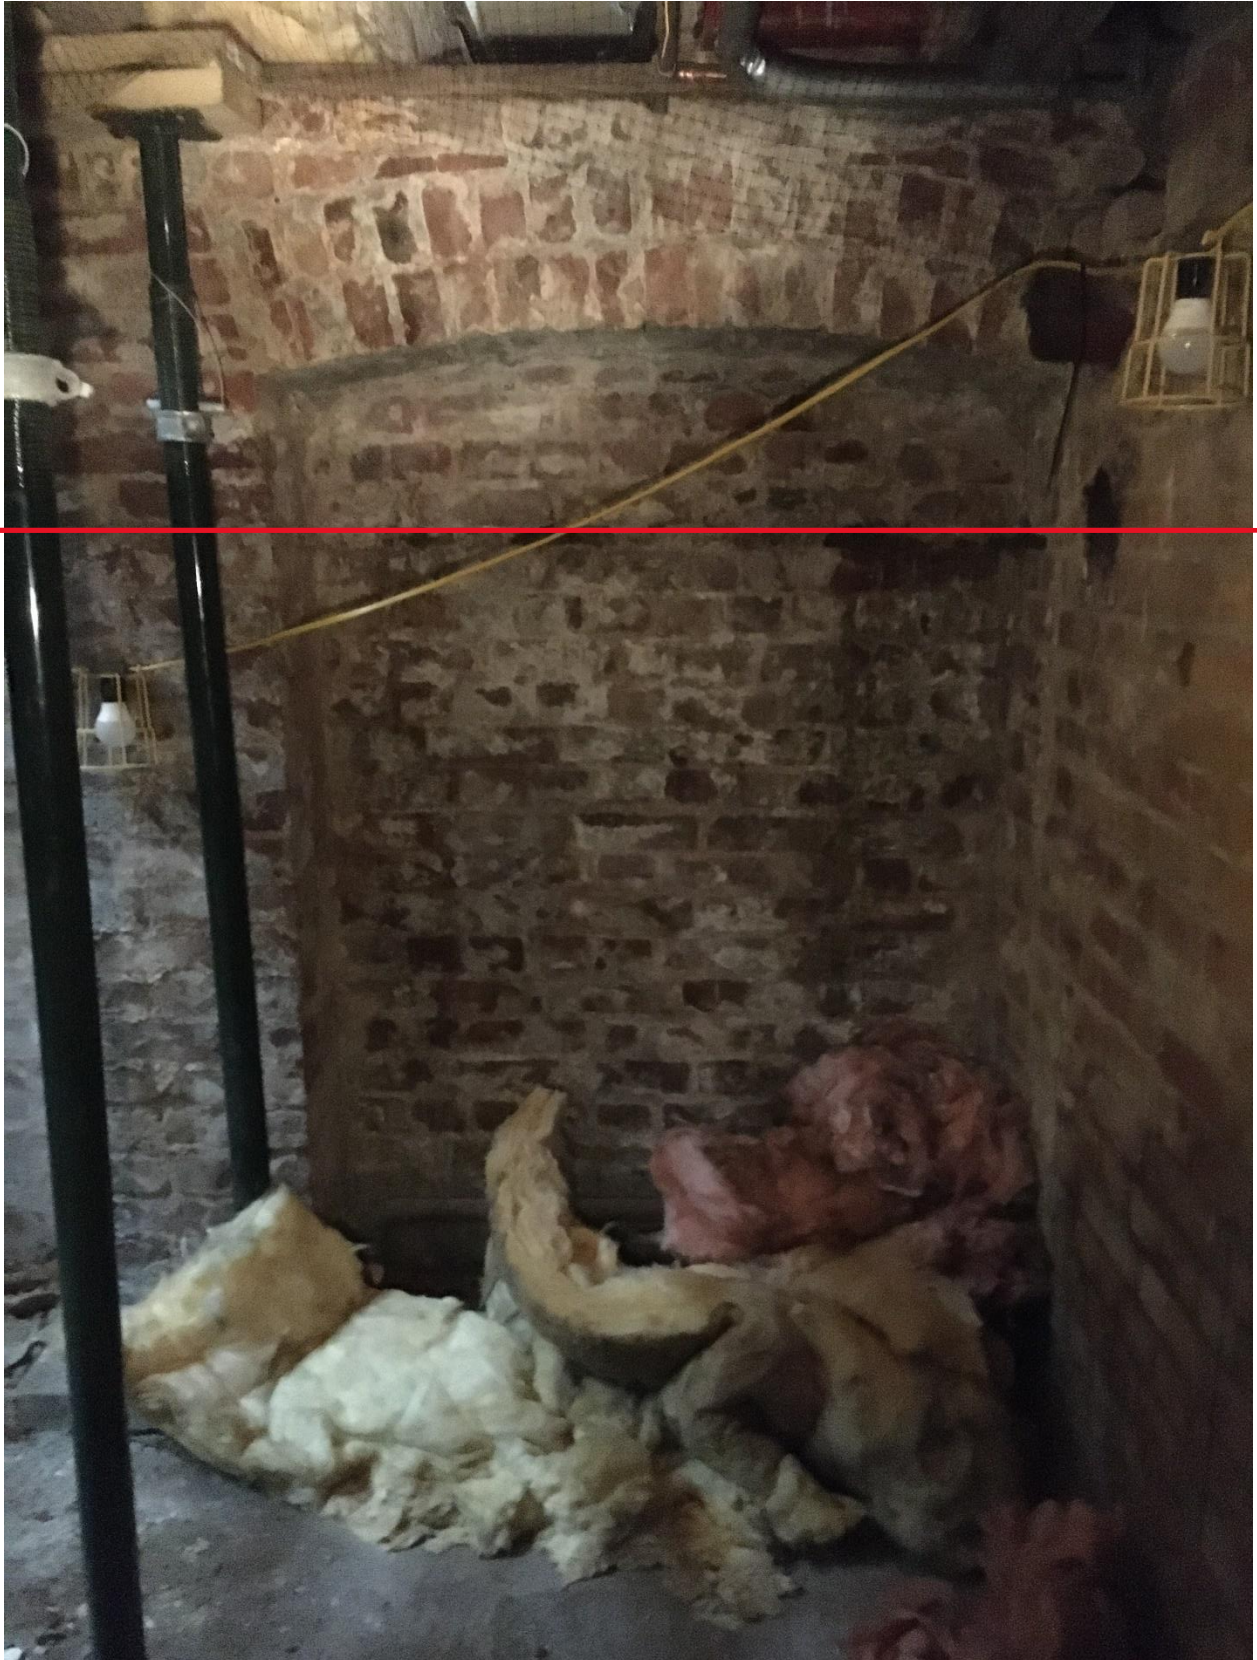
I also noted slate DPC's incorporated into the original brick walls including horizontal DPC's well below the level of ground floor timbers. This is clear evidence that the original building was thoughtfully constructed so as to preclude the harmful influence of moisture on the construction. However, wherever timbers come into contact with the wet external walls or are built into them, severe decay has occurred, because the wall construction is wet.

The red line shows the level of DPC.

*This arched recess was not a window but the structure below a fireplace that served the ground floor room above, originally the dining room of the school. This is where I first noted the position of a traditional double slate damp proof course.*

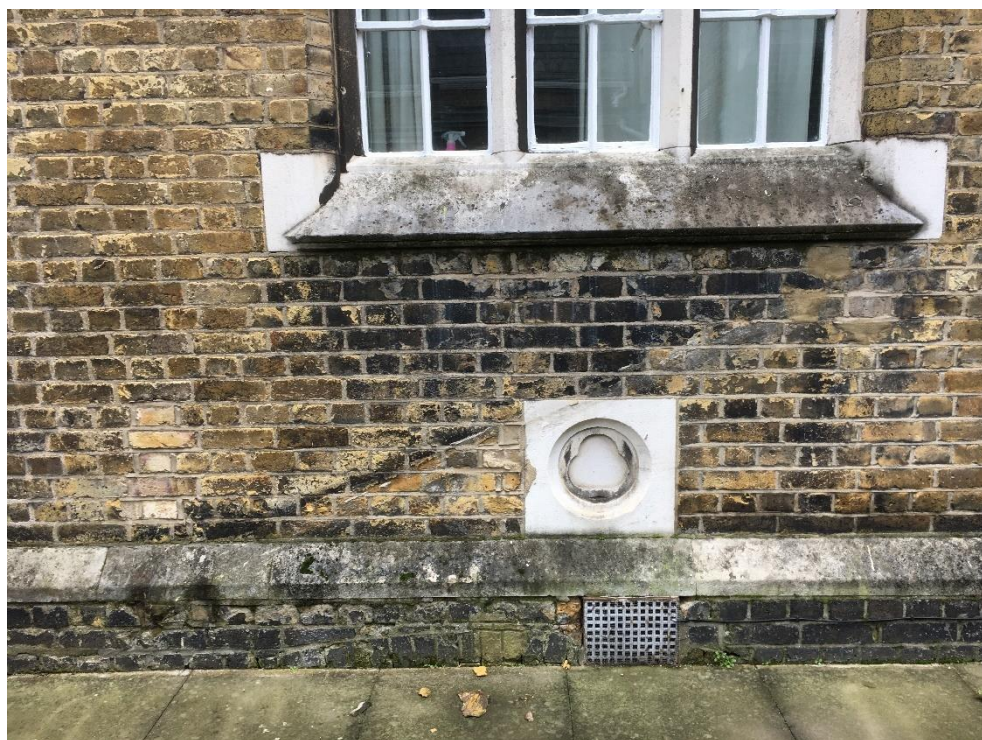
- Below the ground floor window of Flat 26 there is an inclined scar of a former structure that could relate to covered over external steps down to the basement level. (This is the position of the cupboard in the basement). This would have given ready access to the boiler room.

*Window to 26. Note the scar indicating a former covering to protect an external access stair/steps down to an opening into the basement. The brick arch head is visible immediately above the pavement level. Cut into it is the sole ventilator into the entire basement.*

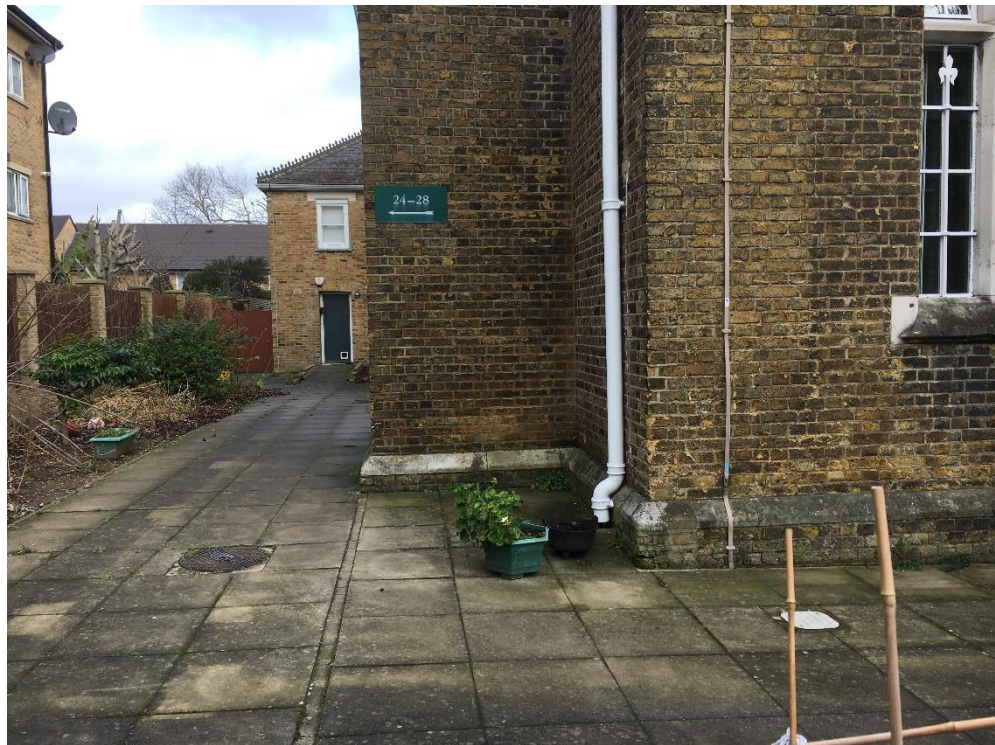
*Note that the Portland stone plinth runs “level” around the building and gives an easy way of assessing how high the external level is in relation to the internal floor level – see further detail below. Ground very high to left hand side (No.24).*

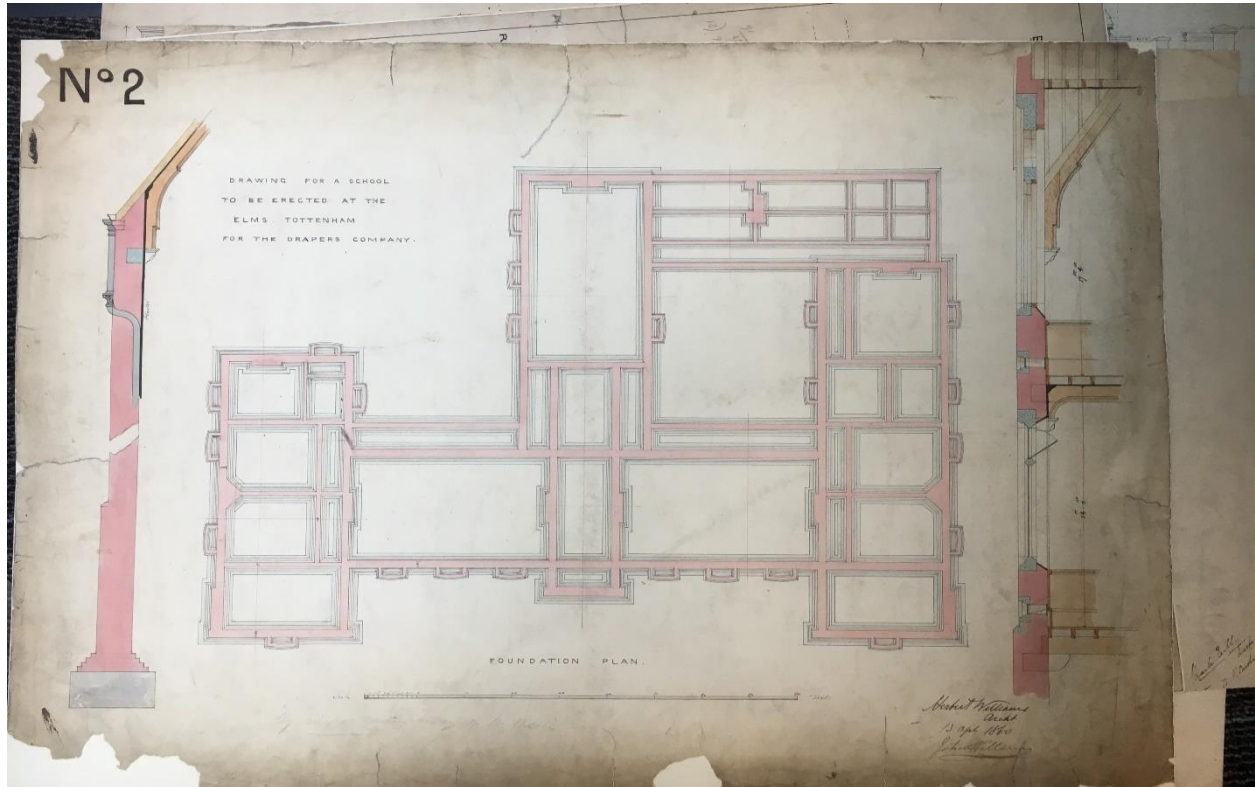
*This drawing shows how every window at ground level had below it a deep area to provide ventilation to openable windows at basement level. The 24, 25, 26 block has four areas. From careful inspection of the brick footings as drawn the base of the areas seems to have been several courses above the basement floor itself.*

*To the right of the drawing the section is as built. Note relationship of stone plinth band and floor construction.*

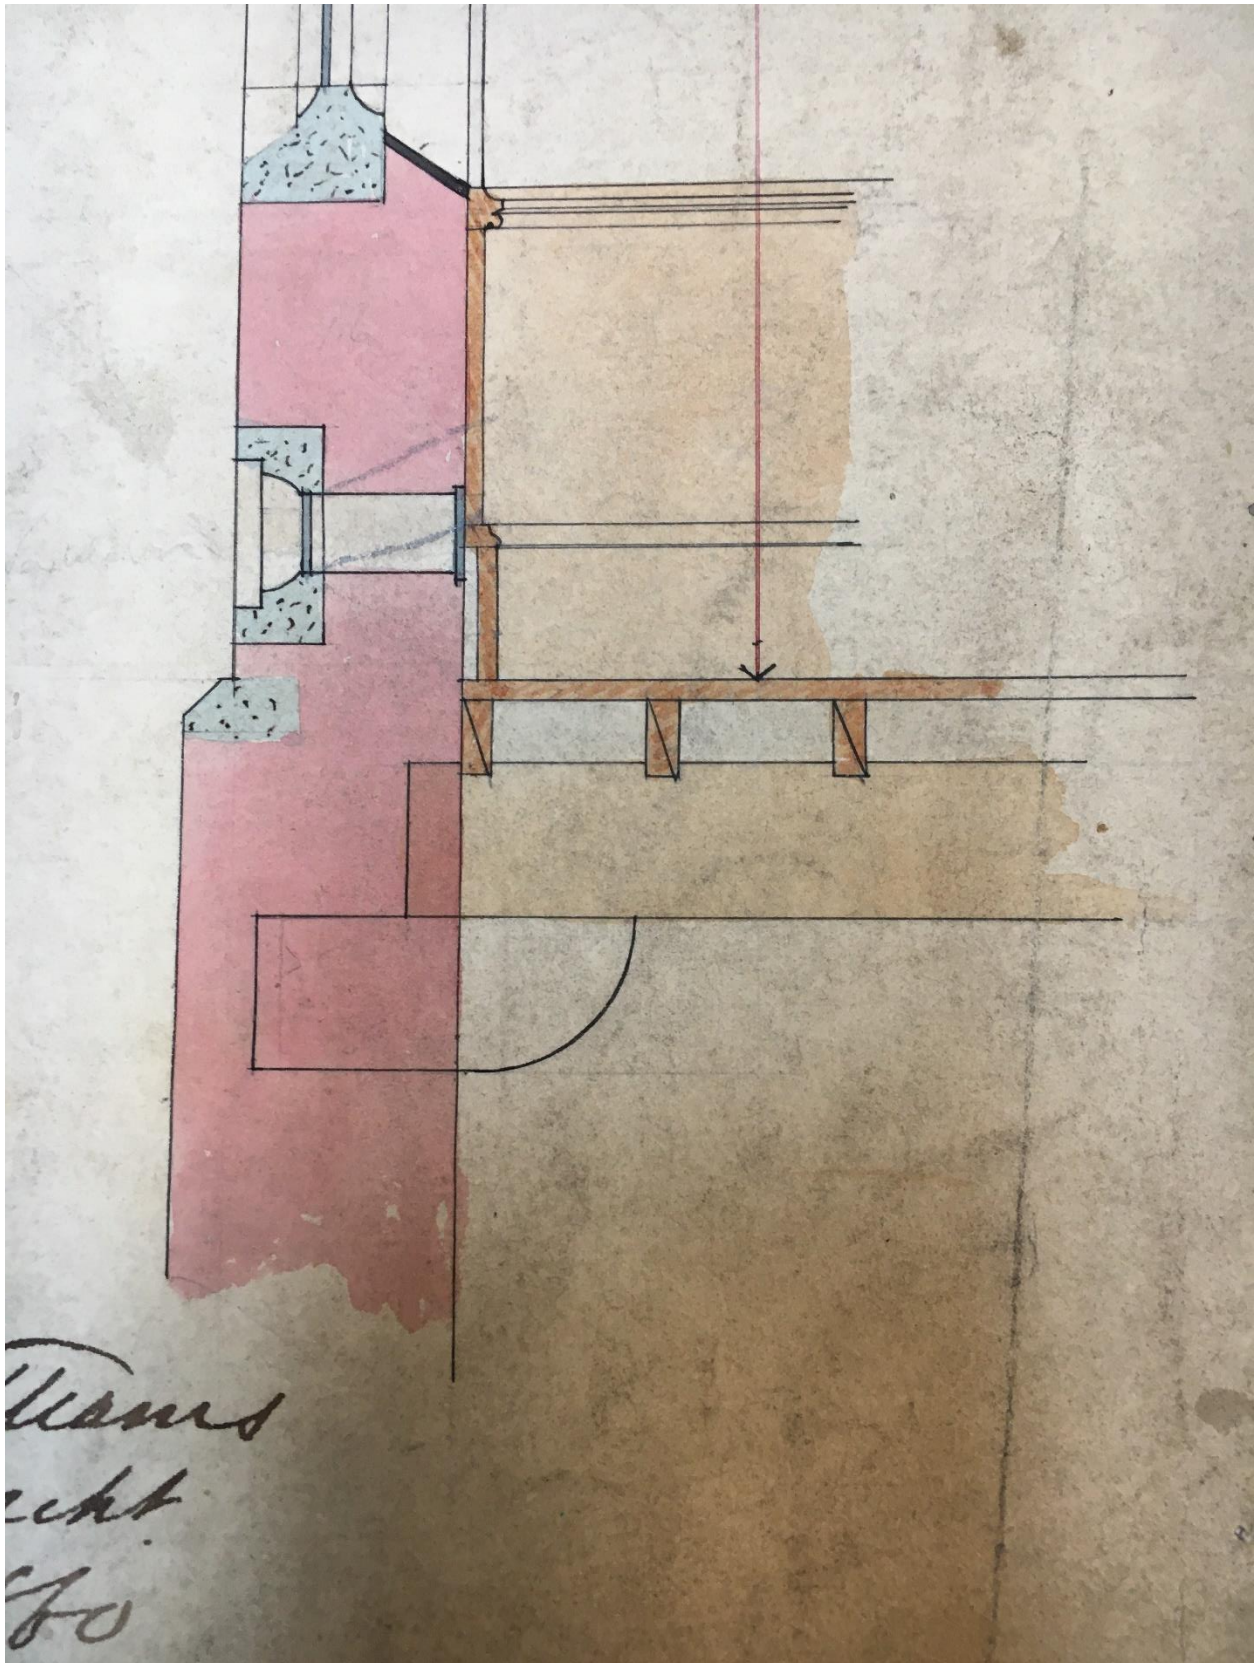
Detail showing designed relationship between corbel, flitch beam, floor joists and floorboards. Note that the finished floor level is level with the top of the stone plinth band. The flitch beam and stone corbel are shown built into the brickwork and we observe this on site. The damp proof course is not shown on this 1860's drawing but it is located immediately below the stone corbel.

This gives us an easy way of assessing the location of wooden floor members in relation to the external levels all around the building. From observation of the construction found insitu, including the stone corbel that supports floor beams, is all as designed in the 1860's. By observation on site one can readily see that the internal floor level of 24 and the external construction (pavement and raised brick plinth behind the Acco drain) are at the same level. Therefore, all the wood, wall plates, joints etc. related to floor construction of 24 is situated within saturated walls. None of this is as the building was designed to perform.
