OLD SCHOOL COURT  
TOTTENHAM, N17 6LY

SECOND INVESTIGATION REPORT INTO DEFECTS CAUSED BY DAMP  
AT FLATS 1, 2, 24 AND 25 OLD SCHOOL COURT  
WITH REPAIR RECOMMENDATIONS

441301

September 2022  
Revised 12 October 2022

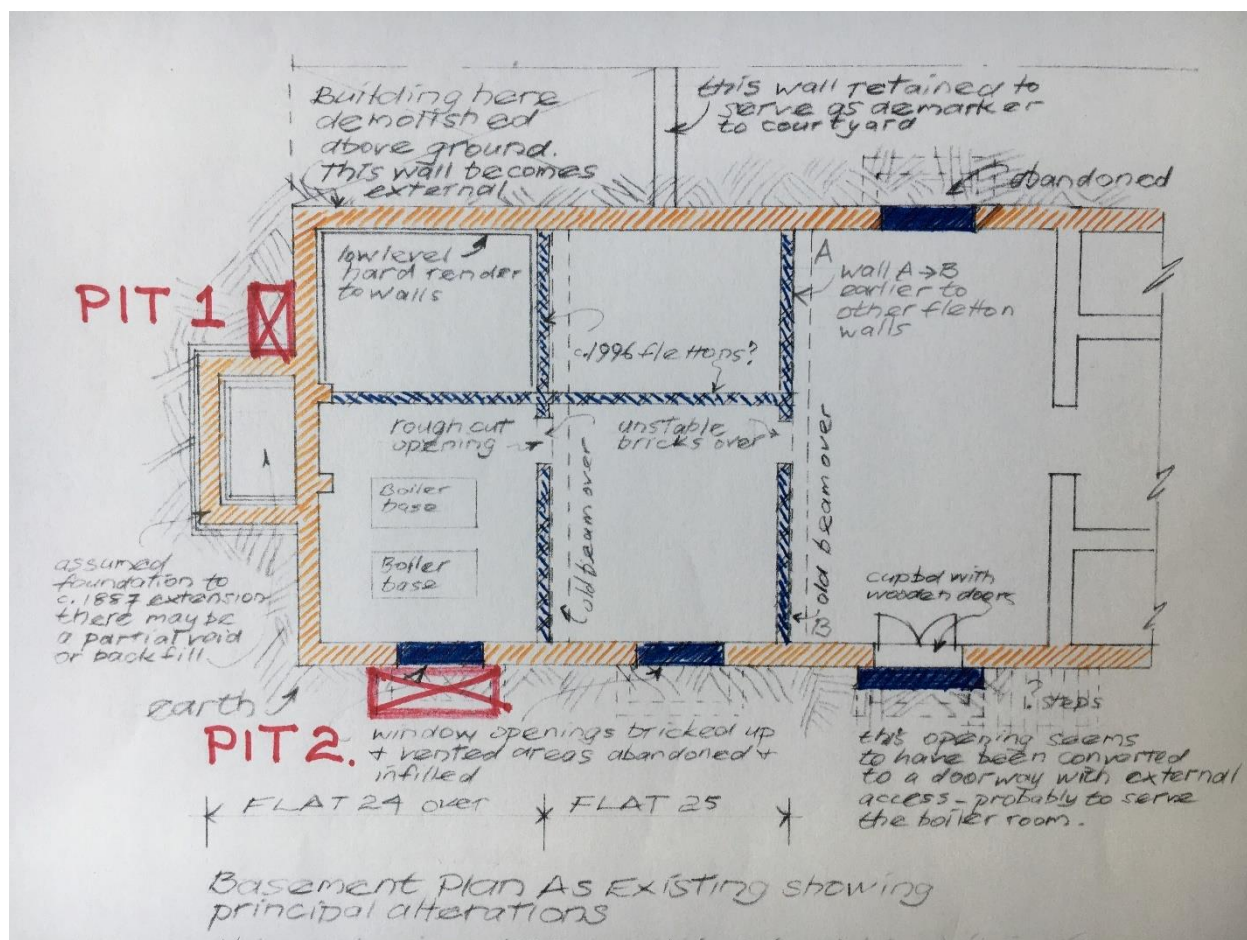
Location of Inspection Pits 1 and 2 at the external walls of Flat 24

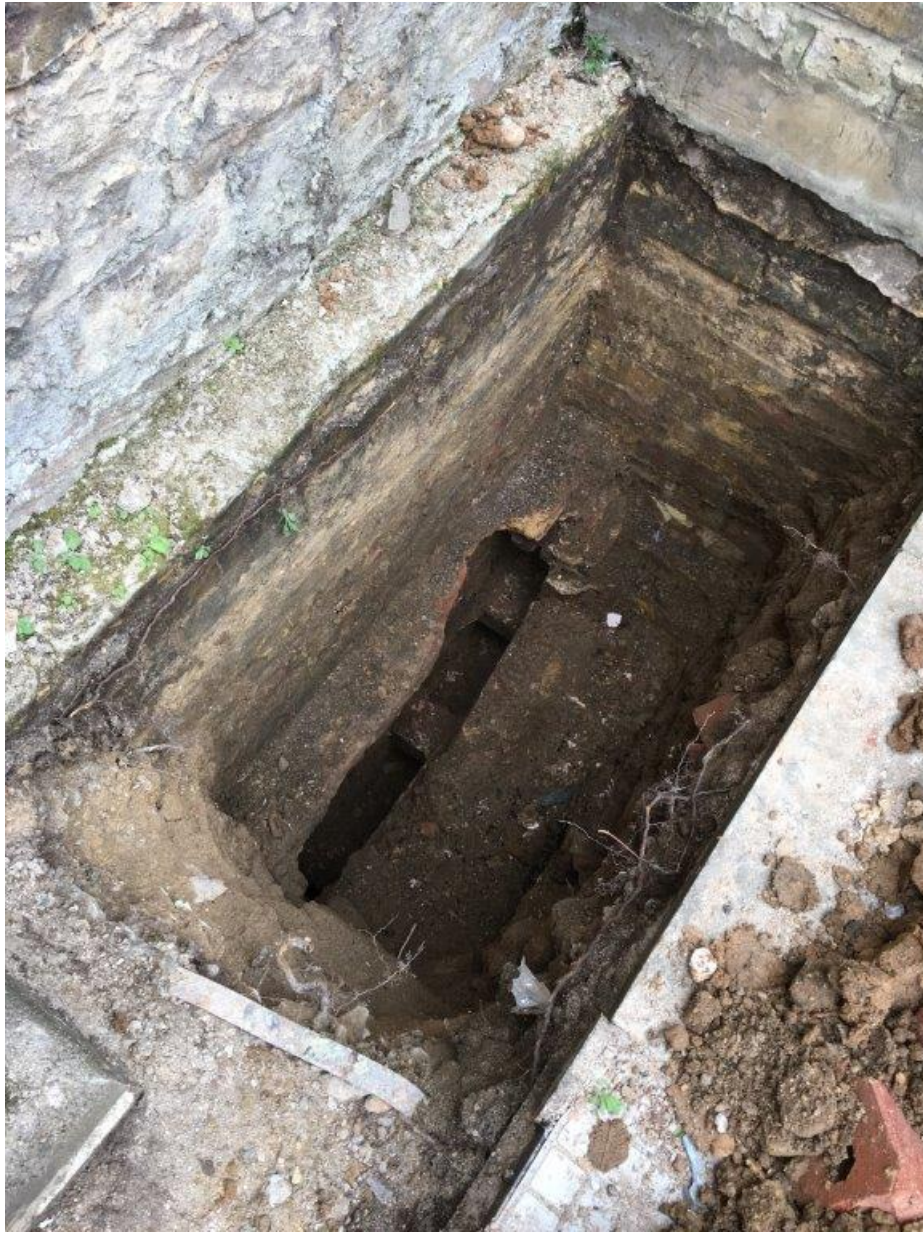
*Pit I. This shows the pit fully dug.*

- 2.1 Pit 1 was the first to be dug at the angle of the external wall of Flat 24 exposing the original 1860's construction and the 1890's extension. The original 1860's wall descends vertically below the current ground level by 10 courses where it then becomes thicker by way of three bricks set-offs. The brick set-offs look like foundation footings but closer inspection shows this not to be the case; the set-offs create a cavity wall with a cavity approximately 4" wide. (Refer to drawing 3). The cavity was revealed when a few of the set-off bricks were removed. It descends approx. 2000mm below existing external ground level. The external brick leaf is braced to main wall by end-on bricks across the cavity set in a staggered diagonal pattern like modern cavity ties. The original 1860's ground level adjacent to the wall was approximately 150mm below the level of the brick set-offs, the original DPC being at the top of the first set-off brick.

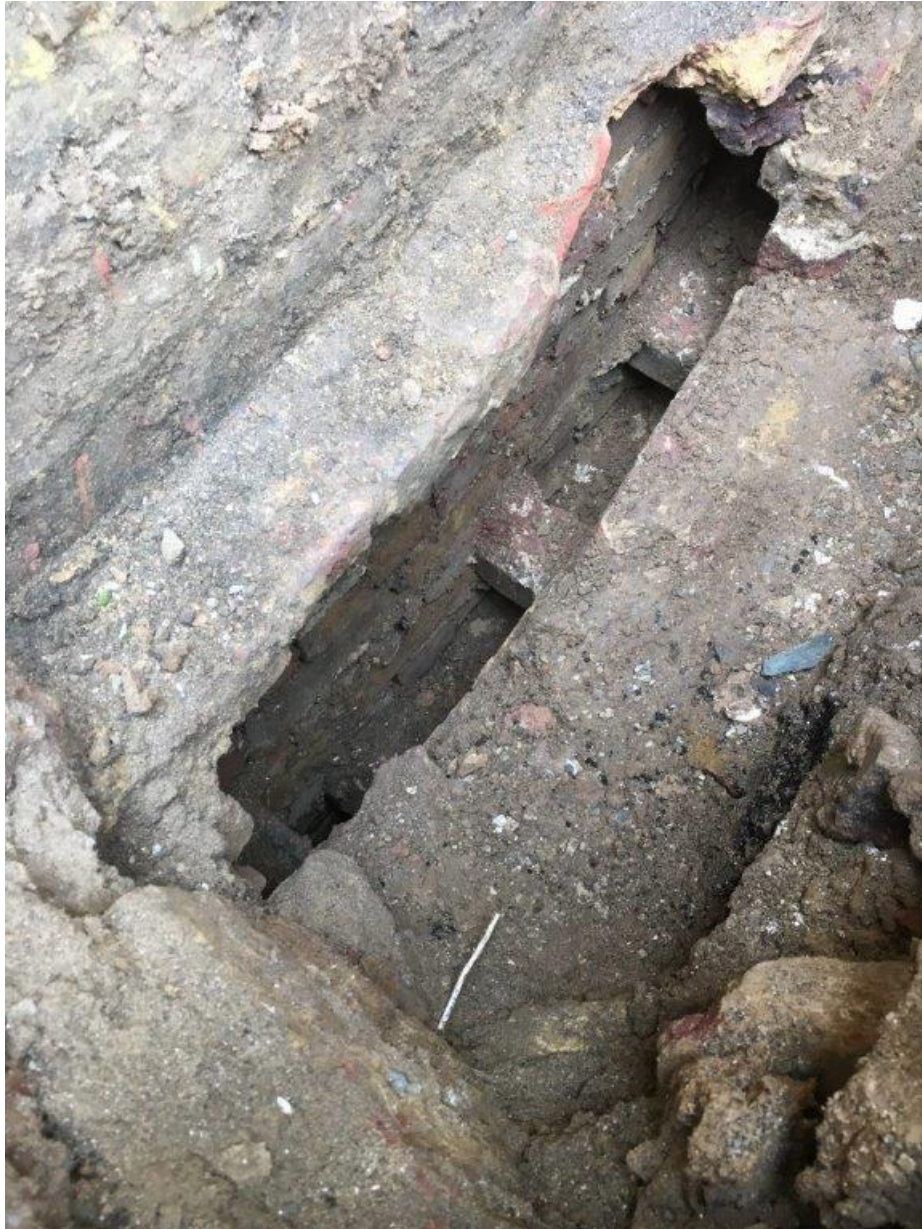
*Pit 1. Detail showing the cavity constructed to guard against excessive wetting of the lower part of the external basement wall. This construction was found also at Pit 2 and at the front of the building at the external wall of Flat 3.*

- 2.2 This very interesting construction is not shown on the 1860's drawings held by the Drapers Company and would seem to have been devised during construction to deal with the ground conditions as encountered, to ensure that the basements remained substantially free of excessive penetrating moisture. The original construction took care to prevent excessive moisture reaching any wooden construction by the combination of a double slate dampproof course and the cavity construction that descends below the level of the dampproof course.
- 2.3 At the 1890's projecting extension there is no evidence of a cavity construction but there is continuation of a dampproof course at the same level in the walling as the 1860's DPC.

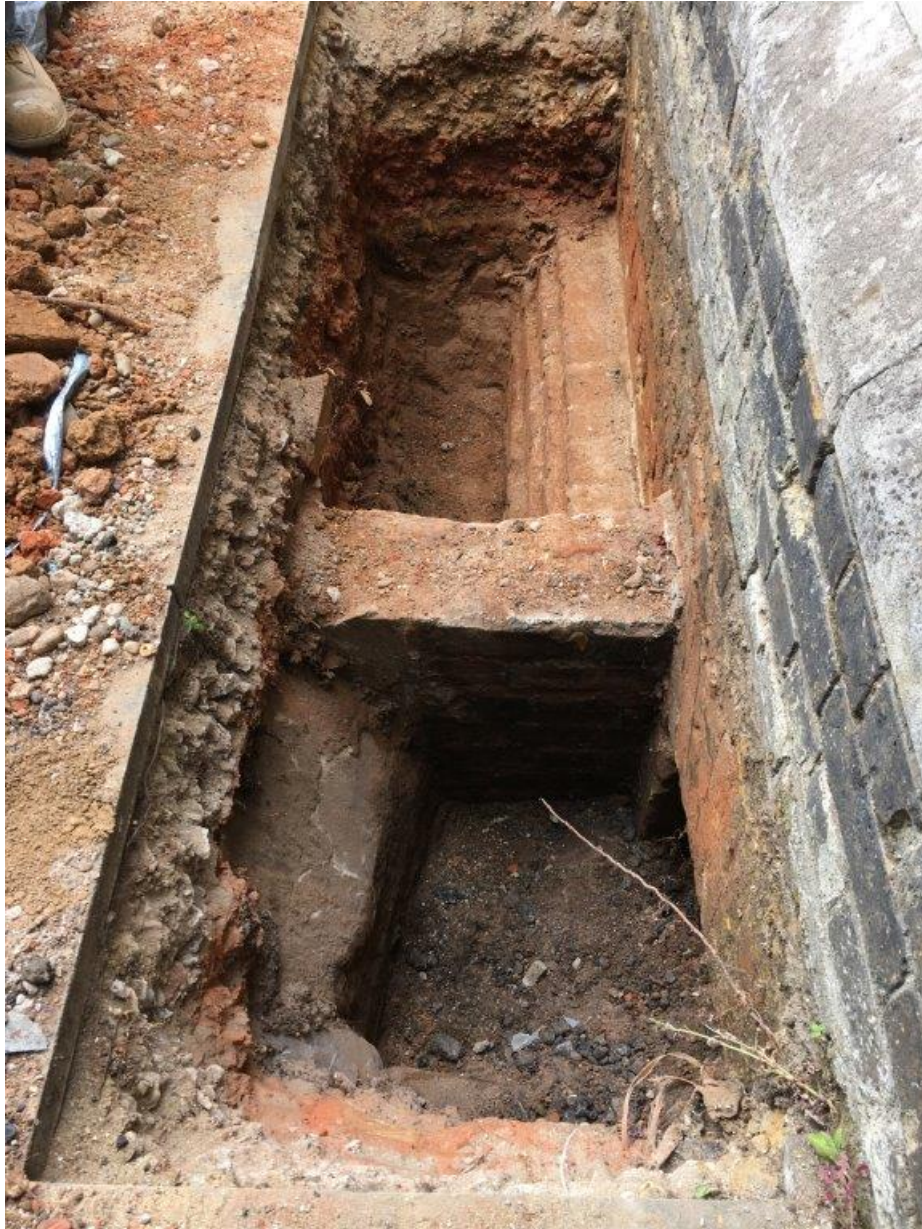
*First stage excavation at Pit 2 exposing the top of the window arch (bottom of image), the vent area cross-wall and the brick set-offs denoting the external cavity construction.*

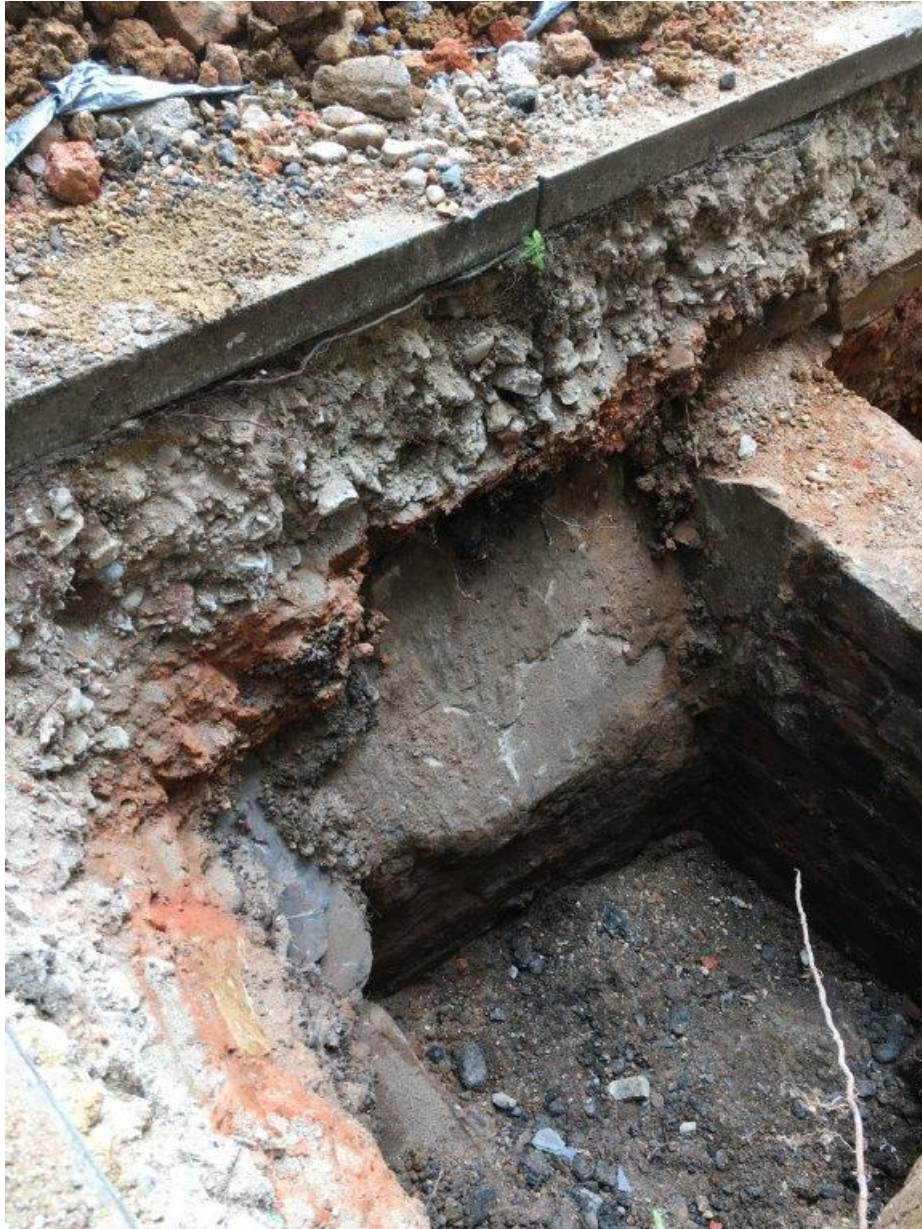
*The top stone of the coal chute exposed.*

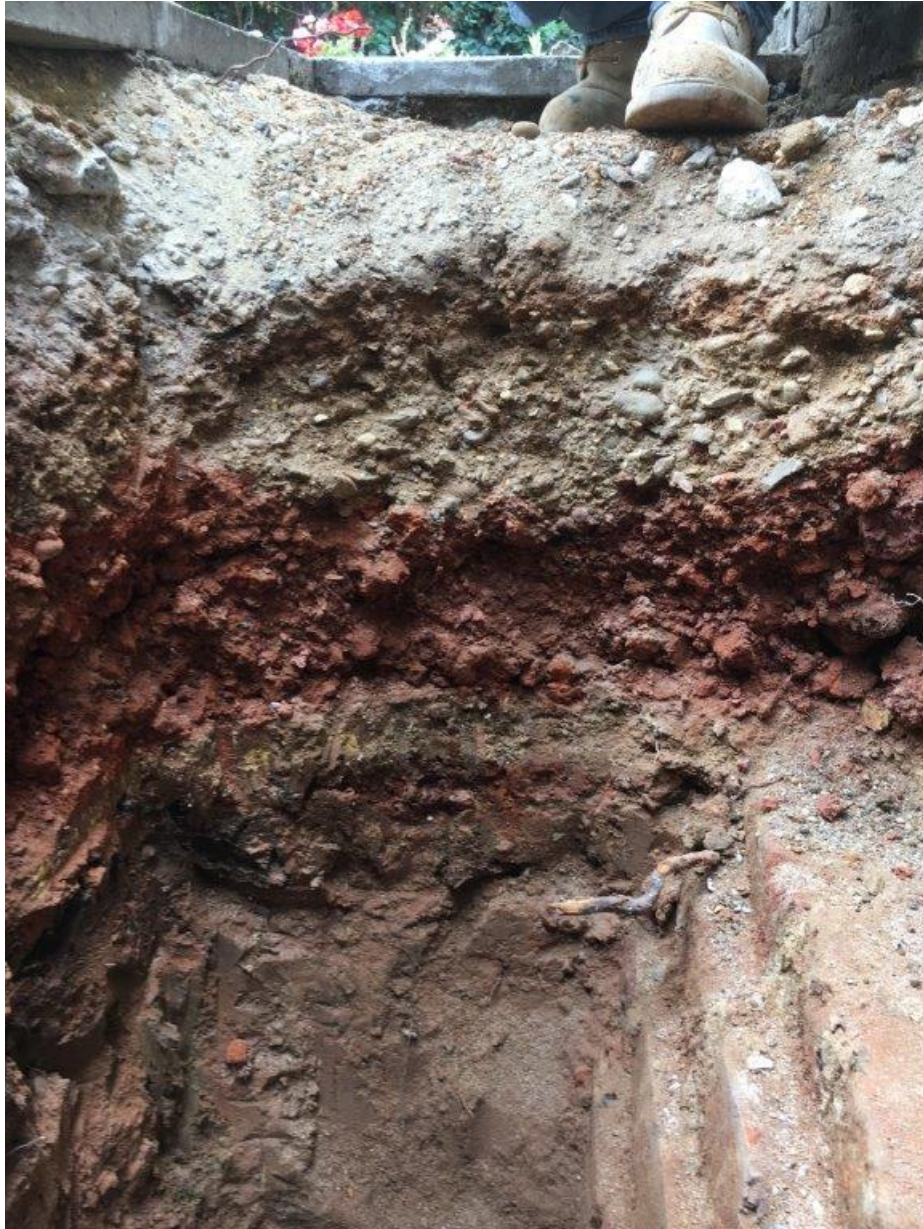
*The above image shows the modern paving on a grey cementitious bedding and fill, below this a bright red layer of backfill that I assess as spoil from the demolition of the former gymnasium and swimming pool buildings which were formerly behind the main school and below this an early backfill relating to the original construction period.*

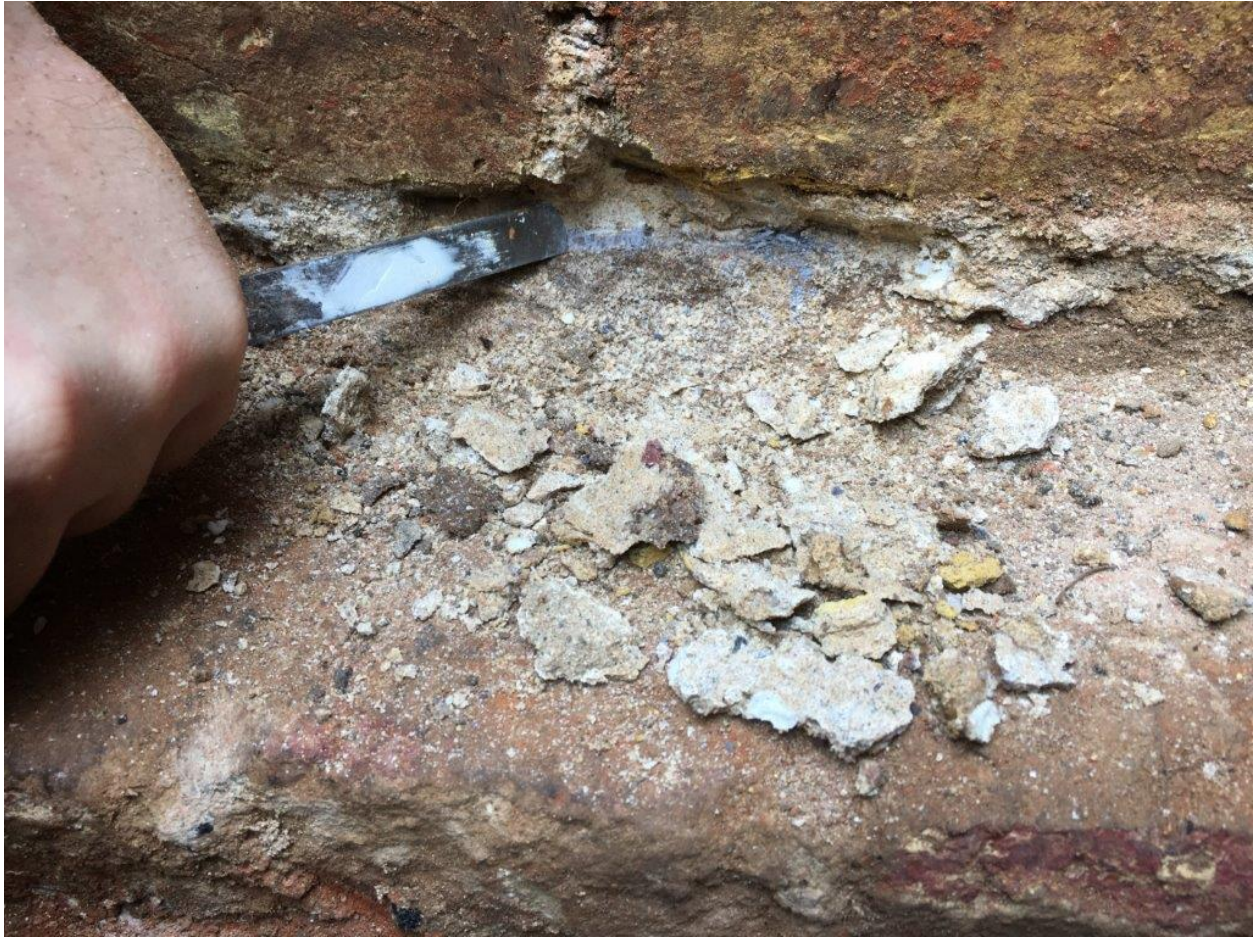
*Original slate DPC exposed.*

The original DPC level is at the top of the set-offs. It is clear that the ground against the building has been raised in stages over the years.

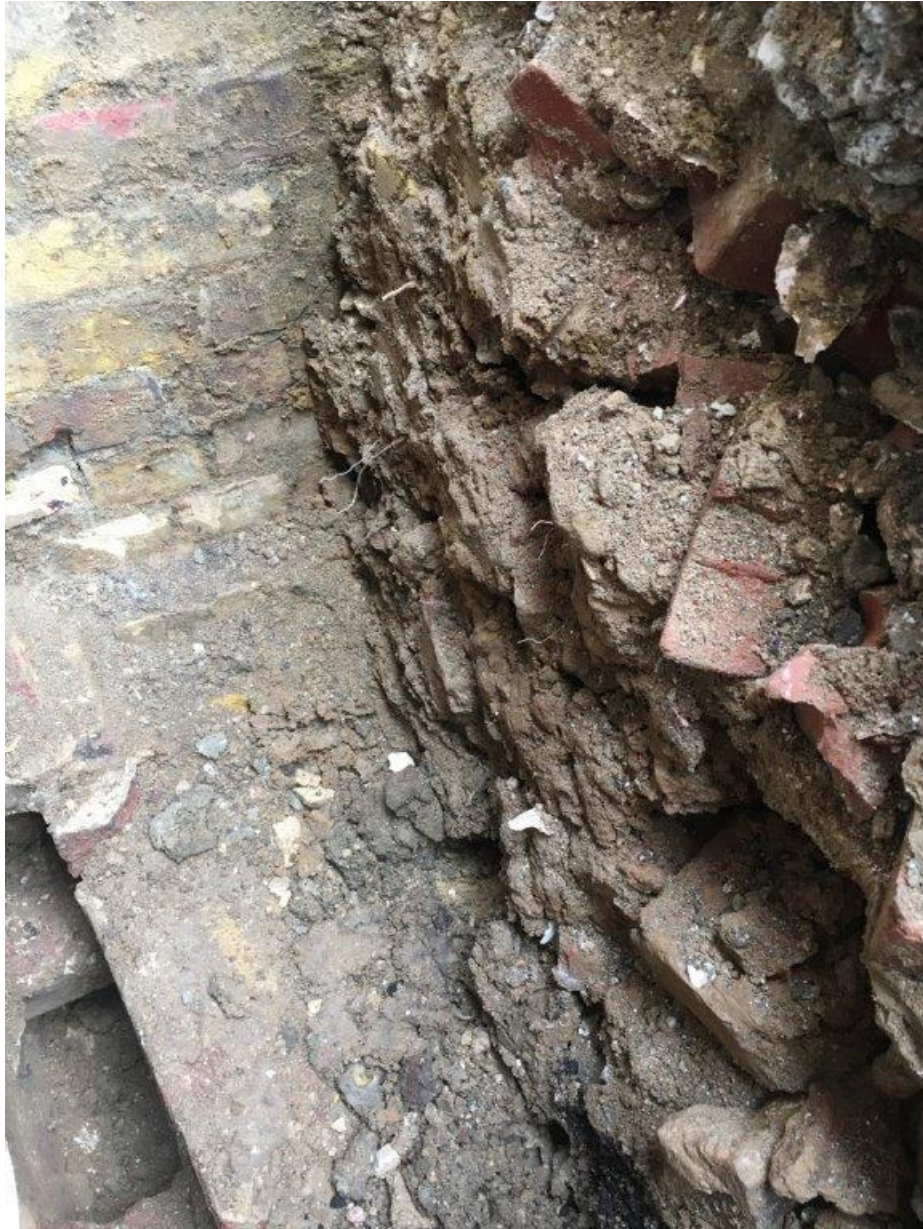
*Chaotic backfilling at Pit 1 using it seems demolition material from the school gymnasium and swimming pool buildings.*

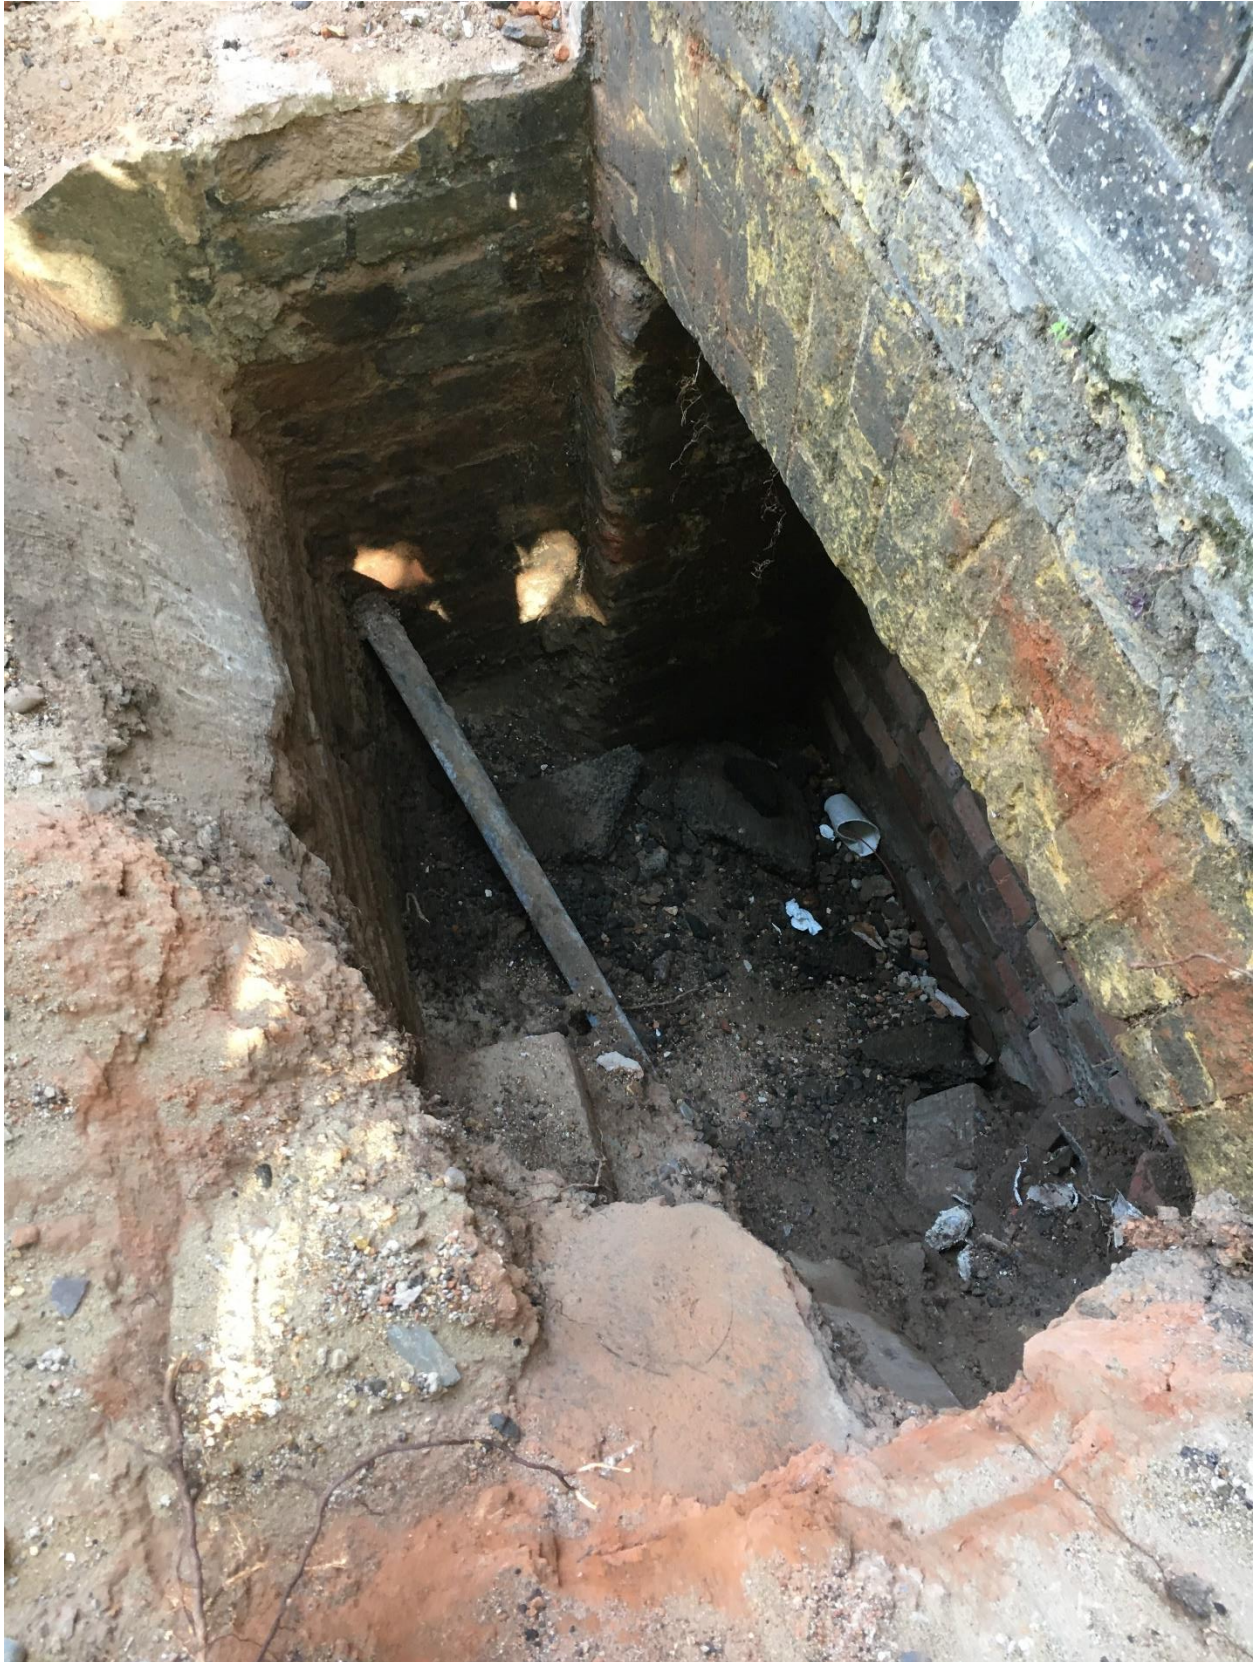
*The extent of excavation at the basement “window” Flat 24.*

- 3.4 From the details exposed one can deduct that the original window to the basement was soon converted to be used as a coal chute. The cill was lowered (different bricks at the reveals at low level) and a stone chute lip installed. The reveals of the window are covered in coal dust and the excavation once open up smelt strongly of coal as if it had been in use yesterday.
- 3.5 When heating converted to oil, with tanks installed in the basement, but on opposite side of the basement, all deliveries were by pipes installed to the other side. However it seems that gas was also used for some functions as a gap pipe and remnants of a gas meter (redundant) were found at the bottom of the excavation. The pipe can be seen in the above image.

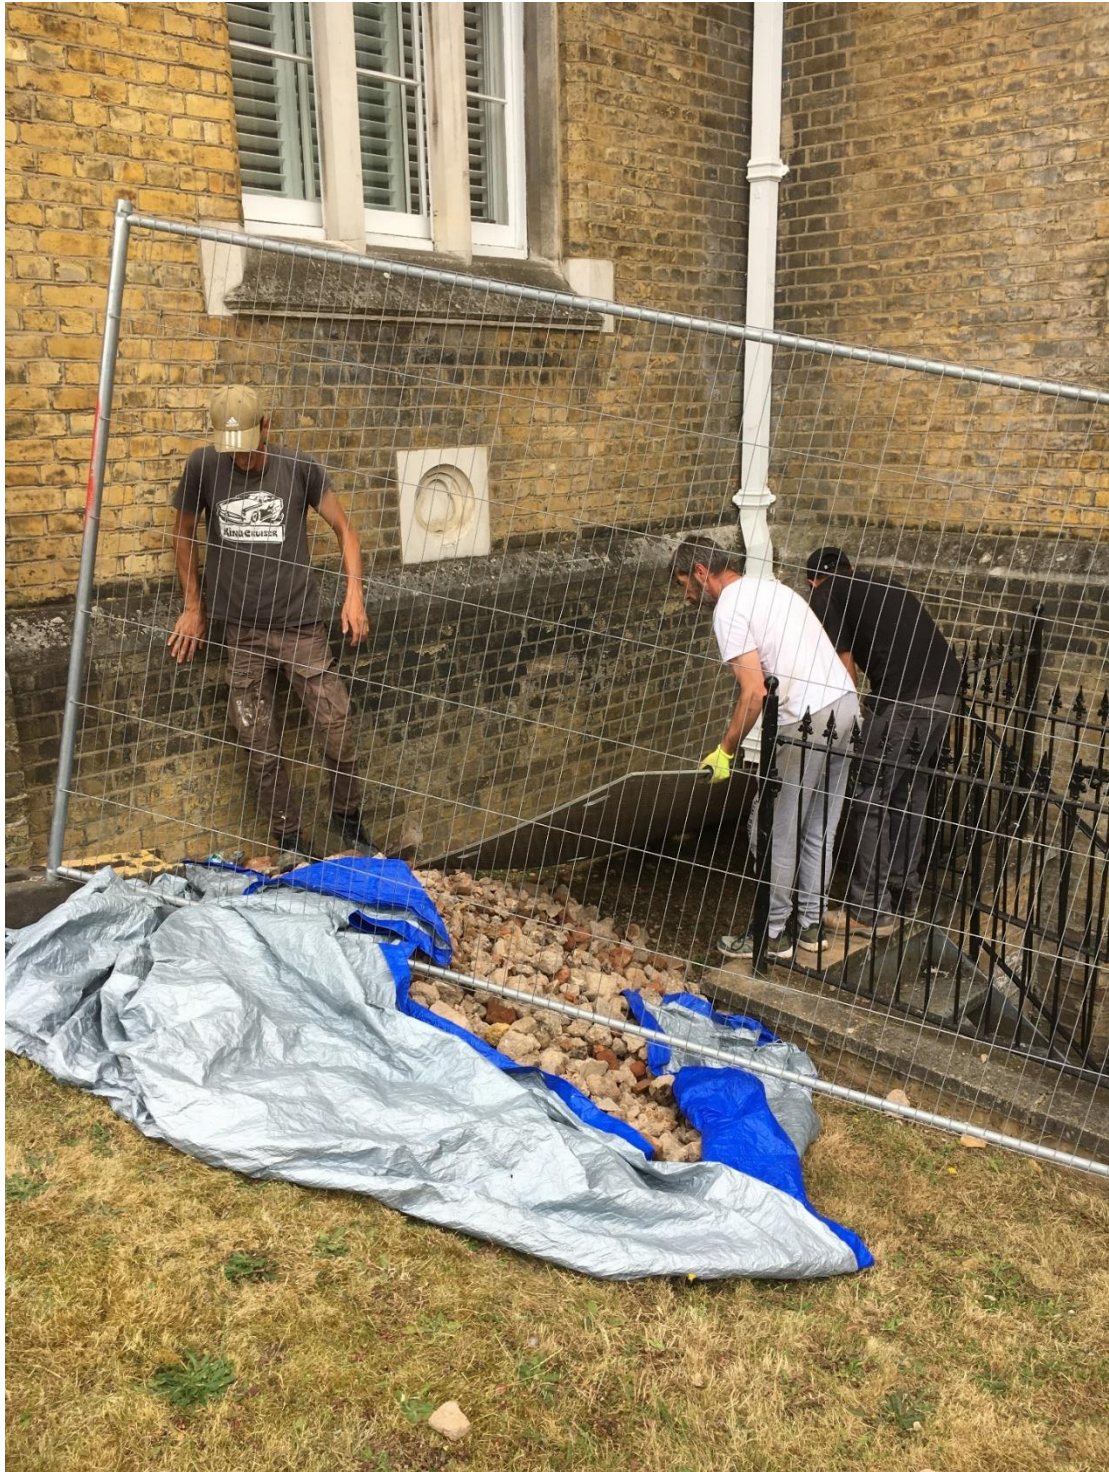
*The excavation adjacent to Flat 3 wall. The modern ground level and reset modern drainage gulley are both too high. Both need to be reset to below DPC level.*

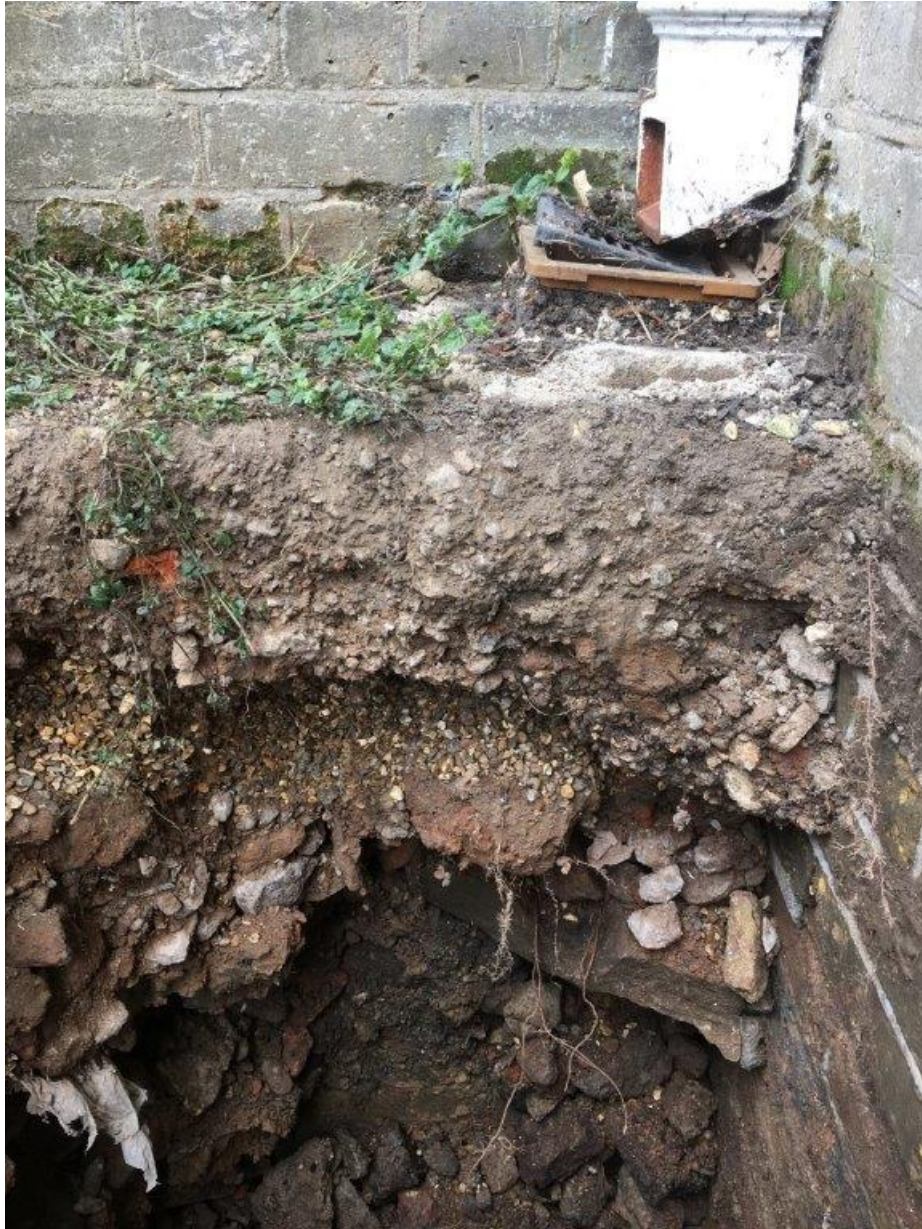
*The dig adjacent to the downpipes shows that the existing gulley is inadequate to take the large flow of water from the main roof and it is set above the DPC leading to saturation of the wall. A section of original stone drainage gulley remains in position and is included in this image. It is approx. 10 brick courses below the modern drain, the correct level for finished ground.*

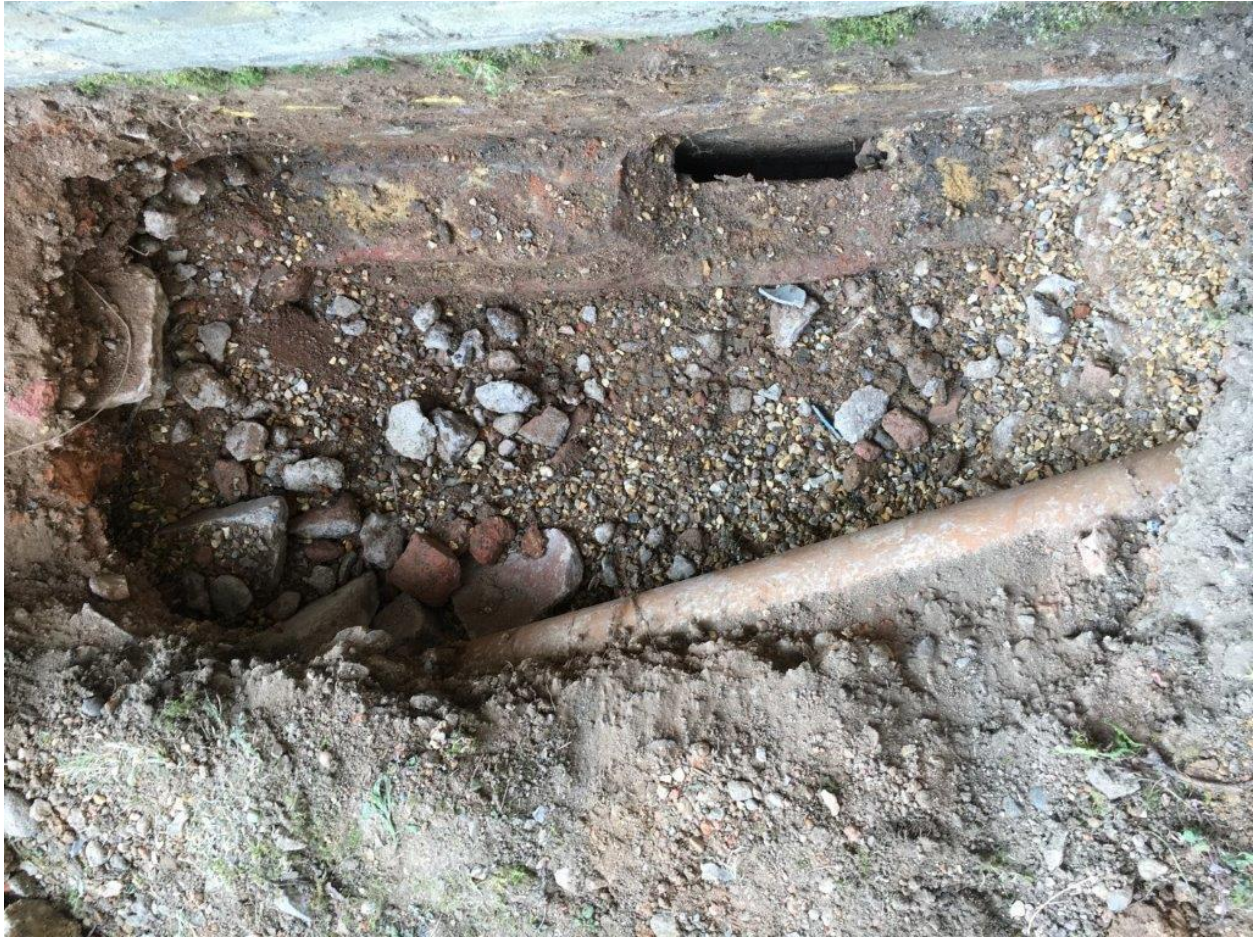
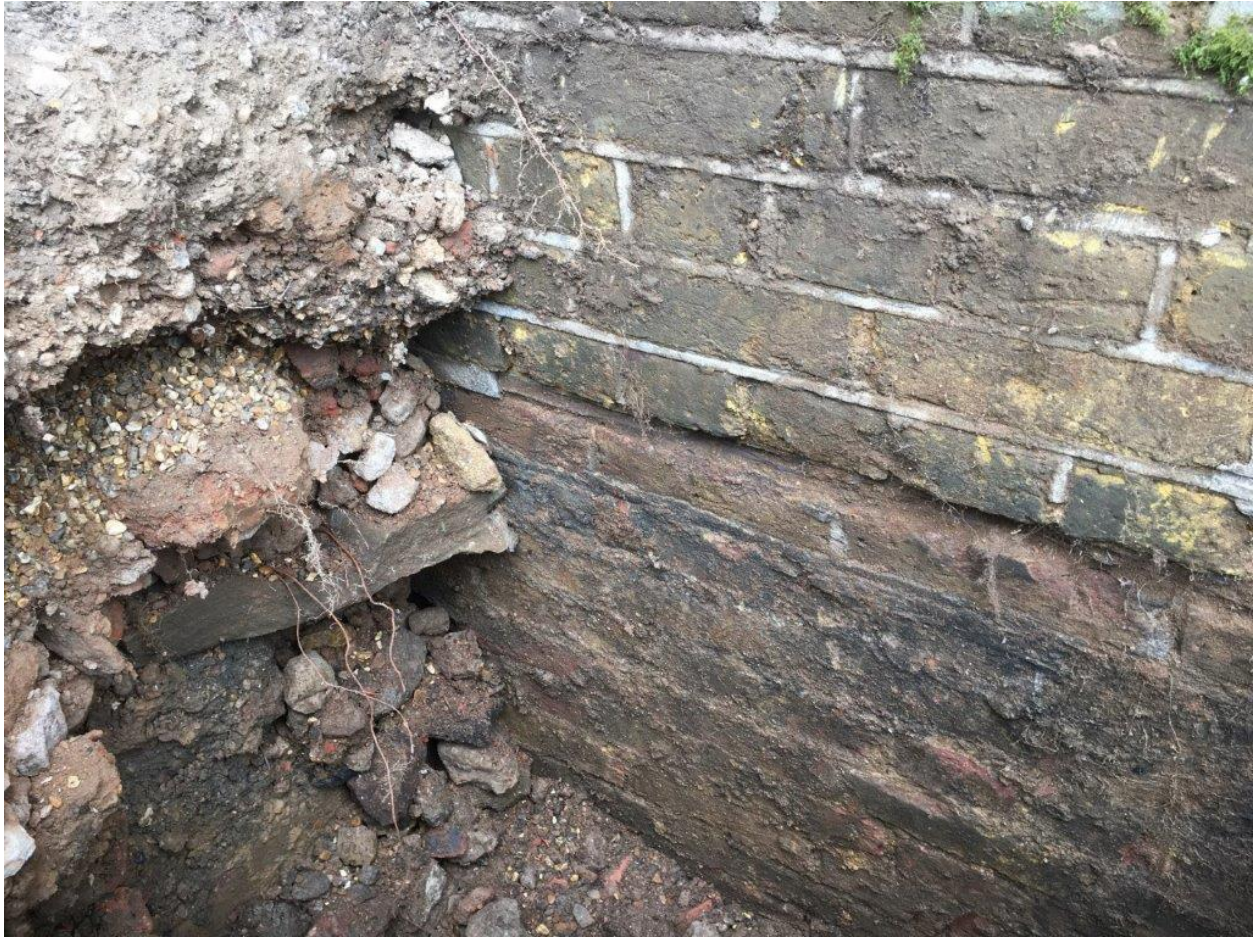
*This shows the excavated ground at Flat 3 adjacent to the rainwater gulley, and the drain coming from the gulley pot is in the picture. Also in the picture is the cavity wall construction, all as seen before and the DPC is at the top off-set brick. Unfortunately as before the ground has been raised above the DPC and the wall is permanently wet giving rise to internal dampness and threatening the timber ground floor construction.*

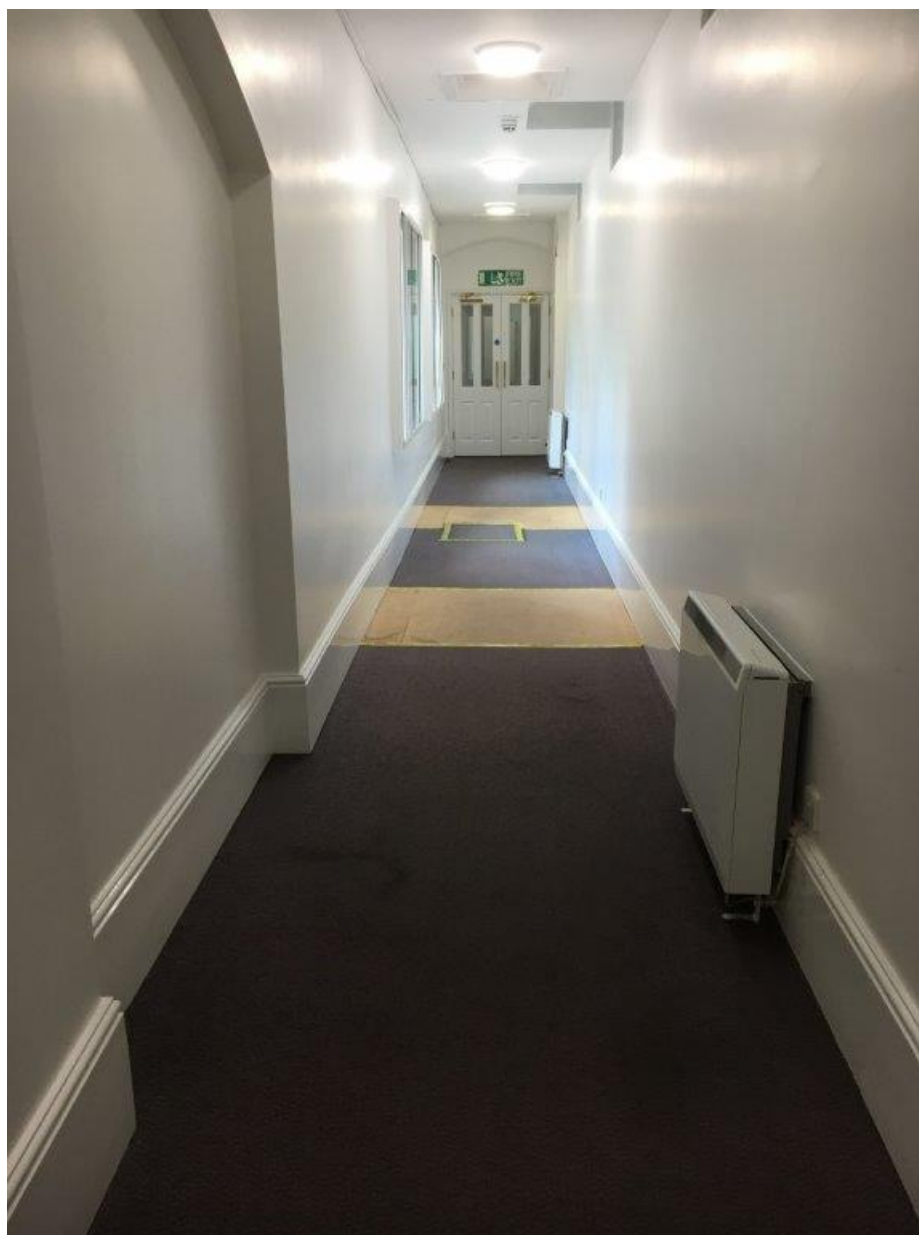
*Location of Inspection Pits at Flats 1 & 2*

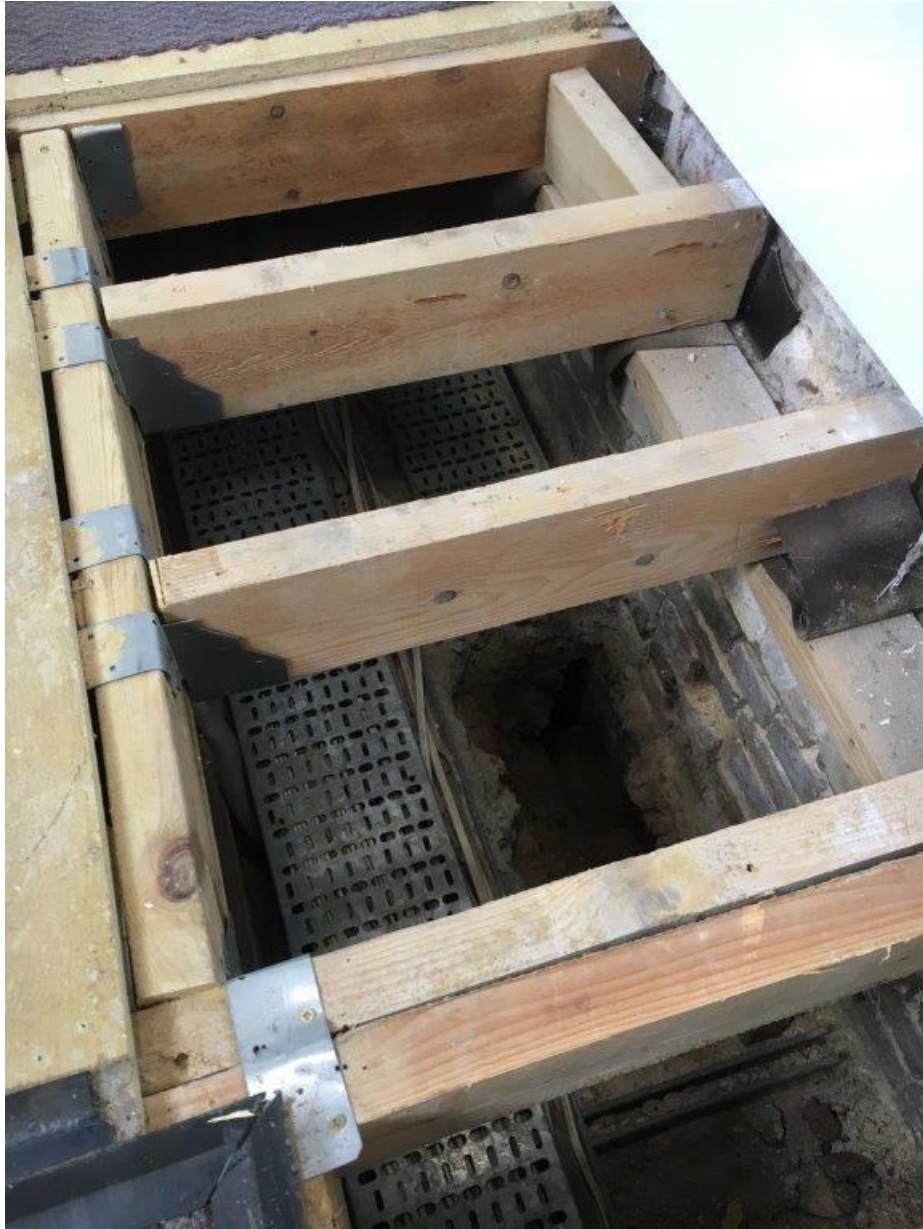
*Recently constructed corridor floor structure*

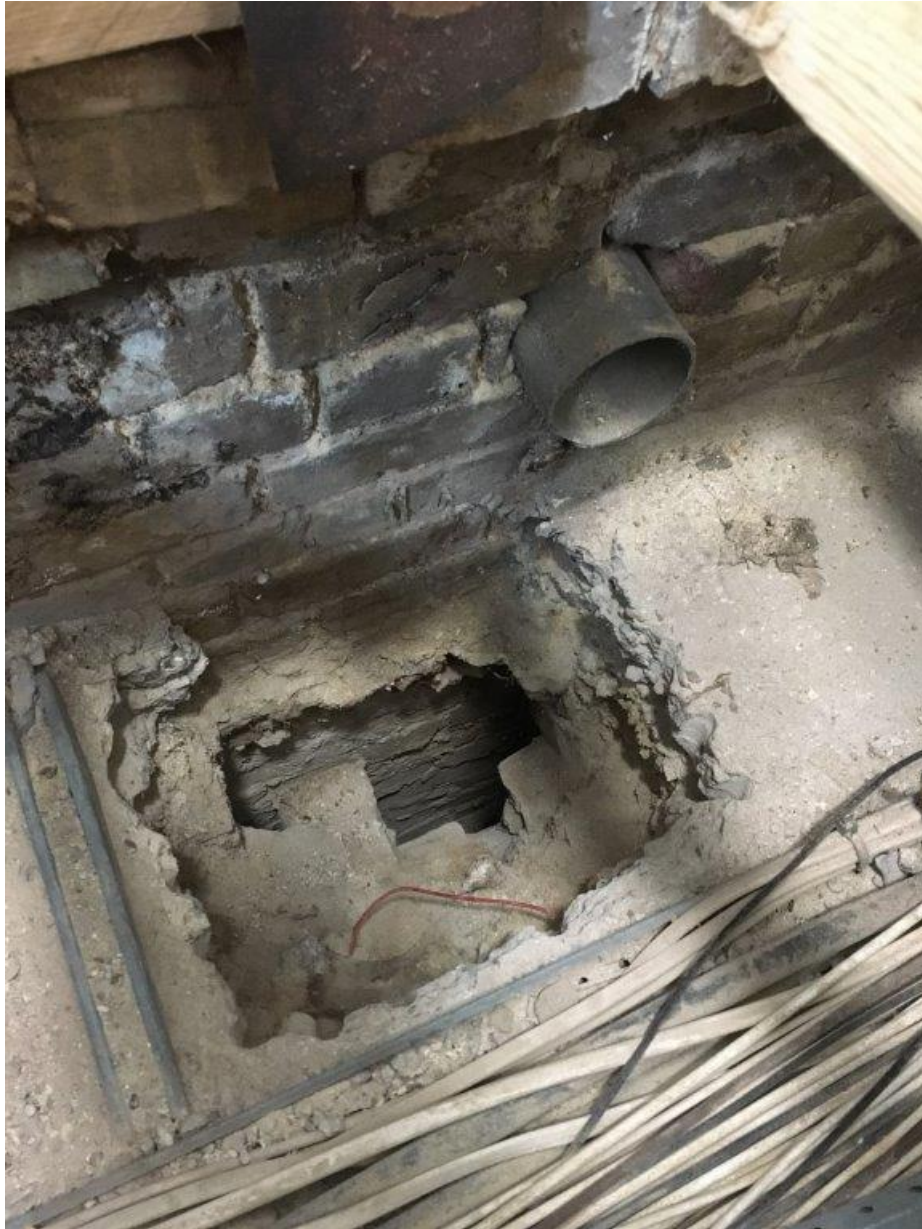
*Looking into the corridor underfloor void. The hole in the picture show the breakthrough into the cavity wall construction which is the same as that discovered at the external walls.*

- 5.1 A hole had previously been cut through the 1996 concrete oversite slab and some bricks removed to reveal that there is a cavity construction, as we have previously seen at the external walls. This wall is not external. The corridor external wall is not deeply founded as the corridor is only a single storey. Therefore the inner wall, which is the Flats perimeter wall, goes lower than the outer wall. The construction of the inner corridor wall seems to follow the same logic as the external walls already described,
- 5.2 Also visible is a plastic pipe which serves as an extract from the bathroom on the other side of the wall. This introduces moisture into the floor void, exacerbating dampness.

- 6.9 The issue at the internal corridor walls is similar but the solution is different. To reinstate the original regime a section of the concrete oversite must be removed for the full length of the corridor. Doing this will return the condition at the corridor side of the flats to that which formerly obtained. However, there could be hidden decay ongoing or incipient decay could occur if there is trapped moisture on the flat side of the wall. This should be checked on the flat side of the wall, adjacent to the stone corbel, by opening up a section of ceiling plasterboard. This could be carried out initially with minimal damage using a camera boroscope. Through the drying out process the construction should be monitored as it is possible for rot to emerge during drying out should critical zone condition come about.

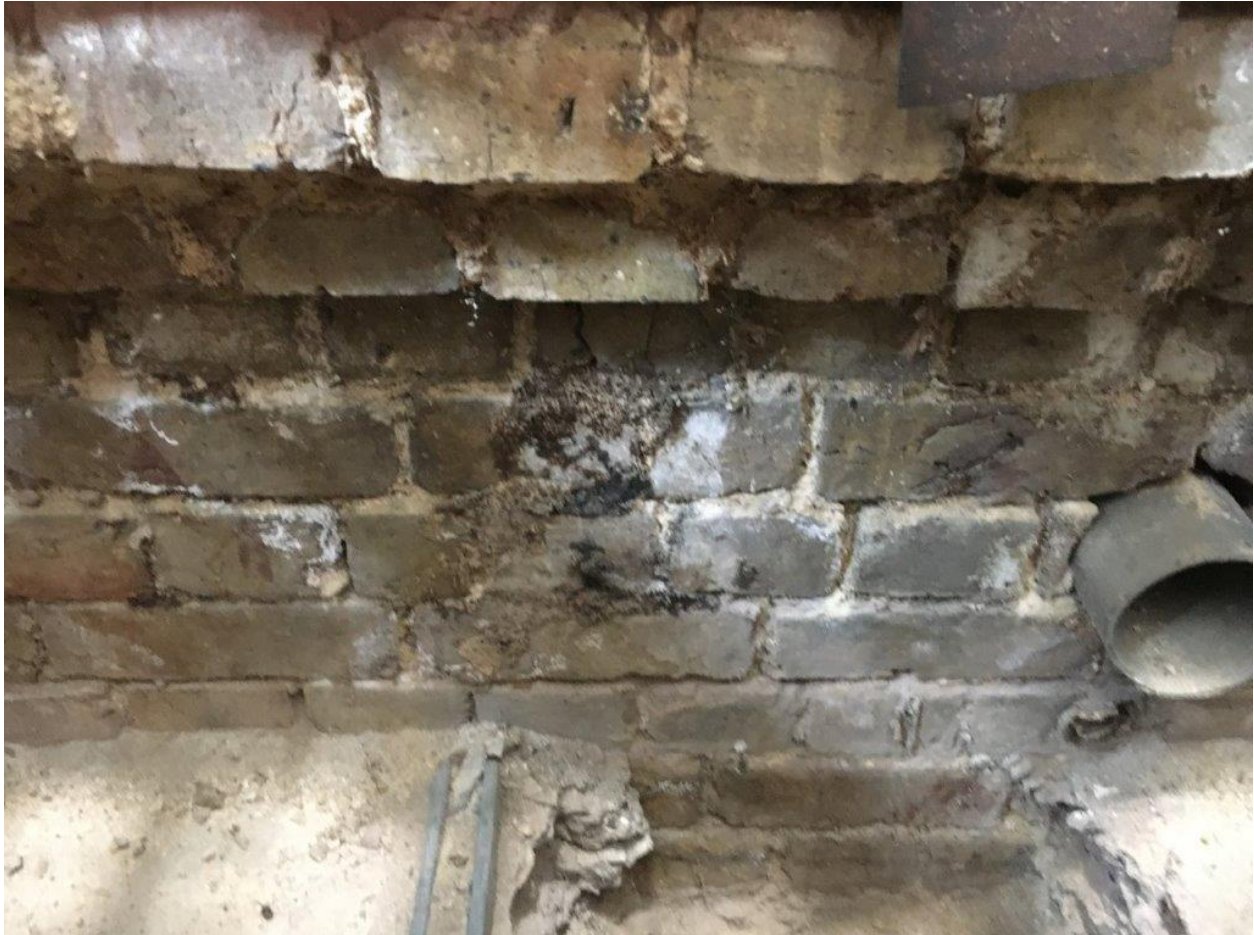
*The wall at this position should be perfectly dry but the presence of efflorescence on the bricks and erosion of joints indicate fluctuating dampness in the wall, the dampness drawn from below. Efflorescence appears at the evaporation zone. The oversailing courses in the image relate to the wall plate of the wooden corridor floor,*
