OLD SCHOOL COURT  
TOTTENHAM, N17 6LY

SECOND INVESTIGATION REPORT INTO DEFECTS CAUSED BY DAMP  
AT FLATS 1, 2, 24 AND 25 OLD SCHOOL COURT  
WITH REPAIR RECOMMENDATIONS

441301

September 2022  
Revised 12 October 2022

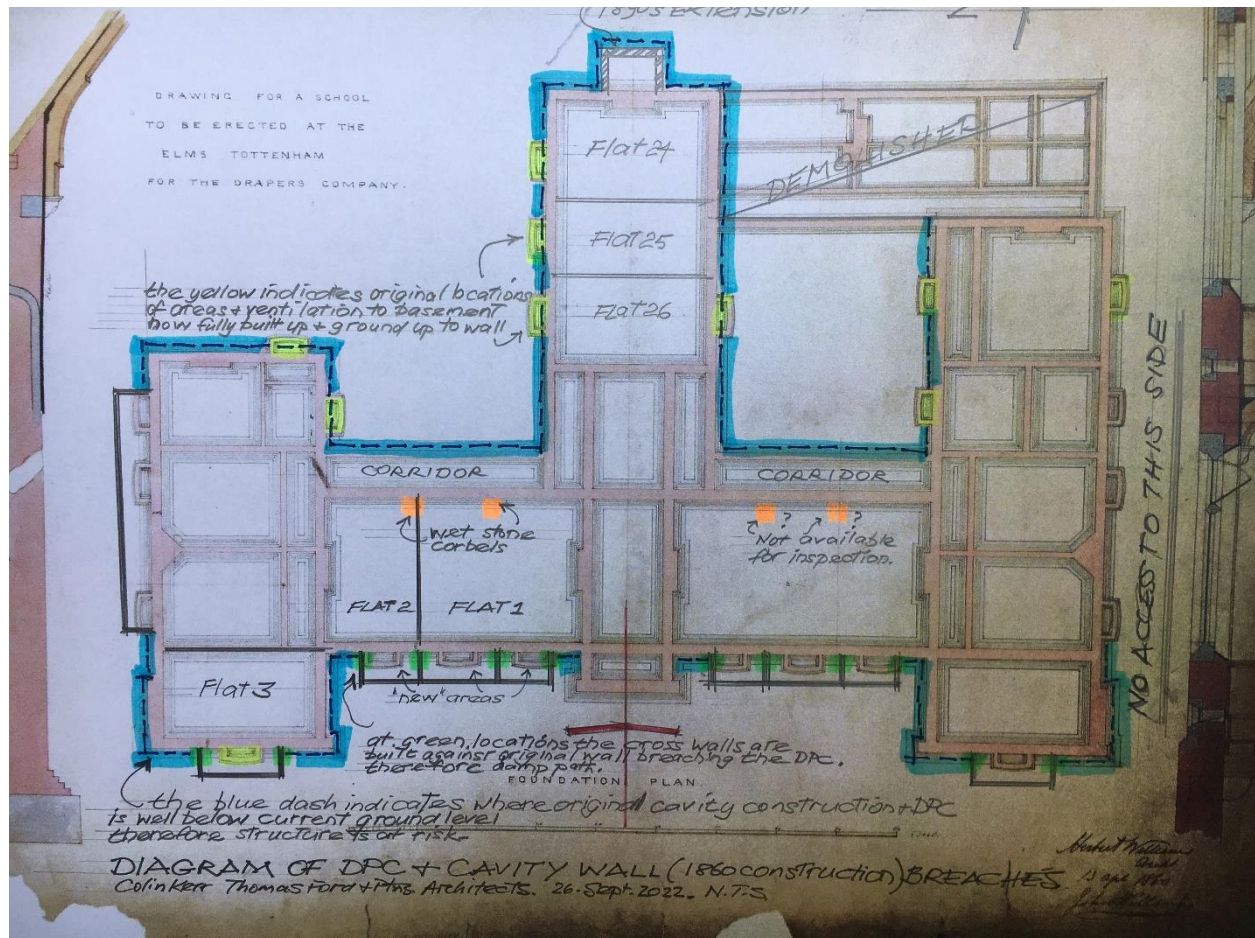
The blue line in the diagram indicates where the ground level is above the DPC. There was no access to the north side of the building but similar conditions may exist
