**Donald Insall Associates**  
Chartered Architects and Historic Building Consultants

## Former Highgate Chapel

### Existing Boundary Wall Elevation Condition Survey - Bay 14

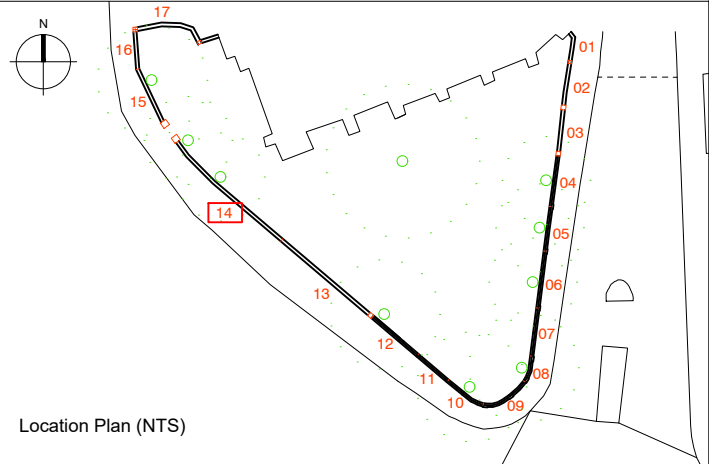
No. brick repairs: 10

m<sup>2</sup> of repointing: **28**

The above are approximate quantities based on a limited visual survey. For information purposes only.
