**Donald Insall Associates**  
~~Chartered Architects and Historic Building Consultants~~

Former Highgate Chapel

Existing Boundary Wall Elevation  
Condition Survey - Bay 2

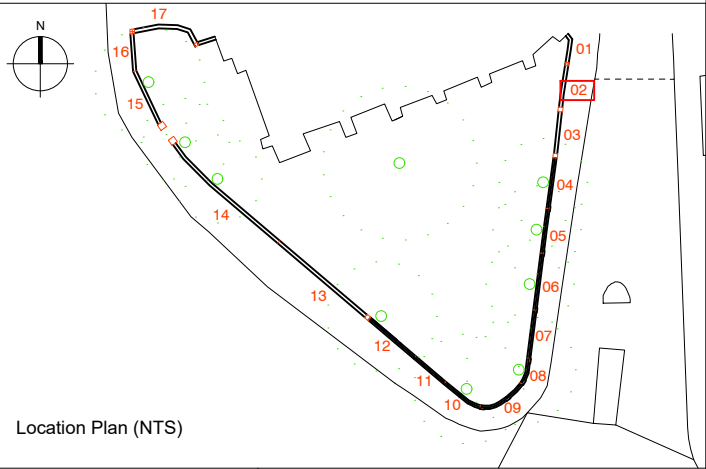
Masonry Wall Repairs

No. brick repairs: 49

m<sup>2</sup> of repointing: 10
