Former Highgate Chapel

Boundary wall repairs

Heritage Statement

November 2022

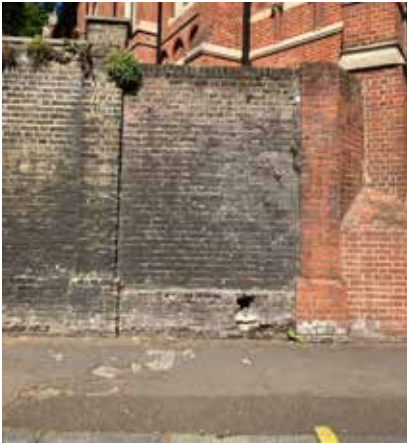
Figure 3.1. Campaigns of repair

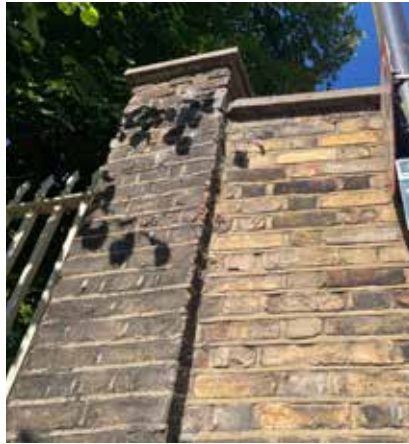
Figure 3.2. New brickwork panel at high level

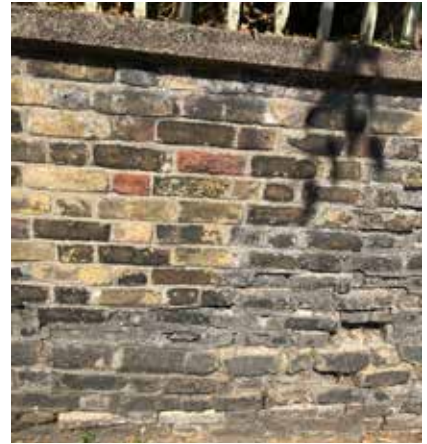
The greatest deterioration in the brickwork is generally to the areas of original brickwork, and to the lower courses of the wall, as shown in photos 3.3 and 3.5, particularly on the side of Southwood Lane.

Figure 3.3. Missing bricks and odd new bricks

Sound bricks should be retained in situ, and where bricks have decayed, are considered not sound or are missing, these should be carefully removed and individually replaced to match using salvaged bricks.

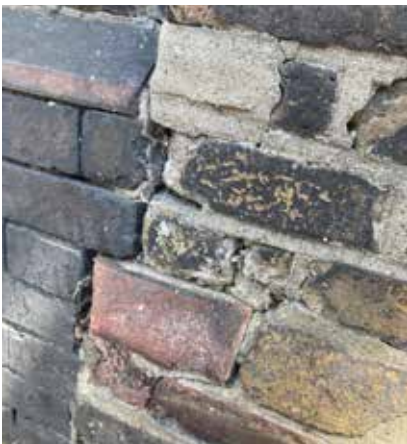
Figure 3.4. Poor jointing between brickwork

Inappropriate and failing pointing should be raked out and replaced using lime mortar. Open joints should be re-pointed in lime mortar.

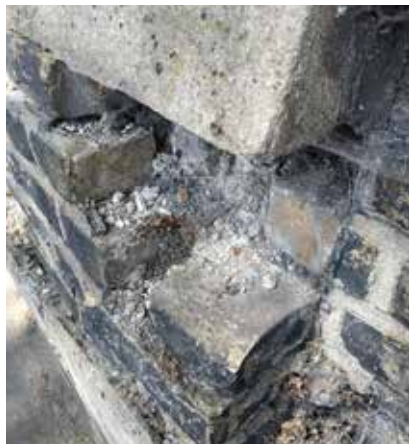
Figure 3.5. Missing bricks beneath coping

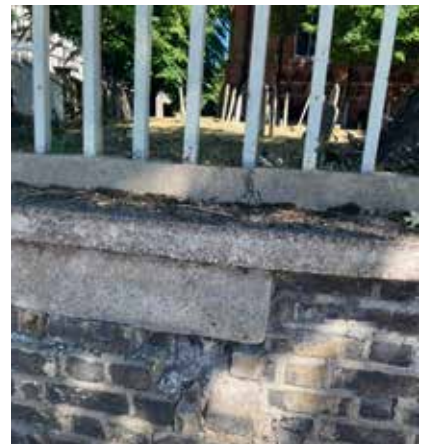
Figure 3.6. Concrete pad on top of coping

To the south end of the boundary wall where it is curved, a concrete pad stone has been applied on top of the coping stone, embedding the railings in. The reason for this is uncertain, however it has been decided to retain this pad stone as the harm it would cause to remove it, both to the railings and stone copings, cannot be justified against the aesthetic visual improvement.

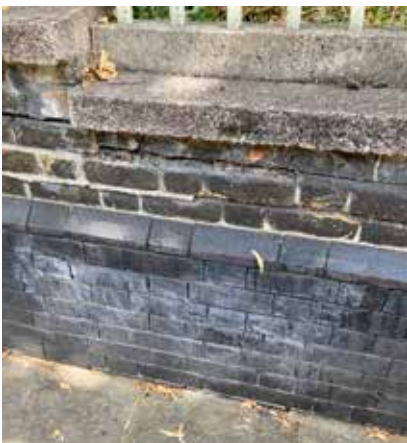
Figure 3.7. Layers of repair to wall

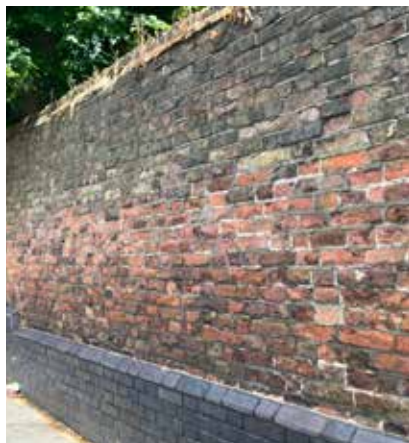
Figure 3.8. Loss of face to High Street elevation

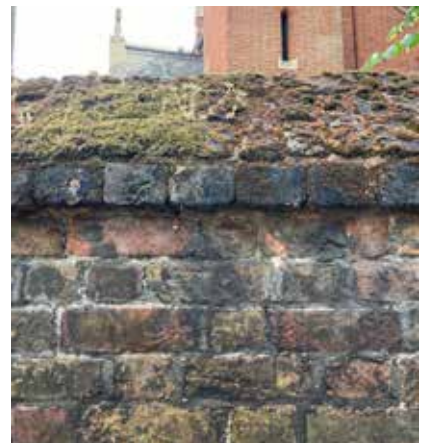
The coping along the entire length of wall has at least some vegetative growth and is bedded directly in soil in some locations.

Figure 3.9. Vegetation growth on coping

The wall, due to its adjacency to the cemetery, has extensive vegetation growth, especially to the coping stone on the road side and extensively across the entire wall face on the graveyard side. This vegetation is predominately ivy or low level suckers from the mature sycamore trees. This is periodically removed by the London Borough of Haringey maintenance team, but as part of this project will be removed entirely back to ground level.

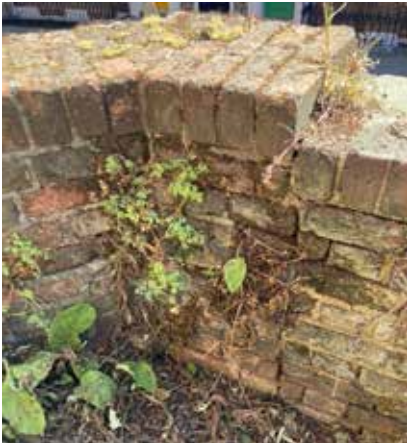
Figure 3.10. Opening joint between brick panels

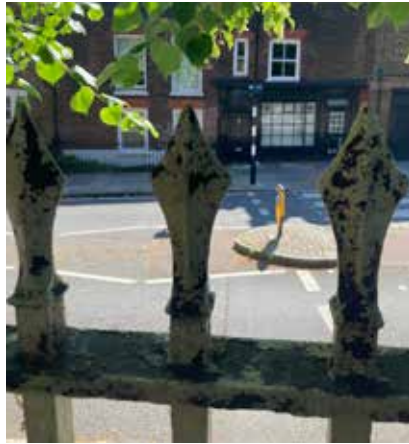
There is some rust throughout to the balusters, rails and posts along the whole length of the railing system.

Figure 3.11. Degrading paint finish on railings

All metalwork will be wire brushed by hand and in some of the bad areas rotary wire brushes and grinders will be used to get back to solid steel for the paint system to work effectively.

The paint system will be applied by hand (not sprayed). A zinc based primer is to be applied to prevent corrosion and to adhere to the surface. The finishing coat will be a weatherproof paint in invisible green.

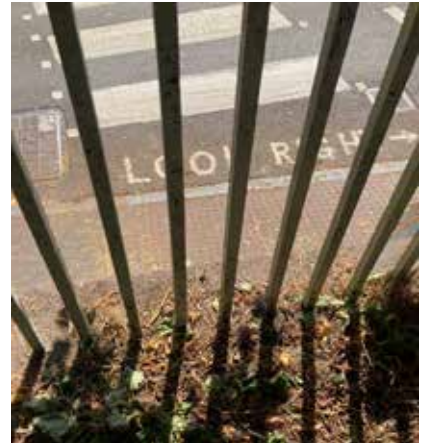
Figure 3.12. Level soil on graveside with railings

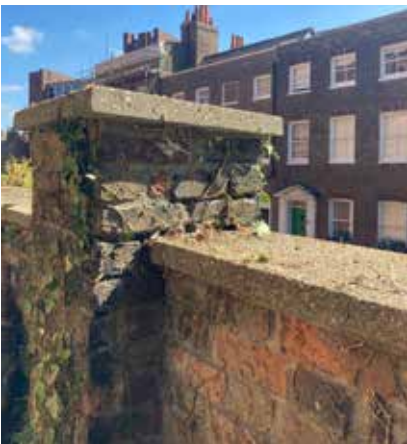
Figure 3.13. Loss of brick face

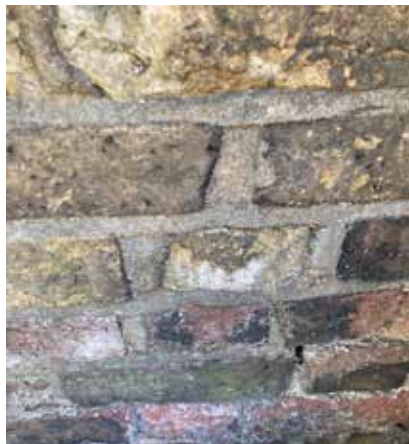
Figure 3.14. Cementitious pointing

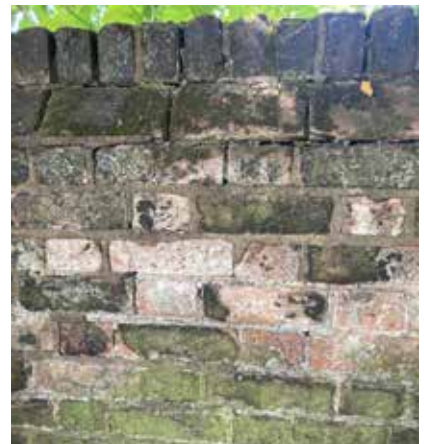
Figure 3.15. Open joints and missing pointing
