**Tree Report**  
**Picus Testing – 63 Lanchester Road London N6 4SX.**

**1.1 Inspection date:** 2nd November 2022 by Mr. Kim Gifford, undertaken in the area of test and at the time of inspection.

## **1.6 Hornbeam (Carpinus betulus) Front Garden.**

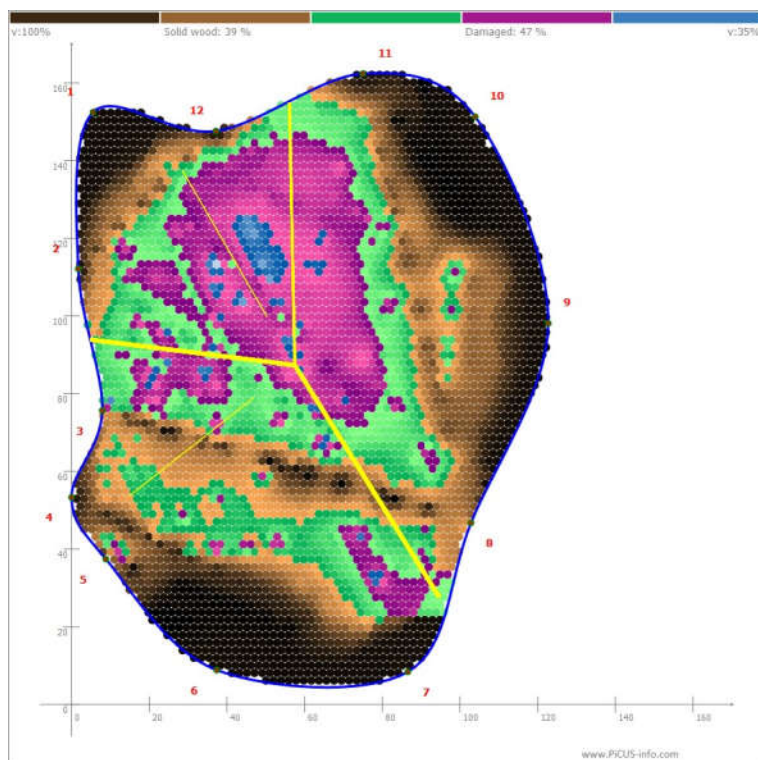
**Test point 1 orientation North.**

The measuring point readings give evidence of low velocities overall in the area of test representation showing as altered timber. The tomographic images shown above has a percentage amount of altered timber. With reference to the 'colour chart see figure 2', the slower sonic speed of sound is represented by three bands of data representation blue/violet/white being the slowest altered/decayed timber, green being faster altered timber, brown being fast sonic-speeds solid timber.

The resulting Picus tests are of unacceptable limits in relation the altered timber. This ratio called a 'trunk ratio' TR (*reference Claus Mattheck*) has been calculated to be a guideline in terms of stability and rigidity of cylindrical structure. Although a debated theory in arboriculture in general terms the TR of 30% is an average.

Further to the previous Picus test December 2021. The recent Picus test shows decay under the main union at the base adjacent to the fungal bracket centrally.

It will appropriate to recommend further pruning to relieve stress from these areas by crown retrenchment overall by 3m to 4m. This will limit the risk of branch breakage in these areas. Continue to monitor.

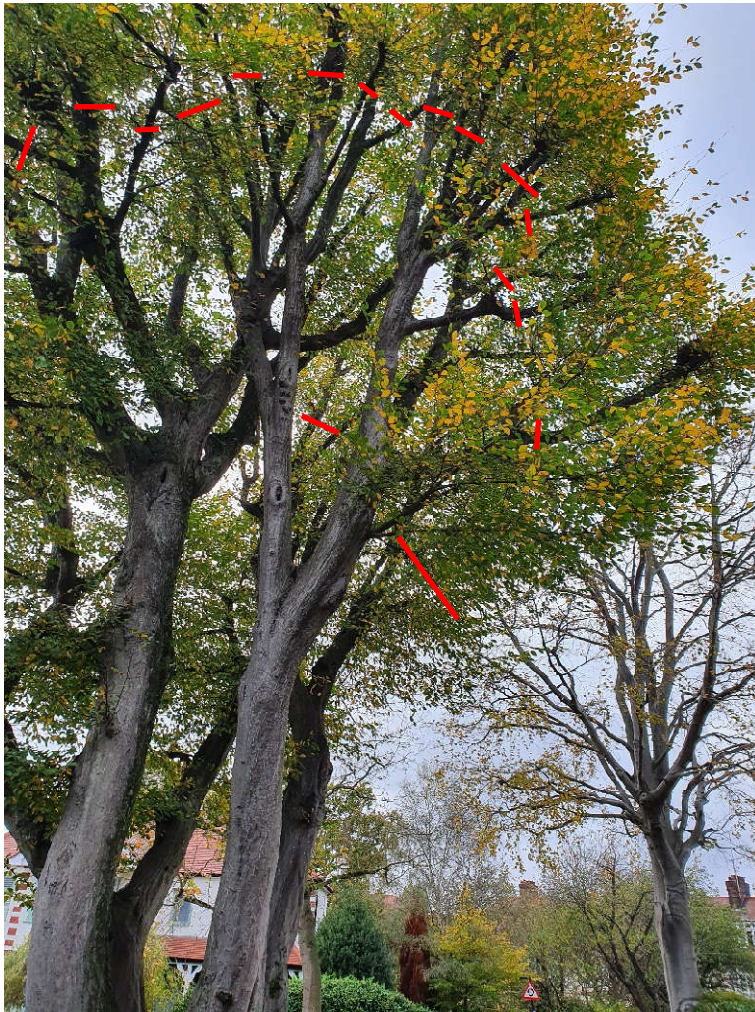
**Figure 1: Further pruning of 3m to 4m overall stress from the decayed areas.**

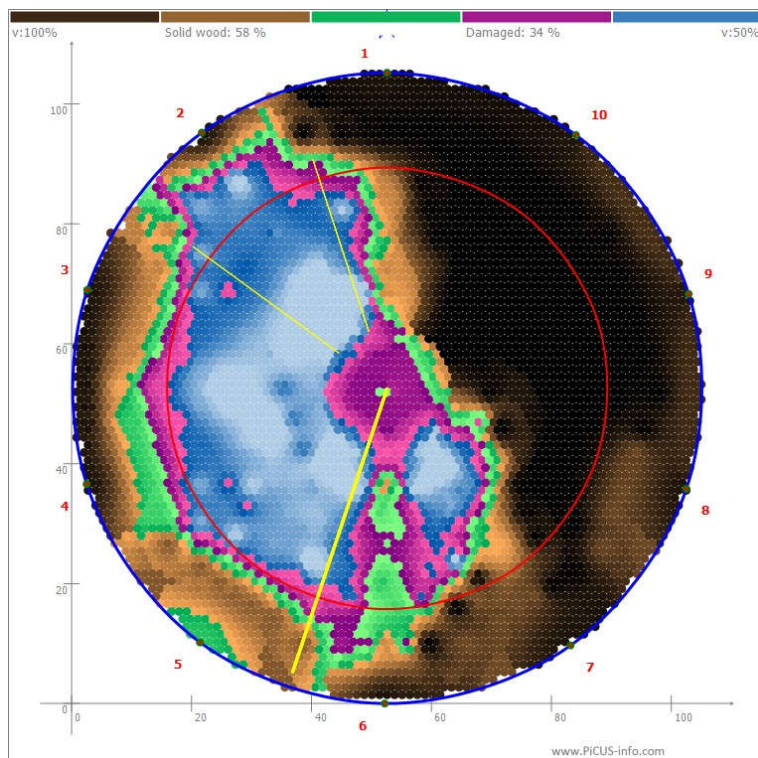
**Test point 1 orientation North.**

The measuring point readings give evidence of low velocities overall in the area of test representation showing as altered timber. The tomographic images shown above has a percentage amount of altered timber. With reference to the 'colour chart see figure 2', the slower sonic speed of sound is represented by three bands of data representation blue/violet/white being the slowest altered/decayed timber, green being faster altered timber, brown being fast sonic-speeds solid timber.

The resulting Picus tests are of acceptable limits in relation the altered timber. This ratio called a 'trunk ratio' TR (*reference Claus Mattheck*) has been calculated to be a guideline in terms of stability and rigidity of cylindrical structure. Although a debated theory in arboriculture in general terms the TR of 30% is an average.

The Picus test results show that there is sufficient sound timber, in the area of test to sustain the specimen.

Continue to monitor future decay on a regular basis.

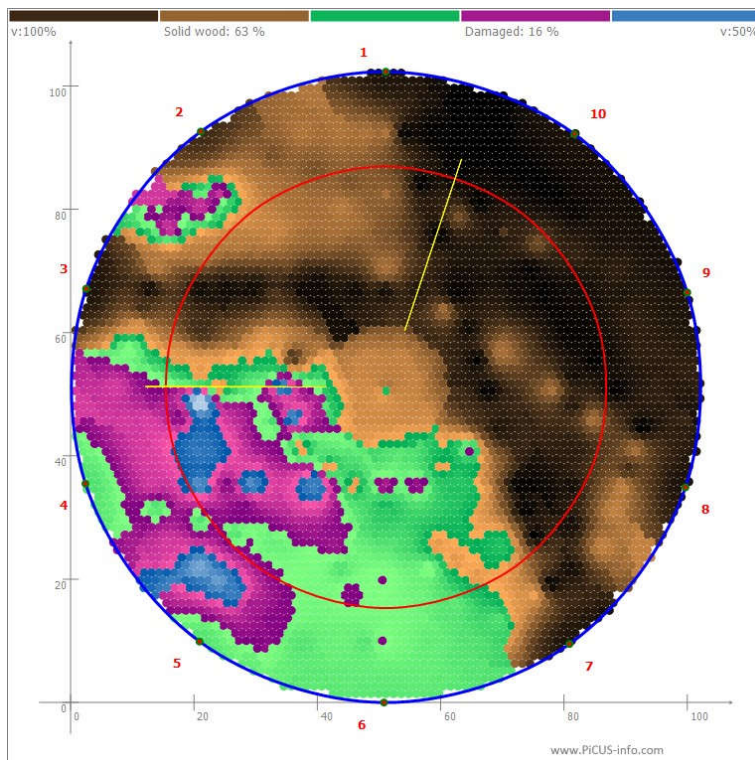
**Test point 1 orientation North.**

The measuring point readings give evidence of low velocities overall in the area of test representation showing as altered timber. The tomographic images shown above has a percentage amount of altered timber. With reference to the 'colour chart see figure 2', the slower sonic speed of sound is represented by three bands of data representation blue/violet/white being the slowest altered/decayed timber, green being faster altered timber, brown being fast sonic-speeds solid timber.

The resulting Picus tests are of acceptable limits in relation the altered timber. This ratio called a 'trunk ratio' TR (*reference Claus Mattheck*) has been calculated to be a guideline in terms of stability and rigidity of cylindrical structure. Although a debated theory in arboriculture in general terms the TR of 30% is an average.

The Picus test results show that there is sufficient sound timber, in the area of test to sustain the specimen.

Continue to monitor future decay on a regular basis.
