## **ARBORICULTURAL IMPACT ASSESSMENT REPORT FOR:**

2 Courtenay Avenue  
London  
N6 4LP

**Ref:** WFA/2CNY/AIA/02a

**Date:** 29<sup>th</sup> November 2022

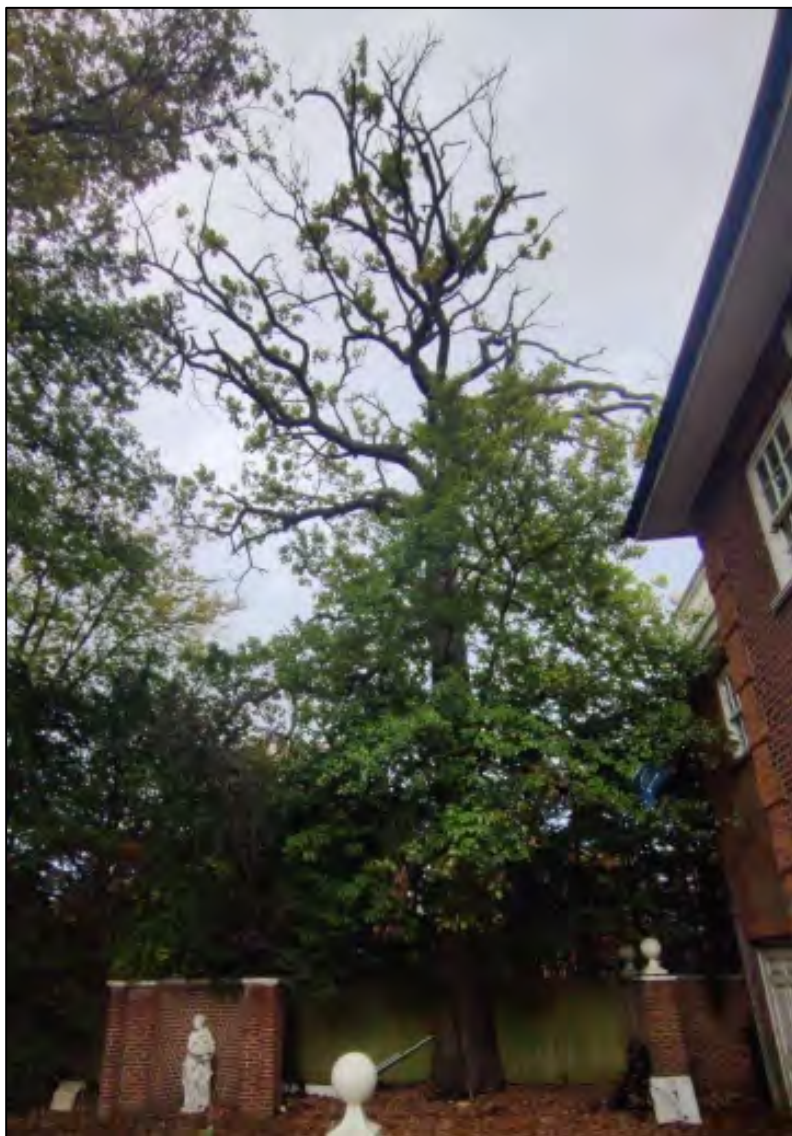
- 3.3.5 There are recommended works for 4 on-site trees. These are listed in Appendix 2.
- 3.3.6 NB T3 oak (see photo 3 below) is recommended therein for felling on account of its moribund condition. In view of the local (Bishops Wood) sensitivity to removal of oaks, a proviso is made for the tree's retention through pollarding (severe pruning) subject to further investigation. To some extent the applicant would be led by the council's sentiments here, not wishing an essentially separate management decision to adversely impact upon a wider planning decision. Notwithstanding this sensitivity, my inclination would be to fell. I think it reasonable to go out of one's way to maintain a mature oak tree in decline at the bottom of the garden (as with similarly affected T15) where a preference for benign neglect may be expected; more intensive maintenance and formal aesthetics are reasonable within a front driveway courtyard at <5m from the corner of the house and overhanging the neighbours' boundary. Moreover, the tree's habit (high crown break) leaves little of aesthetic value to retain in a pollard (but a pole shape). On this basis, felling is my preference.

Photograph 3: Oak T3 recommended for removal regardless of development

- 6.1.4 The potential impact to T3 could be mitigated by airspade / manual excavation within the relevant area of encroachment - however, as indicated in Appendix 2, the felling / pollarding of T3 is recommended in the interests of good husbandry because of its moribund condition (regardless of proposed development), in which case replacement planting would offset the loss. The impact is therefore rated as very low, unlikely to harm either the resource or the wider conservation area.

- 6.3.8 The immediate canopy encroachment from T3 and T4 can be avoided with a crown lift of lower limbs and minor crown reduction – however, as indicated in Appendix 2, the felling / pollarding of T3 is recommended in the interests of good husbandry (regardless of proposed development).

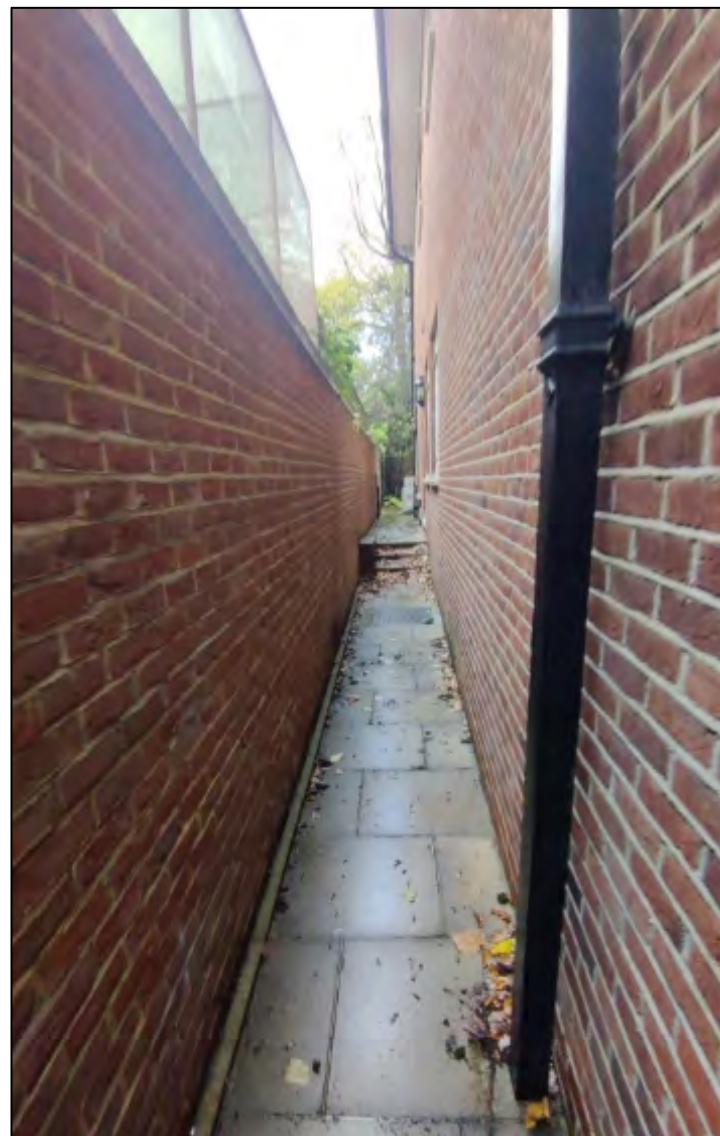
Photograph 4: Existing arrangement between house and northern boundary

- 6.1.3 Accordingly, the impact to T3 is assessed as being negligible with the impact to T4 assessed as being very low, as the distribution of an RPA below the existing building is in principle, unjustified: notwithstanding a reduced probability of rooting below significant structures, the principle of protecting and promoting root colonisation below vulnerable building foundations conflicts with other responsibilities of / liabilities for the council. We would also consider the existing brick boundary wall and hard landscaping shown in Photograph 4 to have acted as barriers to root growth into the application site by T4.

- 6.1.5 In respect of T4, hand-digging the top 750mm of lower ground floor encroachment under arboricultural supervision with root-pruning where appropriate in the event that rooting were to be present in the relevant location would reduce the risk of damage (see 6.3) – accordingly this is therefore rated as a low impact unlikely to harm either the resource or the wider conservation area.
