# Arboricultural Appraisal Report

## Subsidence Damage Investigation at:

1 Donovan Avenue  
London  
N10 2JU

| REPORT DATE: | 14/11/2022 |

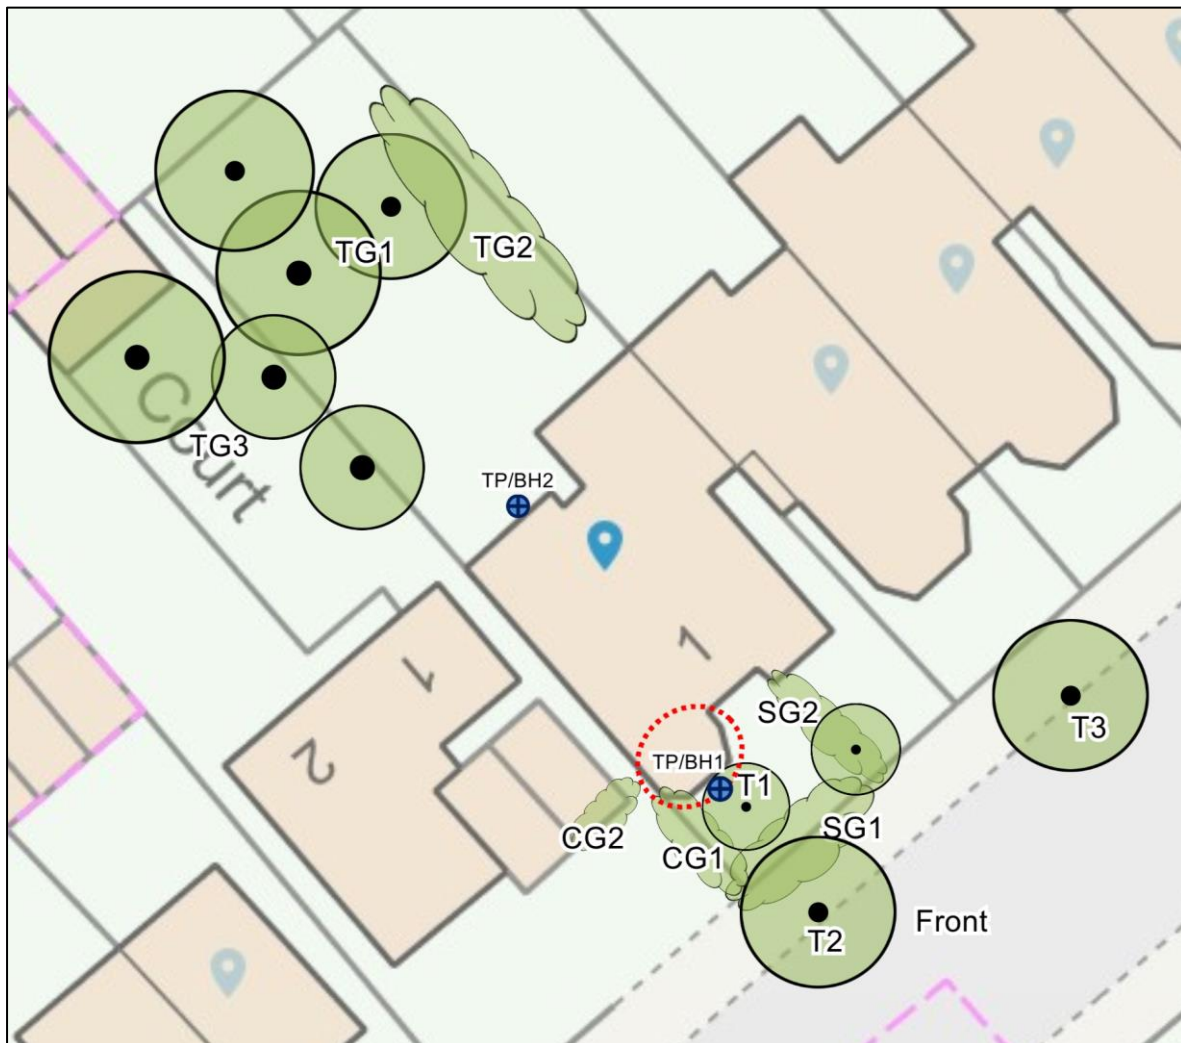
Damage relates to the front bay window where cracking indicates downward movement. Damage is reported to have first been observed during August 2022.

Approximate areas of damage

If an arboricultural solution is to be implemented to mitigate the influence of the implicated trees/vegetation we recommend that T2 Sycamore, CG1 Ivy, CG2 Wisteria and the Japanese maple of SG2 are removed, combined with selective removal of shrubs from SG1 group. Given the presence of the Japanese Maple which may also pose a source of the Acer spp. roots as well as the T2 Sycamore, the Local Authority may require confirmation of ongoing movement once the Japanese Maple has been removed.

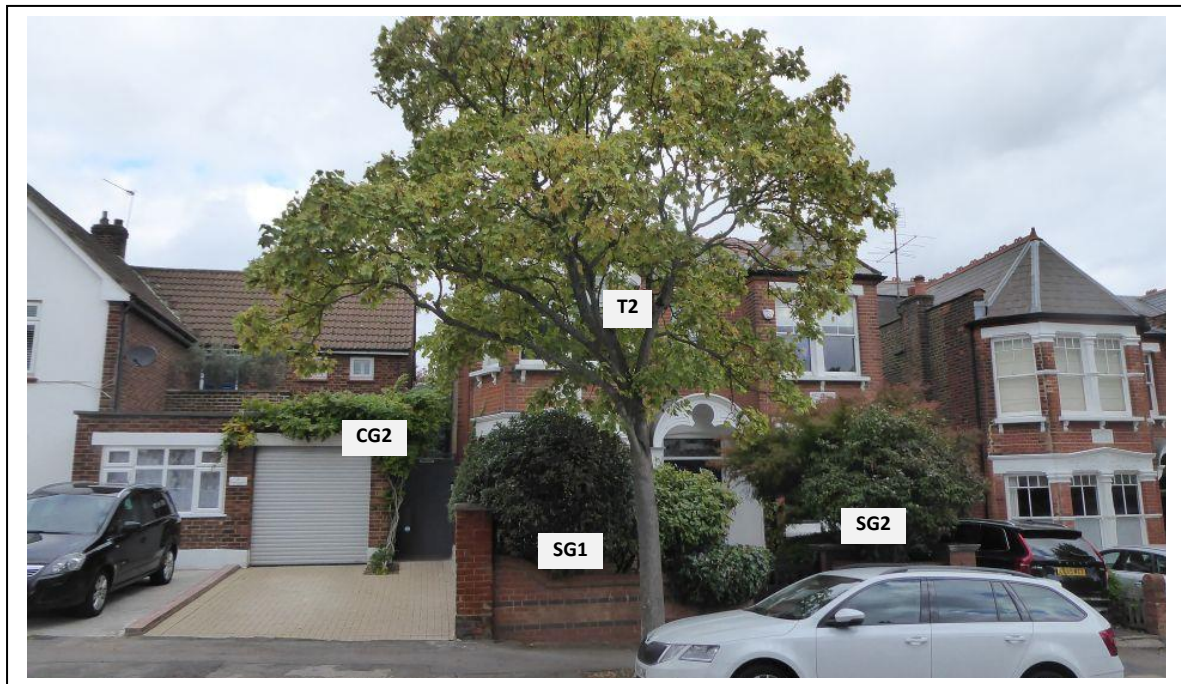
Based on the technical reports currently available, engineering opinion and our own site assessment we conclude the damage is consistent with shrinkage of the clay subsoil related to moisture abstraction by vegetation. Having considered the information currently available, it is our opinion that the T2 Sycamore is the likely principal cause of the current subsidence damage, combined with a significant contributory influence from the smaller but more proximal trees and shrubs.

Overview of property frontage, with T2 Sycamore to foreground

| Tree No. | Species | Ht (m) | Dia (mm) | Crown Spread (m) | Dist. to building (m) | Age Classification | Ownership |
|---|---|---|---|---|---|---|---|
| Recommendation | | Remove (fell) to near ground level and treat stump to inhibit regrowth. | | | | | |

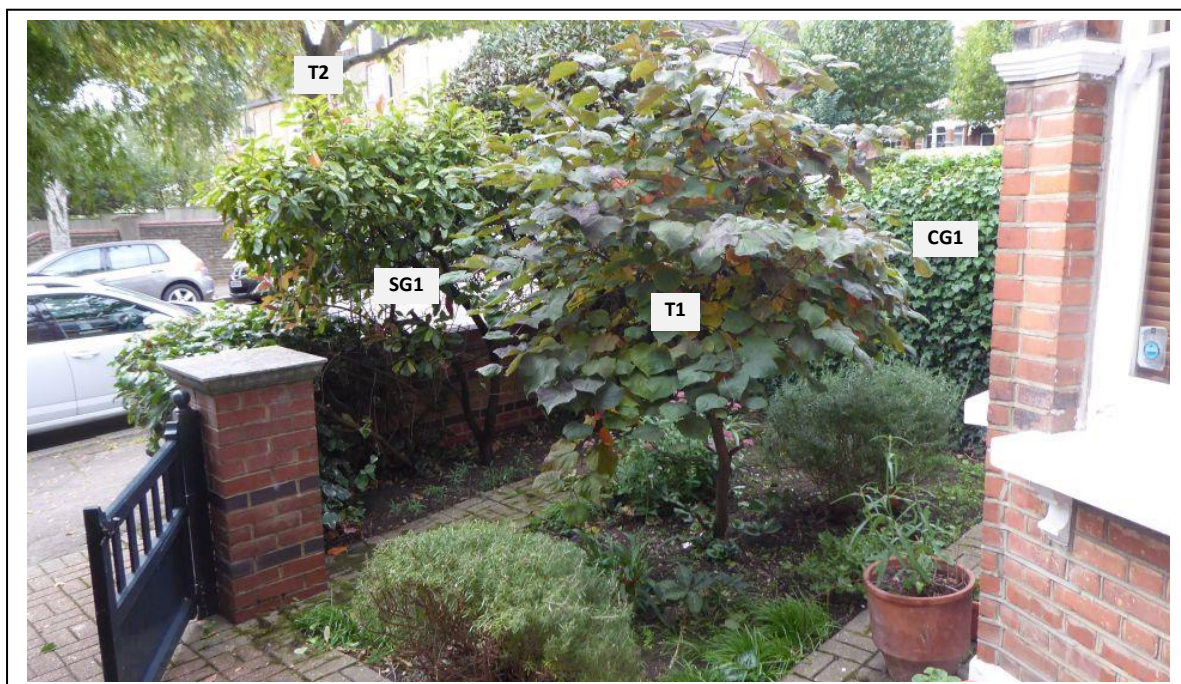
Irrespective of the identification of recovered root samples, the roots of the nearby trees and shrubs T1, SG1, CG1 and CG2 are also likely to be present below foundation level in proximity to the area of movement/damage and contributing to the influence of soil moisture and volumes.

View of T1 Cercis, with SG1 group and CG1 Ivy and T2 Sycamore visible beyond

| Tree No. | Species | Ht (m) | Dia (mm) | Crown Spread (m) | Dist. to building (m) | Age Classification | Ownership |
|---|---|---|---|---|---|---|---|
| Recommendation | | Remove (fell) to near ground level and treat stump to inhibit regrowth. | | | | | |
| Recommendation | | Remove (fell) Viburnum and Pyracantha elements to near ground level and treat stumps to inhibit regrowth. | | | | | |

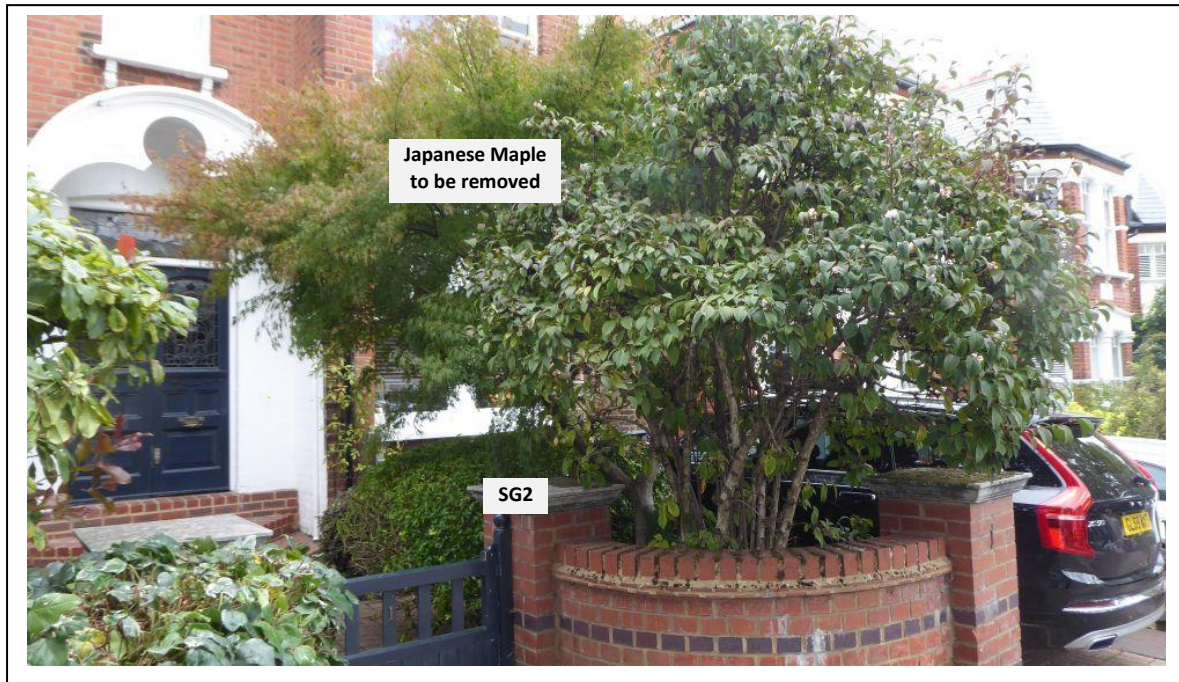
Roots were observed to a depth of 1.15m bgl in TP/BH1 at the property frontage, and recovered samples have been positively identified (using anatomical analysis) as Acer spp.; the origin of which will be either the Japanese Maple of SG2 group, or the Sycamore T2.

View of SG2 group

| Tree No. | Species | Ht (m) | Dia (mm) | Crown Spread (m) | Dist. to building (m) | Age Classification | Ownership |
|---|---|---|---|---|---|---|---|
| Recommendation | | Remove (fell) Japanese Maple to near ground level and treat stump to inhibit regrowth. | | | | | |
