# Site Investigation Report

140865.1.USI

| Overview | |
|---|---|
| Brief | Auger were commissioned by Crawford & Co to undertake a site investigation and CCTV inspection of the underground drainage within the area of concern (AOC) at the property. |

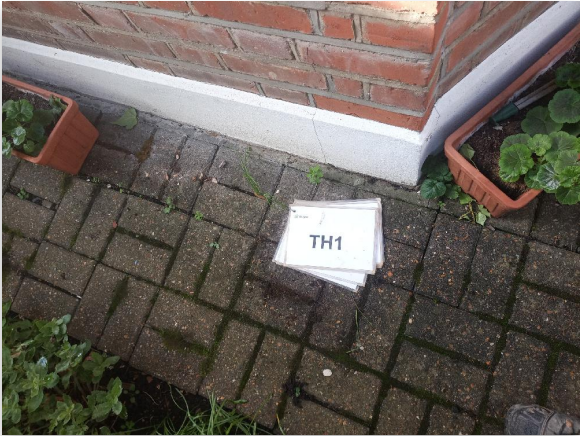
| Trial Hole 1 | |
|---|---|
| Fig 1.1: Trial Hole 1 Location | Fig 1.2: Trial Hole 1 Footing |

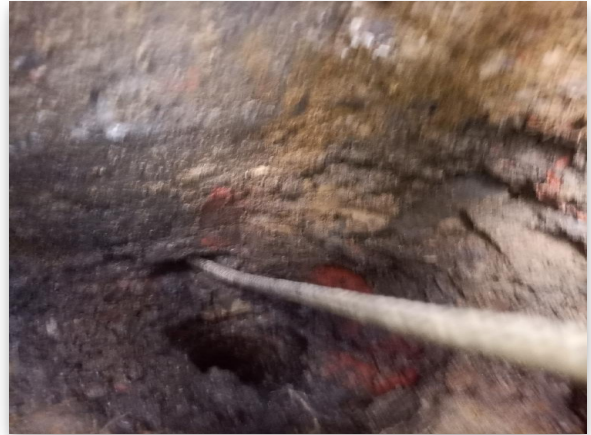
Fig 2.2: Trial Hole 2 Footing

| Overview | |
|---|---|
| Trial Hole Findings | TH1 and TH2 were able to reach the required depth in the proposed locations. Soil and root samples were taken. Water was encountered at 0.7m in TH2. |

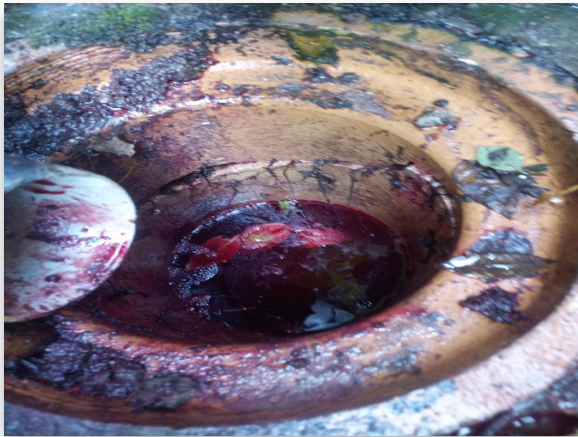
Fig 3.1: WG1 Dye Test

| Overview | |
|---|---|
| Visual Inspection | A visual inspection of the site revealed WG1 has broken/cracked. Our engineer also noticed that the trap in MH1 had a large fracture. However these were noted to be outside of the AOC. |
| | Dye testing was undertaken on WG1 to confirm it runs to MH1, the dye test did not reveal an escape of water. |
