## TECHNICAL REPORT ON A SUSPECTED SUBSIDENCE CLAIM

**Crawford Reference: SU2202472**

**1 Donovan Avenue  
London  
N10 2JU**

### **SUBSIDENCE CLAIM**

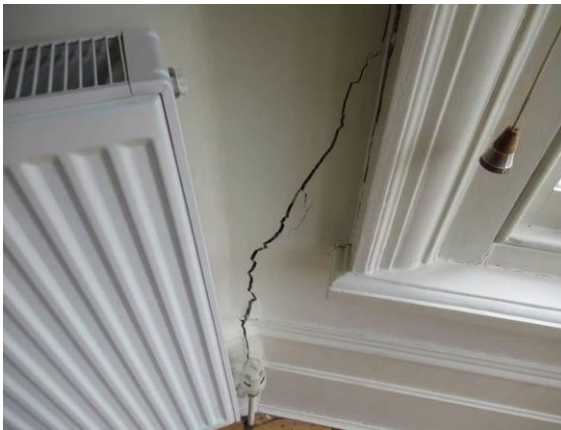
Cracking to right side of bay in Lounge.

- A large diagonal crack was noted to the wall on the right-hand side of the bay window measuring approximately 1.5m long.
- Horizontal cracking was found to run along the wall and window frame.
- Diagonal cracking extended from the left-hand side of the bay window and into the skirting boards.
- Vertical, tapered cracking was noted to run through the skirting boards.
- Cracking was found along the window frame junction
- Cracking was found above the bay window, extending through the ornate plaster coving.

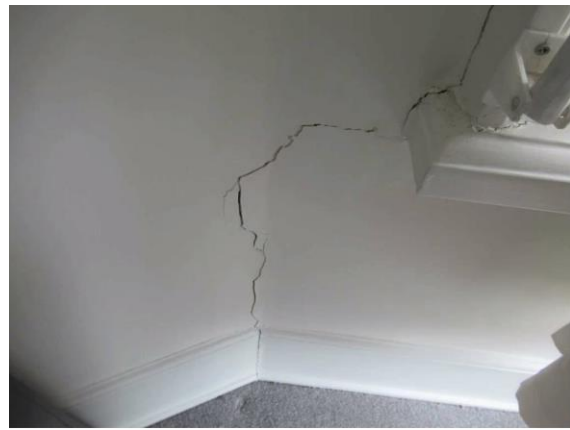
Cracking to bay in Bedroom.

- Cracking was noted to the bottom left-hand corner of the bay window measuring approximately 1m long.

- Stepped cracking was noted to the bottom right corner of the bay. The crack measured roughly 1m long.
- Vertical cracking was found along the wall and skirting board joints.
- Vertical cracking was noted along the main house and bay window juncture.

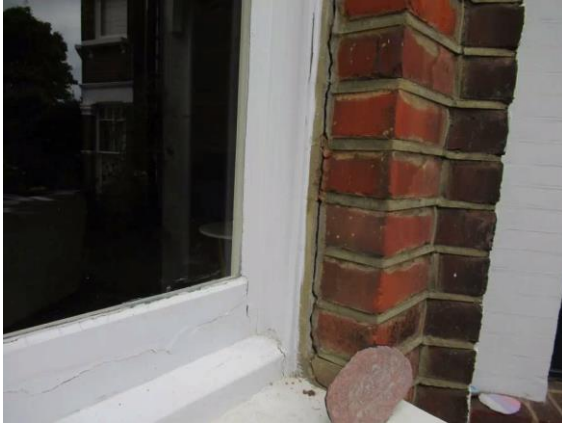
Cracking to mortar on ground floor bay.

- Horizontal cracking was found along the lower part of the timber window frame.
- Horizontal cracking was noted to the mortar between the brickwork and timber window frame.
- Several horizontal and stepped cracks was noted to the ornate stonework.

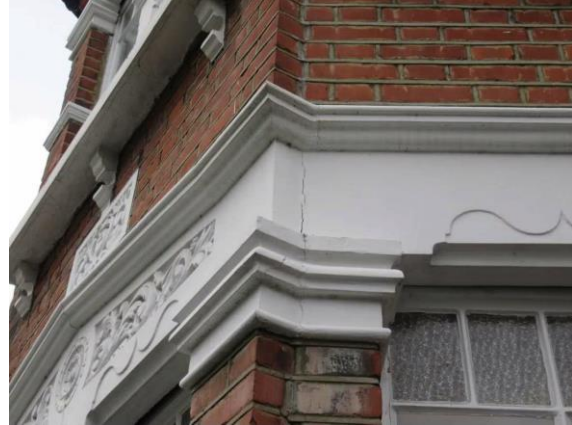
Cracked ornate stonework.

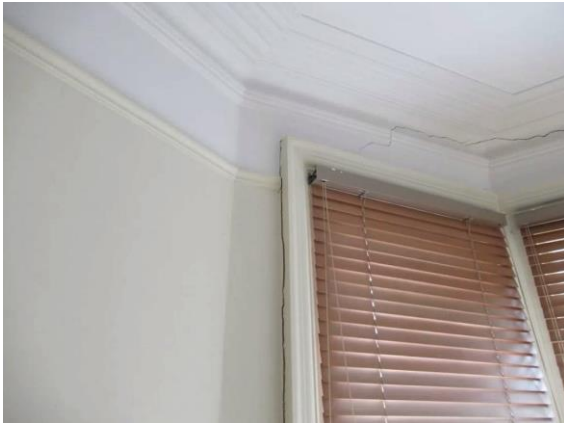
Cracking along window frame and coving.

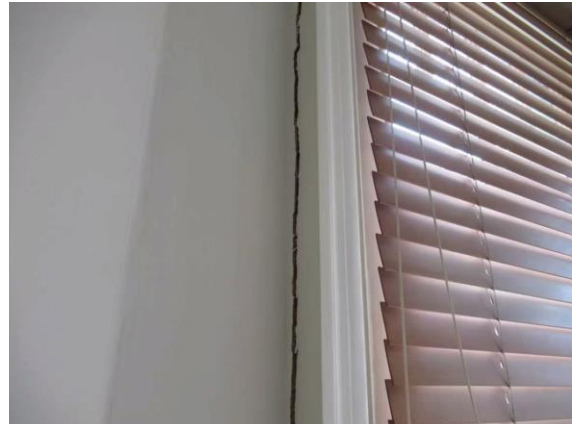
Cracks between woodwork and wall.

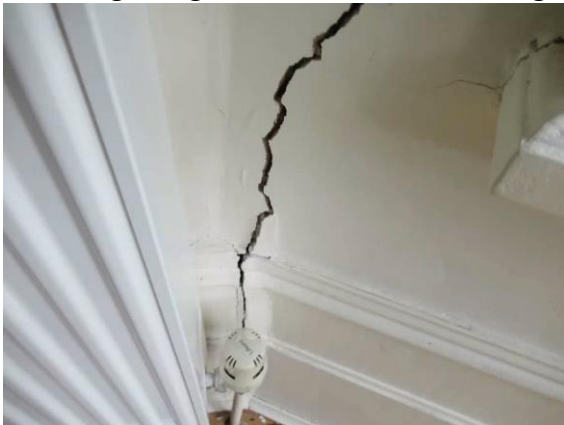
Closed up of Lounge damage.

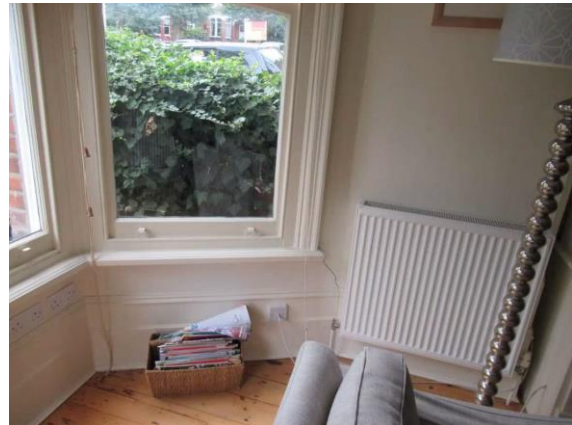
Cracking to the left side of bay.

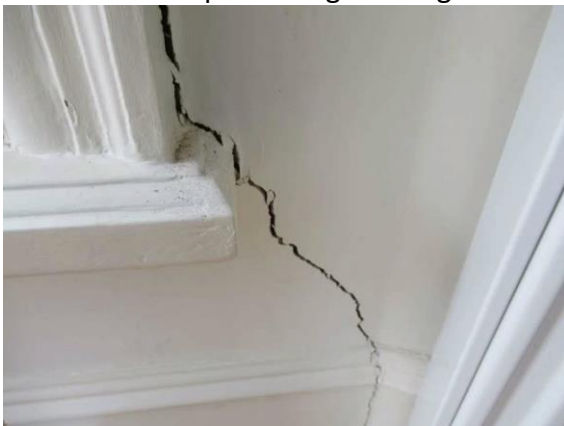
Cracking to the left side of bay.

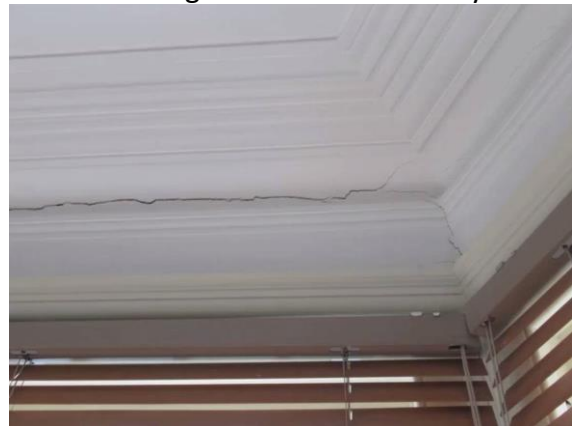
Cracking to ornate coving.

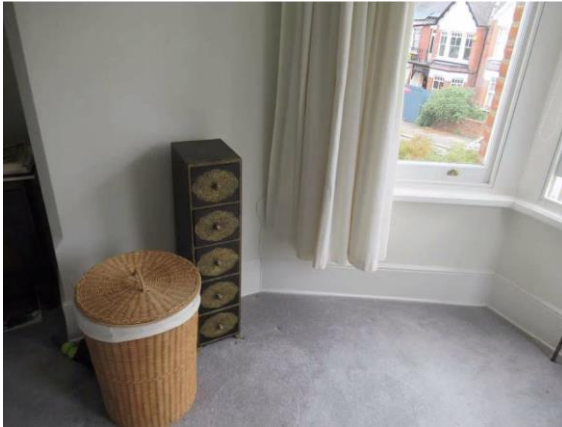
Cracking to bay junction in Bedroom.

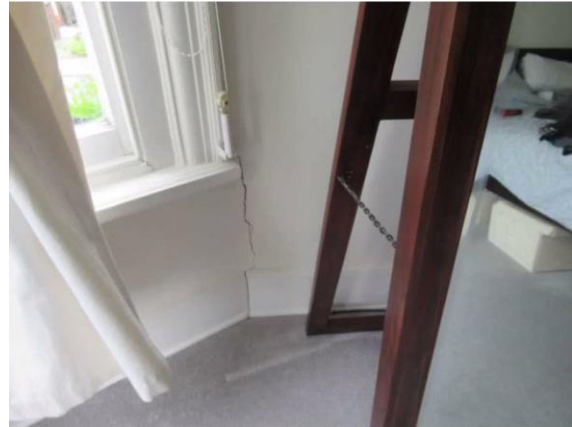
Cracking to left side of bay in Bedroom.

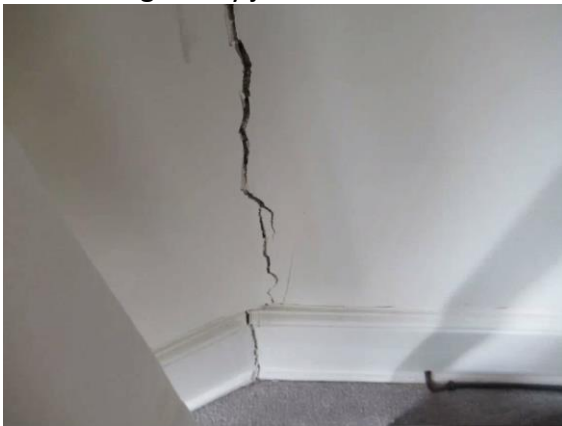
Close up of Bedroom damage.

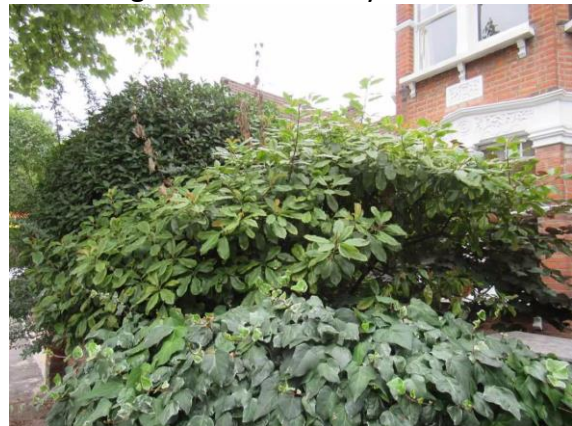
Insured owned vegetation.

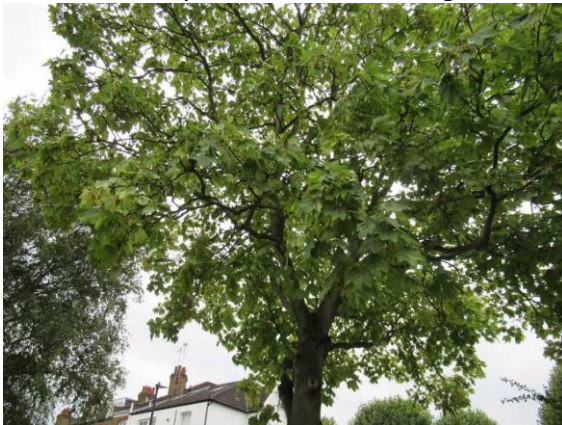
Local Authority tree.

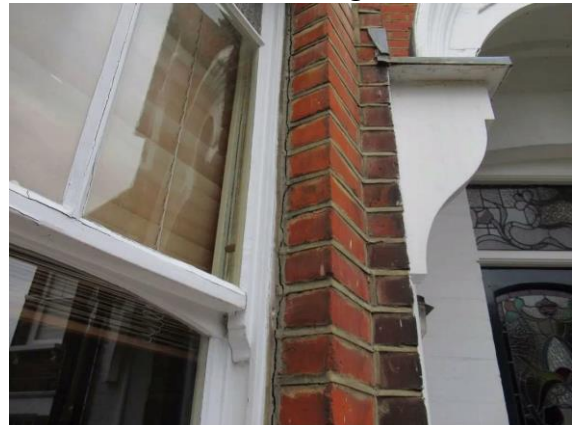
Cracking to mortar.

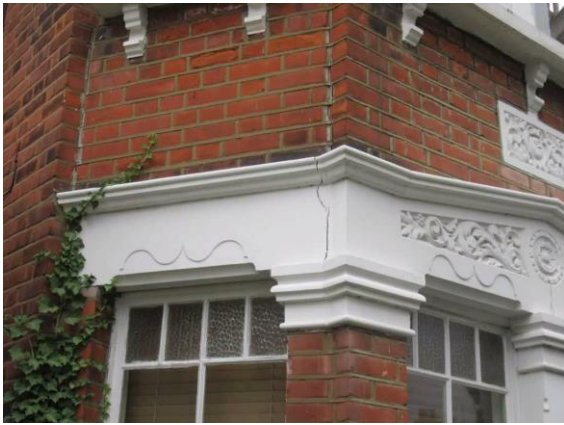
Cracked ornate stonework.

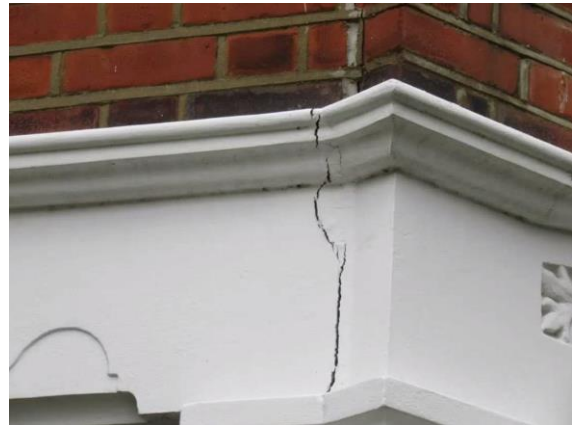
Cracked ornate stonework.

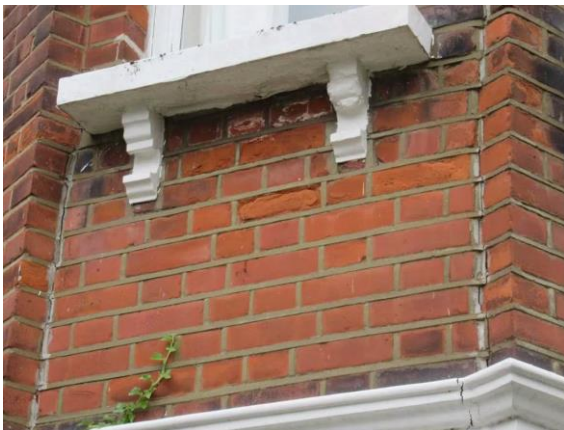
External bay damage.
