**Roof Report 47 North Road N6 4BE**

47 North Road

N6 4BE

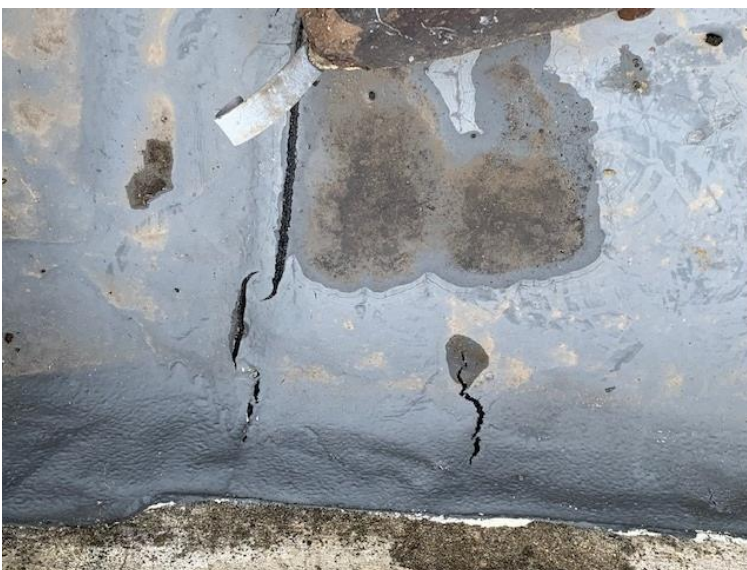
Pic 1) splits to side valley

We recommend removing the asphalt from the valleys and to achieve this we need to remove the slates from the roof and the ridges.

Once we have repaired any unforeseen damage to the valley boards, we recommend re-laying new BS988 asphalt roofing to an average thickness of 20mm on, and including black sheathing felt laid to, the valley falls. We will install 225mm asphalt upstands to all upstands under slates on EML, including fillets. We will supply and fix asphalt to all brickwork sides on EML, including fixing arris rails to all valleys. We will fit [all cover flashings, which will be lead clipped and pointed, then slate all roofs with new/ reclaimed Welsh slate. All ridges we will replace where necessary with reclaimed/new blue clay angle ridge tiles. All flashings will be lead and will be held in place with lead clips and will be pointed with sand lime and cement.

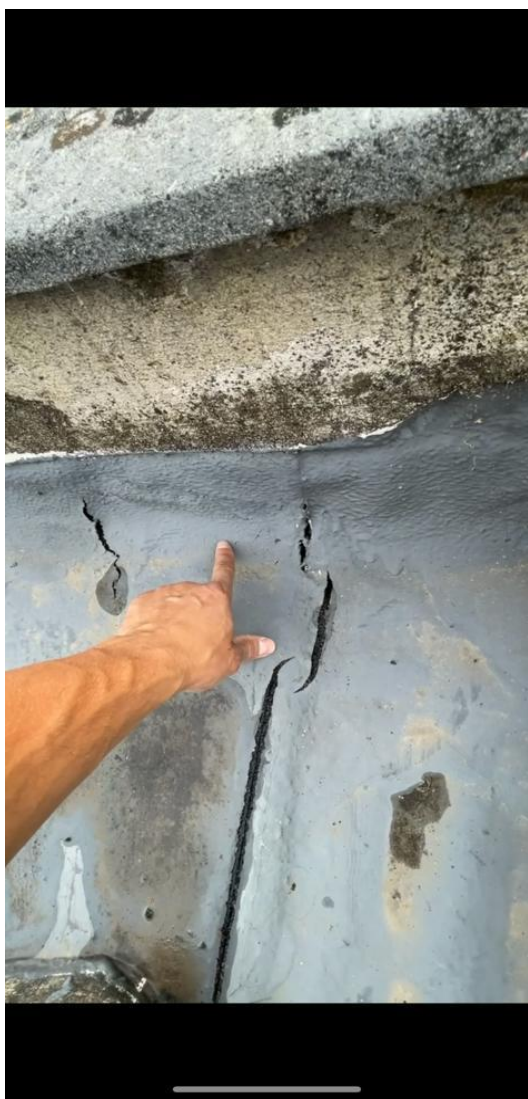
Pic 2) front valley split through mineral and sides are bulging.

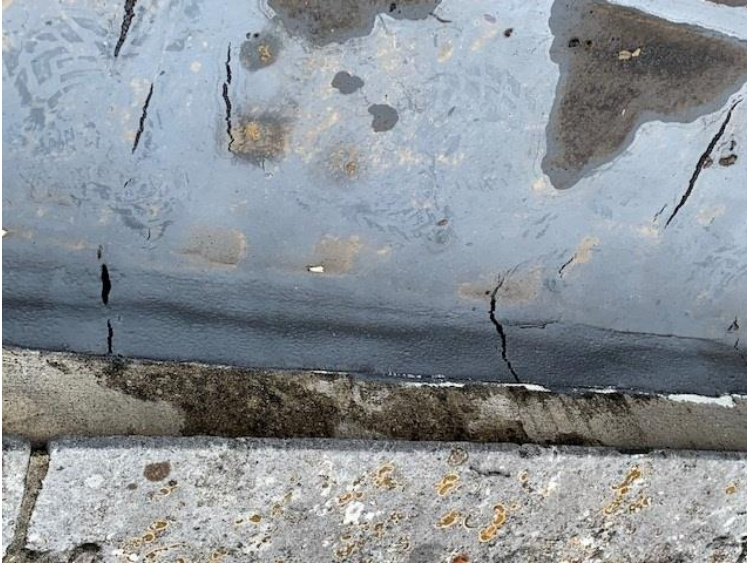
Pic 3) splits to front valley

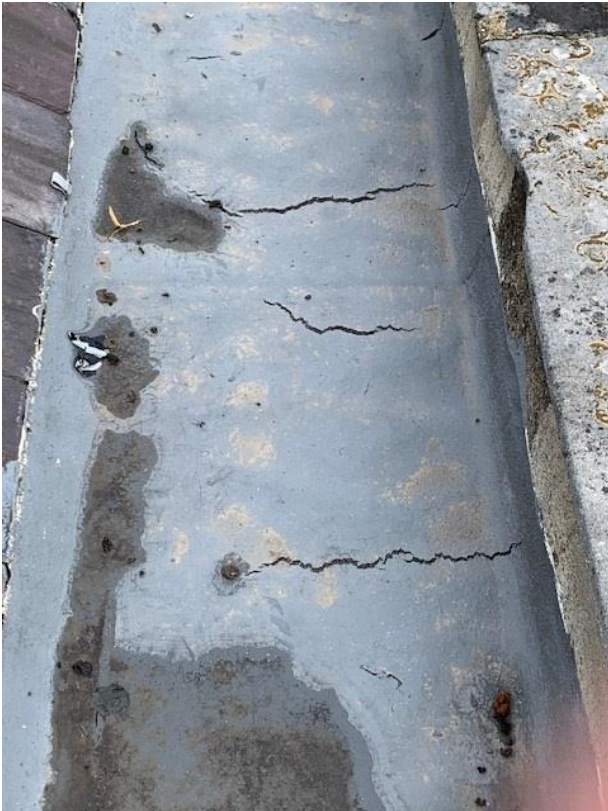
Pic 4) Front valley splits through the liquid covering and deeper than the felt layer

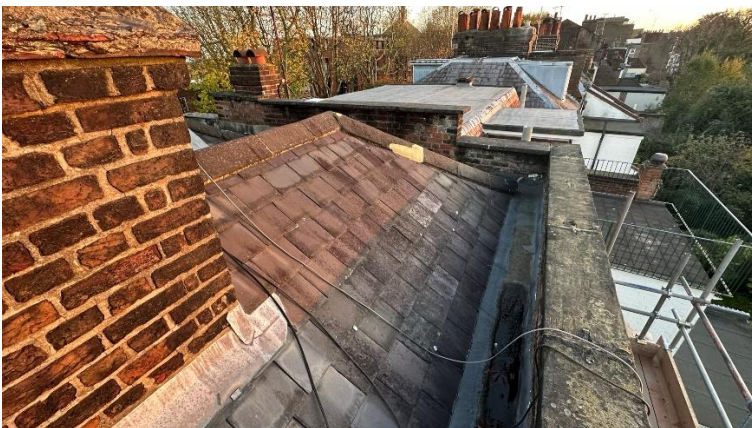
Pic 5) Rear Pitch Valley to hopper has sunk, retaining water

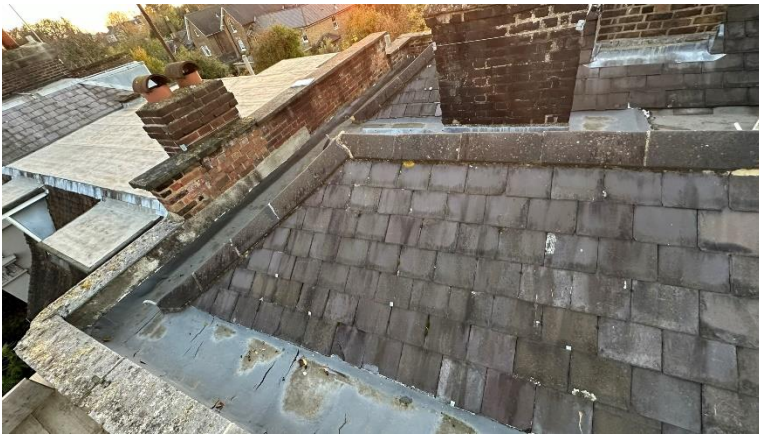
Pic 6) front picture of the two pitched roofs

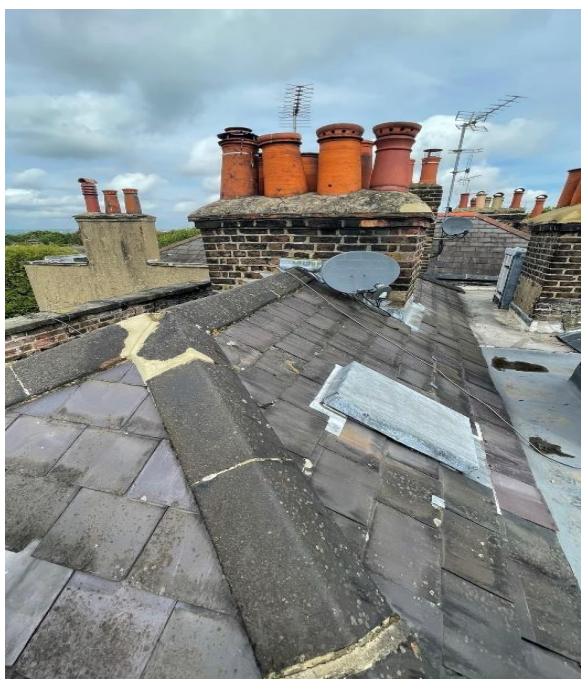
[Repairs to the ridges have been made over time with sand and cement and a mastic of some kind. Some slate repairs have also been done, judging from the visual of lead clips and the tiles' nail holes where slates have been turned upside down. There are also signs of degradation to slates due to their age, in order to replace valleys the bottom three tiles need to come out and in order to do that we need to start from the top and the ridges will also need to be removed and they I feel are past their life as 90% of them have been repaired with sand and cement or mastic of some kind we will do our best to salvage any decent slates and ridges also to try and re use them.

Pic 7) cement repairs to ridges

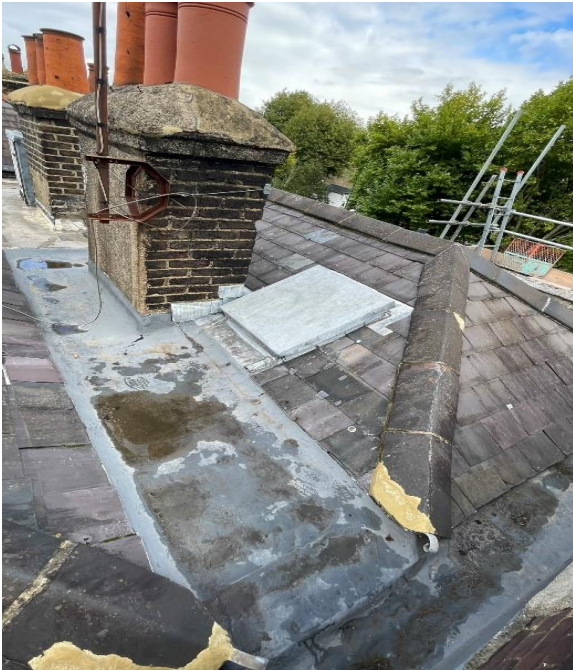
Pic 8) up the central valley showing sunk valley and cement repairs to ridges

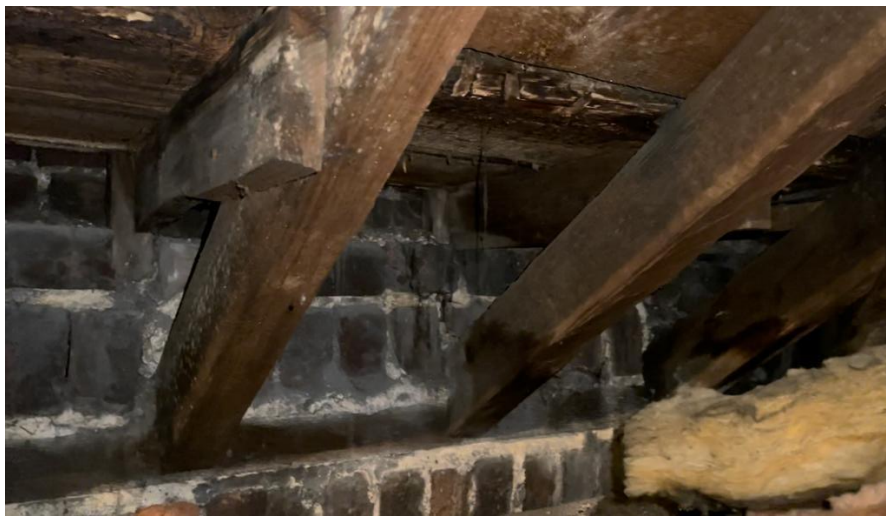
Pic 9) internal timbers showing decay from previous leaks

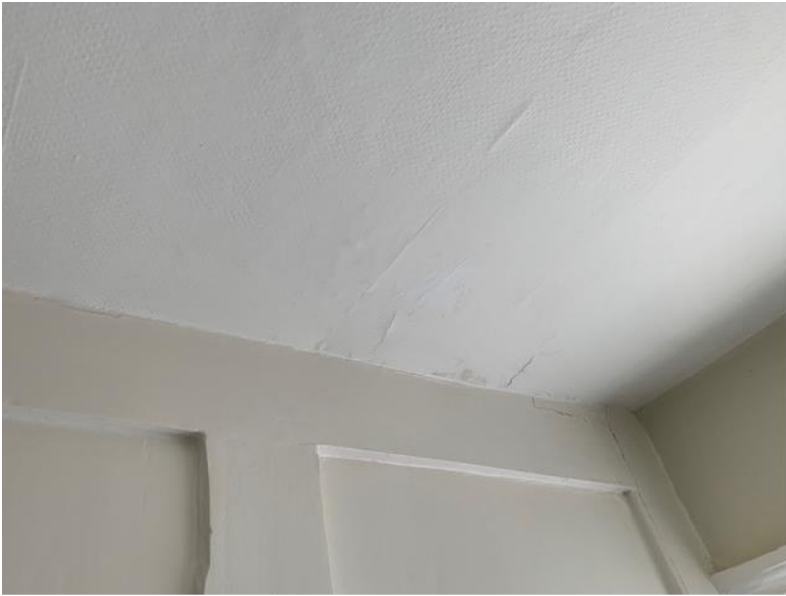
Pic 10) internal from front valley directly underneath pic 9

Internal images the ceilings are made up of lathe and plaster and there are signs of water ingress, the paneled wall at the front bedroom which is directly under pic 9 and the front valley where there is signs of water ingress. The pic above 13 is the center of the room coming from the rear pitched roof. It's not in line with the valley but as you can see there is already water ingress and this has worsened since summer.

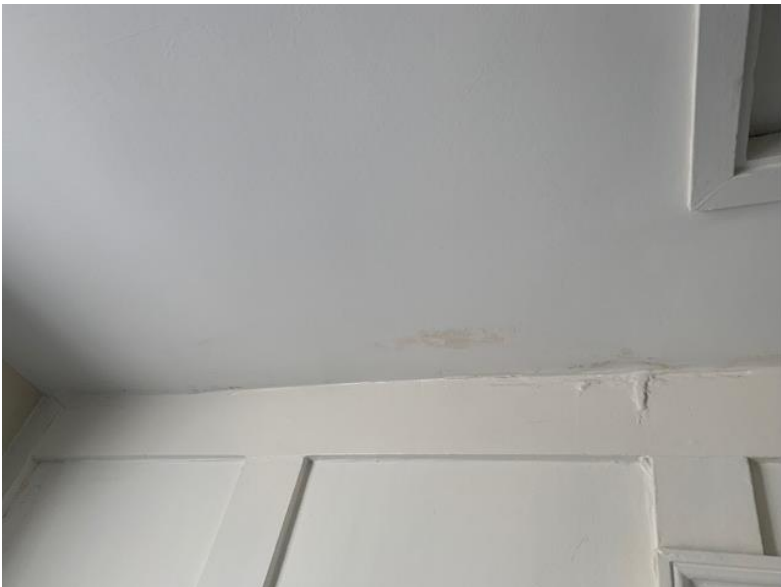
Pic 11) opposite side of the internal timber paneling pic 10

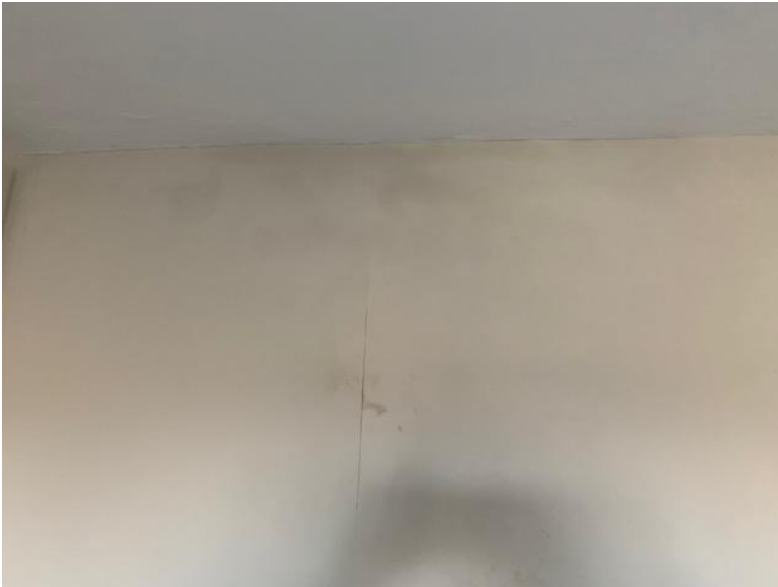
Pic 12) spine wall central to center valley

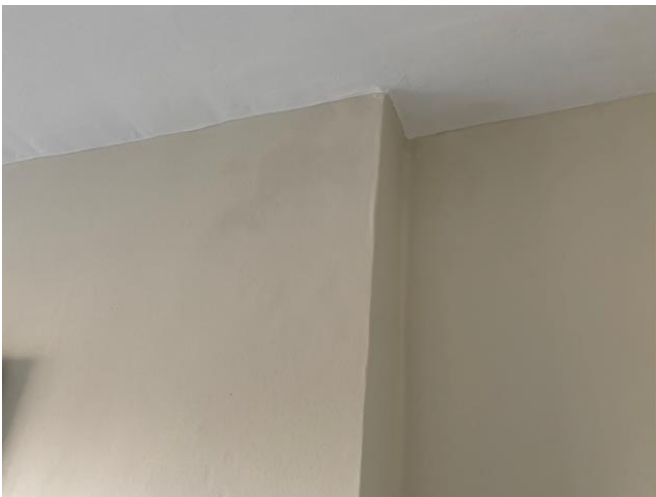
Pic 13) side wall of rear adjoining neighbor

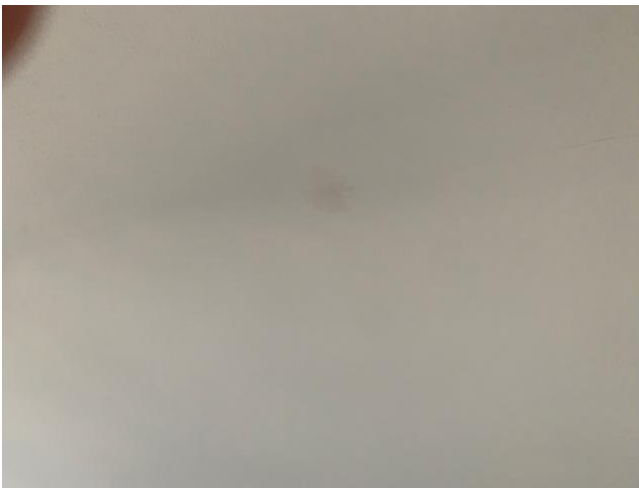
Pic 14) ceiling of rear room under the pitch roof
