### No. 792 Ground Floor

3.0      **CONDITION 3 - APPROVAL OF DETAILS (PRE COMMENCEMENT)**

**(C) map of the exact location, extent, and assessment of conditions of historic stone floors to basement**

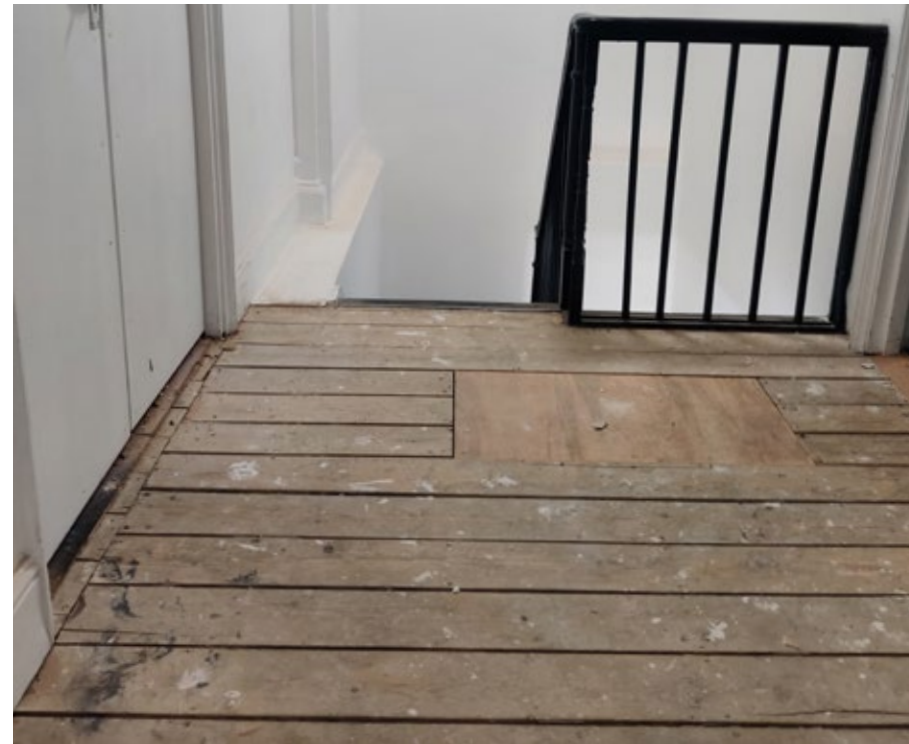
- Existing historic floor boards evident following strip out of modern finishes as part of investigative works.
- Boards are in good condition. Allow for minimal like for like repairs required via the scarfing in of small sections of matching timber or glue sensitively where floorboards appear to be spliced with joints under 20MM wide.
- Note existing paint/adhesive marks : Sensitively use turpentine and allow for surface cleaning by hand scrapping without damaging historic fabric.

**FIGURE 19.** 792-G-02 Existing Floorboards

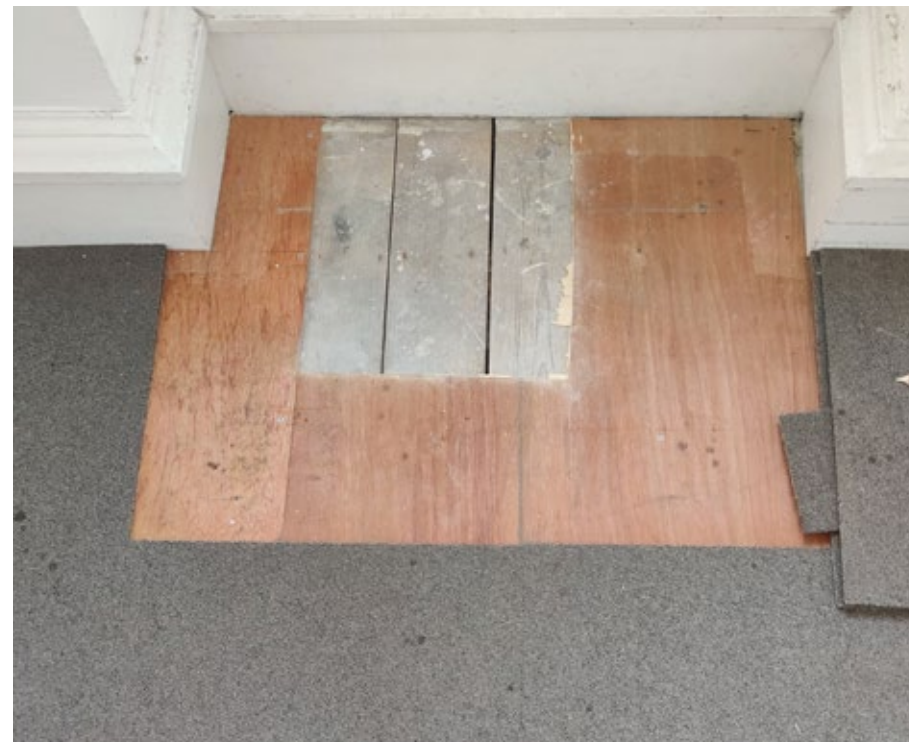
**FIGURE 20.** 792-G-04 Existing Floorboards visible through following removal of modern finishes

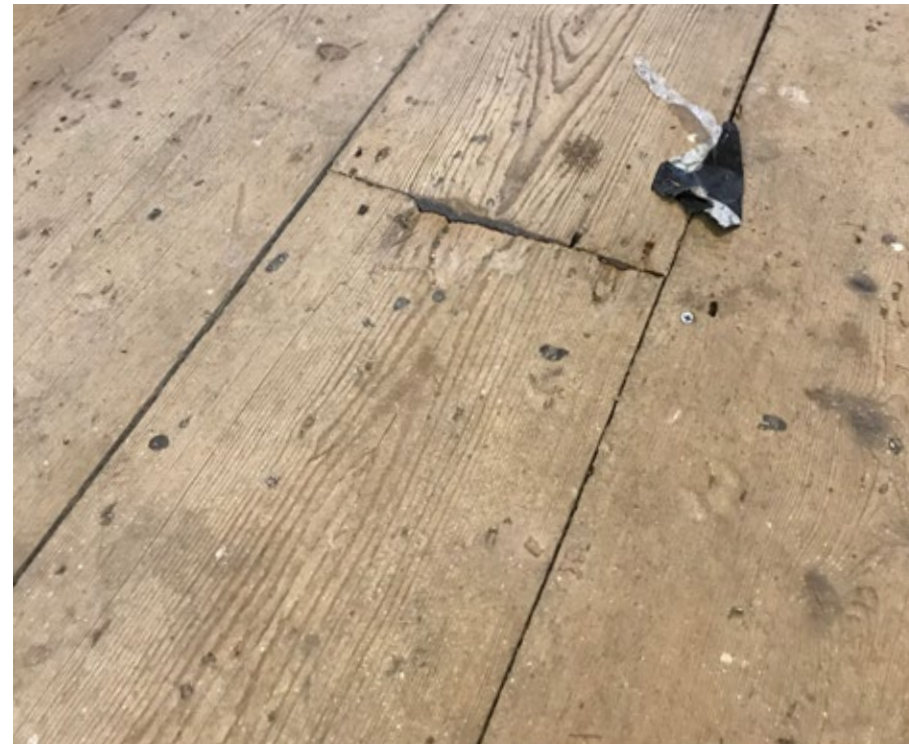
- Existing historic floor boards evident following strip out of modern finishes as part of investigative works.
- Boards are in good condition. Allow for minimal like for like repairs required via the scarfing in of small sections of matching timber or glue sensitively where floorboards appear to be spliced with joints under 20MM wide.
- Note existing paint/adhesive marks : Sensitively use turpentine and allow for surface cleaning by hand scrapping without damaging historic fabric.

**FIGURE 21.** 794-G-01 Existing Floorboards in good condition

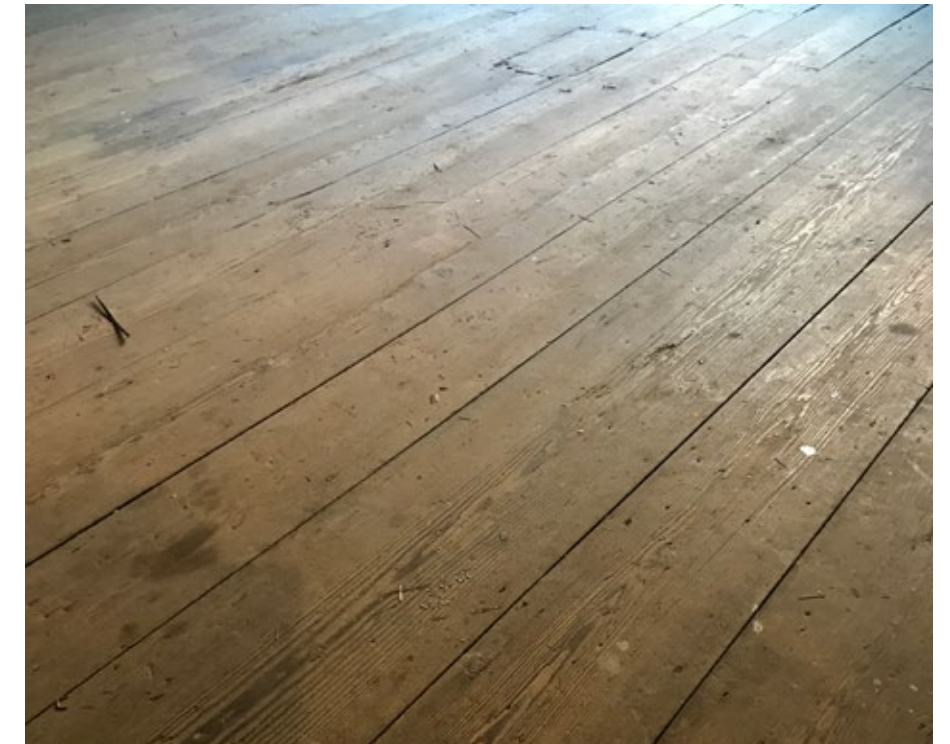
**FIGURE 23.** 794-G-03 Existing Floorboards in good condition

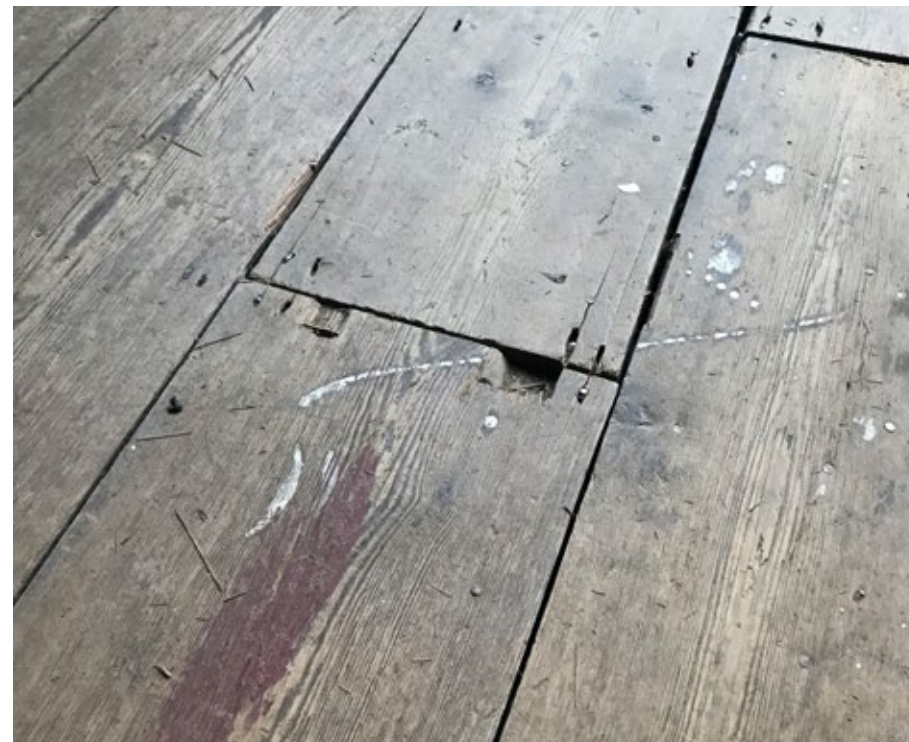
**FIGURE 22.** 794-G-04 Existing Paint Marks and spliced ends

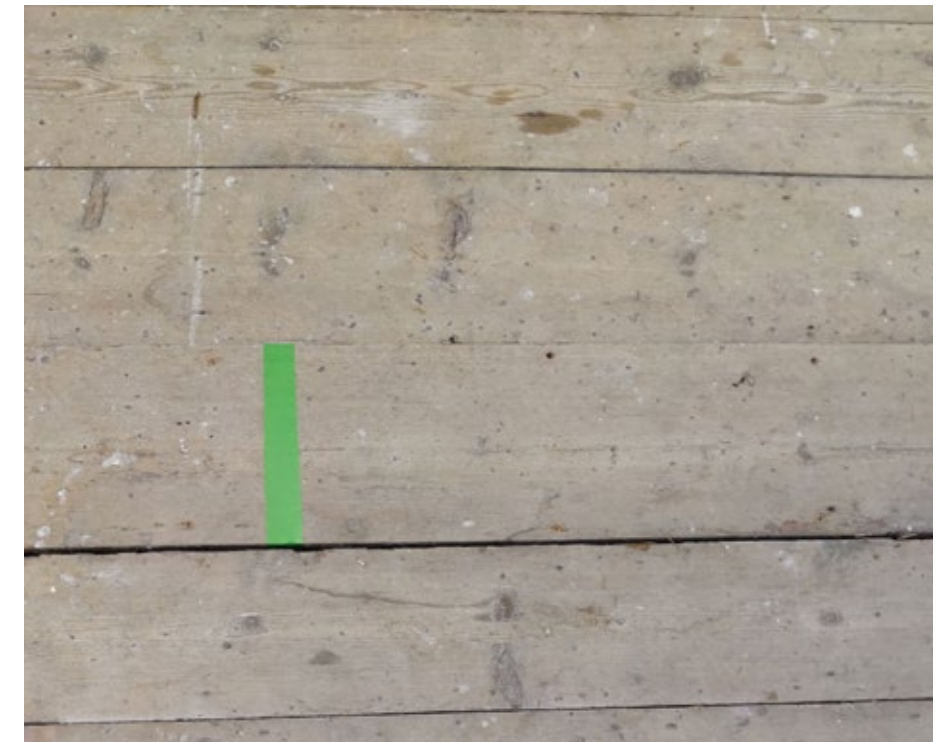
**FIGURE 24.** 794-G-06 Existing Floorboards demarcated to allow for opening up

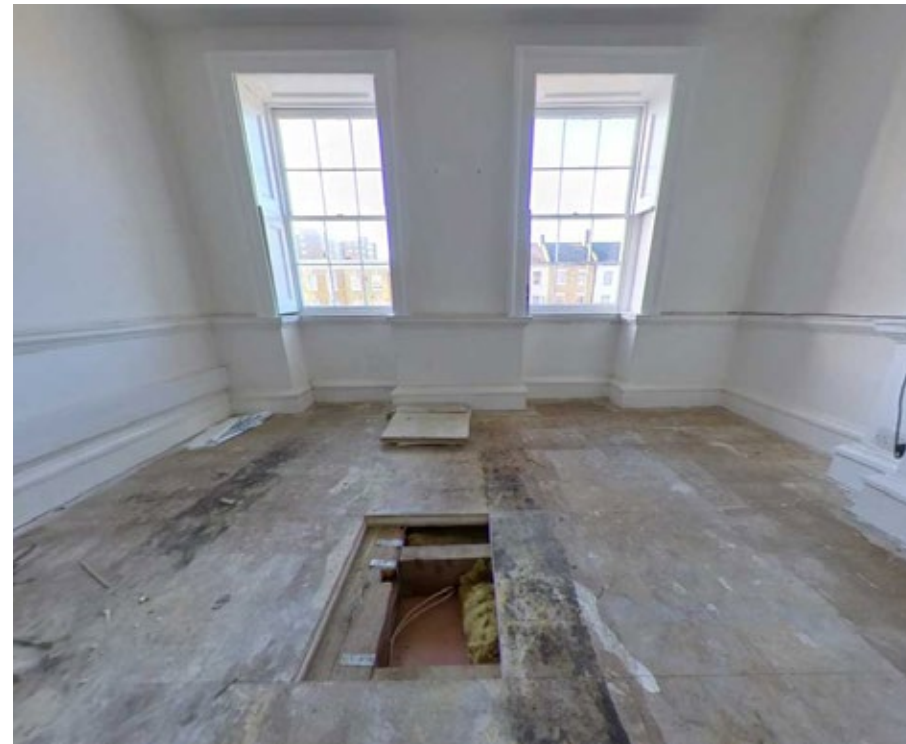
Investigative works were carried out by stripping out modern carpet at and lifting 500×500 mm area of modern finishes to substrate to reveal floorboards. However, following investigative works no evidence of existing floorboards have been found.

**FIGURE 25.** 792-F-04 No Evidence Of Floorboards

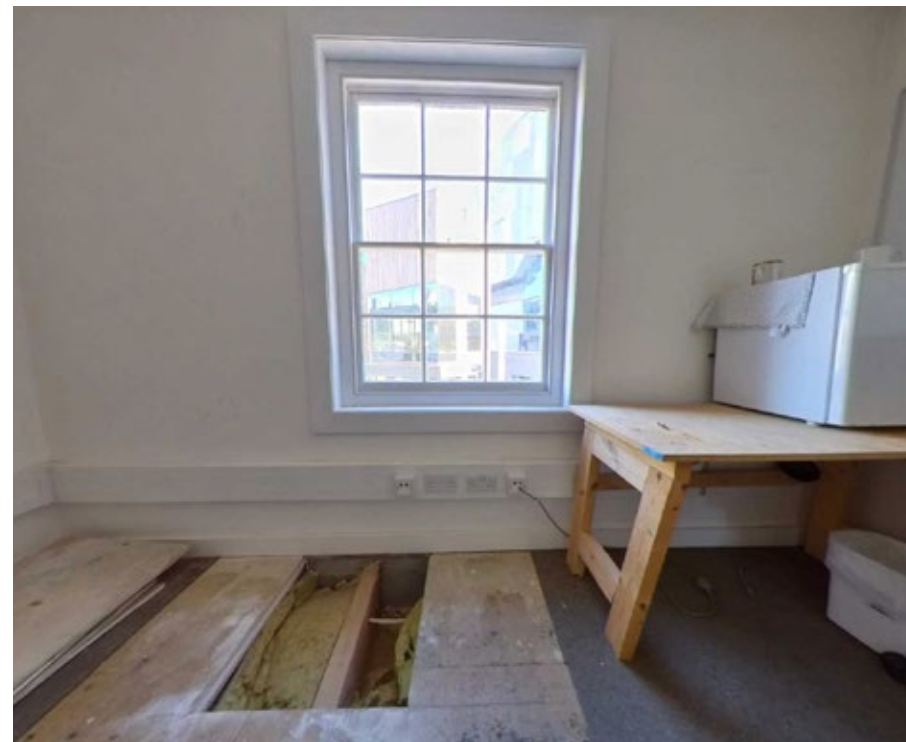
**FIGURE 26.** 792-F-06 No Evidence Of Floorboards

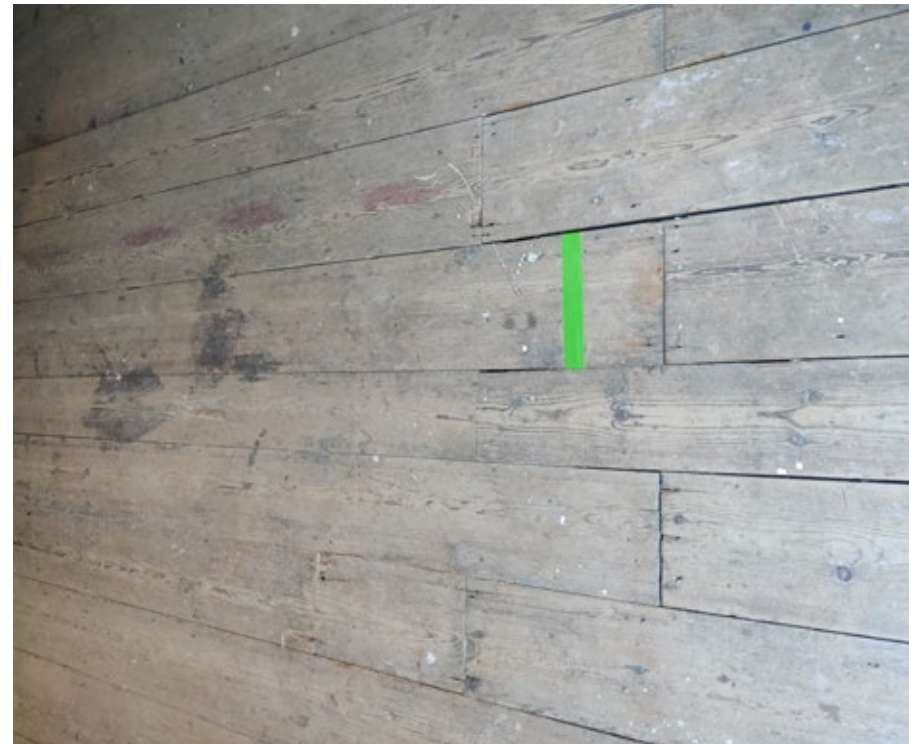
- Existing historic floor boards evident following strip out of modern finishes as part of investigative works.
- Boards are in good condition. Allow for minimal like for like repairs required via the scarfing in of small sections of matching timber or glue sensitively where floorboards appear to be spliced with joints under 20MM wide.
- Note existing paint/adhesive marks : Sensitively use turpentine and allow for surface cleaning by hand scrapping without damaging historic fabric.

**FIGURE 27.** 794-F-03 Existing Floor Finish To Be Retained

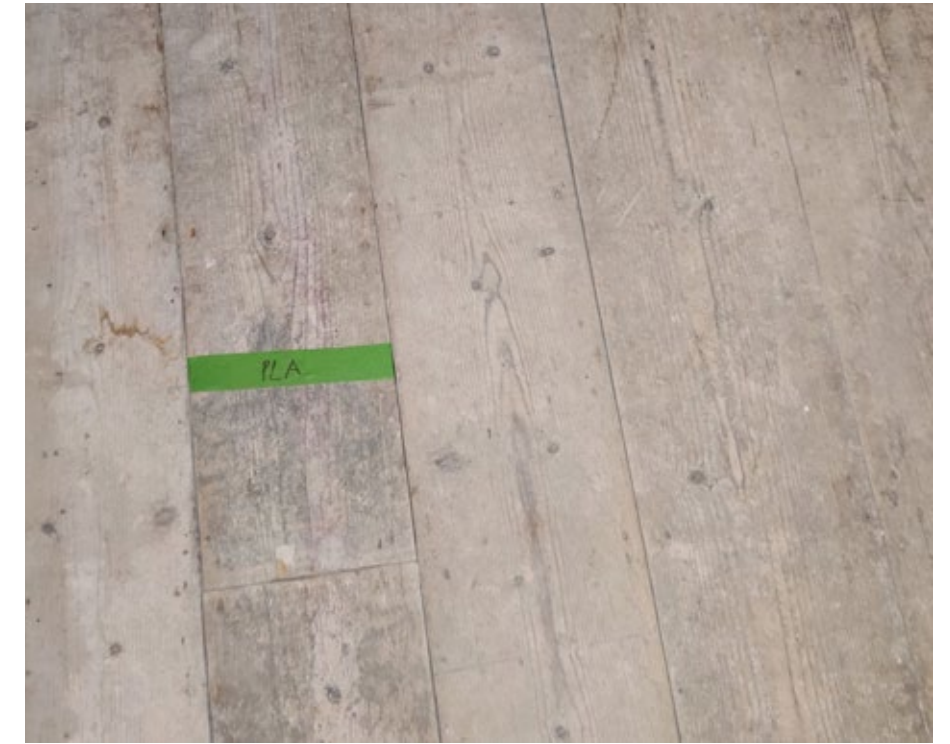
**FIGURE 30.** 794-F-07 Existing Floor Finish To Be Retained

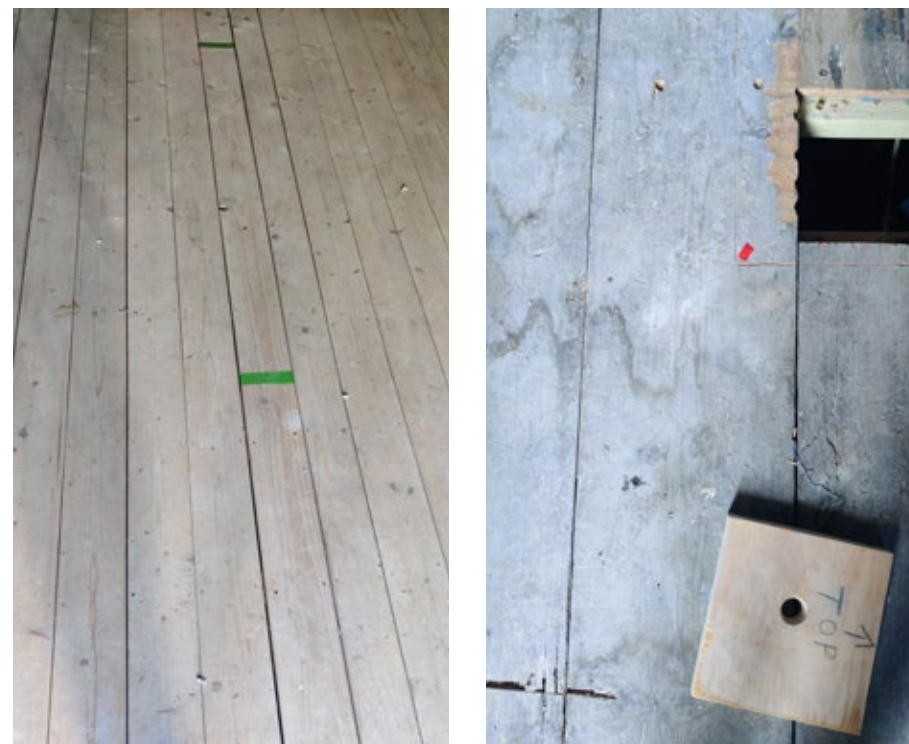
**FIGURE 28.** 794-F-04 Existing Floor Finish To Be Retained

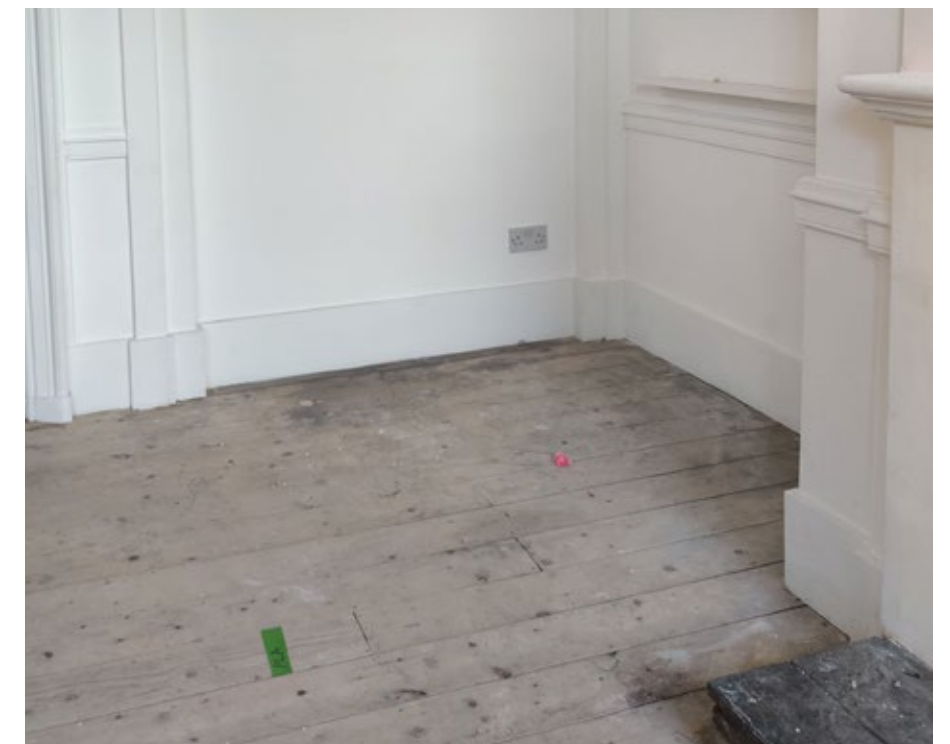
**FIGURE 29.** 794-F-05 Existing Floor Finish To Be Retained

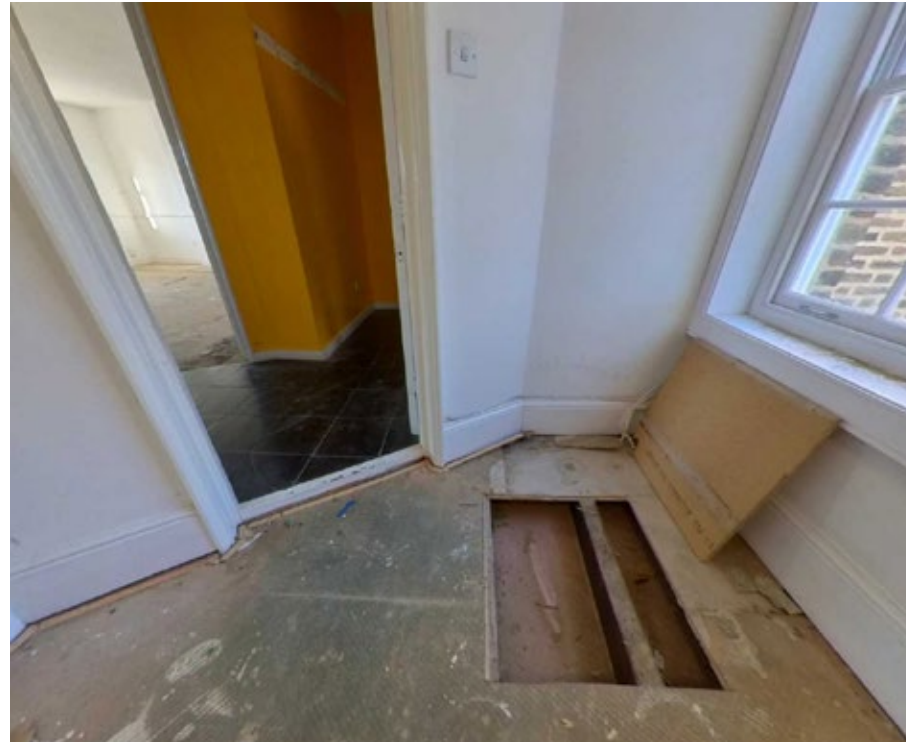
Investigative works were carried out by stripping out modern carpet at and lifting 500×500 mm area of modern finishes to substrate to reveal floorboards. However, following investigative works no evidence of existing floorboards have been found.

**FIGURE 31.** 792-S-01 No Evidence Of Floorboards

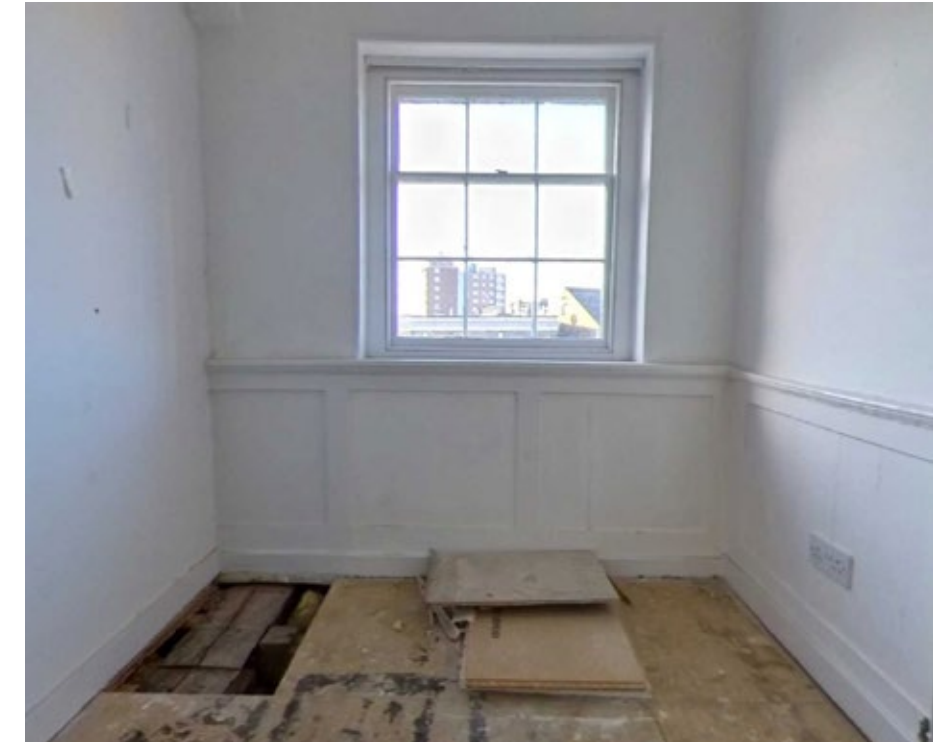
**FIGURE 33.** 792-S-05 No Evidence Of Floorboards

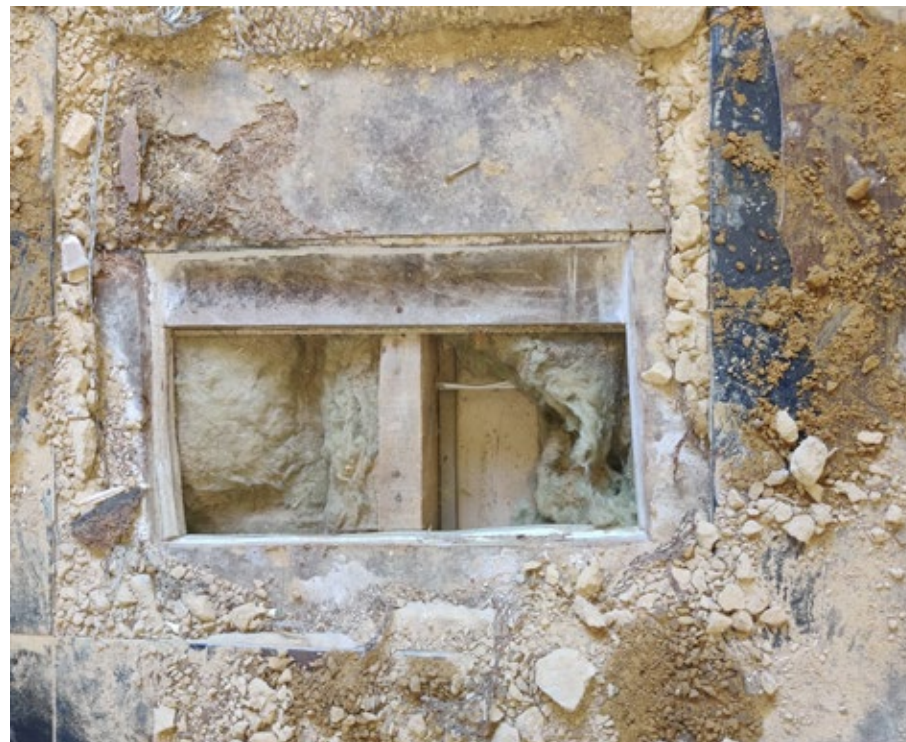
**FIGURE 32.** 792-S-02 No Evidence Of Floorboards

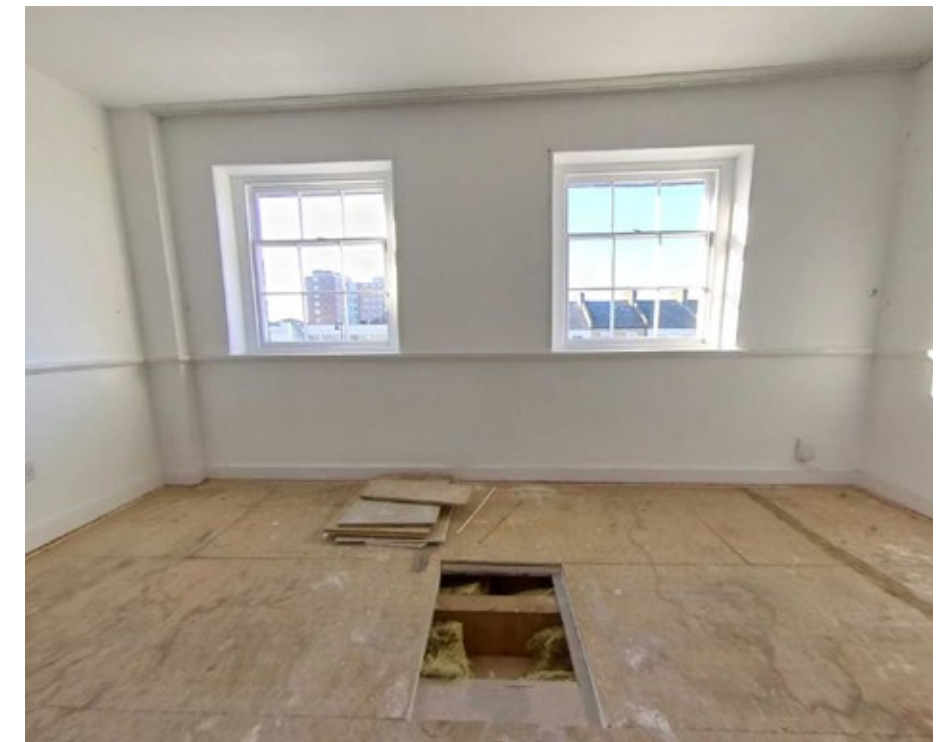
**FIGURE 34.** 792-S-04 No Evidence Of Floorboards

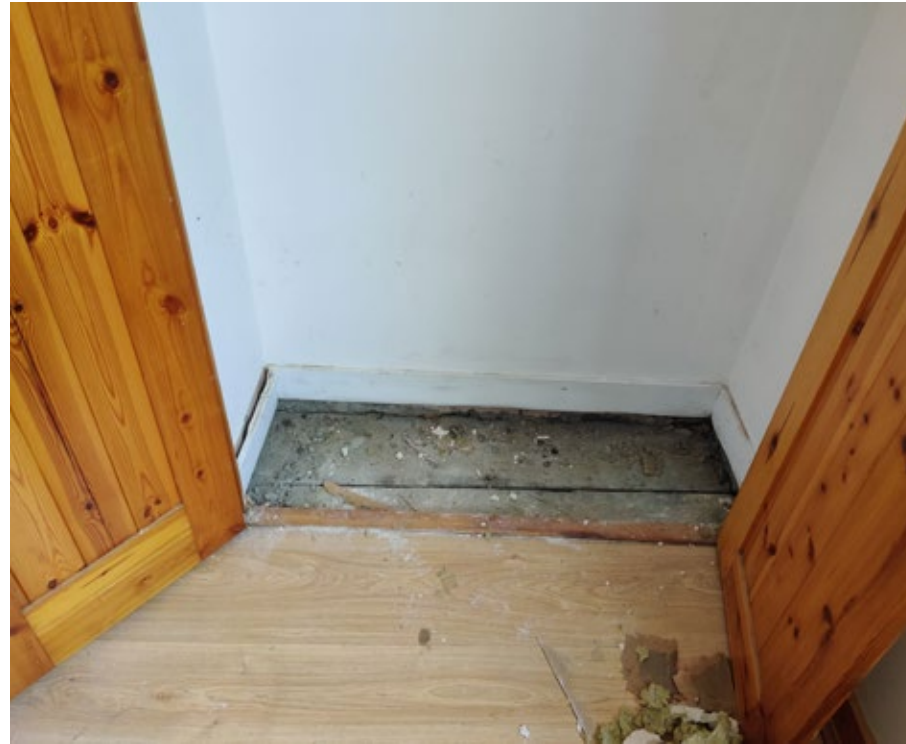
- Investigative works were carried out by stripping out 500×500 mm of modern vinyl finish to reveal floorboards. Existing historic floor boards evident following strip out of modern finishes.
- Boards are in good condition. Allow for minimal like for like repairs required via the scarfing in of small sections of matching timber or glue sensitively where floorboards appear to be spliced with joints under 20MM wide.
- Note existing paint/adhesive marks : Sensitively use turpentine and allow for surface cleaning by hand scrapping without damaging historic fabric.

**FIGURE 35.** 794-S-03 Existing Floor Finish To Be Retained

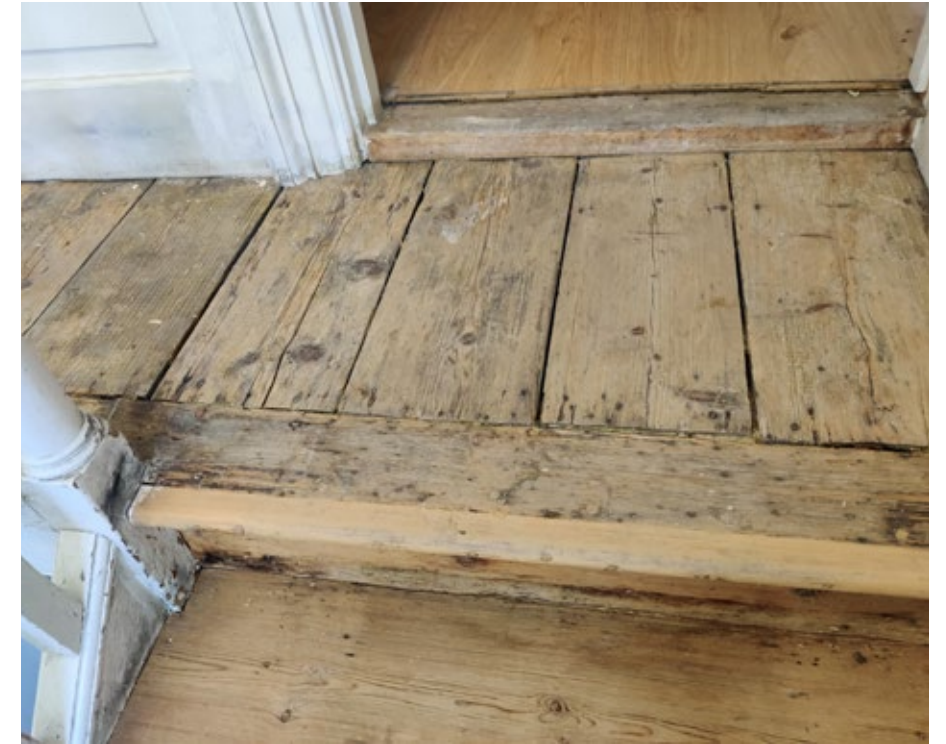
**FIGURE 36.** 794-S-01 Existing Floor Finish To Be Retained

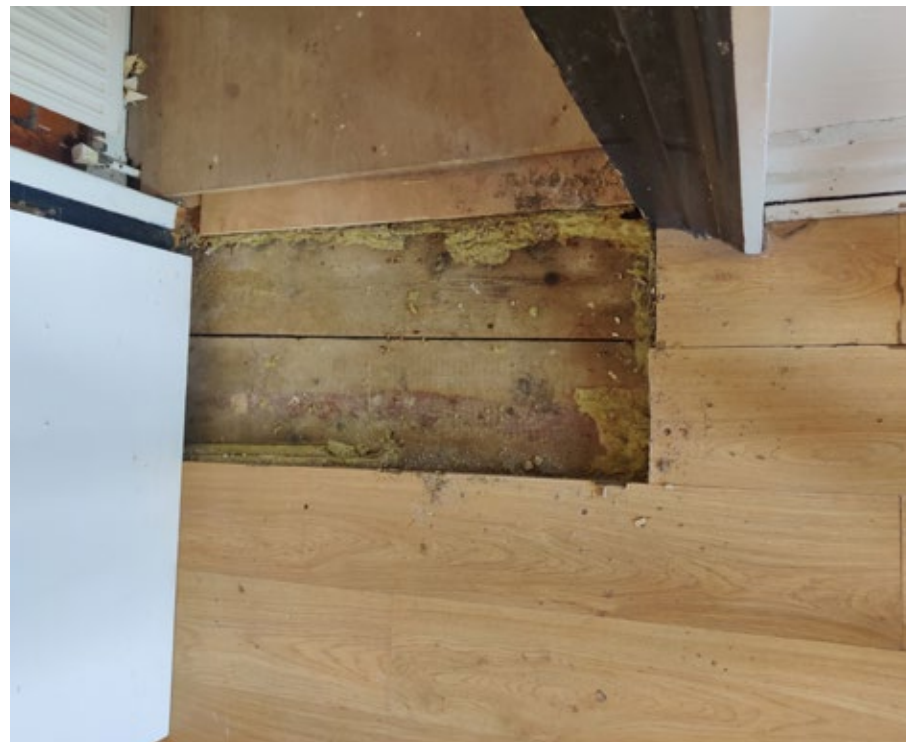
**FIGURE 37.** 794-S-04 Existing Floor Finish To Be Retained

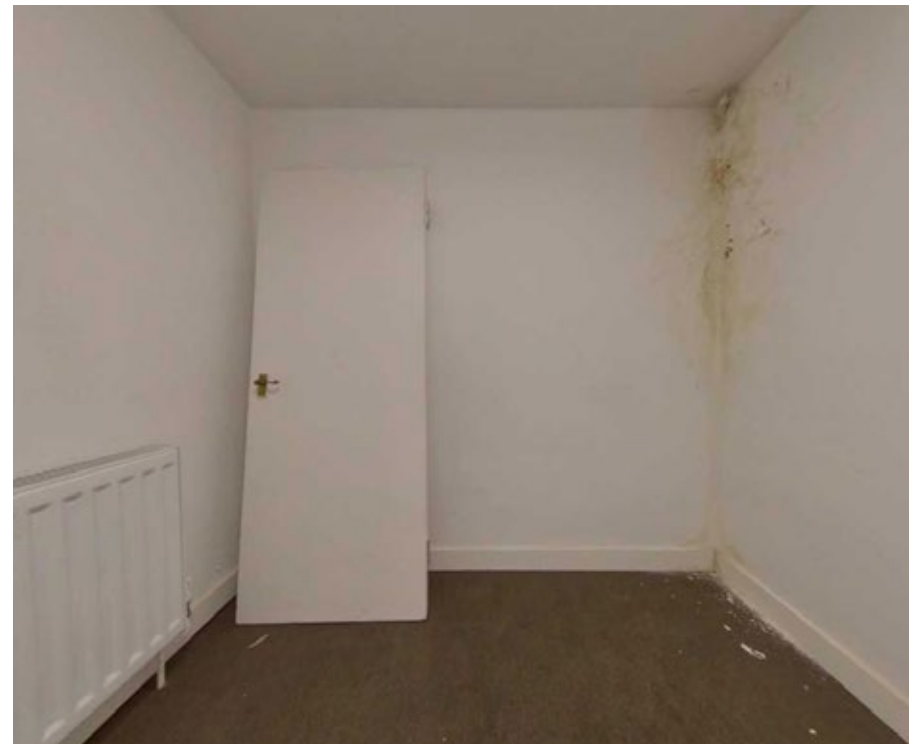
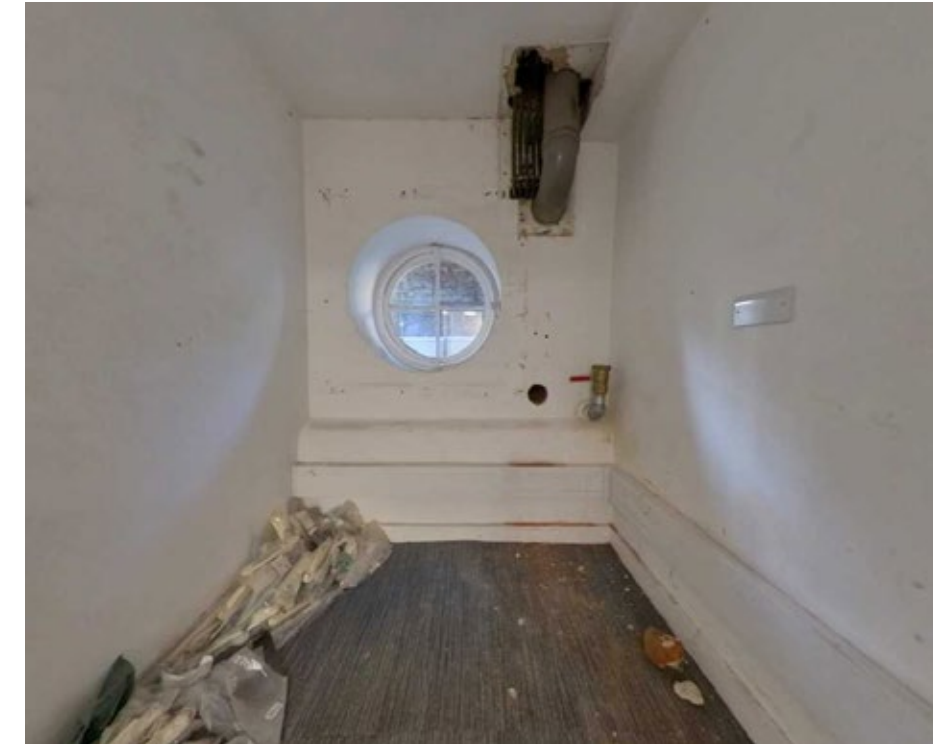
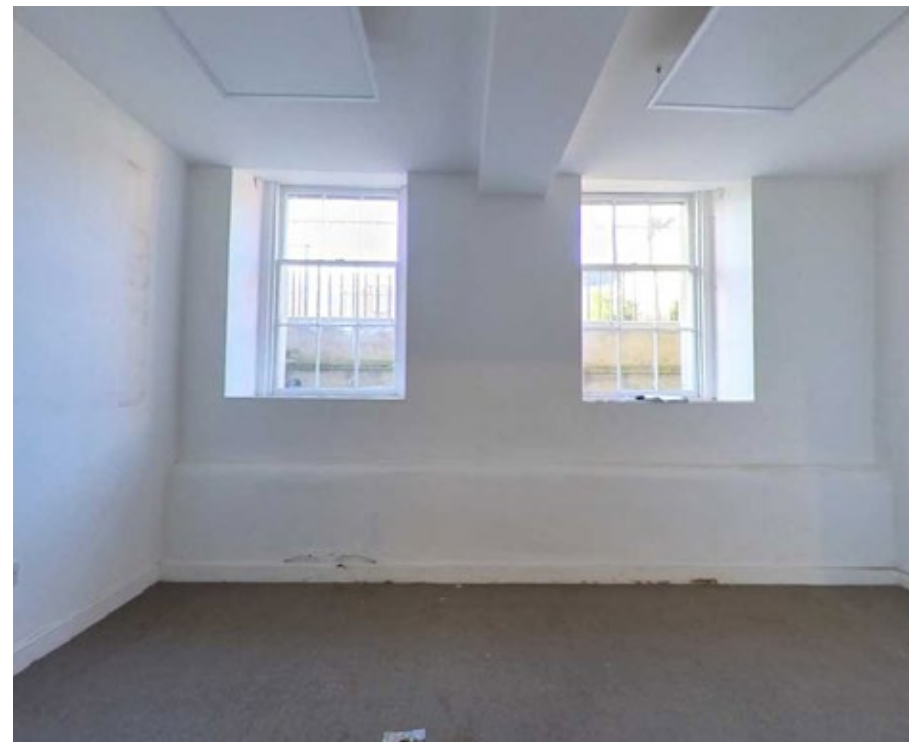
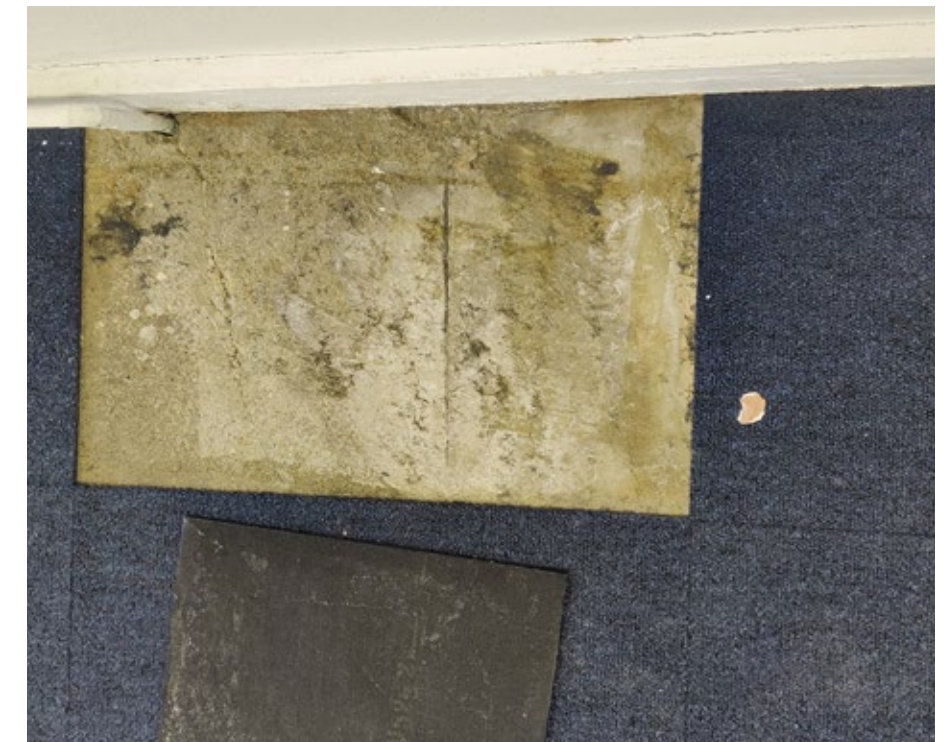
Following investigative works no evidence of historic flagstones found.

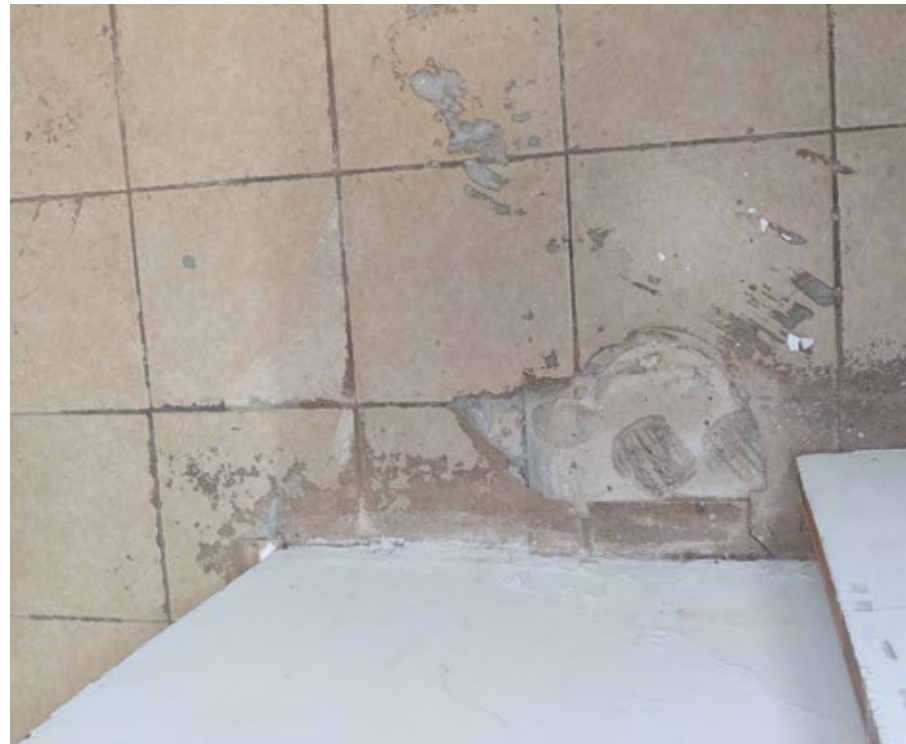
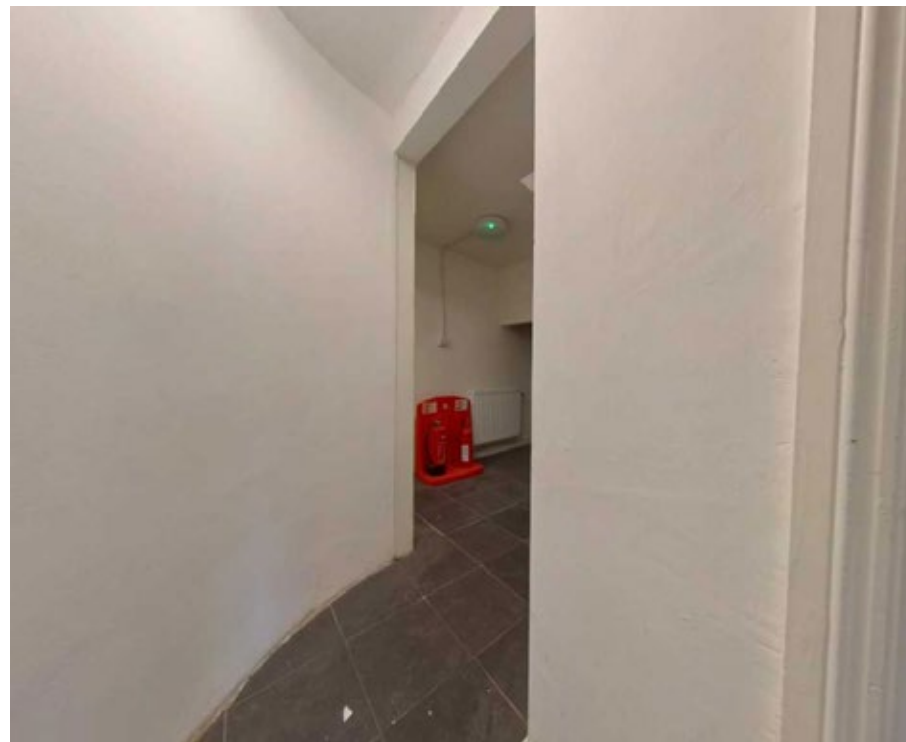
Following investigative works no evidence of historic flagstones found.

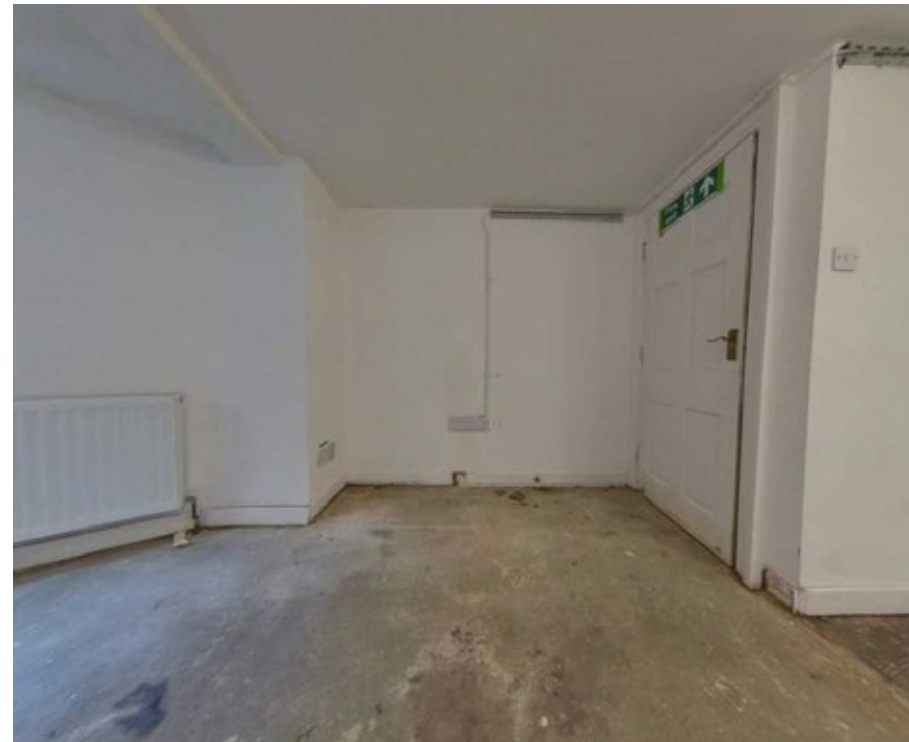
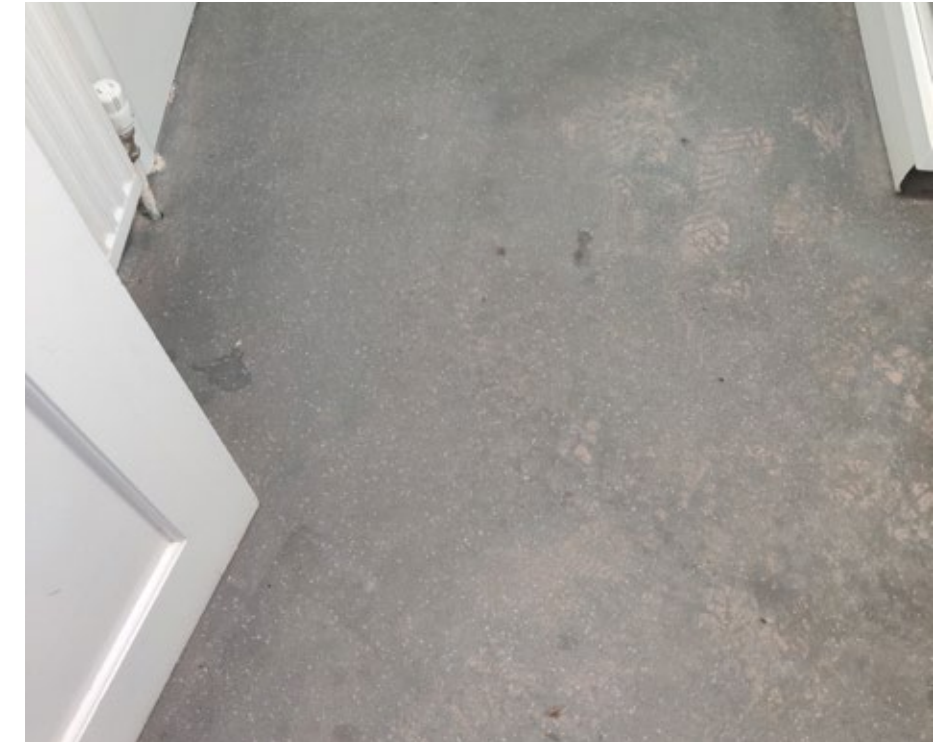
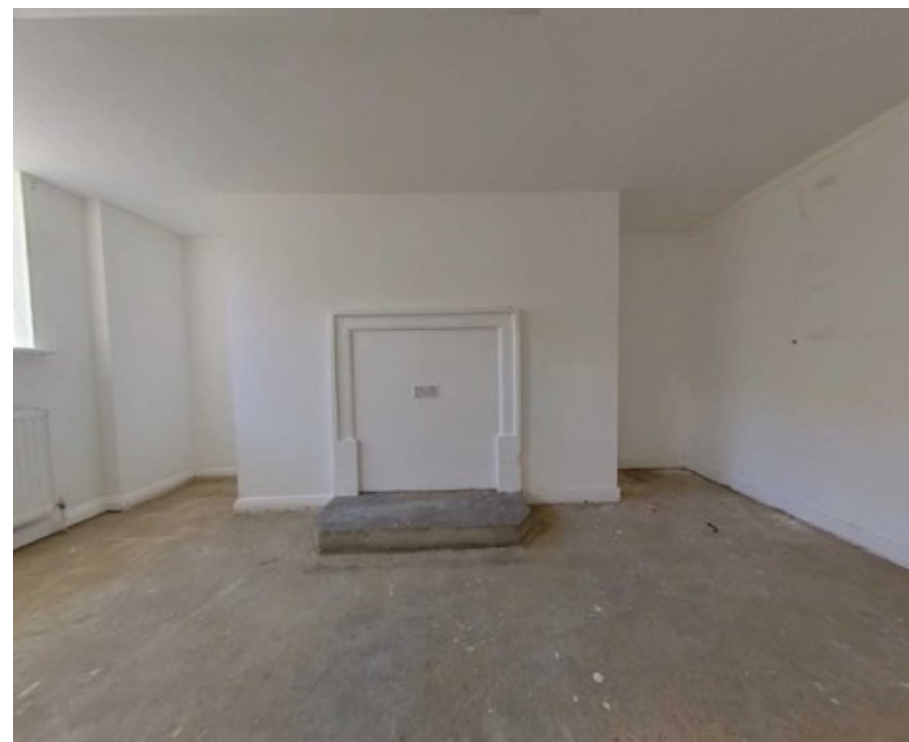
Following investigative works no evidence of historic flagstones found.

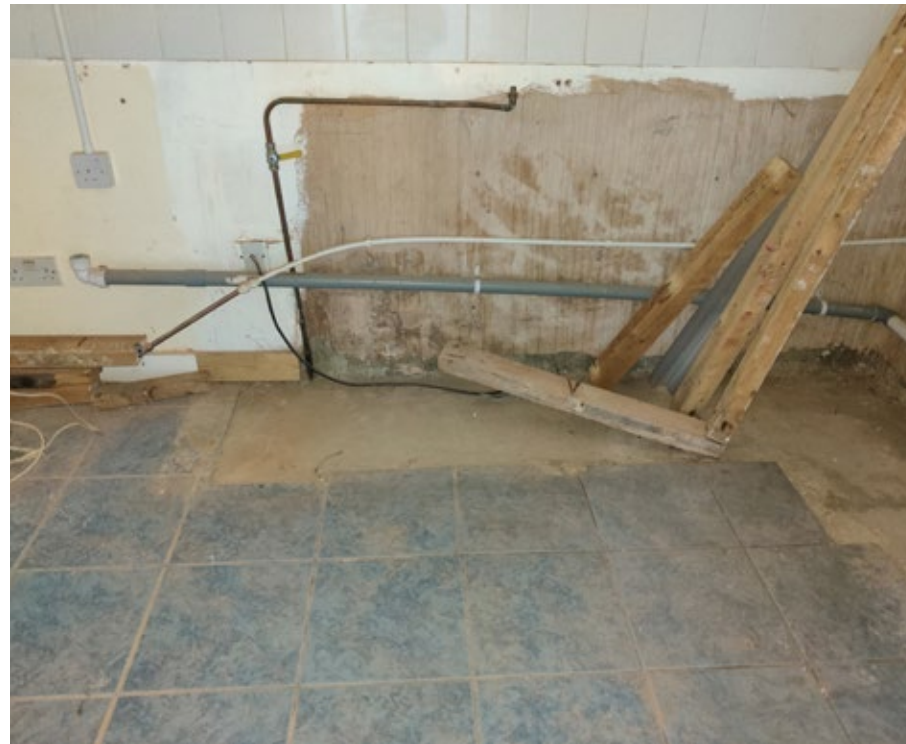
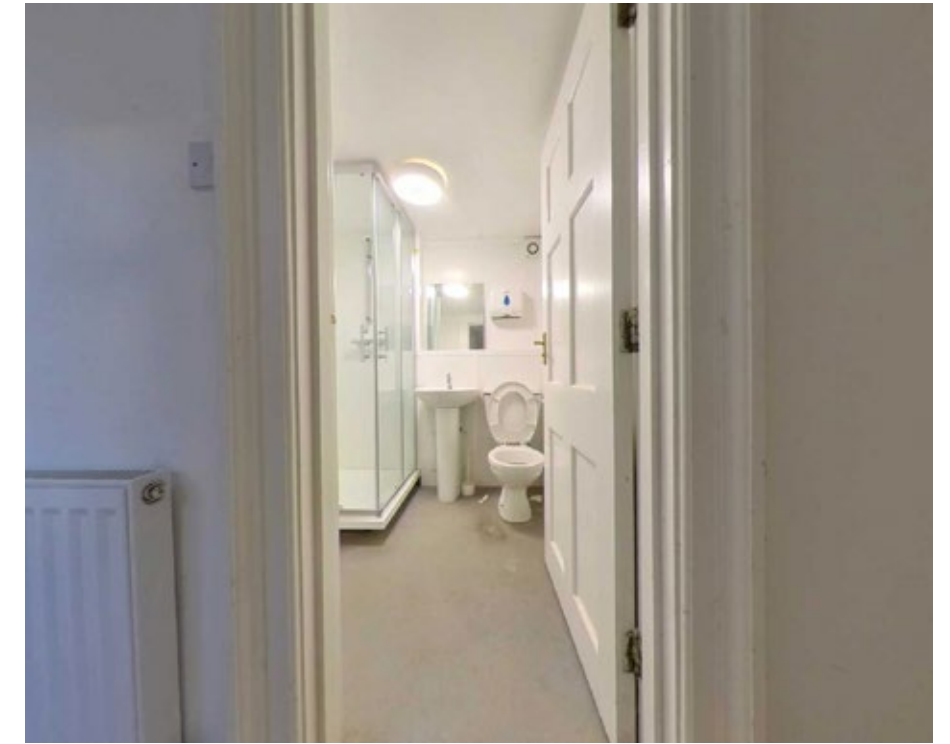
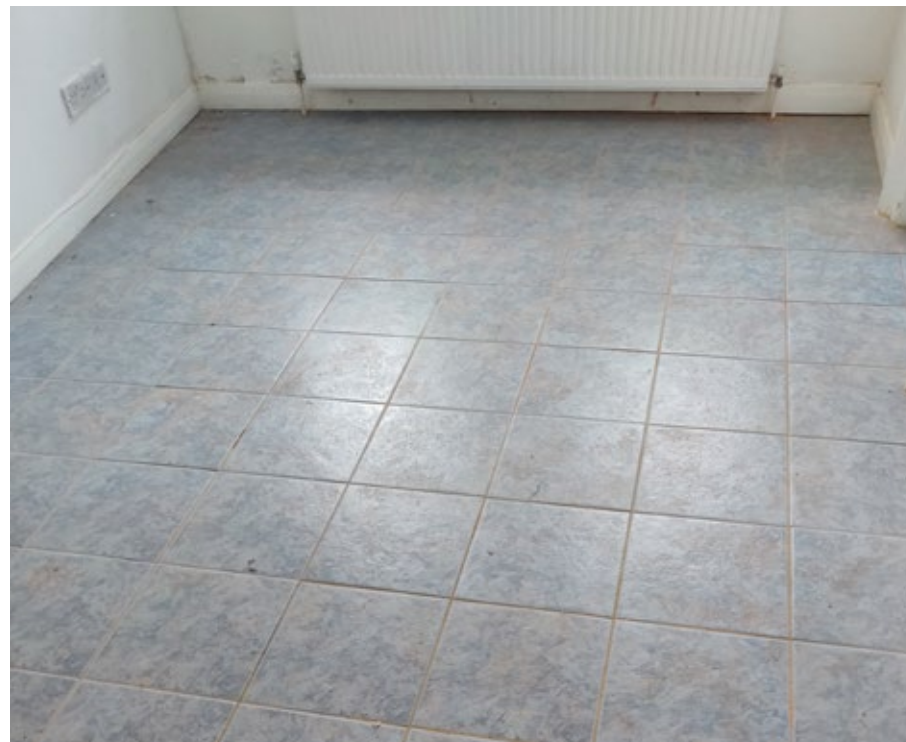
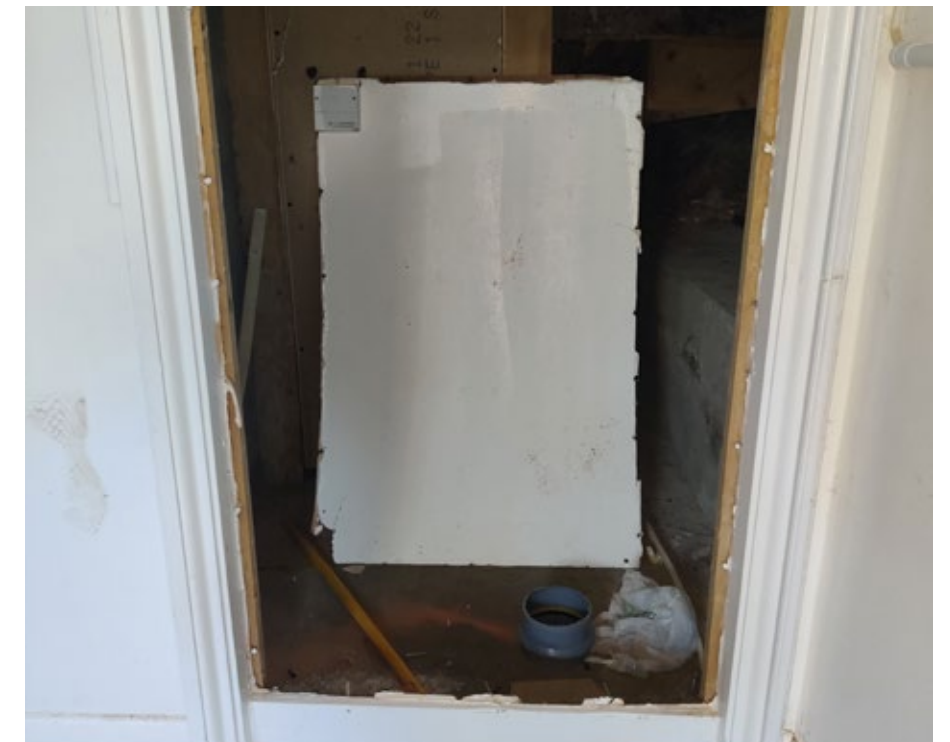
Local investigative works were carried out by stripping out modern fabric to the existing cupboard and in the kitchen at the west and southwest front rooms at the basement floor in No. 974.

Following investigative works no evidence of historic flagstones found.
