# Nos. 792-794 **HIGH ROAD**

RESPONSE TO LISTED BUILDING CONSENT APPLICATION  
PART CONDITION DISCHARGE

SUPPORTING INFORMATION RELATING TO NOS. 792-794 HIGH ROAD  
LISTED BUILDING APPLICATION REFERENCE : HGY/2022/1659

NOVEMBER 2022

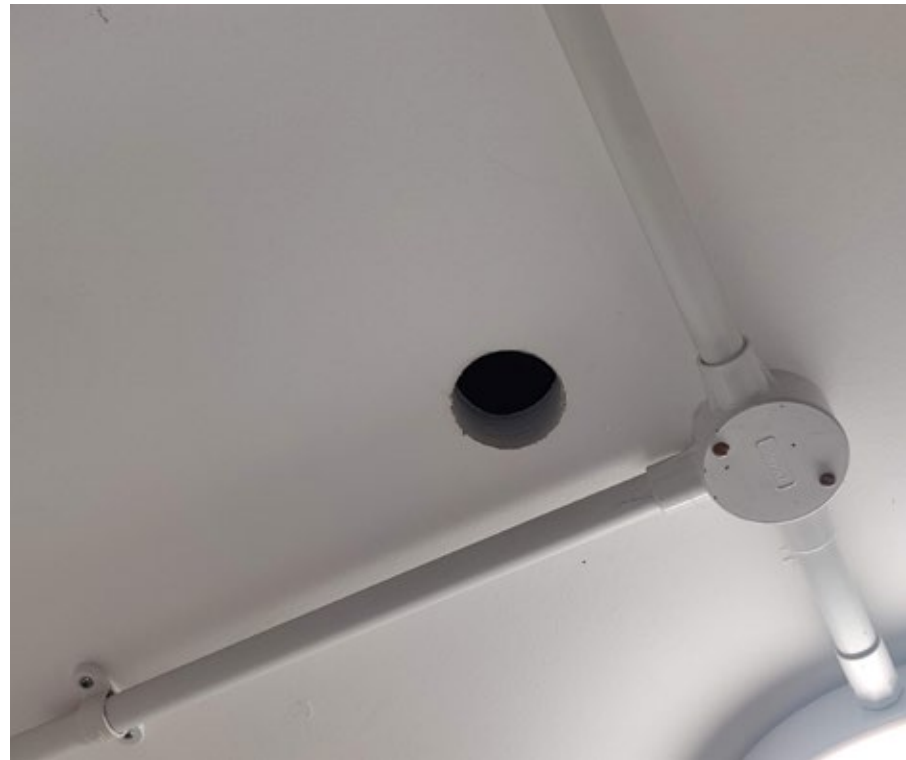
**FIGURE 1.** 50MM Core Hole

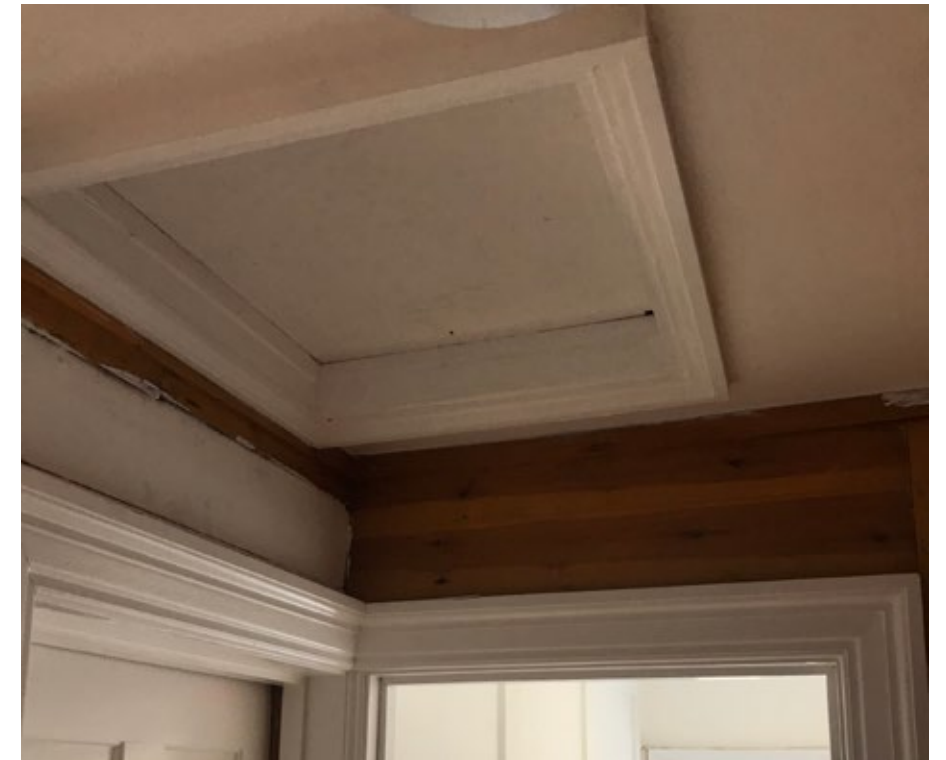
**FIGURE 2.** Existing Loft Hatch

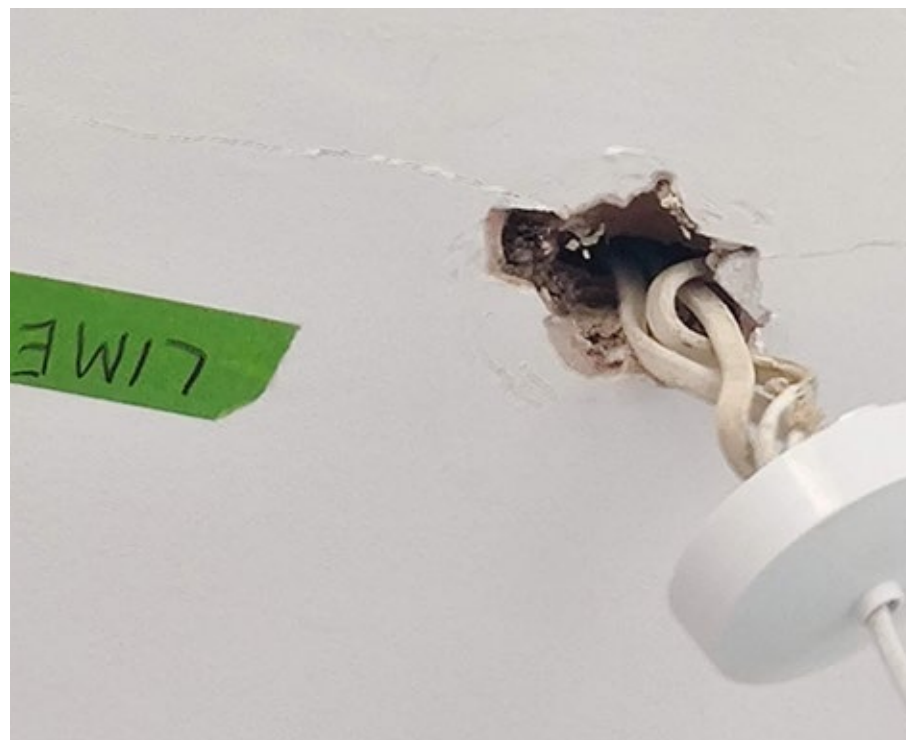
**FIGURE 3.** Existing Service Penetration

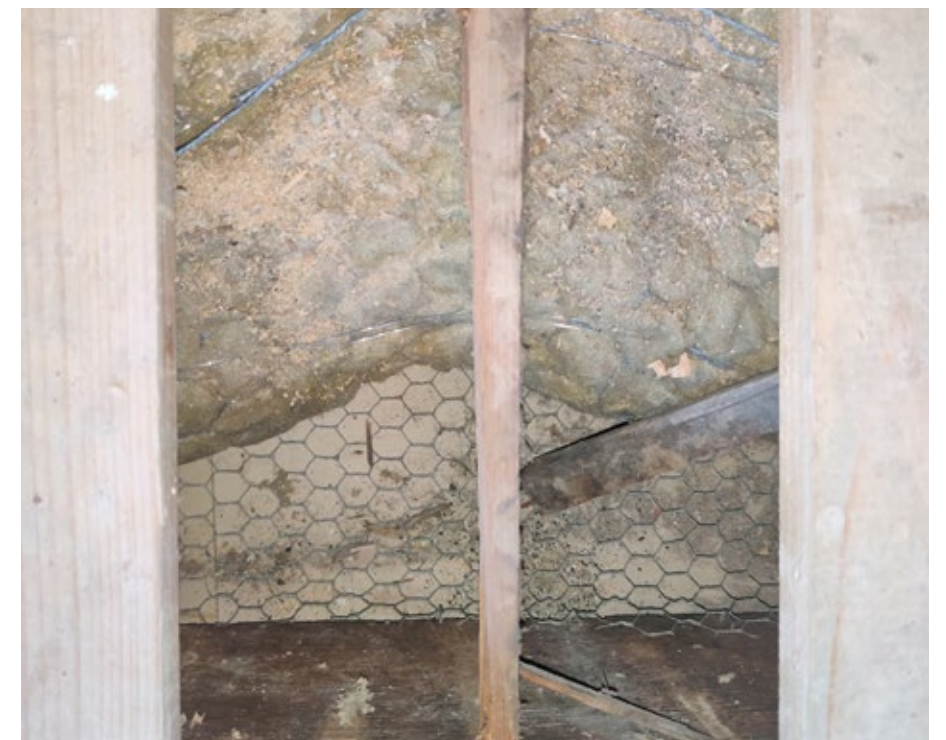
**FIGURE 4.** Existing Floor Boards Lifted

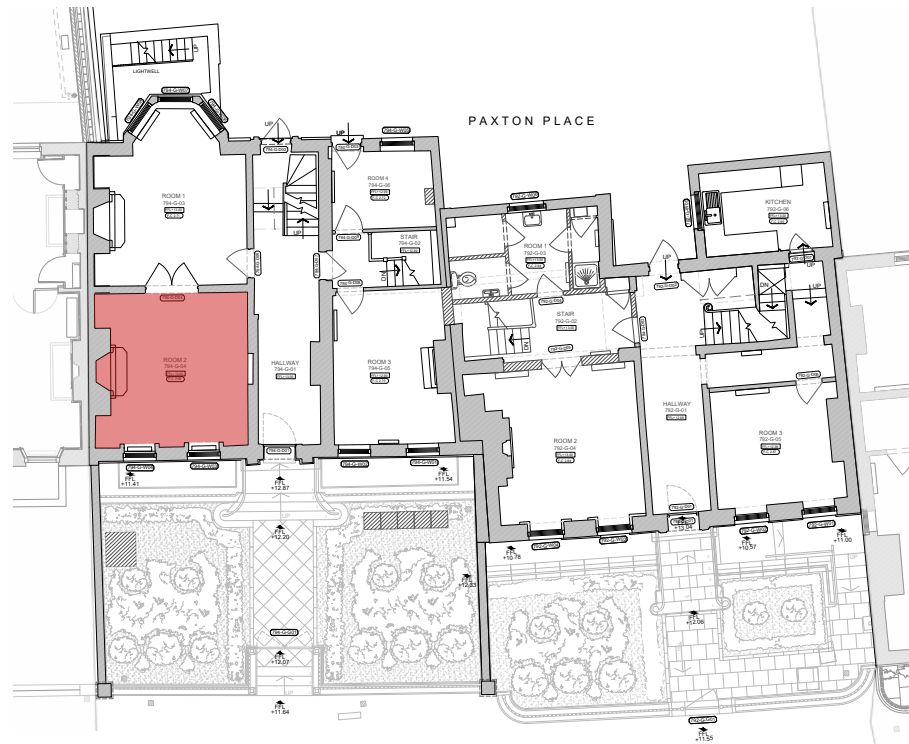
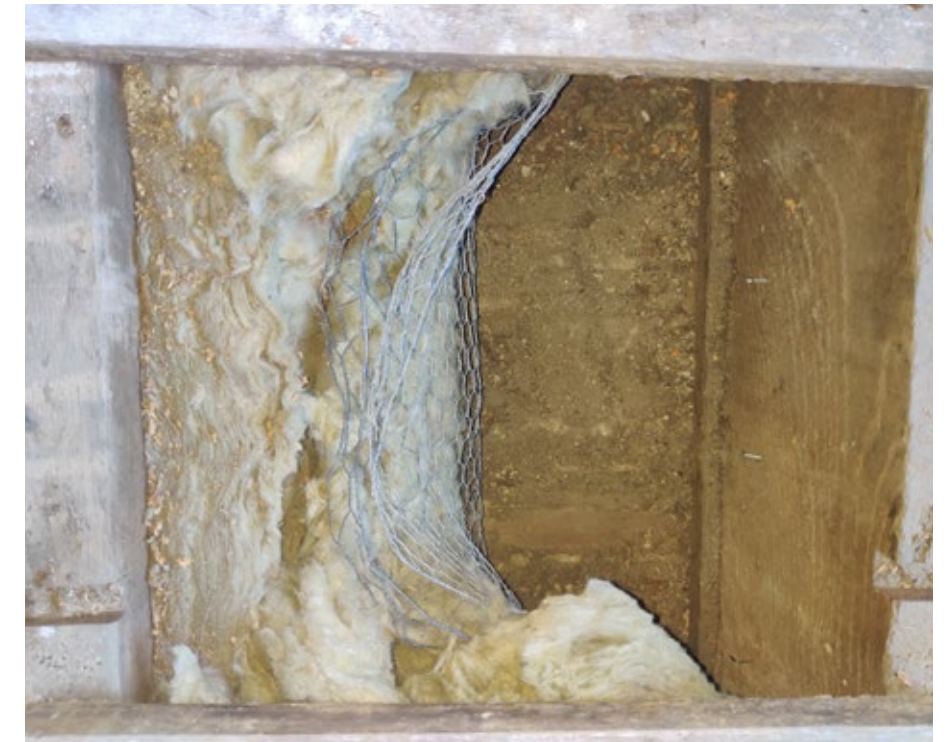
**FIGURE 9.** Existing Ground Floor Key Plan Showing Location

- **ROOM 2 : 794-G-04** - At ground, the ceiling was found to be in good condition with no further works required, decoration only.
- **ROOM 3 : 794-F-05** - At first, a crack emanates from the central ceiling rose and will be repaired using like for like materials and suitable methods, by a specialist contractor.

**FIGURE 11.** Lathe And Plaster Visible Through Historic Floor Boards On The First Floor Room Above

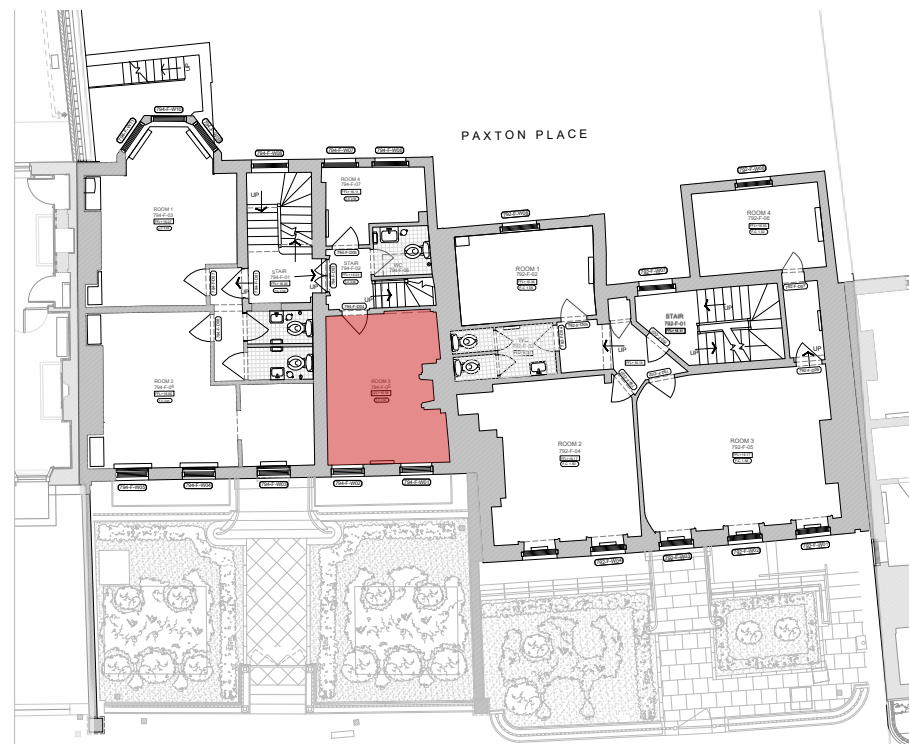
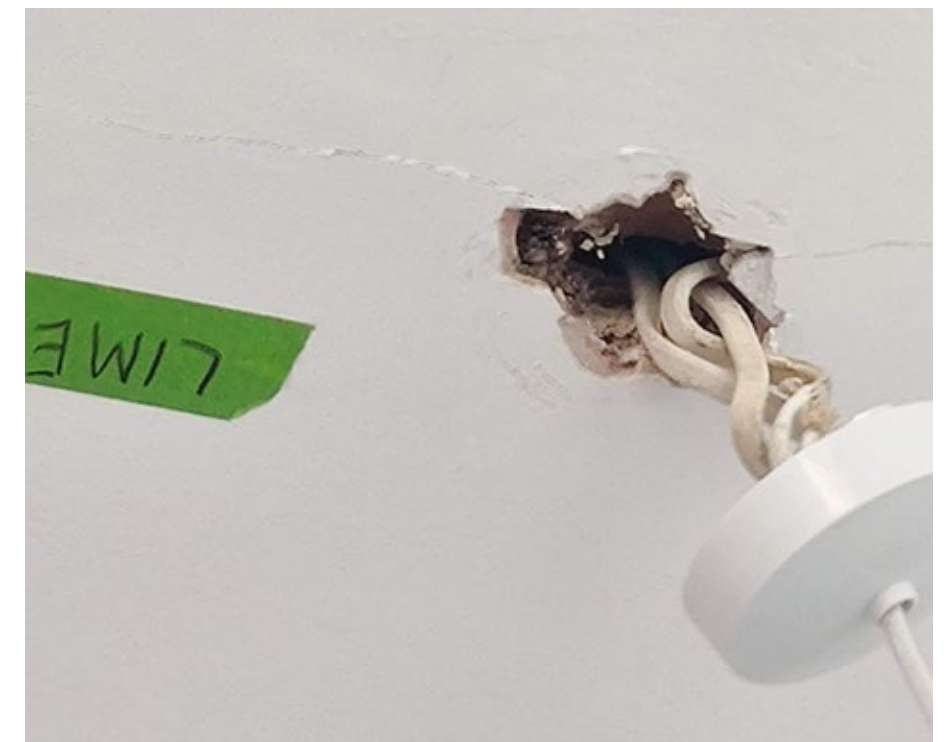
**FIGURE 10.** Existing First Floor Key Plan Showing Location

**FIGURE 12.** Lathe And Plaster Visible Through Existing Penetration

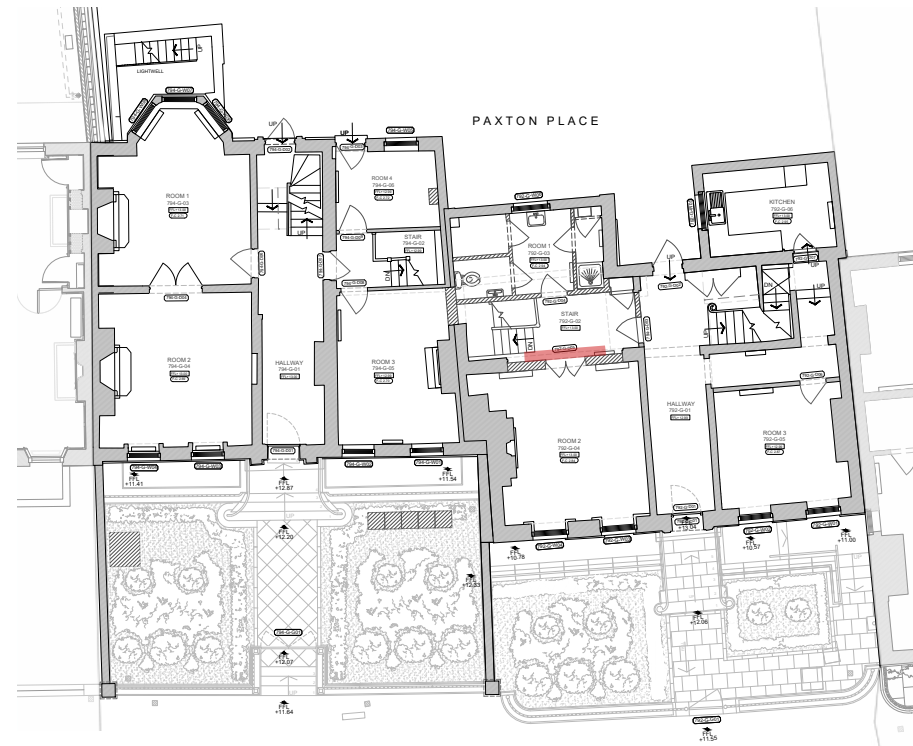
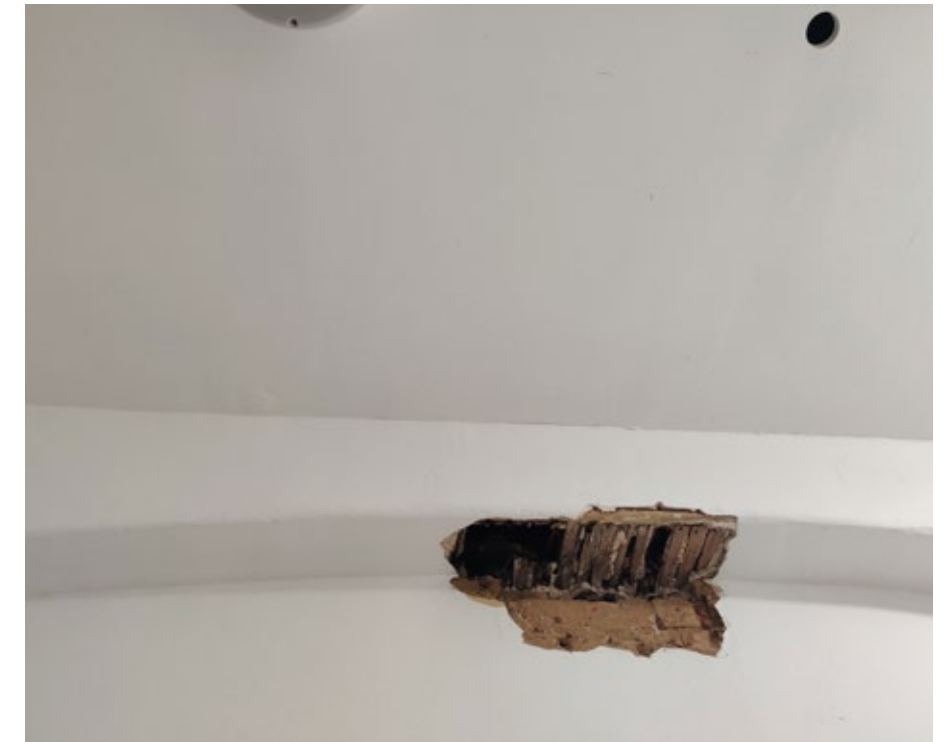
**FIGURE 13.** Existing Ground Floor Key Plan Showing Location

- **STAIR : 792-G-02** - To the west of ground floor lobby, the ceiling was found to be in poor condition requiring further repair works and decoration.

**FIGURE 14.** Lathe And Plaster Visible Through existing void in the ceiling

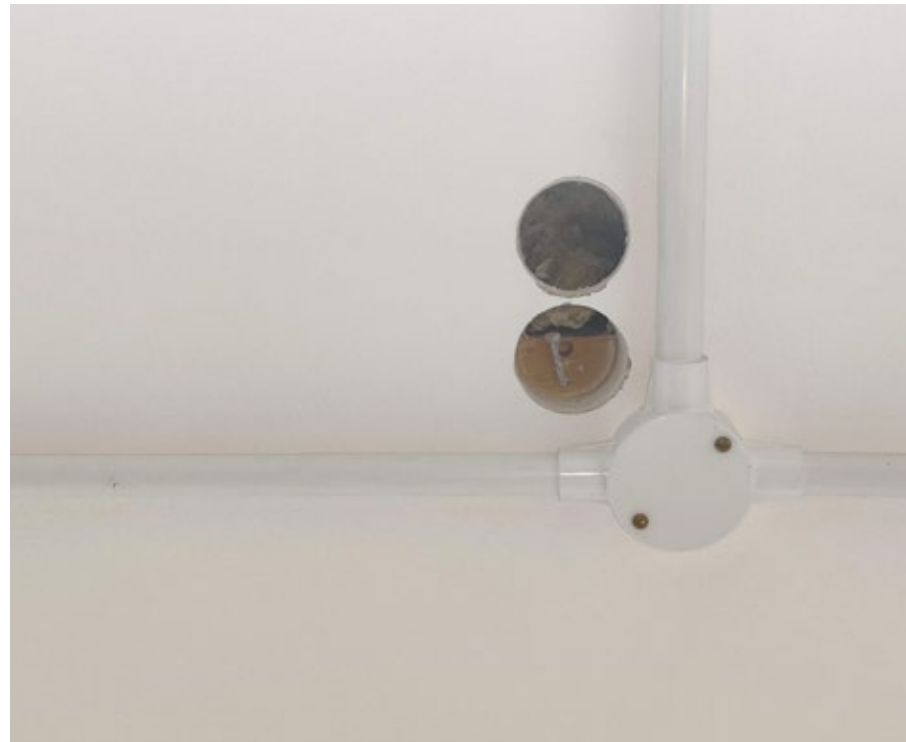
**FIGURE 15.** 794-B-05 Double Plasterboard Visible Through Investigative Core Hole Within The Ceiling

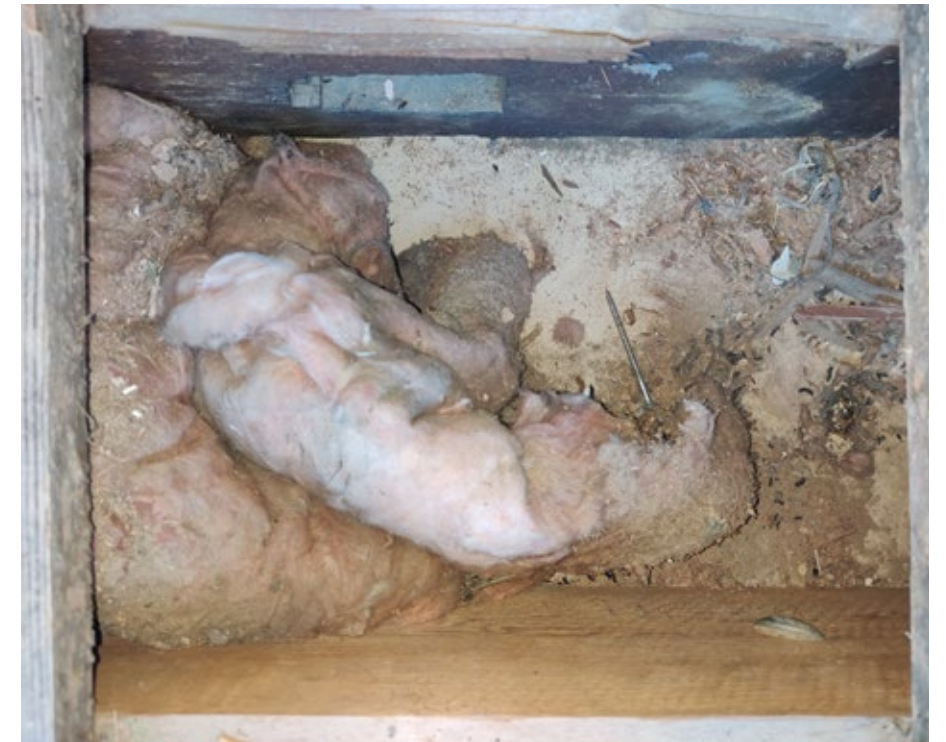
**FIGURE 17.** 794-G-05 Plasterboard Visible Through The First Floor Room Above

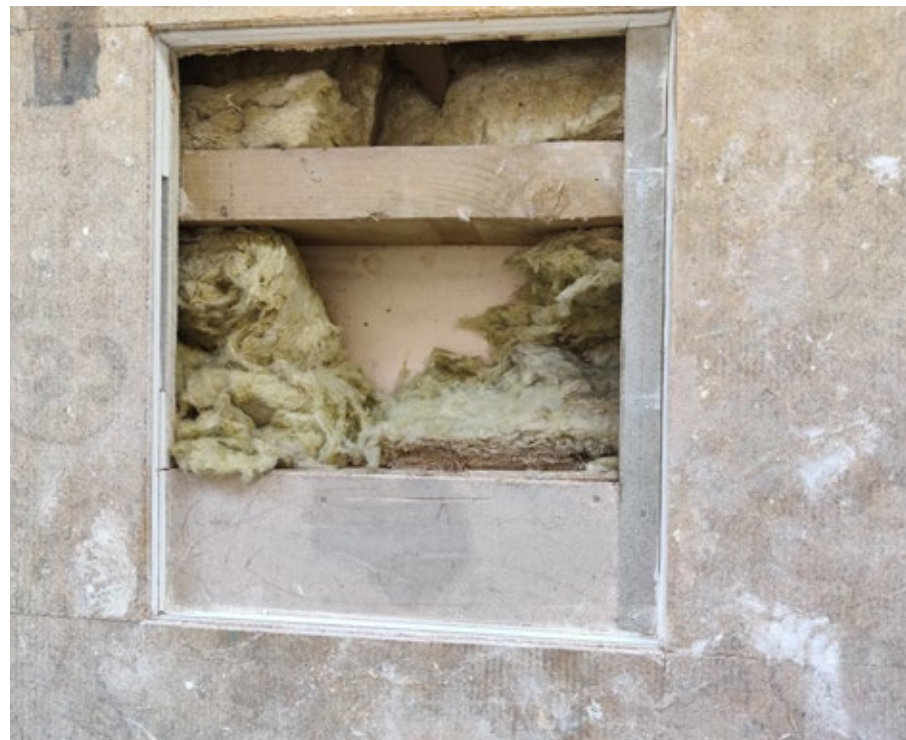
**FIGURE 16.** 792-G-04 Plasterboard Visible Through The First Floor Room Above

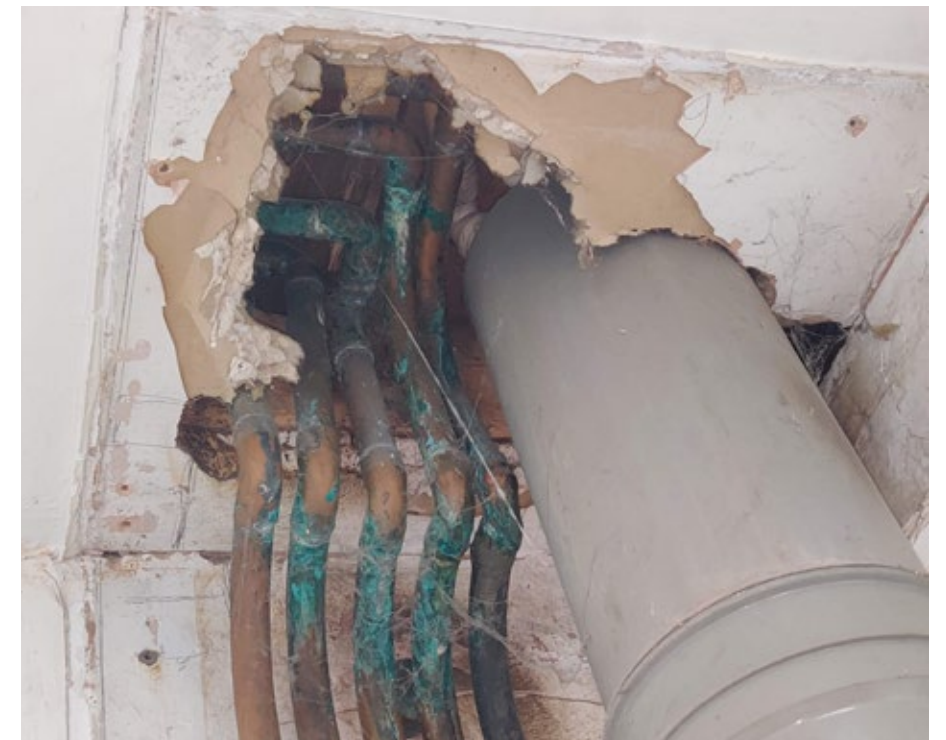
**FIGURE 18.** 792-B-05 Plasterboard Evidently Visible Through Existing Services Opening
