# TREE CONDITION SURVEY AND MANAGEMENT WORK RECOMMENDATIONS

BUTLERS TREES LTD

Tree Condition survey and  
Management Work Recommendations  
For  
Haddon Few Montuschi Architects Limited  
New Acre Limited acting as Agent

| Survey Site Address | The Mall Wood Green - existing tree on Mayes Road - service yard 6 |

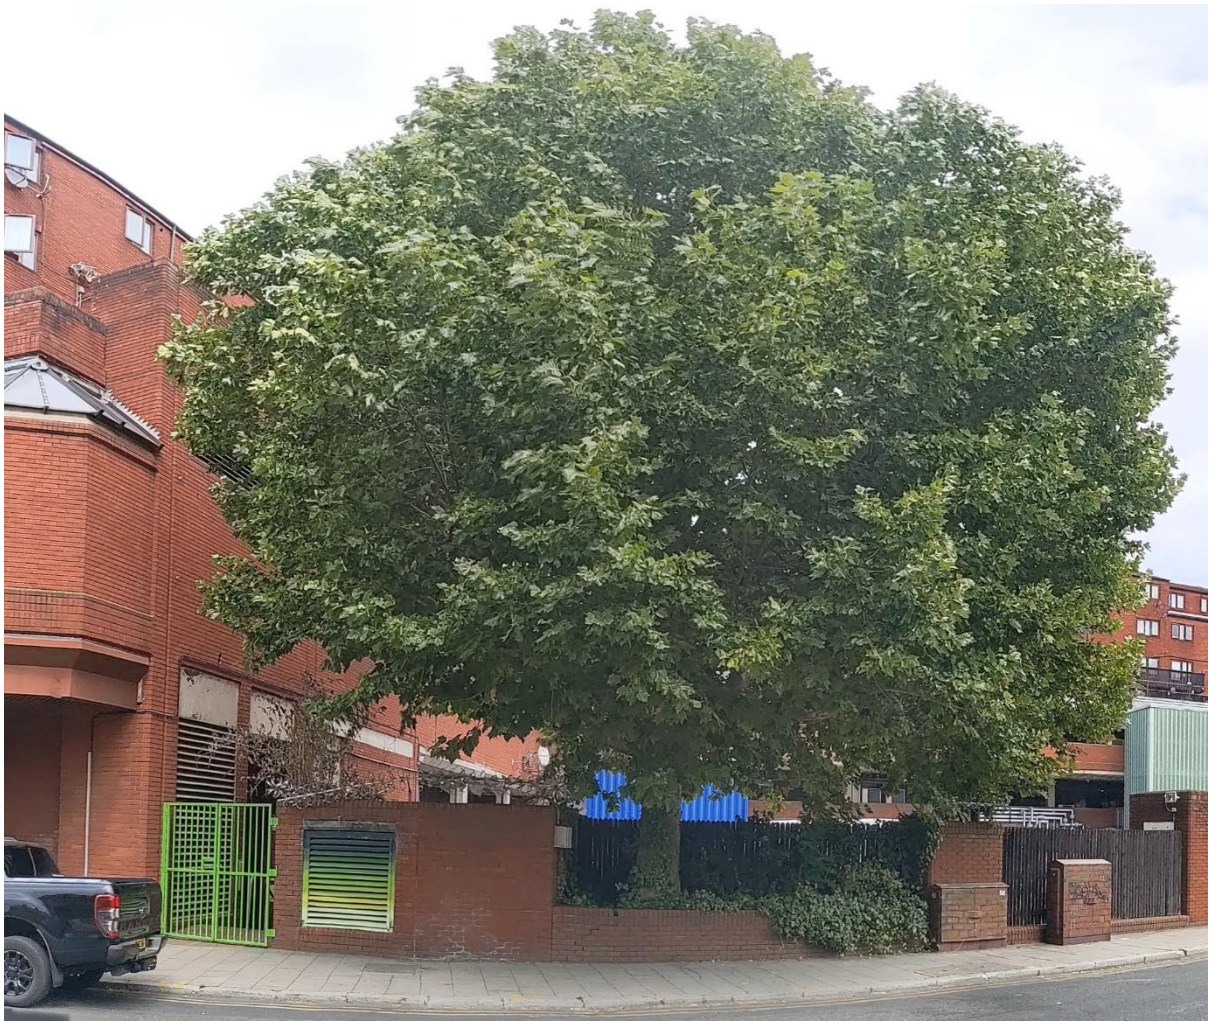
**T1**

- 6.1. The one tree identified by the client on The Mall site, T1, shows no signs of disease or decay from ground level. A Massaria disease (*Splanchnonema platani*) check should be carried when work is undertaken as this infection can only be seen from above major branches and limbs.

The tree has a clear pollard cycle, with the most recent appearing to have been carried out in the last 2-3 years. Re-pollarding should be undertaken on this species of tree every 2-3 years due to their quick growing nature. Ideally, any work to a London plane should be undertaken in winter months due to the small hairy catkins on their branches that can be found during the rest of the year. London Plane is the most common tree throughout London and one of the most commonly pollarded trees.

| Tree No. | Species | Age | Stem | | Height (m) | Crown (m) | | | Physio-logical Condition | Structural condition | | Recommendations and comments | Category, Life Expectancy, Work completion date |
|---|---|---|---|---|---|---|---|---|---|---|---|---|---|
| T1 | London Plane | SM | 1 | 670 | 15.5 | N<br>E<br>S<br>W | 9<br>9<br>8<br>9 | 3<br>4<br>2<br>3 | G | C<br>S<br>B | G<br>G<br>G | Has been previously pollarded approx. 2-3 years ago. Due for a re-pollard.<br>South/west retaining wall adjacent to pavement has possible subsidence movement or root system is pushing the wall out from growth. Keeping it to size will reduce and potentially eliminate subsidence if routine maintenance is kept up to date.<br>Massaria check while work is being undertaken. | B3<br>20+<br><1yr |

- 6.2. The tree appears due for a re-pollard. While this is being undertaken, a Massaria disease check should be undertaken as well.
- 6.3. All works should be carried out as per the recommendations in BS3998 Tree work – 2011.

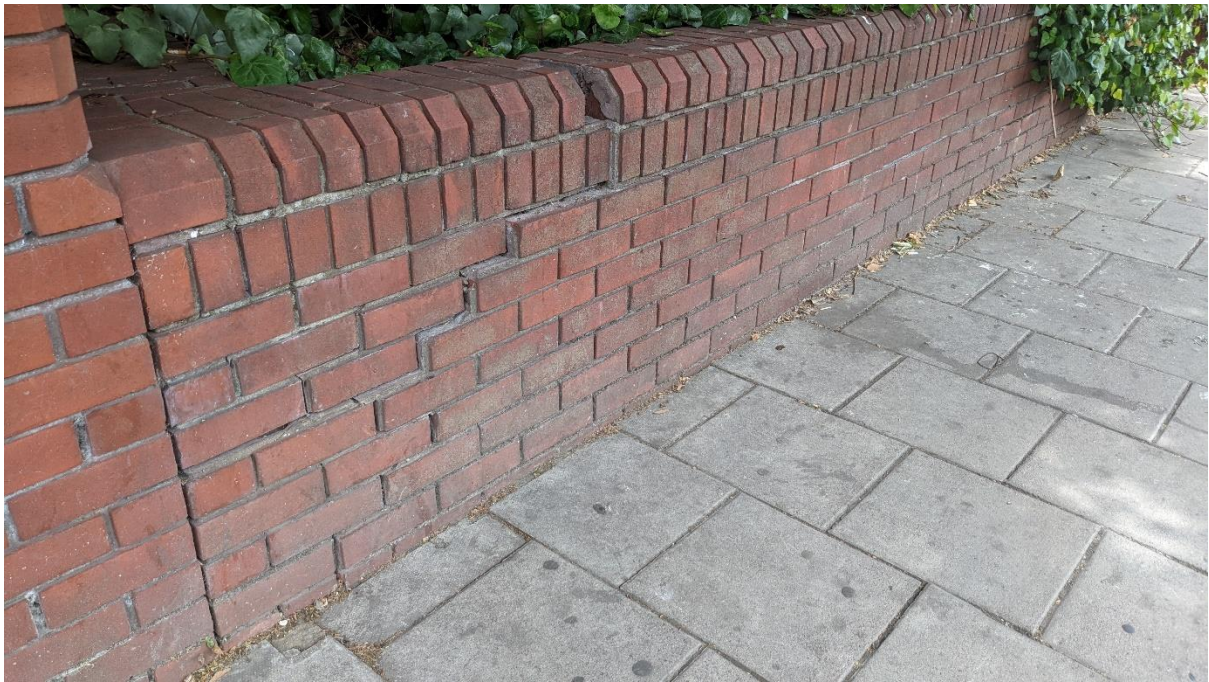
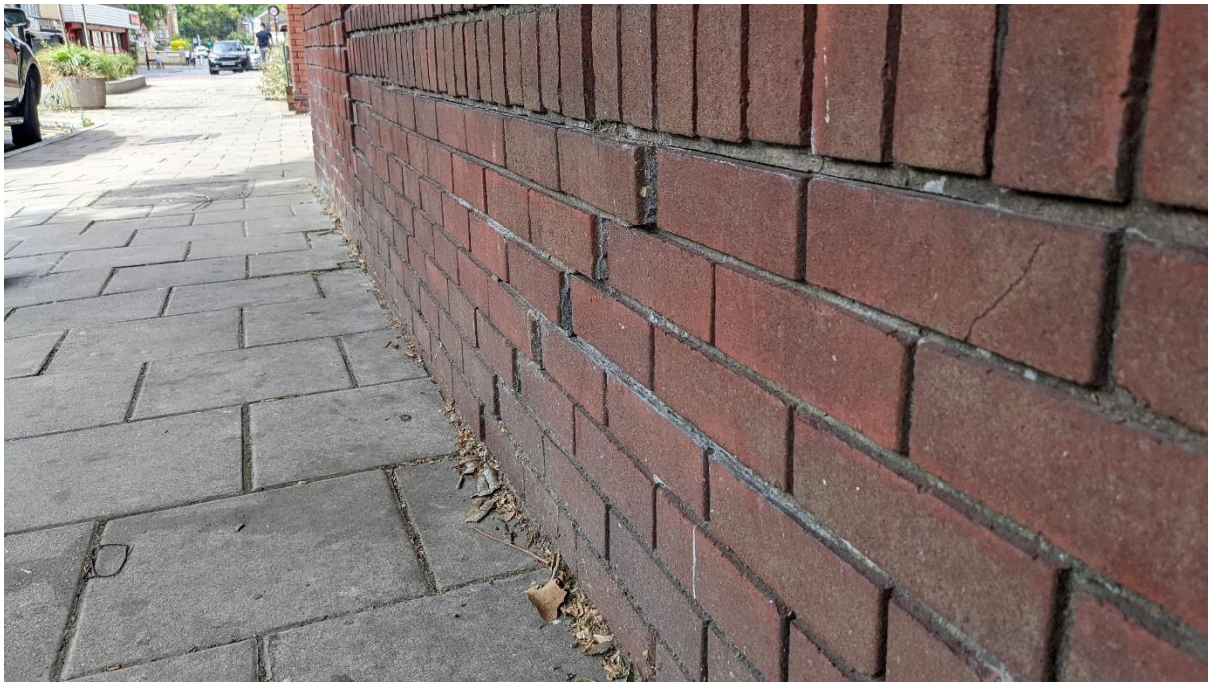
## Brick Wall

The tree is located in a brick walled container adjacent to the north side footpath of Mayes Rd. The wall directly adjacent to the footpath has a number of cracks through the mortar and has moved some sections of the wall, likely through the root ball growing within the container and becoming root bound. Regular maintenance through pollarding should help reduce the growth impact of roots. The crown on the north-west side is approx. under 2m from the wall of The Mall building.
