**SARABANDE NLHF ROUND II BID**

NOS. 808-810/812 HIGH ROAD  
LONDON  
N17 0BX

Title  
**NOS. 808 - 810/812 HIGH ROAD  
BR05 PROPOSED ROOM ELEVATION/DETAILS**

Drawing no  
SBND-1000-ZZ-ZZ-DE-A-22835

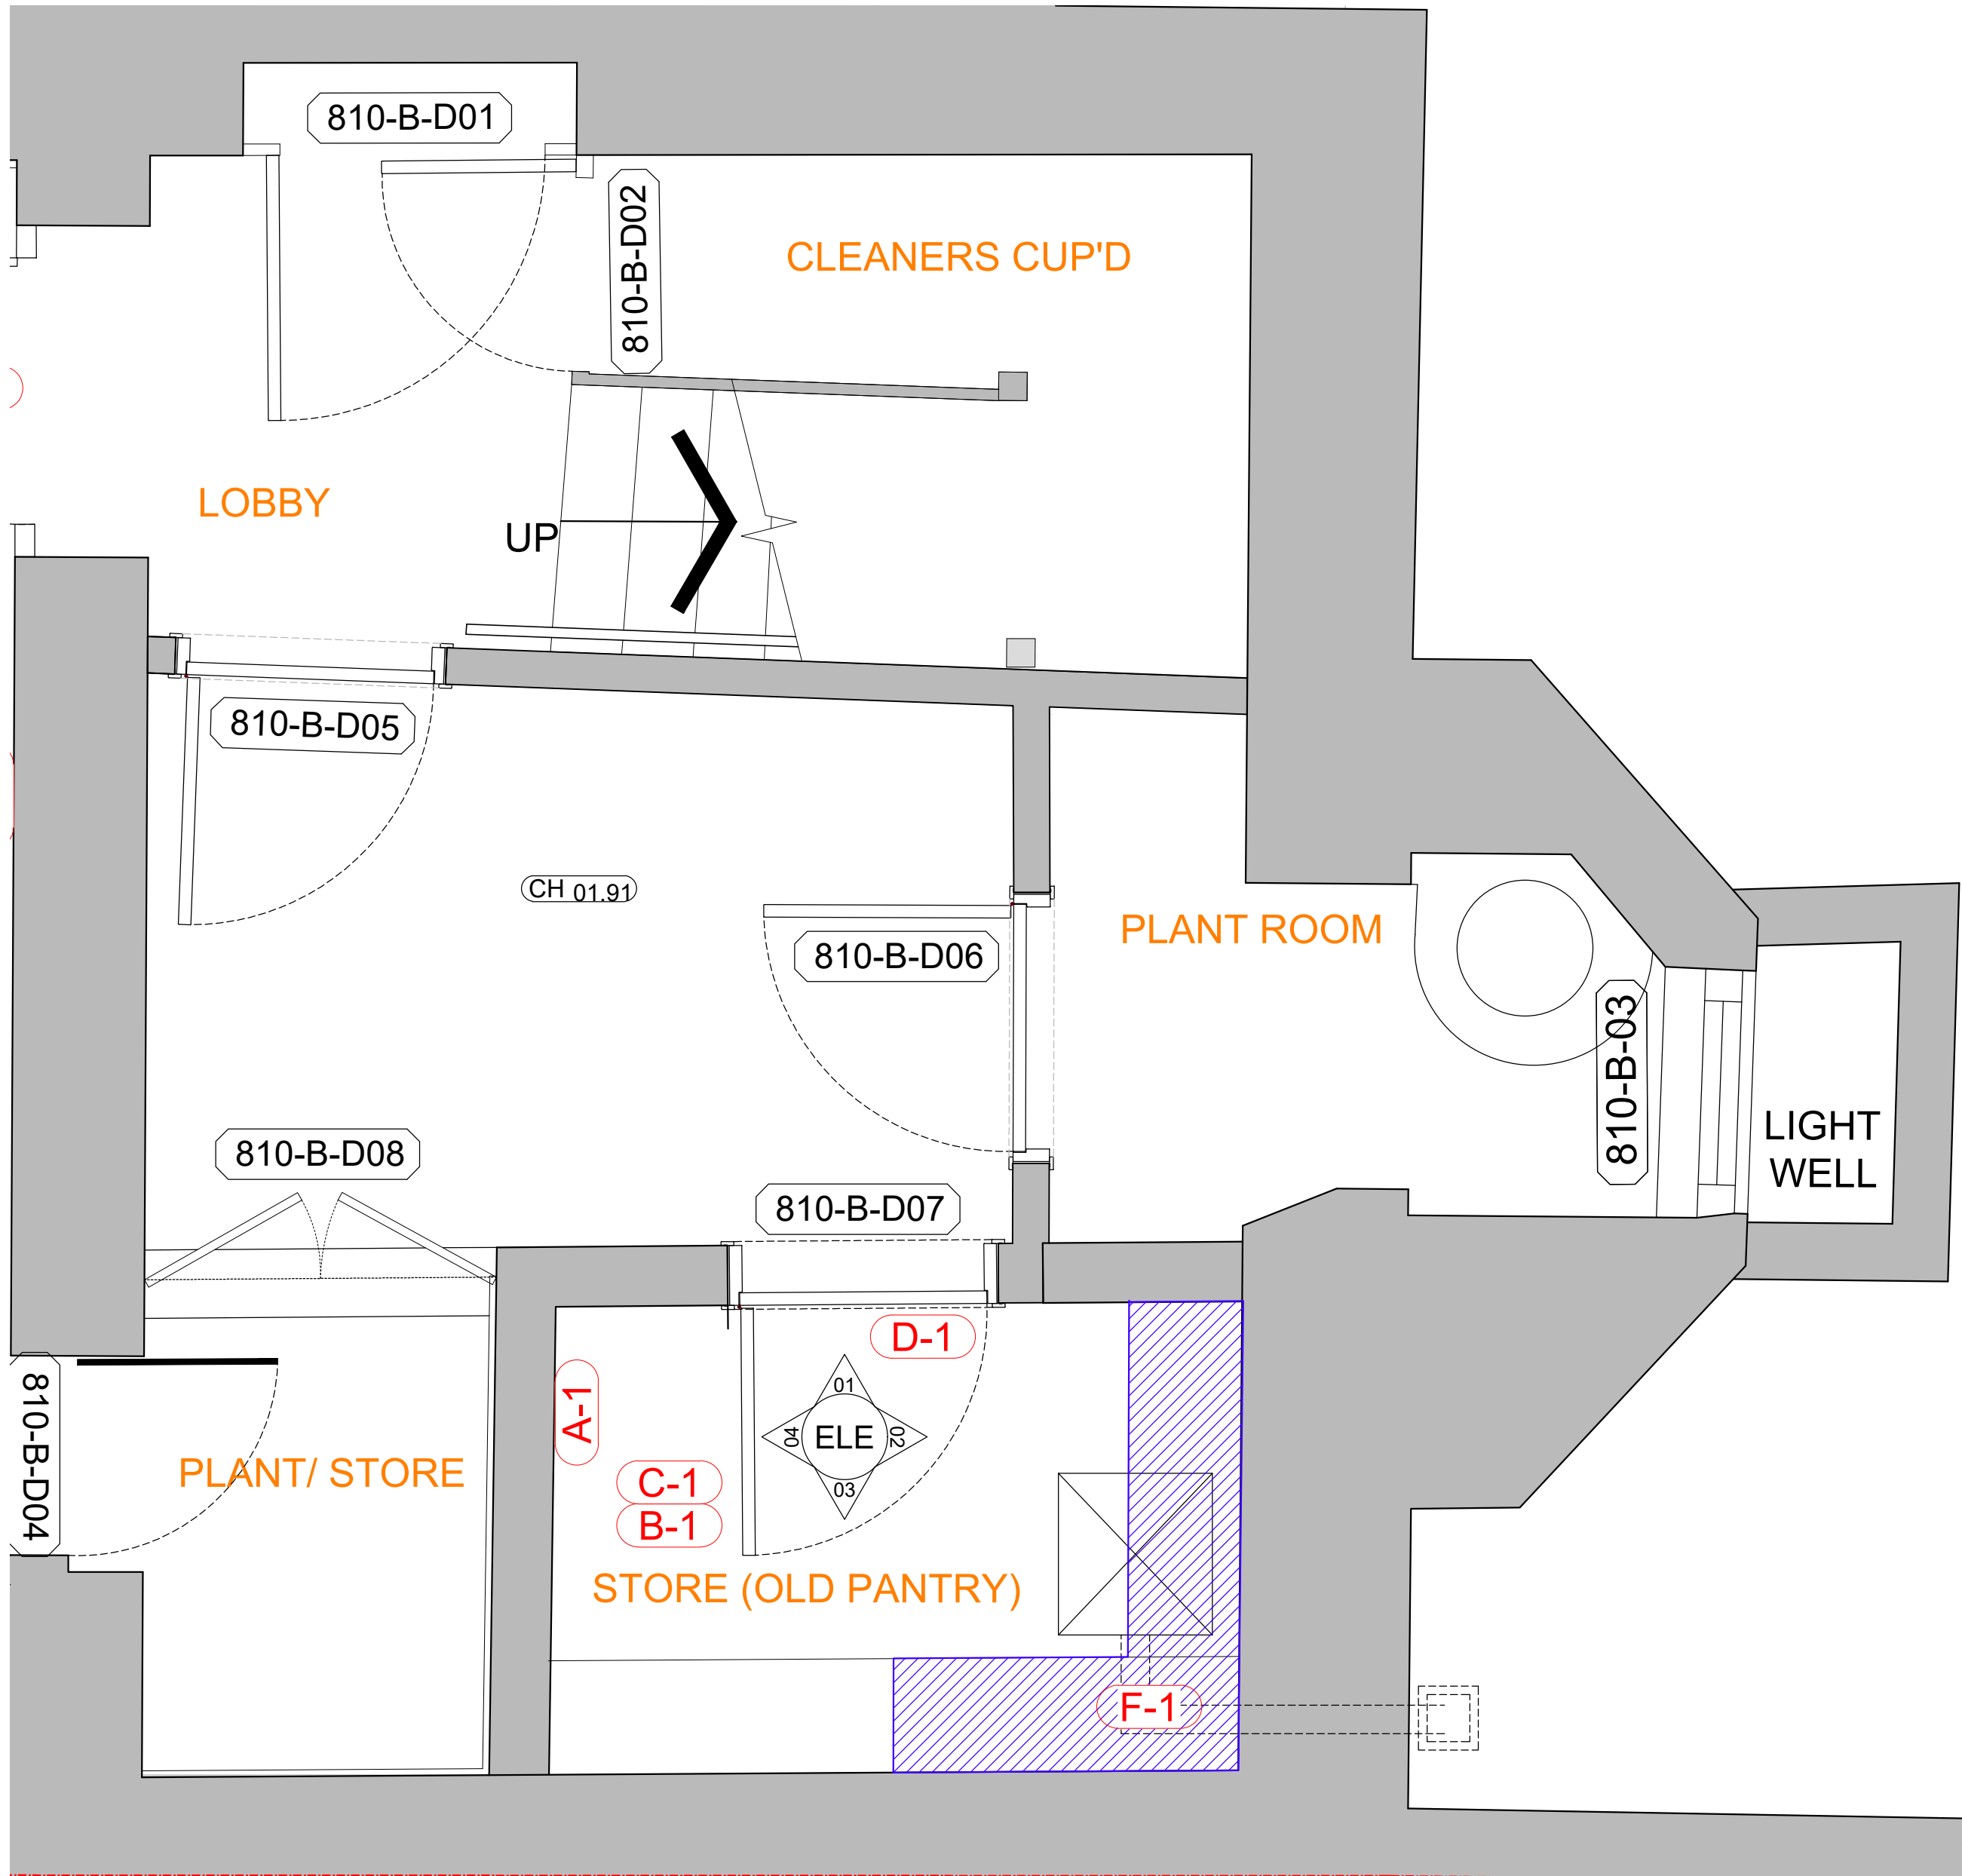
PLN  
22835  
PROPOSED BR05 GA PLAN  
Scale 1:20

- A-1:** Exposed brickwork shows at least 2 phases of build. Repairs have been previously carried out in late C20.
- B-1:** Remains of brick floor to store. Take up and reinstate bricks to 100% of the floor on breathable limecrete floor. Bricks to match where missing and make good.
- C-1:** Previous structured repairs to ceiling joists and strapping, lathe & plaster missing. Re-fix new lathes to underside of joist & re-plaster in lime to provide 60-minute fire rating. Retain bridging joist exposed & limewash or leave.
- D-1:** Door missing. Replace with 18th Century boarded door to match other existing doors.
- F-1:** Remains of shelving in poor condition due to water ingress. Scarf in timber repair.

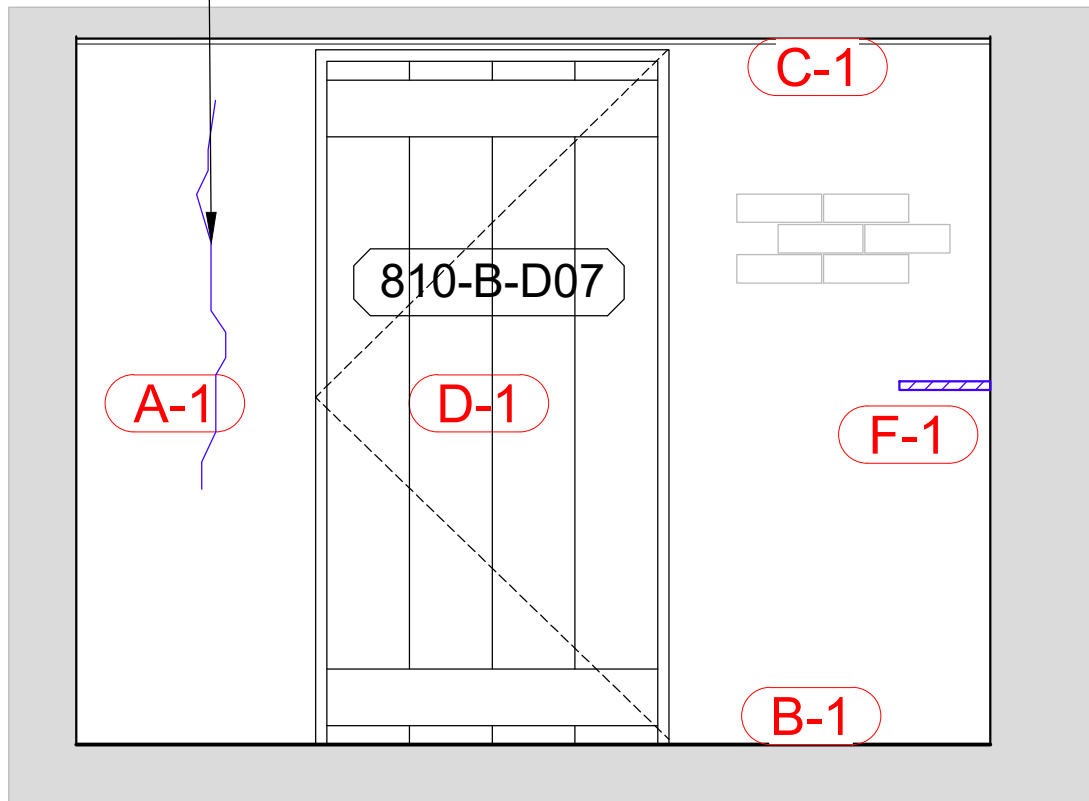
01  
22835  
PROPOSED NORTH WALL ELEVATION  
Scale 1:20

Structural crack -  
Structural Engineer to  
advise.

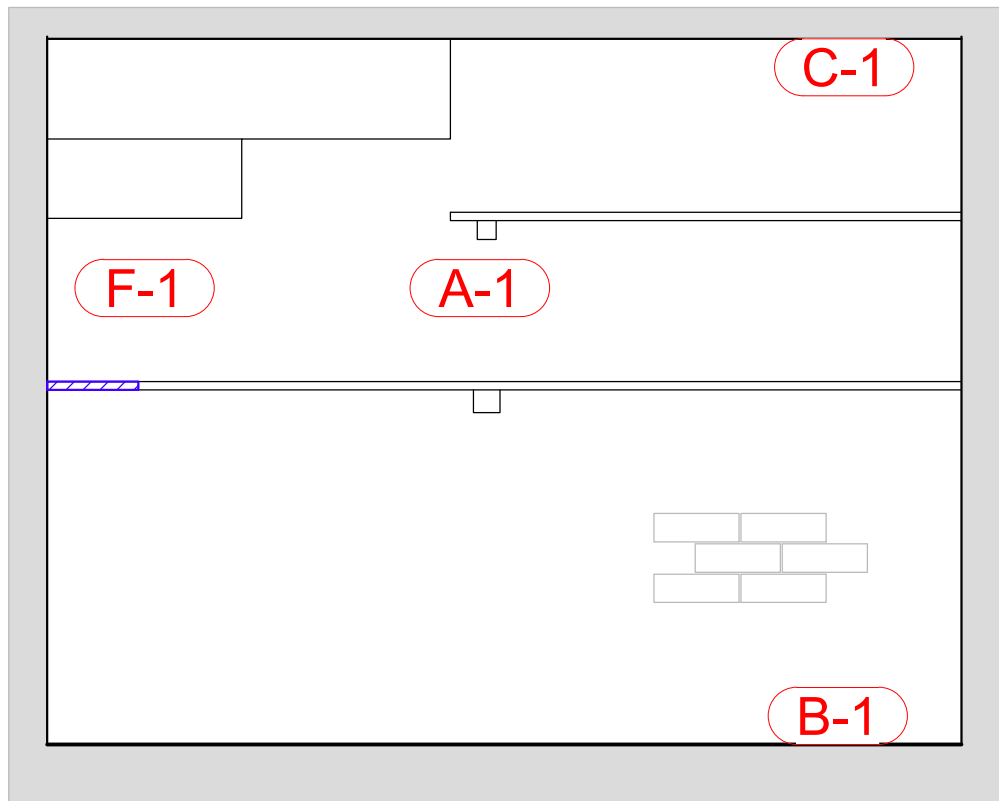
03  
22835  
PROPOSED SOUTH WALL ELEVATION  
Scale 1:20

Prop and repair brickwork. Stainless  
Steel Plate timber to resupport end of  
timber - to Structural Engineers design.  
Make good plaster.
