# Arboricultural Consultancy for Aviva - Commercial

| Insured | Ms Krycia Fedorowitz | Address | 12 Park Avenue, London, N22 7EX | | |

**Scope of Report:** To survey the property and determine significant vegetation contributing to subsidence damage, make recommendation for remedial action and assess initial mitigation and recovery prospects. The survey does not make an assessment for decay or hazard evaluation. The is a revised report based on the results of further site investigations

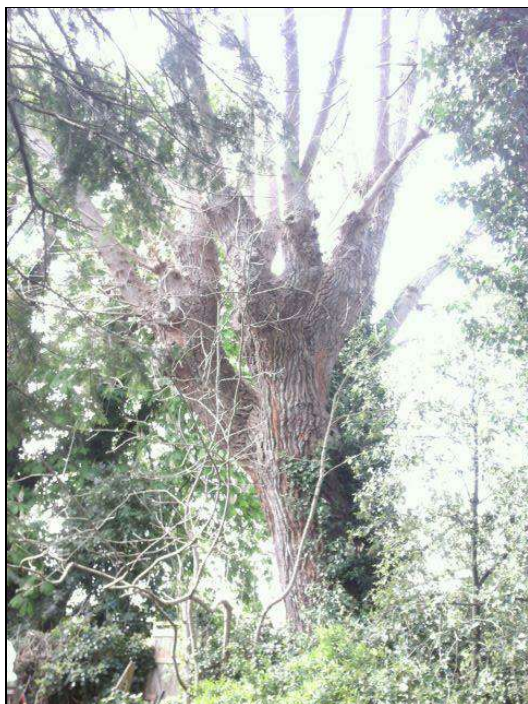
Based on our observations on site and with due regards to species profile, the Poplar (T1) is considered the dominant feature proximate to the area of movement and accordingly we have identified it as the primary cause of the subsidence damage.

T1 - Poplar (Hybrid Black)

Consequently, complete removal of T1, H1 and C1 will offer the most certain arboricultural solution likely to restore long-term stability.

| Tree No. | Species | Age Cat | Approx. Height (m) | Distance to Building (m) * | Ownership | Action | Requirement |
|---|---|---|---|---|---|---|---|
| T1 | Poplar | 1 | 25 | 31 | B - Local Authority | Remove | Remove close to ground level and treat stump to inhibit regrowth. |

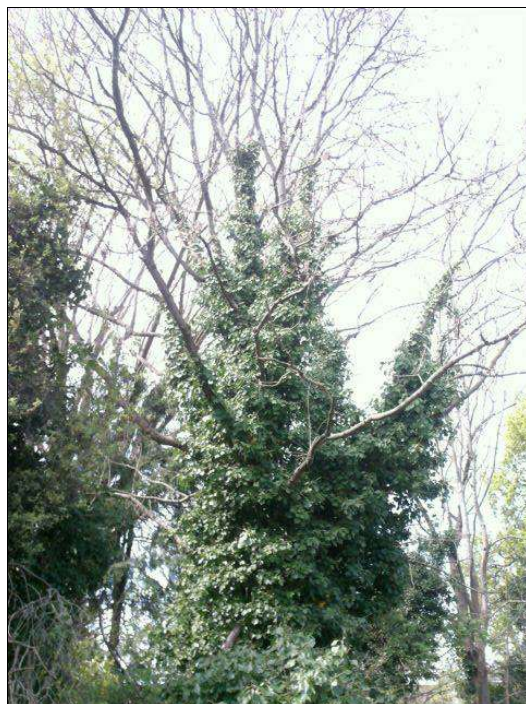
T2 - Ash

| Tree No. | Species | Age Cat | Approx. Height (m) | Distance to Building (m) * | Ownership | Action | Requirement |
|---|---|---|---|---|---|---|---|
| T2 | Ash | 1 | 14 | 20 | C - Insured | Action to avoid future risk | Maintain at broadly current dimensions by way of regular pruning. |

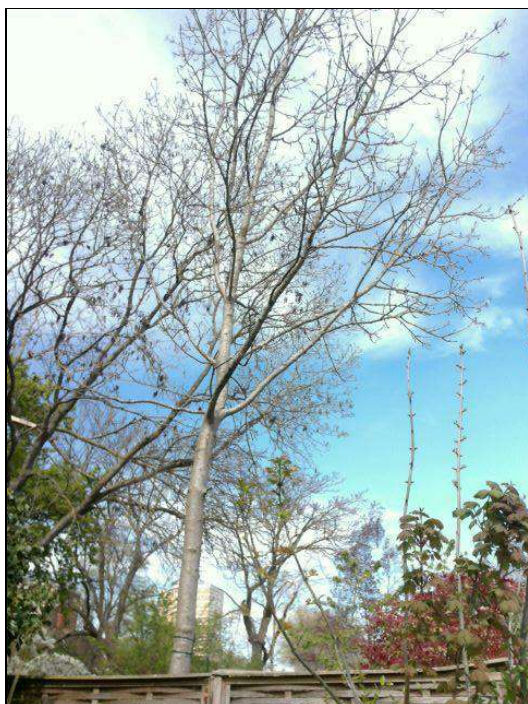
T4 - Ash

| Tree No. | Species | Age Cat | Approx. Height (m) | Distance to Building (m) * | Ownership | Action | Requirement |
|---|---|---|---|---|---|---|---|
| T4 | Ash | 1 | 12 | 12.0 | A - Third Party | Action to avoid future risk | Crown reduce overall canopy by 30% (minimum) to achieve a crown volume reduction in line with BRE IP7/06. Maintain at reduced dimensions by re-pruning back to points of previous reduction on a 3 year cycle. |

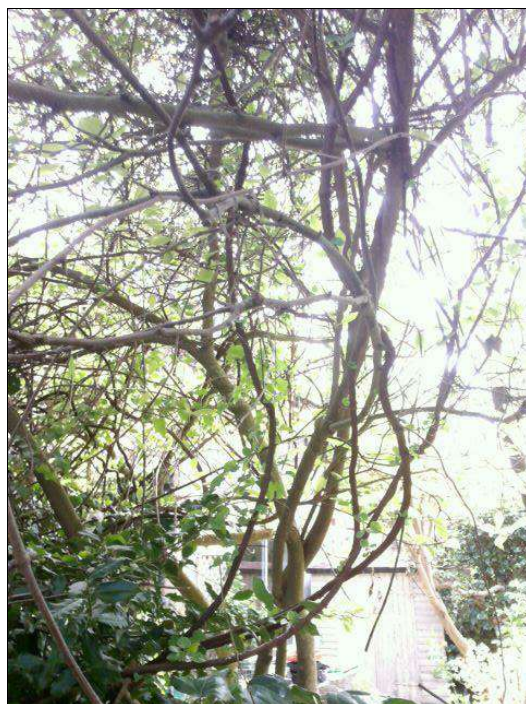
T3 - Magnolia

| Tree No. | Species | Age Cat | Approx. Height (m) | Distance to Building (m) * | Ownership | Action | Requirement |
|---|---|---|---|---|---|---|---|
| T3 | Magnolia | 1 | 4 | 4.7 | A - Third Party | Action to avoid future risk | Maintain at broadly current dimensions by way of regular pruning. |

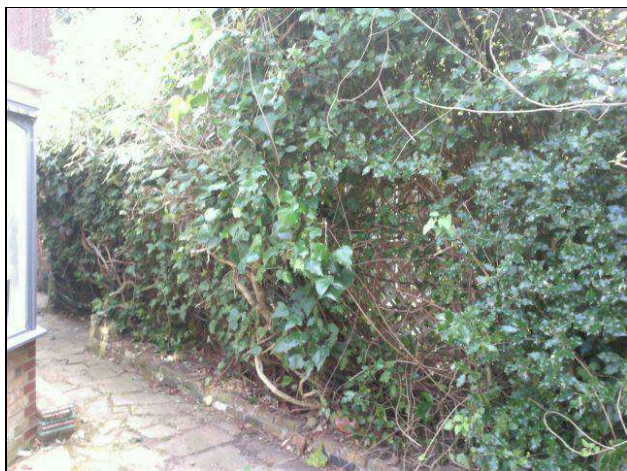
Given the recovery of roots likely to derive from the Mixed Species Hedge (H1) and *Wisteria* (C1), this vegetation cannot be discounted as contributing to the overall level of soil drying proximate to the area of damage and is therefore also considered to retain a contributory influence, albeit in a limited / secondary capacity when compared to T1.

H1 - Mixed species hedge

| Tree No. | Species | Age Cat | Approx. Height (m) | Distance to Building (m) * | Ownership | Action | Requirement |
|---|---|---|---|---|---|---|---|
| H1 | Mixed Species Hedge: includes Holly, Ivy, Clematis & Rose. | 1 | 4 | 1.8 | C - Insured | Remove | Remove close to ground level and treat stumps to inhibit regrowth. |

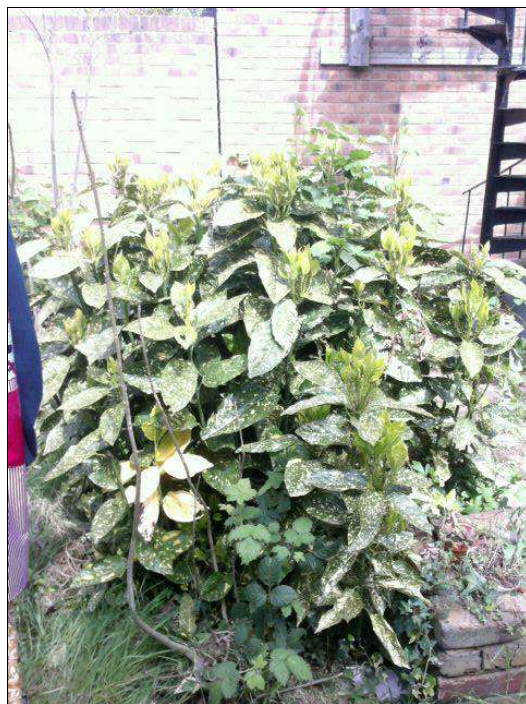
S1 - Aucuba

| Tree No. | Species | Age Cat | Approx. Height (m) | Distance to Building (m) * | Ownership | Action | Requirement |
|---|---|---|---|---|---|---|---|
| S1 | Aucuba | 1 | 1 | 2.3 | C - Insured | Action to avoid future risk | Maintain below 2m max height / spread by way of regular pruning. |

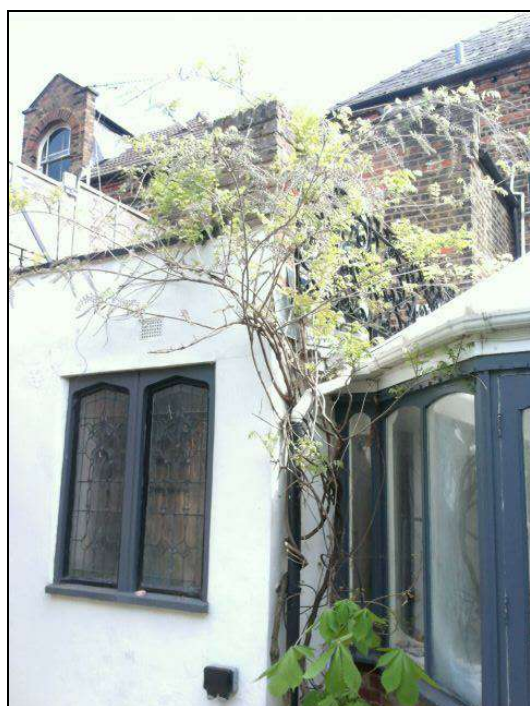
C1 - Wisteria

| Tree No. | Species | Age Cat | Approx. Height (m) | Distance to Building (m) * | Ownership | Action | Requirement |
|---|---|---|---|---|---|---|---|
| C1 | Wisteria | 1 | 4 | 0.1 | C - Insured | Remove | Remove close to ground level and treat stump to inhibit regrowth. |

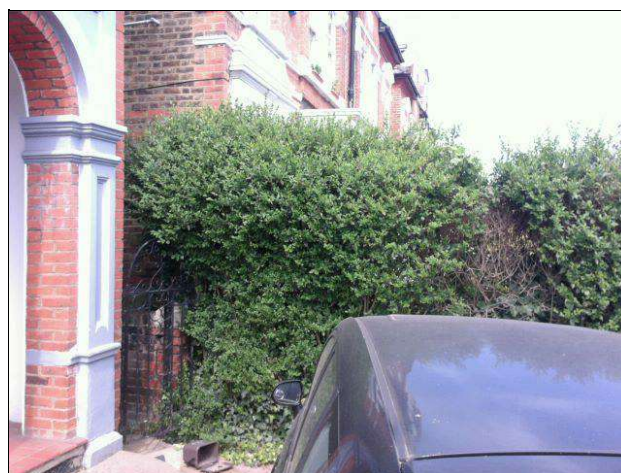
H2 - Privet

| Tree No. | Species | Age Cat | Approx. Height (m) | Distance to Building (m) * | Ownership | Action | Requirement |
|---|---|---|---|---|---|---|---|
| H2 | Privet | 1 | 3 | 1.0 | C - Insured | Action to avoid future risk | Reduce hedge to height of 1.8m and maintain at reduced dimensions by way of regular pruning. |
