**ARBORICULTURAL IMPACT ASSESSMENT  
LAND AT REAR OF 18 DENMARK STREET,  
LONDON N17 0JL.  
JUNE 2022**

**Arboricultural Solutions LLP**

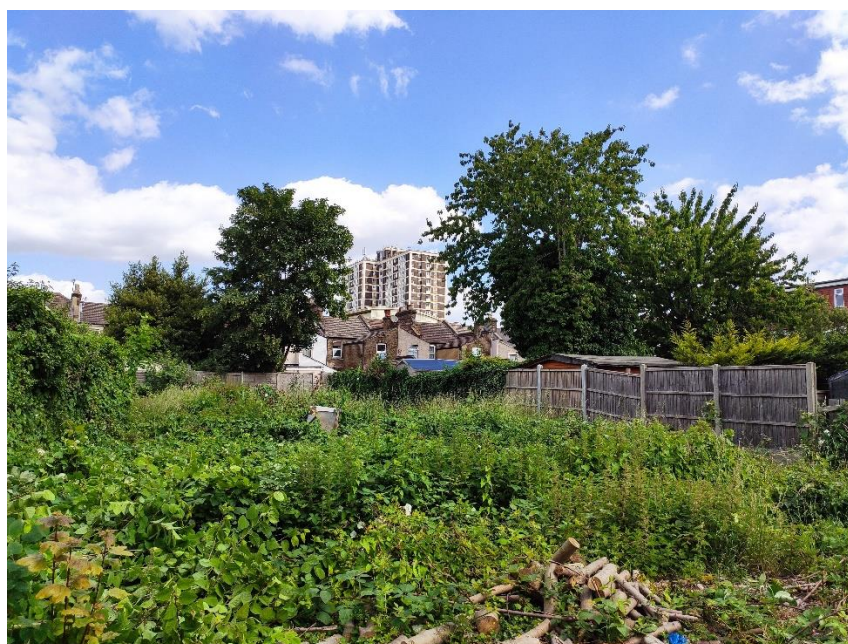
**Photograph 2 looking north across proposed development site.**

5.1.5. Tree 3 is a mature Wild Cherry within the rear garden of a property in Chalgrove Road (refer to photograph 2 above). It is a mature tree with dense Ivy growth on the trunk and extending into the crown which is prohibiting the inspection. The tree is of average condition but may be declining in vigour as the crown of the tree appears to be becoming sparse. It has been categorised as C2 based on its current condition and life expectancy. However, the tree does provide screening and canopy cover between the rear gardens of the properties in Chalgrove Road and the proposed development site.

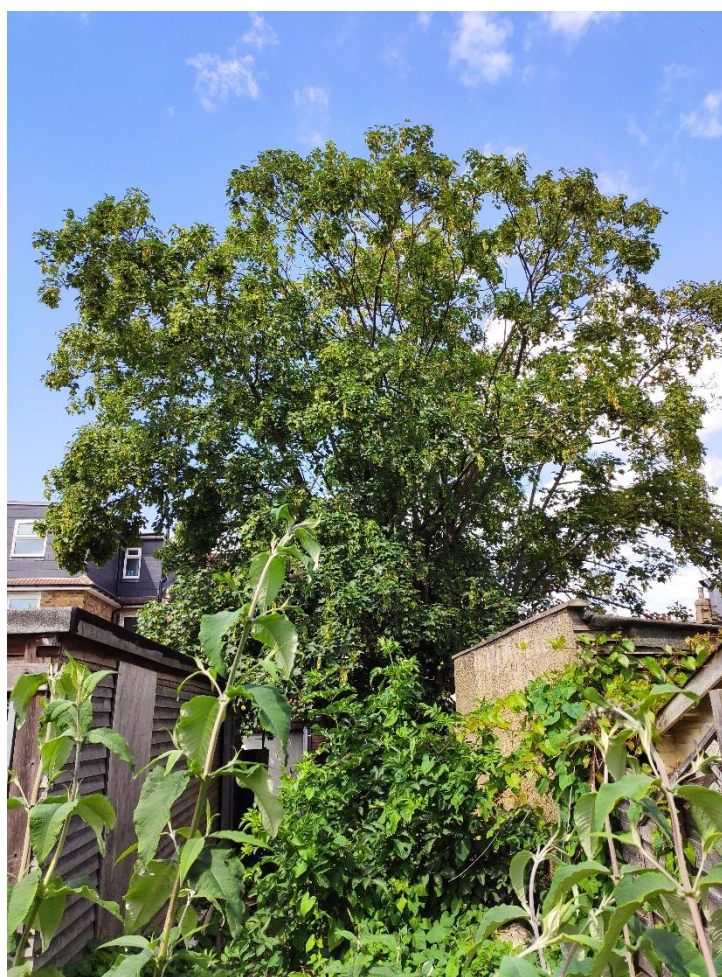
**Photograph 3 showing tree 1 (Sycamore) adjacent to the entrance to the development area.**

5.1.3. Tree 1 is a mature Sycamore (*Acer pseudoplatanus*) located within the boundary fencing of 18 Denmark Street and the neighbouring property in Park Lane. The tree is of

average condition and normal vigour. It has been pollarded in the past and more recently managed by crown reduction. The tree has been categorised as B2 as it is a significant feature at the entrance to the proposed development and is visible from the surrounding properties.

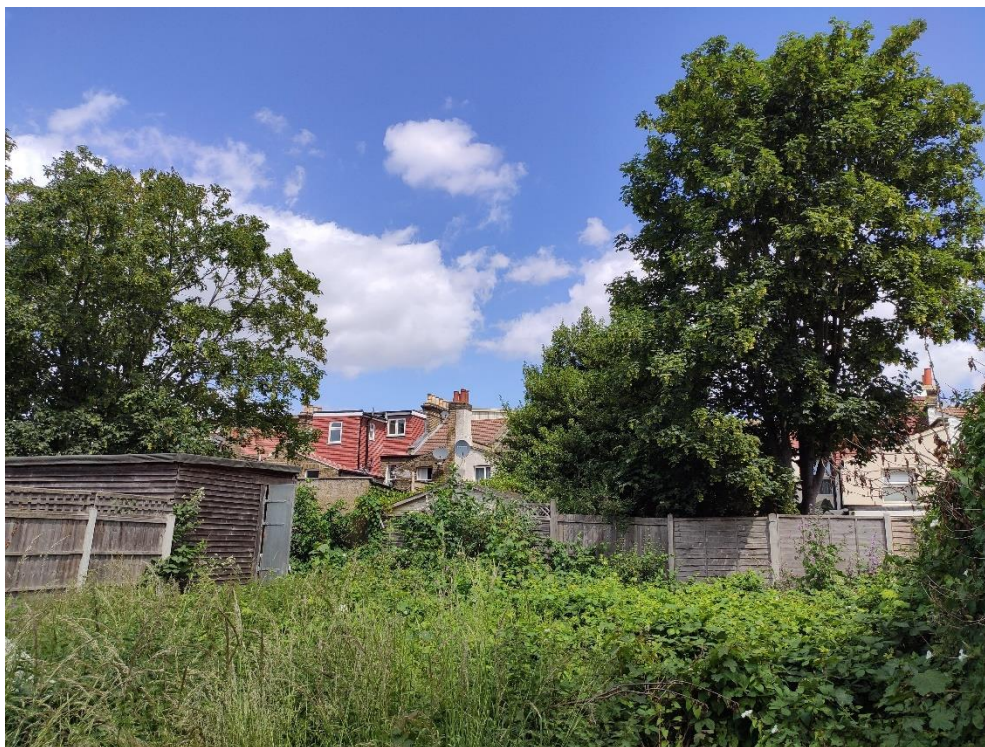
5.1.4. Tree 2 is an early mature Sycamore within the rear garden of a property in Park Lane. It is self-set in origin and multi-stemmed at ground level. The tree is of average condition and normal vigour. This tree has been categorised as B2 on the basis of its amenity provision and life expectancy. Both trees 1 and 2 provide screening and canopy cover between the rear gardens of the properties in Park Lane and the proposed development site.

**Photograph 4 showing trees 1 and 2 (Sycamore) at north end of site.**

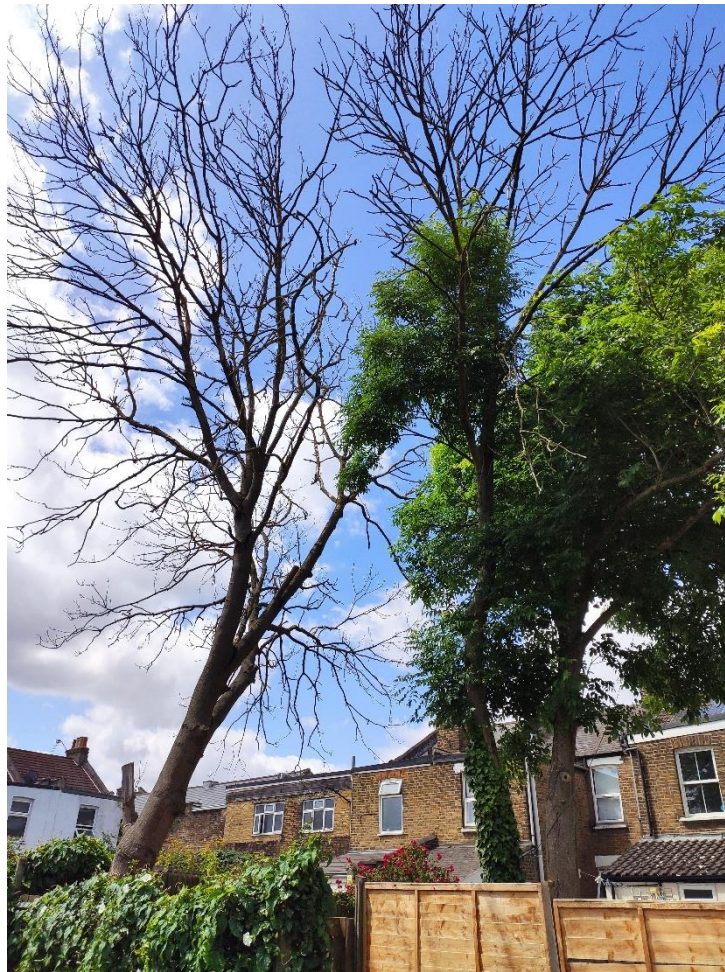
5.1.6. Tree 4 is a mature Ash tree standing within the rear garden of 10 Denmark Street. The trunk of the tree has had bark removed to 1.9 metres height and the tree is dead. This tree has been categorised as U and will require removal regardless of the proposed development.

5.1.7. Tree 5 stands within the rear garden of 11 Denmark Street. The tree is twin stemmed at ground level and the southeast stem is almost dead (refer to photograph 5 below). This stem will require removal in the near future regardless of the proposed development. The stem on the north west side appears to be healthy. The crown has been reduced in the past and is

unbalanced to the north. It has been categorised as C1 based on its current condition and life expectancy. However, the tree does provide screening and canopy cover between the rear gardens of the properties in Denmark Street and the proposed development site.

**Photograph 5 showing trees 4 and 5 (Ash) on southwest side of the site.**
