BRAEMAR AVENUE BAPTIST CHURCH AND CHURCH HALL

BRAEMAR AVENUE  
WOOD GREEN  
LONDON N22

PRELIMINARY ROOST ASSESSMENT

2022

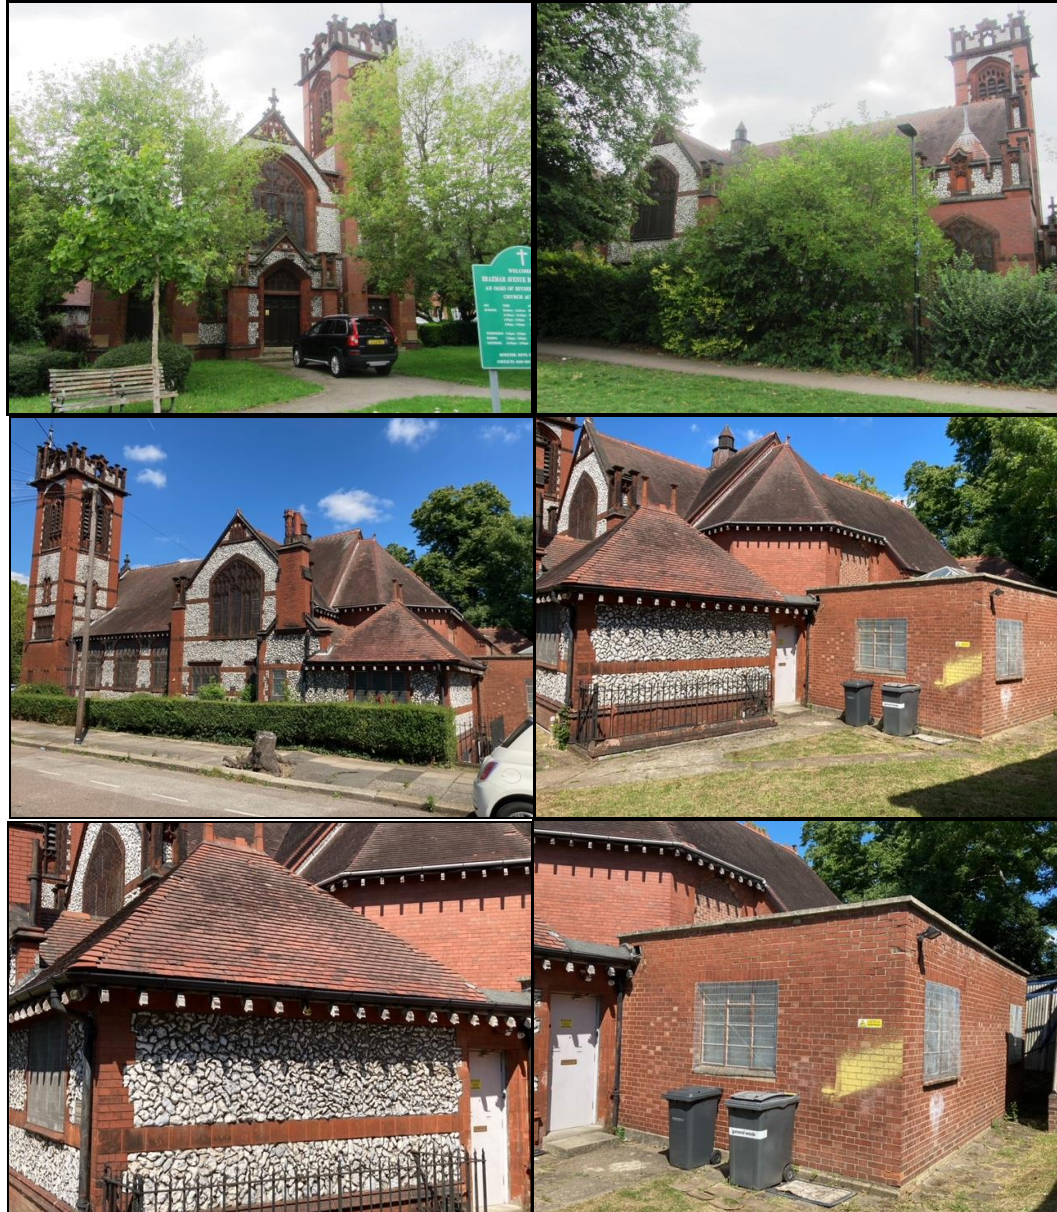
Photographs 1 - 6: Braemar Avenue Baptist Church - front, rear & side elevations

The proposed development footprint comprises a brick-built church, with a tower on the front elevation, located on the south side of Bounds Green Road (A109) between Braemar Avenue and Nightingale Gardens parkland (see photographs 1 - 6 below).

The Grade II listed building, which dates from 1907, has been extended on the southern rear elevation with a modern 1950s, flat-roofed unit that is now proposed for demolition, together with refurbishment works to the main church building.

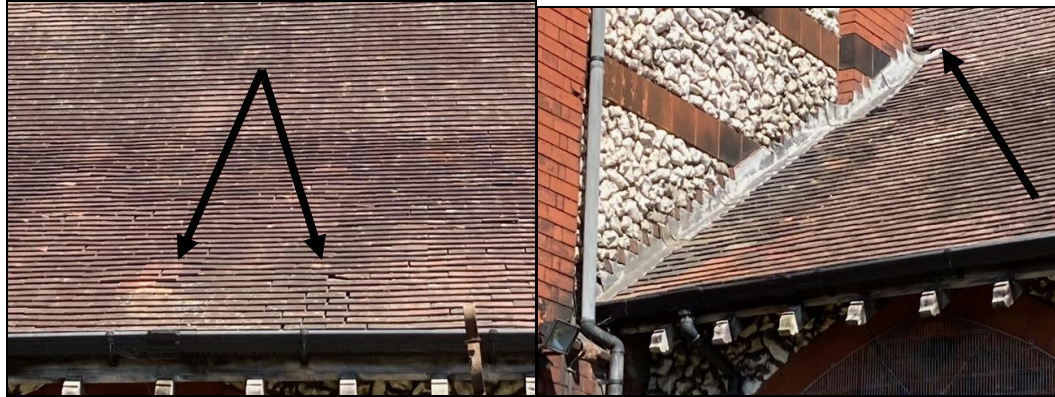
The church building has a suite of pitched, tile-covered roofs at different levels. Most are in good condition but the main roof shows some limited damage with several missing or raised tiles that could act as potential bat ingress points (see photograph 7 below).

The valleys and associated flashings, however, appeared to be tight-fitting with no obvious gaps for bat access (see photograph 8 below). There are no chimneys present.

Photographs 7 - 8: Damaged roof tiles & close-fitting valley flashing

As a result of the structure of the main church building, with several raised or missing roof tiles identified, it was assessed to be of 'low potential' as a roost site for bats.

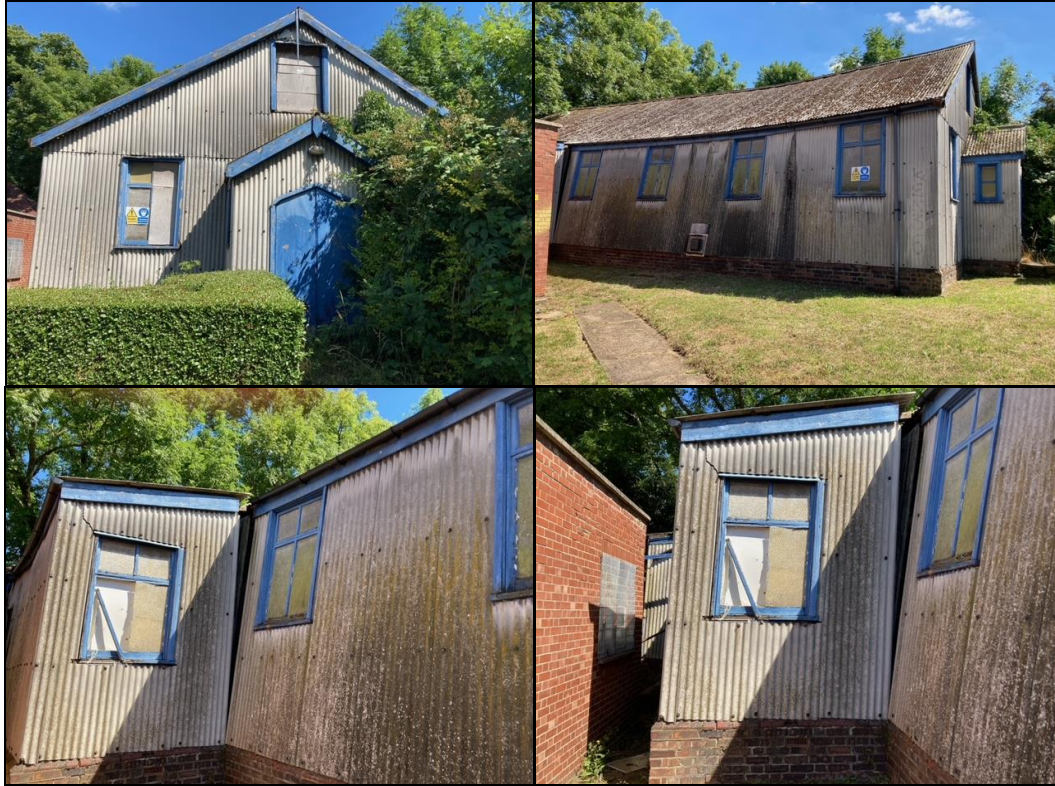
The proposed development footprint also comprises a separate hall, located to the south of the main church (see photographs 9 - 12 below). The building is derelict and has not been used for many years. It shows signs of serious decay and the walls are extensively bowing and separating in places.

As a result of the structure of this building, with no potential bat access points or roost features identified, it was assessed to be of 'negligible potential' as a roost site for bats.

Photographs 9 - 12: Church Hall

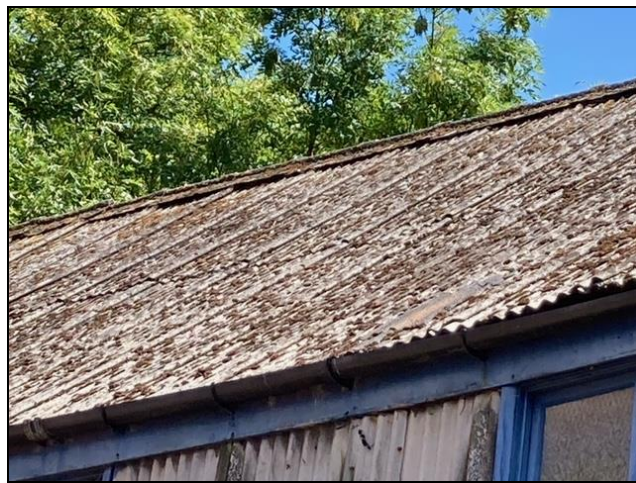
The building has a pitched, sloping roof corrugated iron roof (see photograph 13 below) and asbestos walls.

There is no loft void present and no chimneys. The structure and materials used for the roof covering were considered to provide no suitable roosting opportunities for bats.

Photograph 13: Roof sheeting
