## SUBSIDENCE ENGINEER'S REPORT

| <b>Reference</b> | VOL/31813 |
| <b>Risk Address</b> | Tushingham Cottage, Edison Road, London, N8 8AE |

| <b>Date of Report</b> | 12 October 2022 |

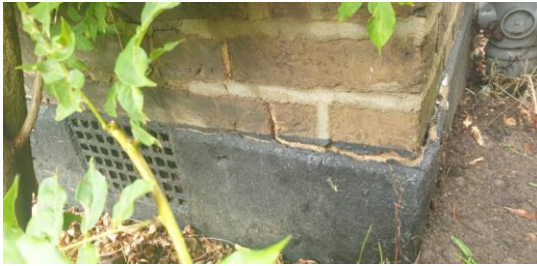
**PHOTOGRAPH E1:**

This photograph showing a view of the circa 2-3mm horizontal crack noted to the front right hand corner of the property.

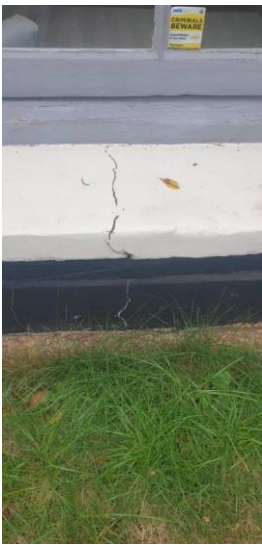
**PHOTOGRAPH E2:**

This photograph shows a view of the circa 1mm diagonal crack to the front elevation of the front bay which continues onto the windowsill.

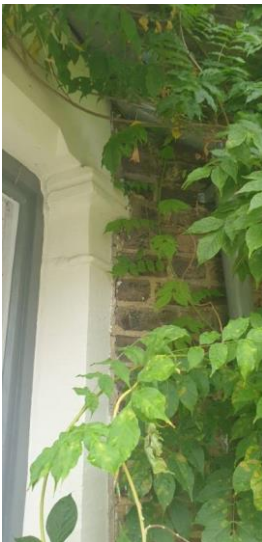
**PHOTOGRAPH E3:**

This photograph a view of the circa 1mm vertical crack at the junction of the right hand stone mullion and junction with the front elevation.

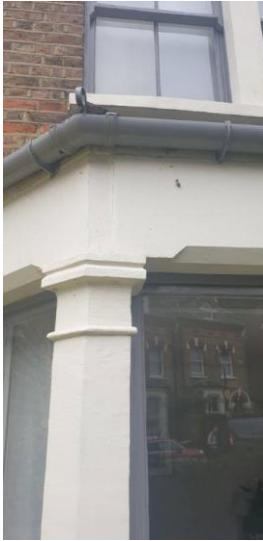
**PHOTOGRAPH E4:**

This photograph shows a view of a slight vertical crack at the junction of the front stone lintel and left hand lintel to the bay window.

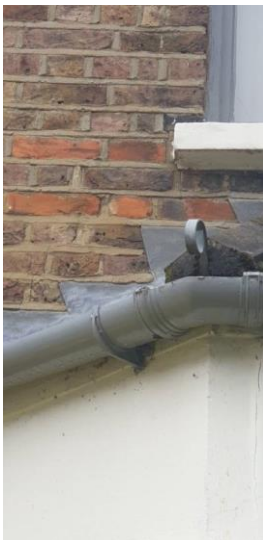
**PHOTOGRAPH E5:**

This photograph shows a view of a slight stepped diagonal crack running from the left hand side of the first floor windowsill extending down to the bay window flashing.

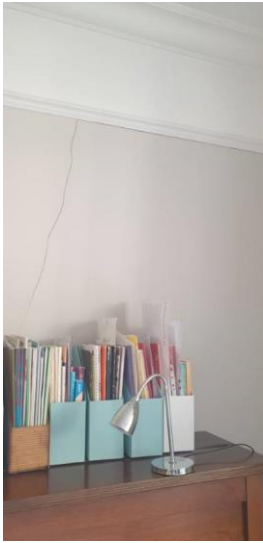
**PHOTOGRAPH I1:**

This photograph shows a view of a diagonal tapering crack up to approximately 1mm in width to the right hand elevation of the front lounge.

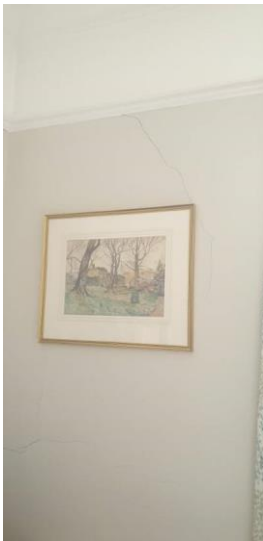
**PHOTOGRAPH I2:**

This photograph shows a view of the diagonal cracking up to 1mm in width to the front elevation of the lounge to the right hand side of the front bay window.

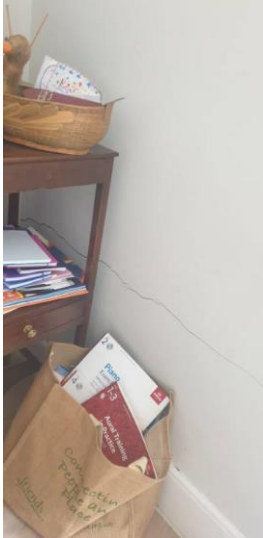
**PHOTOGRAPH I3:**

This photograph shows a view of the 1-2mm horizontal crack to the front elevation which commences on the right hand corner of the front bay and runs across to the right corner of the front elevation.

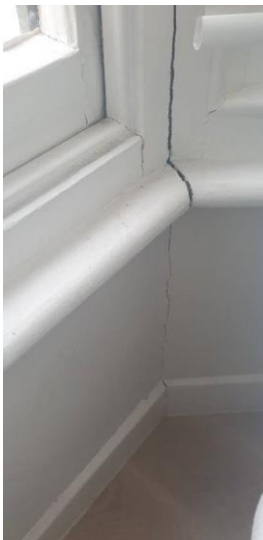
**PHOTOGRAPH I4:**

This photograph shows a view of vertical crack at the junction of the front elevation of the front bay with the movement causing the separation of the sills and window frames immediately above the cracking.

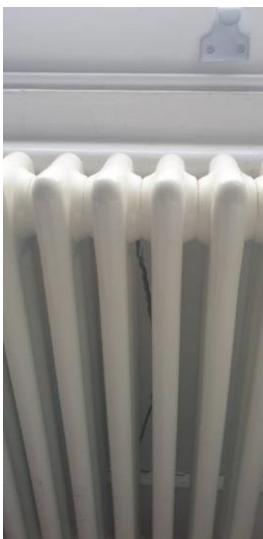
**PHOTOGRAPH I5:**

This photograph shows a view of the circa 67mm essentially vertical tapering crack at the front elevation of the bay located behind the radiator.

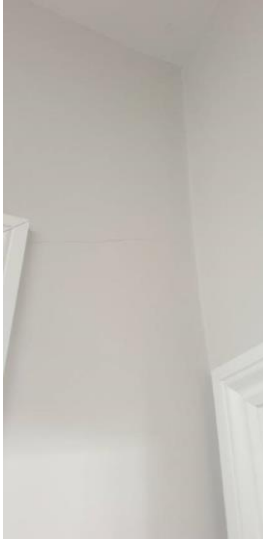
**PHOTOGRAPH I6:**

This photograph shows a view of the minor cracking radiating from the top right hand corner of the right hand lobby door within the hallway.

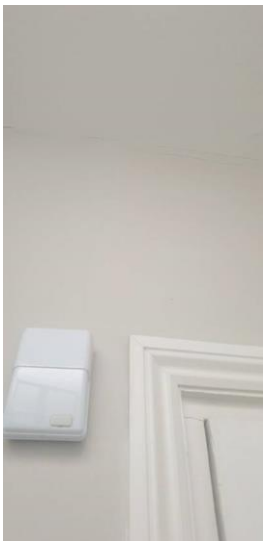
**PHOTOGRAPH I7:**

This photograph shows a view of the minor cracking radiating from the top left hand corner of the right hand lobby door within the hallway.

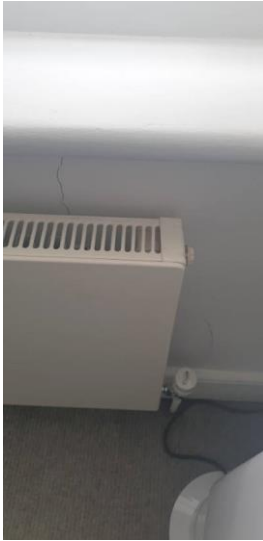
**PHOTOGRAPH I8**

This photograph shows a view of the circa 1mm diagonal crack beneath the front windowsill which extends down to skirting level.

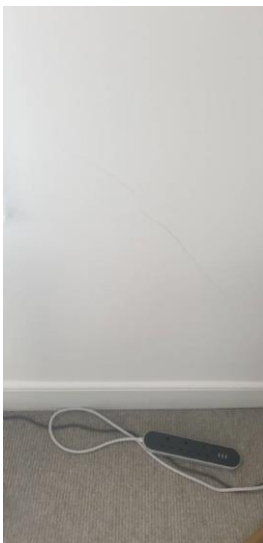
**PHOTOGRAPH I5:**

This photograph shows a view of the diagonal crack which radiates from the left hand reveal of the front elevation window descending down to skirting level within the front bedroom.
