# Arboricultural Appraisal Report

## Structural Damage Investigation at:

Hornsey Reservoir,  
Tile Kiln Lane  
London  
N6 5LG

| REPORT DATE: | 18/08/2021 |

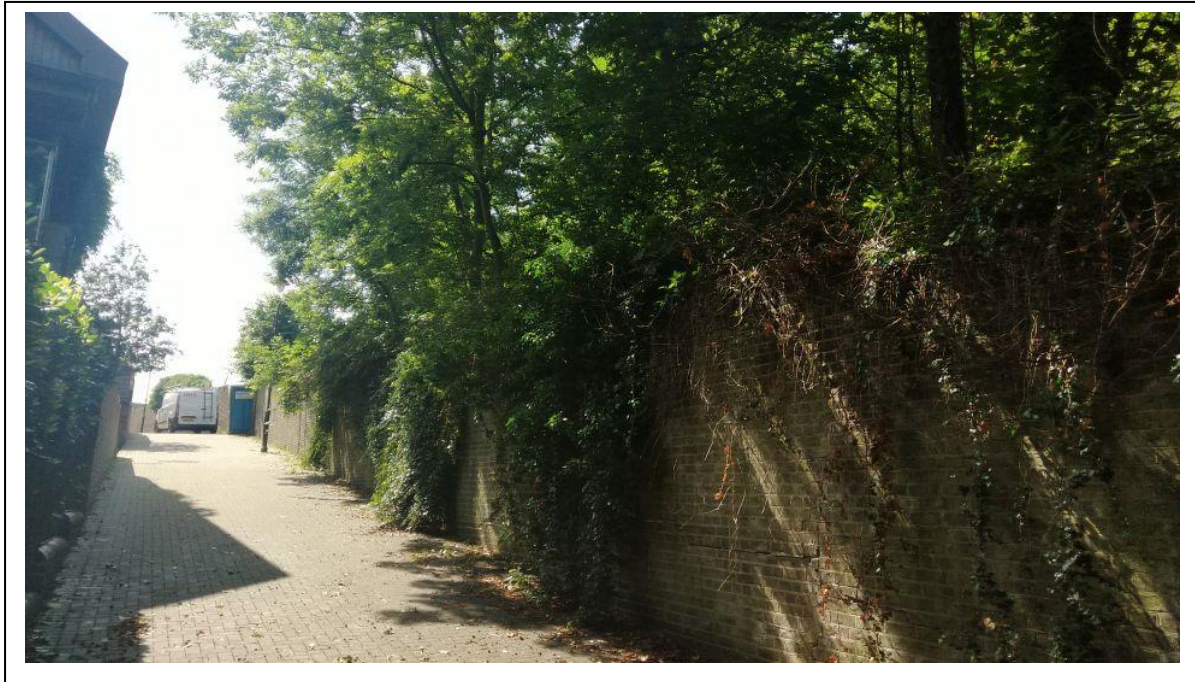
Overview of area of interest from Tile Kiln Lane looking south

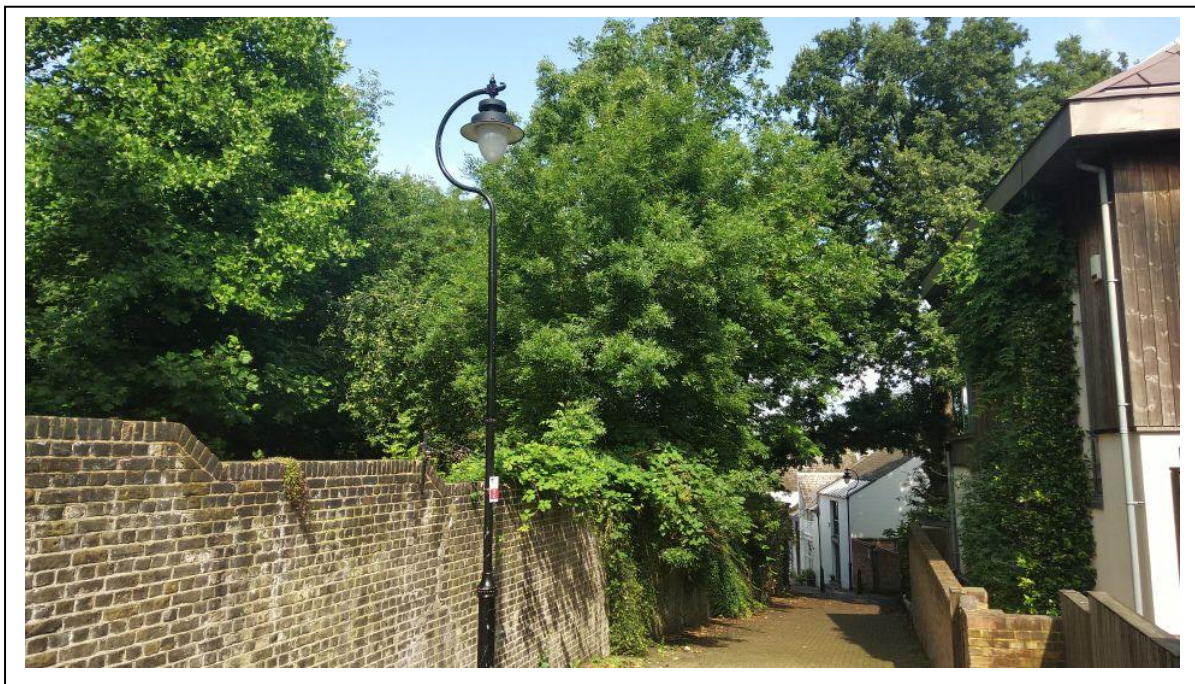
Overview of area of interest from Tile Kiln Lane looking north

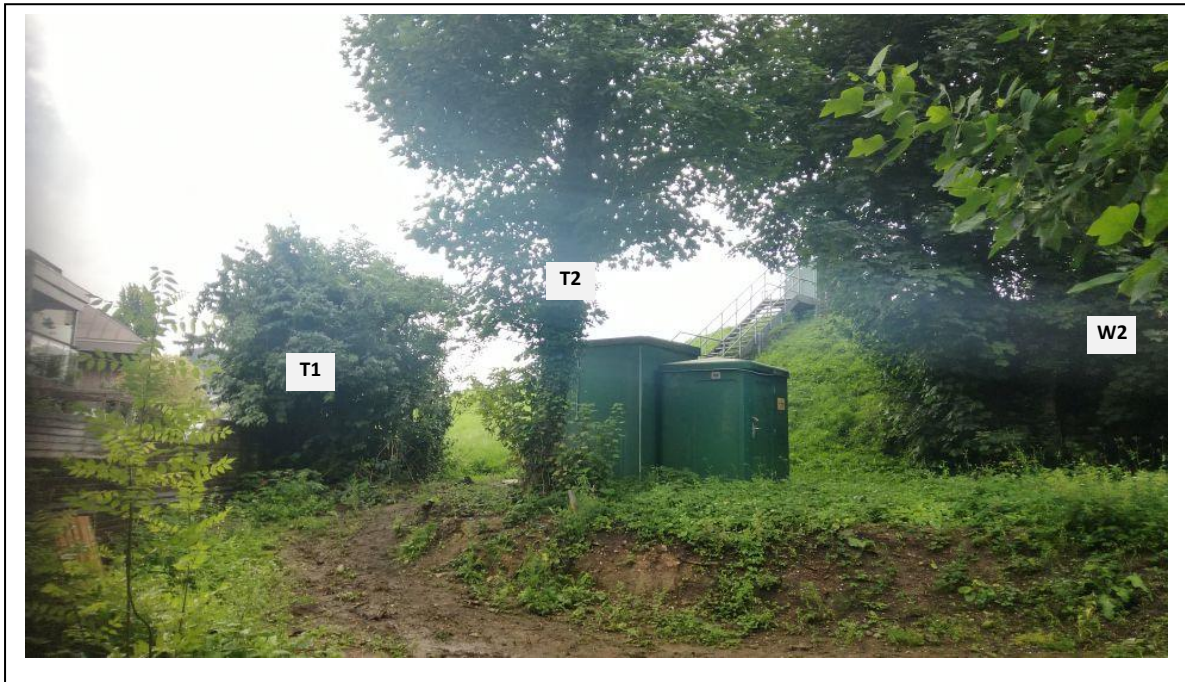
| Tree No. | Species | Ht (m) | Dia (mm) | Crown Spread (m) | Dist. to wall (m) | Age Classification | Ownership |
|---|---|---|---|---|---|---|---|
| Management history | | Some understorey cut to 1.5-2.0m stumps - regrowth appears <5yrs | | | | | |
| Management history | | No significant past management noted<br>Recent excavations within RPA - 1.2m from stem base with severed roots visible | | | | | |

View from site interior of T1 Elder and T2 Sycamore, with W2 woodland area visible to right of frame

| Tree No. | Species | Ht (m) | Dia (mm) | Crown Spread (m) | Dist. to wall (m) | Age Classification | Ownership |
|---|---|---|---|---|---|---|---|
| Recommendation | | Remove (fell) to near ground level and treat stumps to inhibit regrowth. | | | | | |
| Recommendation | | Remove (fell) to near ground level and treat stump to inhibit regrowth [unrelated to wall damage – advisory due to root severance] | | | | | |

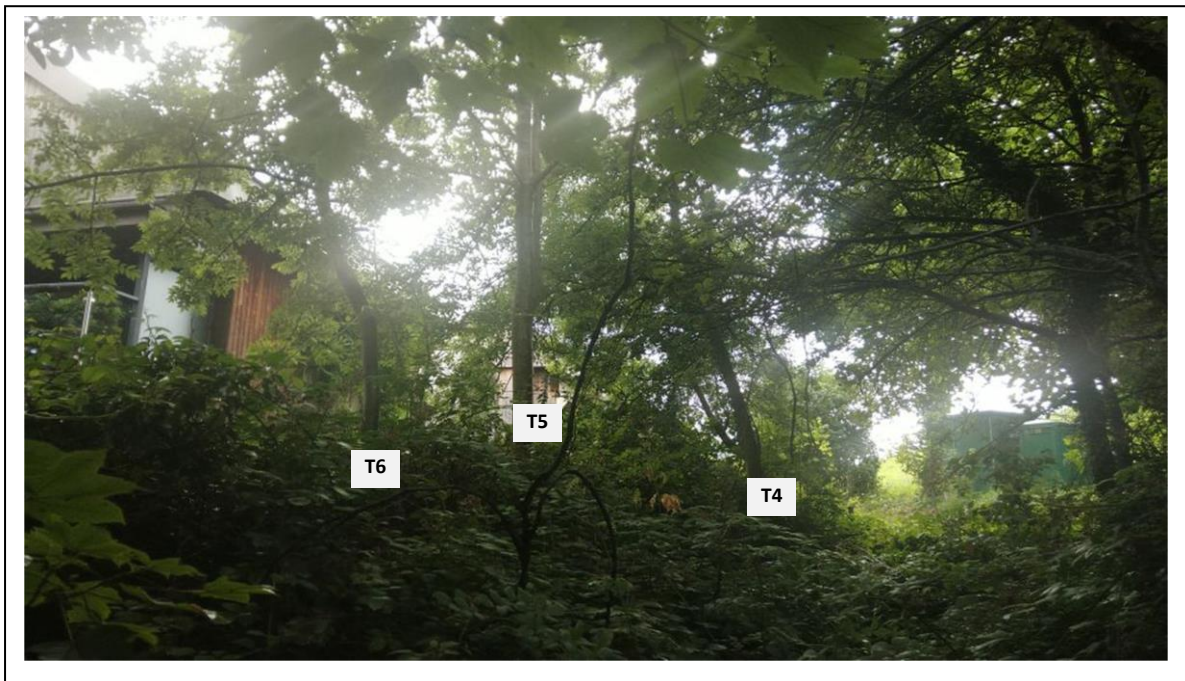
| Tree No. | Species | Ht (m) | Dia (mm) | Crown Spread (m) | Dist. to wall (m) | Age Classification | Ownership |
|---|---|---|---|---|---|---|---|
| Management history | | No significant past management noted<br>Tree appears partially collapsed with stem lean of approx. 20° and asymmetrical crown towards E | | | | | |

| Tree No. | Species | Ht (m) | Dia (mm) | Crown Spread (m) | Dist. to wall (m) | Age Classification | Ownership |
|---|---|---|---|---|---|---|---|
| Management history | | No significant past management noted<br>Suppressed asymmetrical crown with weight bias to E<br>Dense bramble and scrub growth restricts access to stem base | | | | | |

View from site interior of T6, T5 and T4 Ash

| Tree No. | Species | Ht (m) | Dia (mm) | Crown Spread (m) | Dist. to wall (m) | Age Classification | Ownership |
|---|---|---|---|---|---|---|---|
| Recommendation | | Remove (fell) to near ground level and treat stump to inhibit regrowth. | | | | | |

| Tree No. | Species | Ht (m) | Dia (mm) | Crown Spread (m) | Dist. to wall (m) | Age Classification | Ownership |
|---|---|---|---|---|---|---|---|
| Recommendation | | Remove (fell) to near ground level and treat stump to inhibit regrowth. | | | | | |

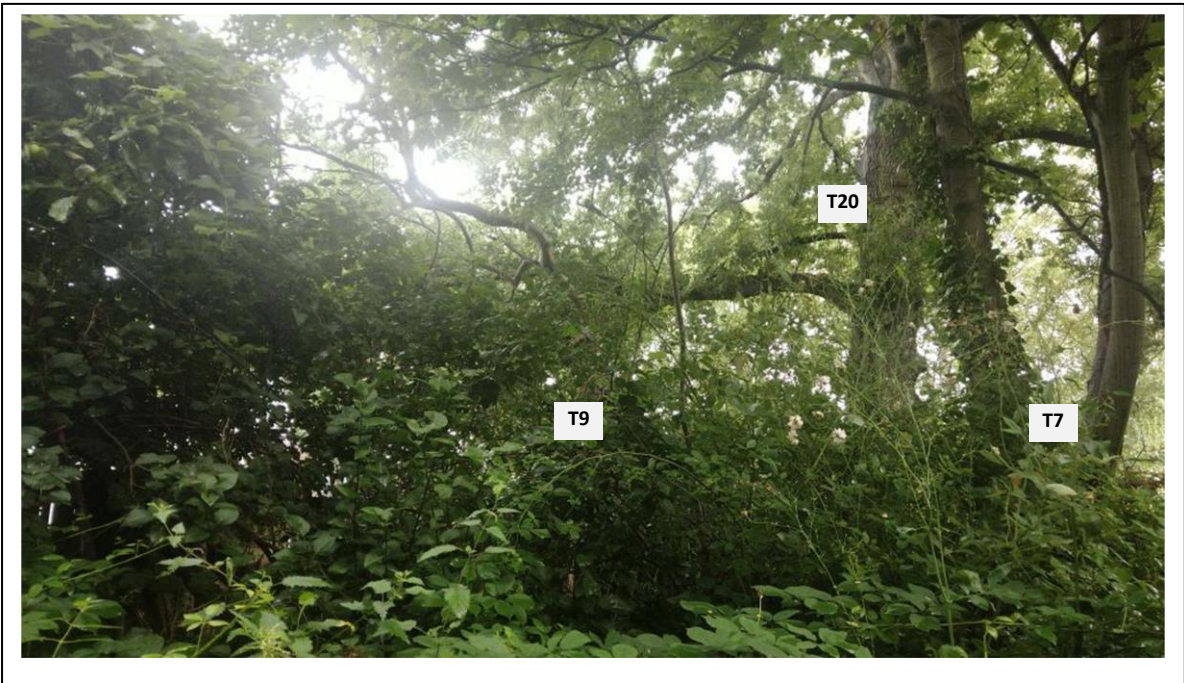
| Tree No. | Species | Ht (m) | Dia (mm) | Crown Spread (m) | Dist. to wall (m) | Age Classification | Ownership |
|---|---|---|---|---|---|---|---|
| Management history | | No significant past management noted<br>Twin-stemmed growth habit from 0.5m<br>Suppressed asymmetrical crown growth habit due to Oak T20 - weight bias to W | | | | | |
| Management history | | No significant past management noted<br>Suppressed contorted stem growth and asymmetrical crown with weight bias to N<br>Dense bramble and scrub restricts access to stem base | | | | | |

View from site interior of T7 Sycamore and T9 Ash, with T20 Oak visible beyond

| Tree No. | Species | Ht (m) | Dia (mm) | Crown Spread (m) | Dist. to wall (m) | Age Classification | Ownership |
|---|---|---|---|---|---|---|---|
| Recommendation | | Remove (fell) to near ground level and treat stump to inhibit regrowth. | | | | | |

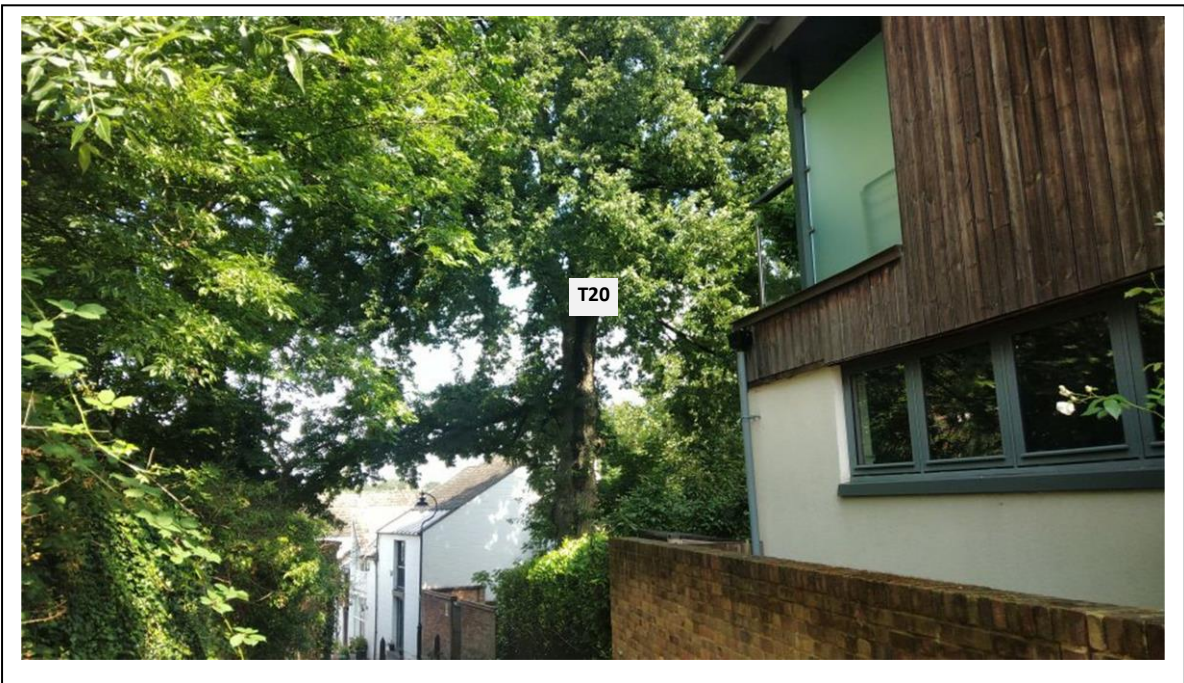
There is also a potential that the large third-party owned T20 Oak may also play a role in the damage, particularly to the northern-most end of the wall run. This large fully mature tree will have a significant presence of roots below the foundations of the wall and, given the presence of a clay subsoil, may be affecting soil moisture and volumes with the potential for subsidence damage to be a factor. This however should be verified by engineering review. A period of level monitoring may also be prudent to assess any vertical foundation movement of the wall arising from soils shrinkage and recovery [seasonal movement].

View of T20 Oak

| Tree No. | Species | Ht (m) | Dia (mm) | Crown Spread (m) | Dist. to wall (m) | Age Classification | Ownership |
|---|---|---|---|---|---|---|---|
| Recommendation | | No works required at present (subject to review if movement persists). | | | | | |
