**REPORT ON TREE INSPECTION AT  
1 ST MARTIN'S TERRACE,  
16 PAGES LANE,  
LONDON N10 1QY.  
AUGUST 2022**

**Arboricultural Solutions LLP**

**REPORT ON TREE INSPECTION AND DAMAGE TO BUILT STRUCTURES  
AT  
1 ST. MARTIN'S TERRACE  
16 PAGES LANE  
LONDON  
N10 1QY.**

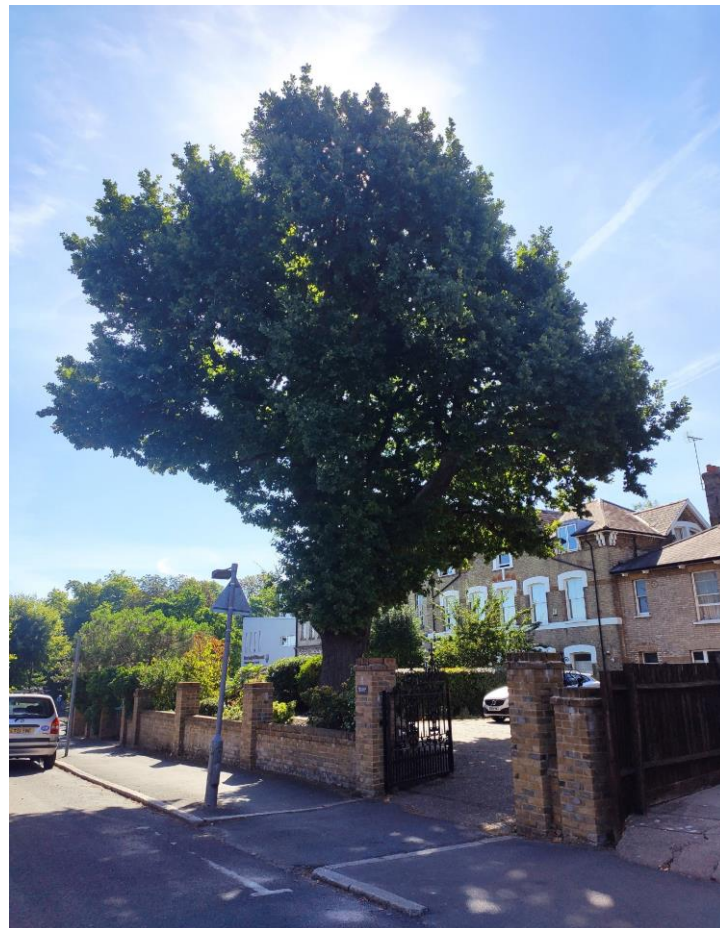
2.4.3. Tree 1 is single stemmed at ground level, located in a shrubbed on the front elevation of the property. It is mature in age and considered to be of average condition and normal vigour (refer to photograph 1 below). The tree has the following approximate dimensions; height 15.5 metres, crown spread to north 7.2, east 6.3, south 7.8 and west 6.0 metre and a trunk diameter of 1200mm.

2.4.4. The soil levels have been raised around the base of the tree to create the raised shrubbed planter, the base of the trunk and the buttress root flare were not visible. There is a partially occluded wound at ground level on the south side of the trunk and several small, occluded bark wounds around the base. However, there was no indication of basal decay or loose bark around the basal area and sounding around the base of the tree using a nylon mallet (Thor 710 400g) returned a solid sound.

**Photograph 1 showing tree 1 from west side in Pages Lane.**

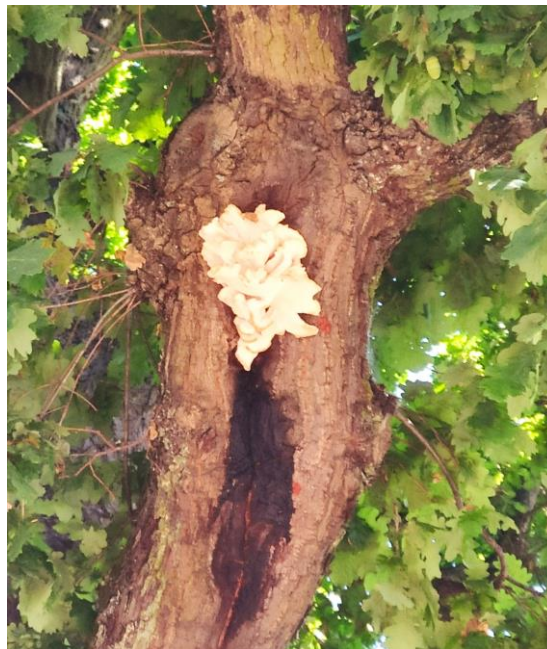
2.4.7. The crown of the tree has been heavily reduced in the past and has recently been more sensitively managed by regular crown reduction. The tree has a generally well-furnished crown, and the leaves are of normal colouration and size. This inspection noted the presence of fungal brackets of Sulphur polypore (*Laetiporus sulphureus*) on the underside of the scaffold limb on the south side of the crown (refer to Appendix 5 for notes on Sulphur Polypore). The fungal bracket is growing at a previous pruning point or shed limb wound. The wound itself has occluded however, the evidence of bark staining and the fungal fruits indicate that there is likely to be decay in this part of the branch. The branch itself has been significantly reduced in the past and is not considered to be a hazard at the present time.

**Photograph 2 showing fungal brackets of Sulphur polypore on underside of branch.**

2.5.1. This inspection did not find any evidence that the tree is unstable at ground level or that the root plate has lifted or moved in the recent storm conditions. The presence of fungal bodies of Sulphur polypore is not considered to be a hazard at present.

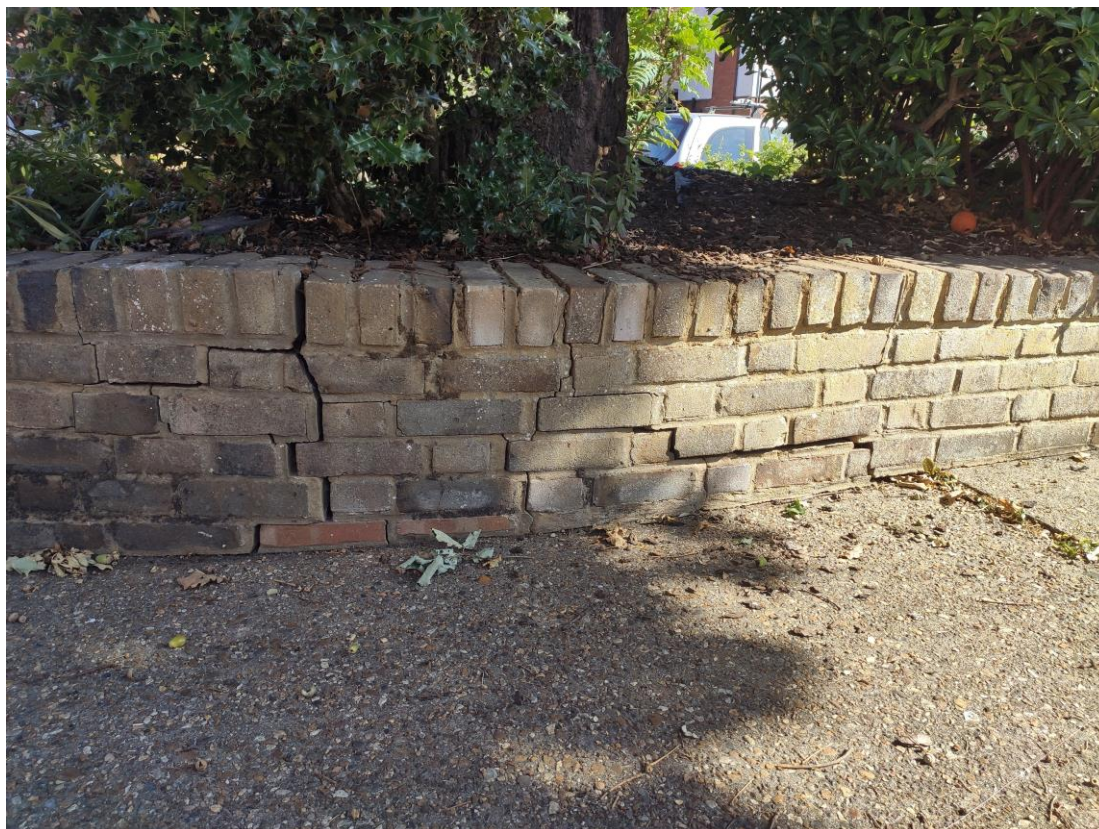
4.1.1. The retaining wall of the front shrubbed is constructed of double-bond bricks and varies in height from 0.47 metres at its east end to 0.77 metres at its north end. The wall is a curved structure and was constructed circa 2000 when the building was converted to residential use. There is cracking extending from ground level to the top of the wall immediately to the south of the trunk and this section of the wall has been rebuilt in the past. Refer to photographs taken at the time of the inspection included below.

**Photograph 3 showing damage to retaining wall of shrubbed at 1 St. Martin's Terrace.**

6.1.1. The tree may be causing direct damage by the expansion of the roots growing against the garden wall and beneath the concrete parking area.

5.2.5. **Removal or repairs to Shrubbed Retaining Wall:** If the area of concrete parking is reduced adjacent to the shrubbed it would be possible to remove the retaining wall, remove the infill soil, and regrade the soil as a slope. This would negate the need for the retaining wall and lower the soils levels around the base of the tree back to the original level. If the wall is retained there are some engineered solutions that may reduce the direct damage of the root growth for example constructing the wall on lintel bridging the roots.

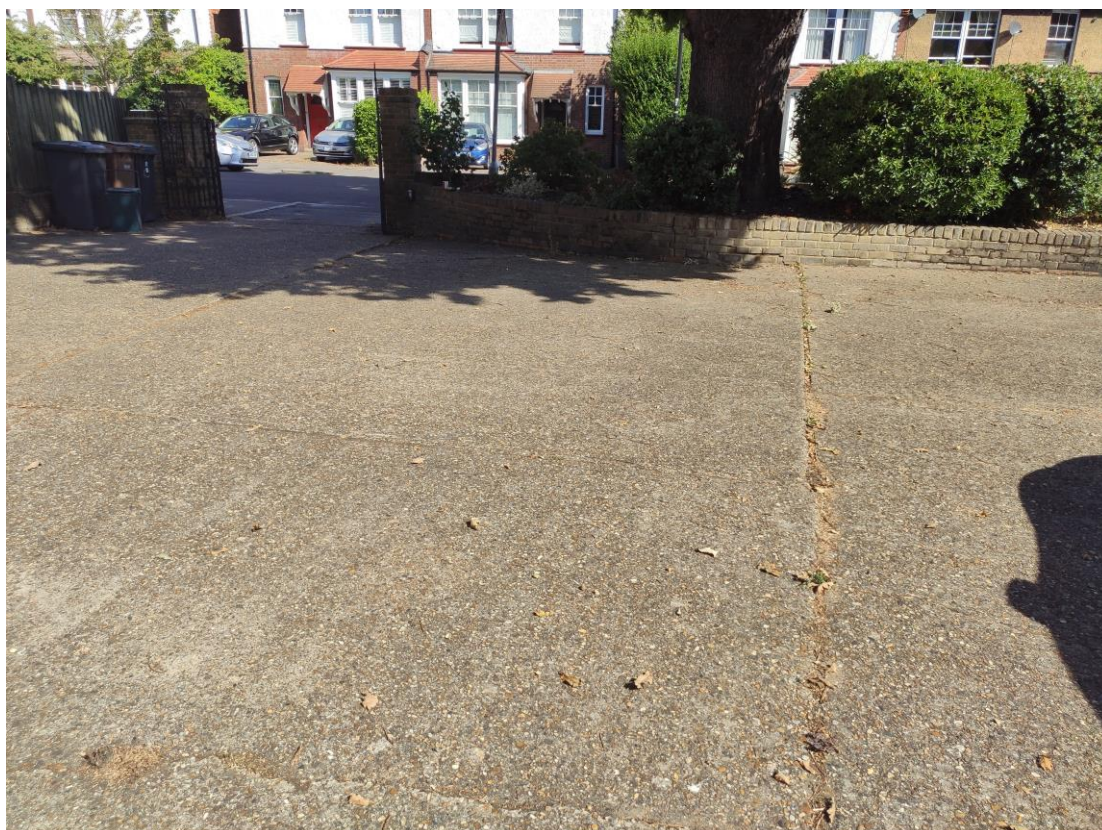
4.2.1. The concrete driveway and car parking area at the front of 1 St. Martin's Terrace measures approximately 13 x 10 metres and predates the conversion of the convent to residential housing. The slabs have lifted and rotated differentially resulting in raised vertical edges and cracking as shown in photograph 5 below.

**Photograph 5 showing lifting and rotation of concrete drive at 1 St. Martin's Terrace.**

5.2.1. **Concrete Driveway:** The existing concrete driveway dominates the front garden area of the property. Large areas of hard impermeable surfaces and can cause local temperatures to rise (often referred to as the urban heat island effect). Concrete is impermeable to rainwater, and in this case, the driveway slopes downhill to the north and away from the buildings so effectively prevents any rainfall from soaking into the front garden area of 1 St. Martin's Terrace. In addition, there is likely to be a thermocline between the underside of the concrete slabs and the underlying soils causing moisture the condense beneath the concrete so allowing root growth to proliferate beneath the concrete slabs.

5.2.2. Removing or reducing the size of the concrete parking area will allow rainwater to penetrate the underlying soils so reducing storm water run off and improving the rooting conditions for the Oak tree. The concrete could be completely removed and replaced using porous hard surfacing and a cellular raft system (such as Cellweb). Another option would be to reduce the area of the hard surfacing by removing the area of concrete closest to the house to allow the planted garden area to be extended. In addition, breaking up any retained concrete slabs and installing a topping layer of gravel would 'infill' any uneven areas and vertical trip hazards whilst increasing the rainwater penetration beneath the parking area.

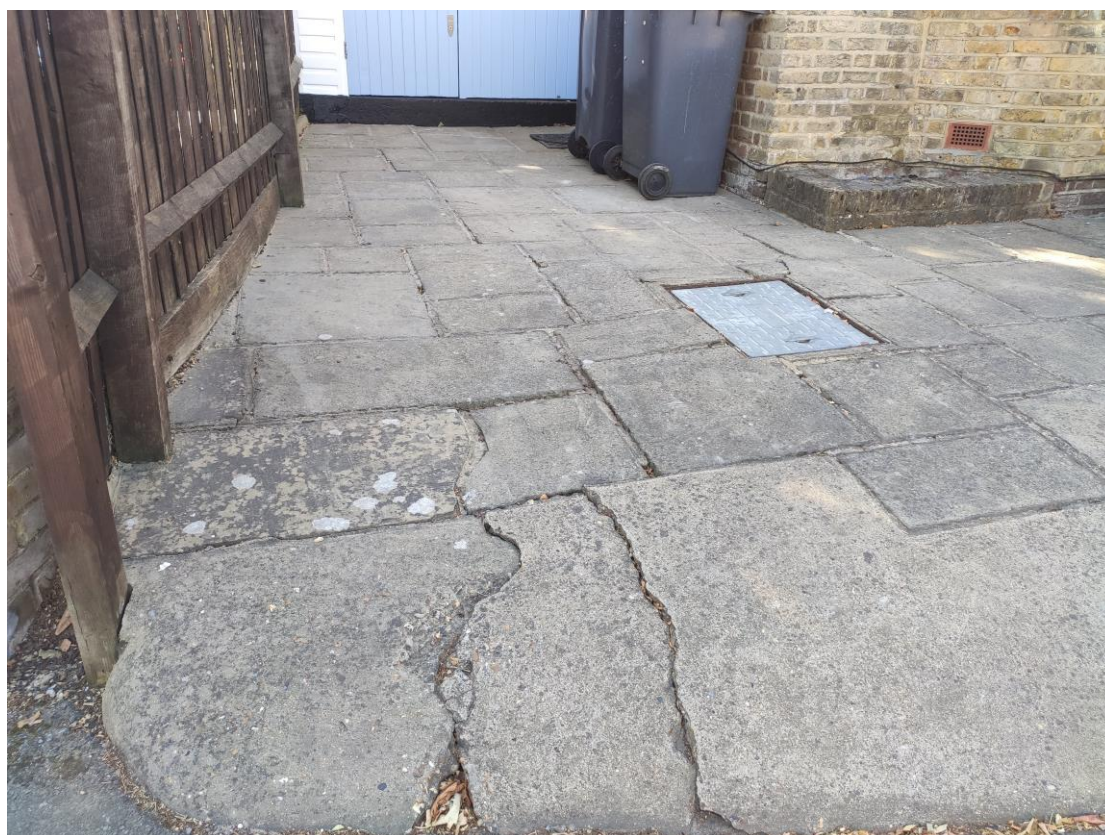
4.3.1. The front paved area and off-street parking within 14 Page's Lane is distorted around the inspection chamber and drains; and has sunk particularly on the eastern side adjacent to the party boundary (refer to photograph 6 below). In addition, there is cracking to the floor slab and tiling of the side extension.

**Photograph 6 showing distorted and sunken paving at 14 Page's Lane.**

6.1.2. The roots may be contributing to indirect damage to the neighbouring property due to the uptake of water close to the foundations.

5.2.3. **Install a Root Barrier:** A trench could be excavated along the party boundary between 1 St. Martins Terrace and 14 Pages Lane. The concrete slabs could be broken up using a pneumatic

hammer and a trench excavated by hand digging or Airspade to below the rooting level of the tree and neatly cutting the roots within the trench. Once the trench is completed a root barrier of Ribbed Root Panels or CuTex Copper root barrier can be installed to manufacturers specifications. The trench will then be back filled using the original soil carefully tamped into place and could be returned to an herbaceous planting area.
