# Arboricultural Survey

139 Stapleton Hall Road  
London  
N4 4RB  
22<sup>ND</sup> November 2022

| Claim number: | 2747535 |

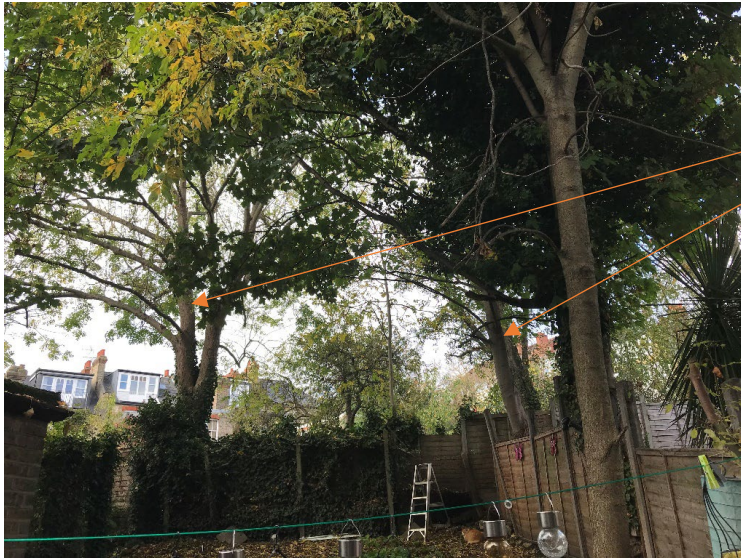
Looking down the garden ash and sycamore in the background. Both offsite trees

| Tree no | Species | Age | Distance to property (m) | Stem diameter (mm) | Spread (m) | Height | Condition structural and physiological | Observations | Ownership | Recommended work |
|---|---|---|---|---|---|---|---|---|---|---|
| T6 | Fraxinus excelsior (Ash) | Early mature | 13 | 650 | 9.0 | 12 | Fair | Offsite tree | Third party | No action at present |

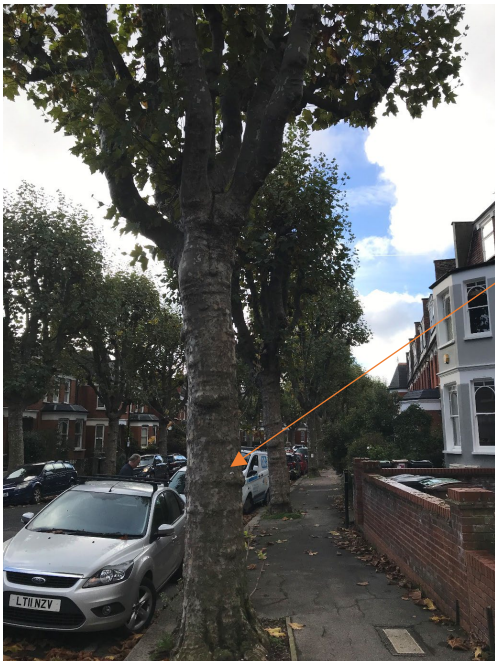
- 5.1.2 The council owned London Plane street trees T7 and T8 are managed as pollards and I believe these to have been pruned last year. Pursuance such as removal is unlikely to be accepted by the London Borough of Haringey based on the lack of data to implicate these trees, however it is advised that they are put on notice of the damage to the property.

Local Authority plane trees at the front of the property.

| Tree no | Species | Age | Distance to property (m) | Stem diameter (mm) | Spread (m) | Height | Condition structural and physiological | Observations | Ownership | Recommended work |
|---|---|---|---|---|---|---|---|---|---|---|
| T7 | Platanus x hispanica (London plane) | Mature | 9.0 | 600 | 7.0 | 8.5 | Fair | Pollarded street tree recently pruned | Third party | Maintain as pollard but notify the LA of the claim |
| T8 | Platanus x hispanica (London plane) | Mature | 9.5 | 600 | 5.0 | 8.5 | Fair | Pollarded street tree, recently pruned | | Maintain as pollard but notify |

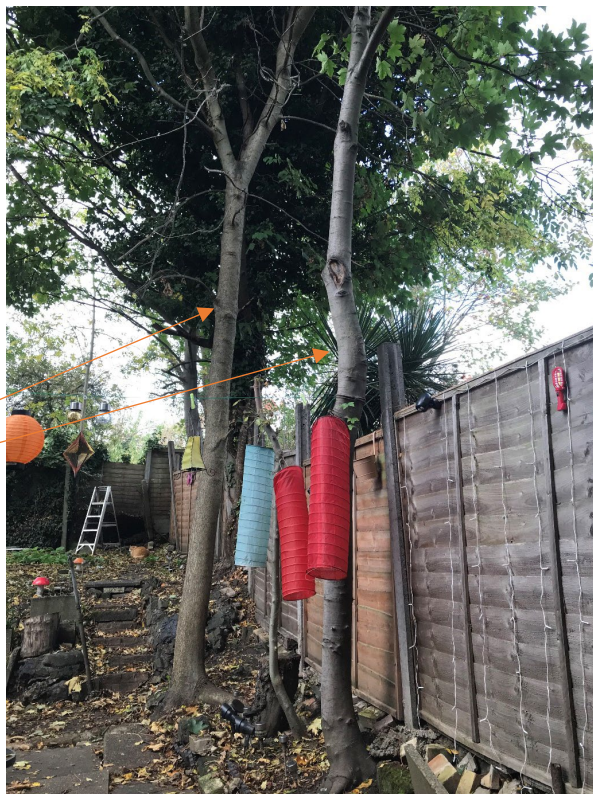
- 3.1.6 Roots were observed in TP3 emanating from Acer and which would appear to emanate from the sycamore located in the rear garden and adjacent garden, these were shown to be recently alive. All of these trees are within the zone of influence and due to their close proximity it is not possible to link the damage to a single tree.

Sycamore and ash tree within 5m of the property.

| Tree no | Species | Age | Distance to property (m) | Stem diameter (mm) | Spread (m) | Height | Condition structural and physiological | Observations | Ownership | Recommended work |
|---|---|---|---|---|---|---|---|---|---|---|
| T1 | Acer pseudoplatanus (Sycamore) | Early mature | 3.5 | 180 | 6.0 | 9.0 | Fair | n/a | Insured | Fell and kill |
| T2 | Fraxinus excelsior (Ash) | Early mature | 5 | 180 | 6.0 | 10.5 | Fair | n/a | Insured | Fell and kill |
