Our Ref: 7649/CCL  
14<sup>th</sup> September 2022

**Re: 25 Sheldon Avenue, N6**

We visited the above address on Monday 5<sup>th</sup> September to view the property and specifically review the left-hand side flank wall. As part of the current planning permission, it is intended to keep the front façade as well as the existing flank wall.

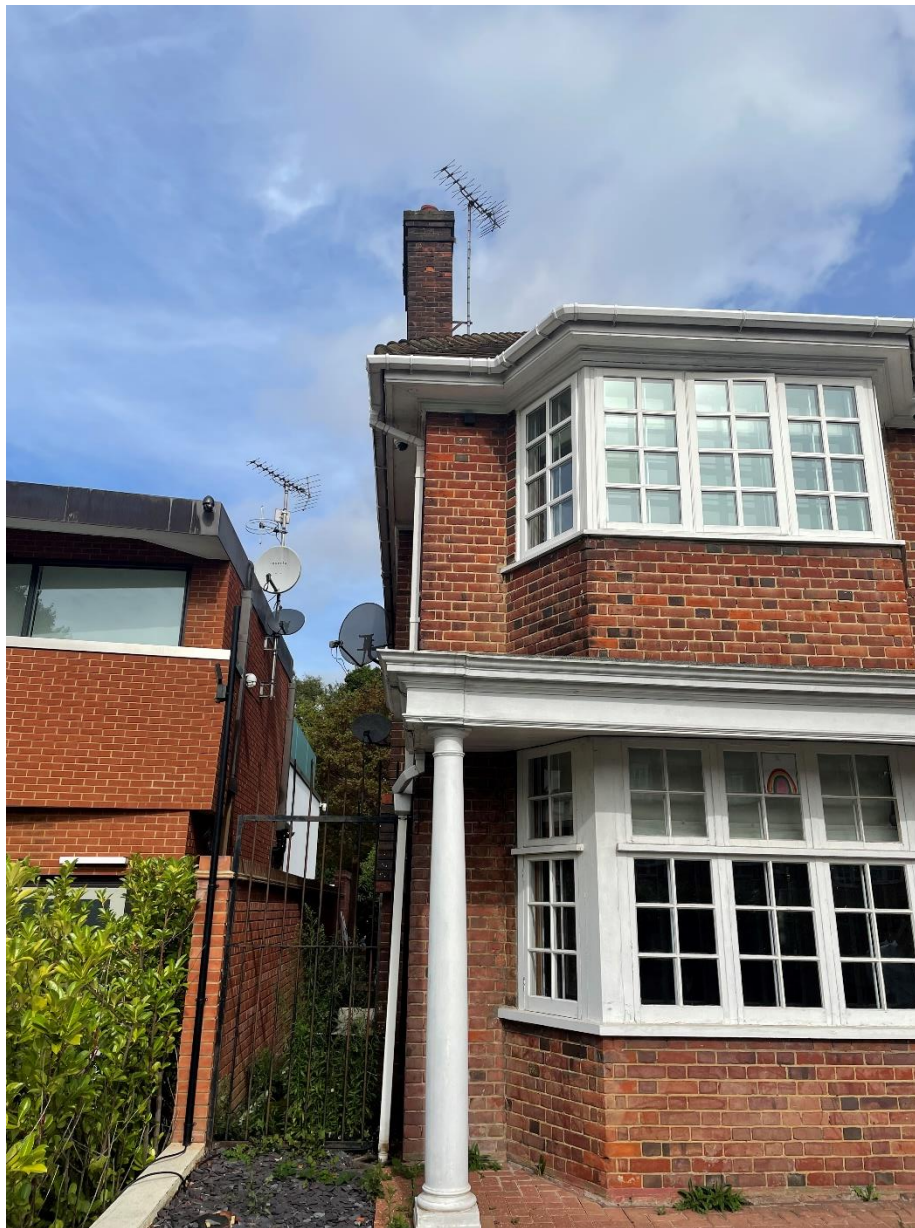
Our main concern about the flank wall is the stability of the chimney. The chimney is currently leaning away from the property and only currently restrained by the roof. It is also highly likely the wall will have been constructed with flues to accommodate the fireplaces at ground and 1<sup>st</sup> floor which will mean numerous stepped voids as these flues transition across to meet at the chimney above roof level, further removing the robustness of the wall. Further, there are defects in the wall such as the cracking under the ground floor window. Due to the position of the openings at ground and 1<sup>st</sup> floor level, the flank wall is providing very little buttress effect to the front wall and conversely, the flank wall is not well buttressed by the front wall for the same reason. There is likely to be little buttress to the flank wall at the rear due to the addition of the rear ground floor extension and the removal of the existing ground floor rear wall. The flank wall does not meet the current requirements for vertical movement joints and as a result may be susceptible to thermal movement.

1.0 Leaning Chimney above Roof level

The current flank wall has numerous defects. As a result of the leaning chimney, questionable wall construction (numerous flues) and poor front and rear wall buttressing the wall will be very vulnerable during demolition and conversion of this property. Unlike the front wall façade retention, the close proximity of the wall to the boundary and the adjacent property hinders effective temporary works measures and therefore creates serious health and safety issues. Based on the above, structurally, we would recommend the wall is demolished to ensure the safe conversion of the property and gives the opportunity to provide a new robust wall to modern standards.

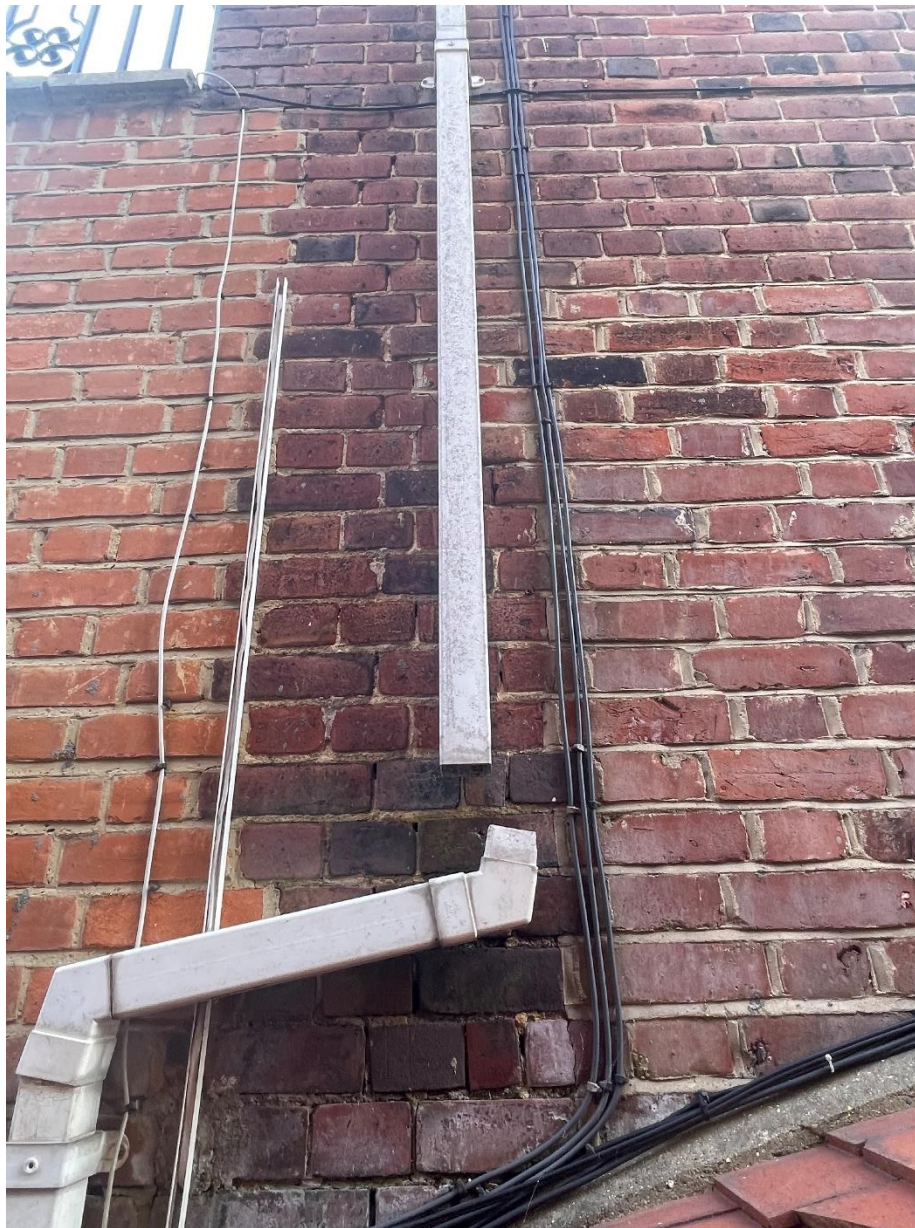
2.0 Cracking at toothed junction with newer extension. Questionable buttress.

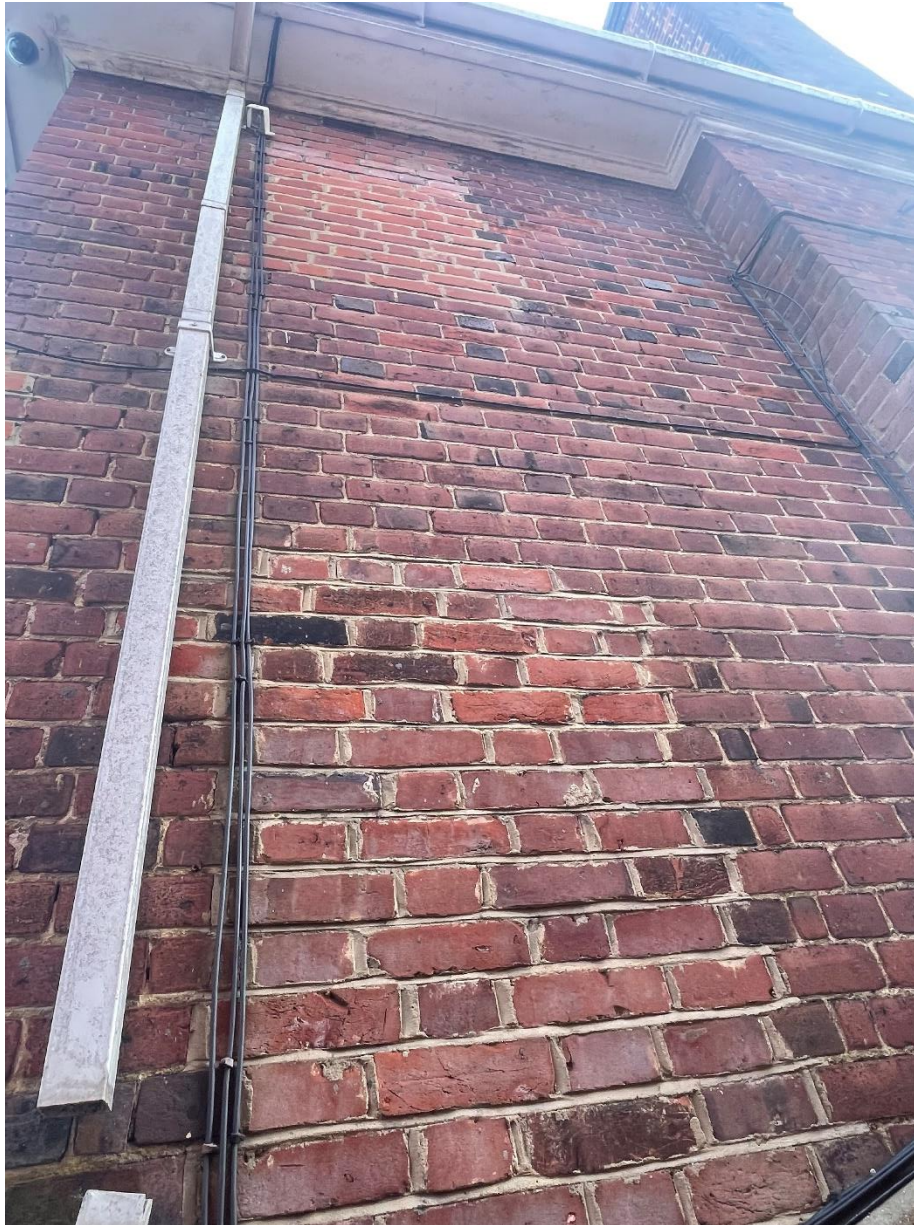
3.0 Infilled windows.

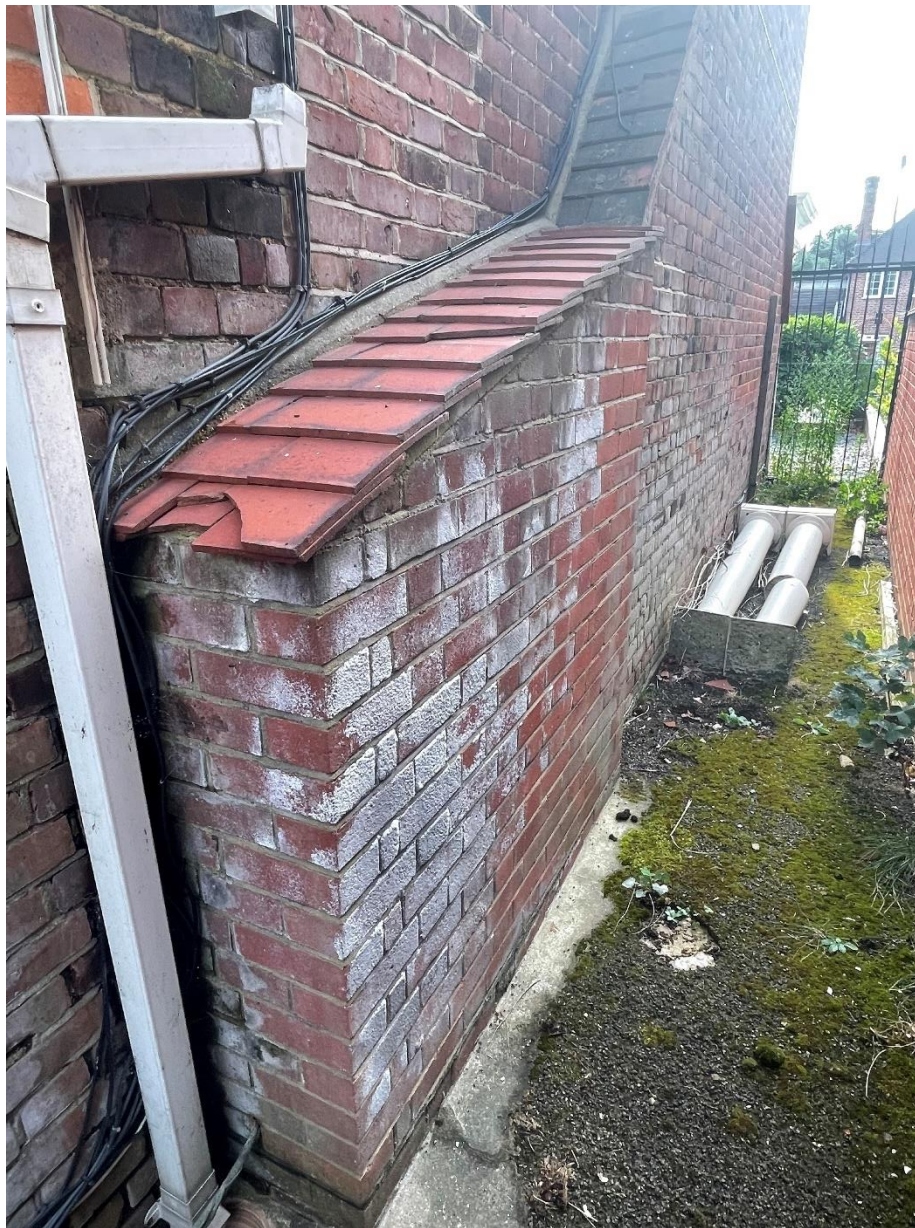
4.0 Newer rear Chimney breast extension.

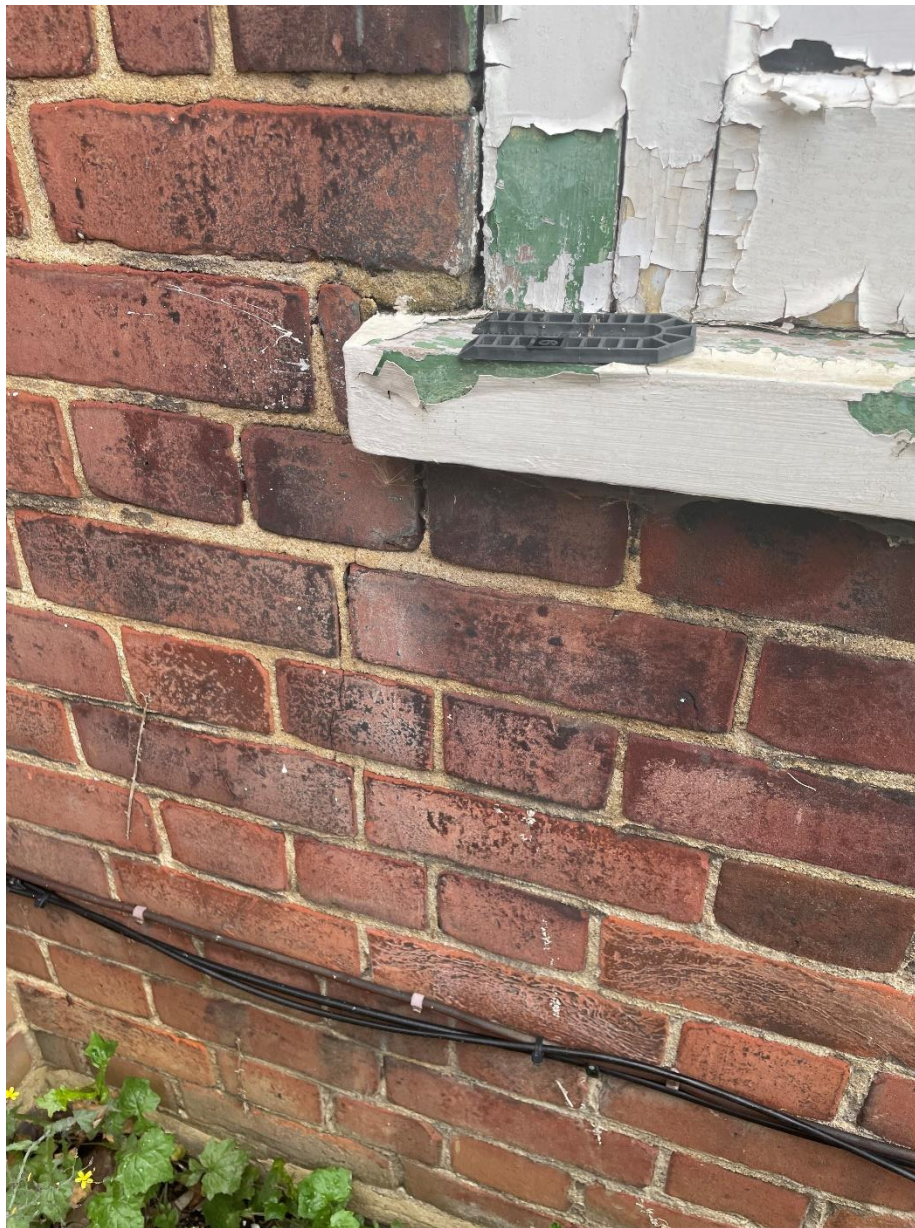
5.0 Cracking under ground floor window.

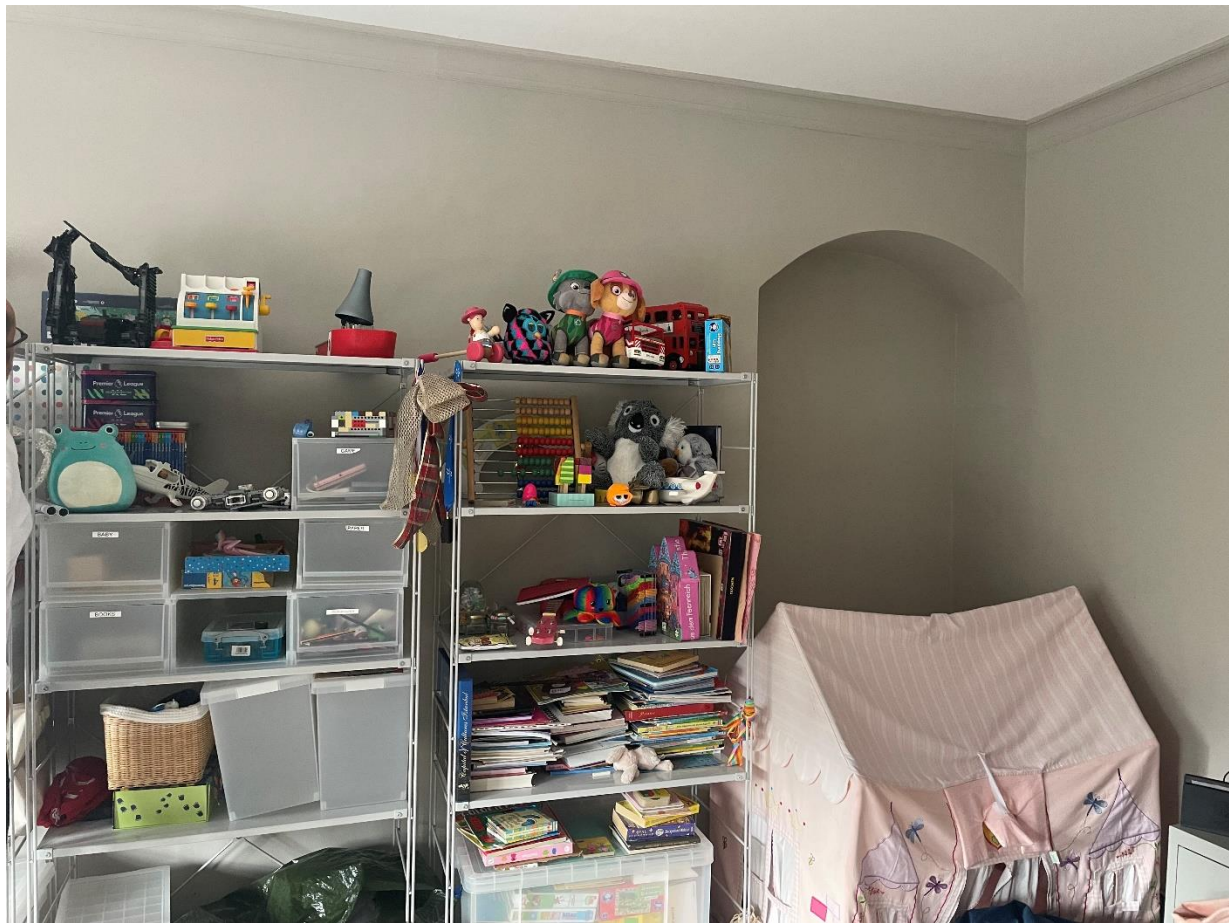
6.0 Internal ground floor. Flues in existing wall serving fireplaces?
