| Site & Location | <b>Highgate School - Richards Music Centre</b><br><b>Bishopswood Road, London N6 4PR</b> | Report No: | <b>9933 / JRCB</b> |

### SUMMARY OF CLASSIFICATION TEST RESULTS

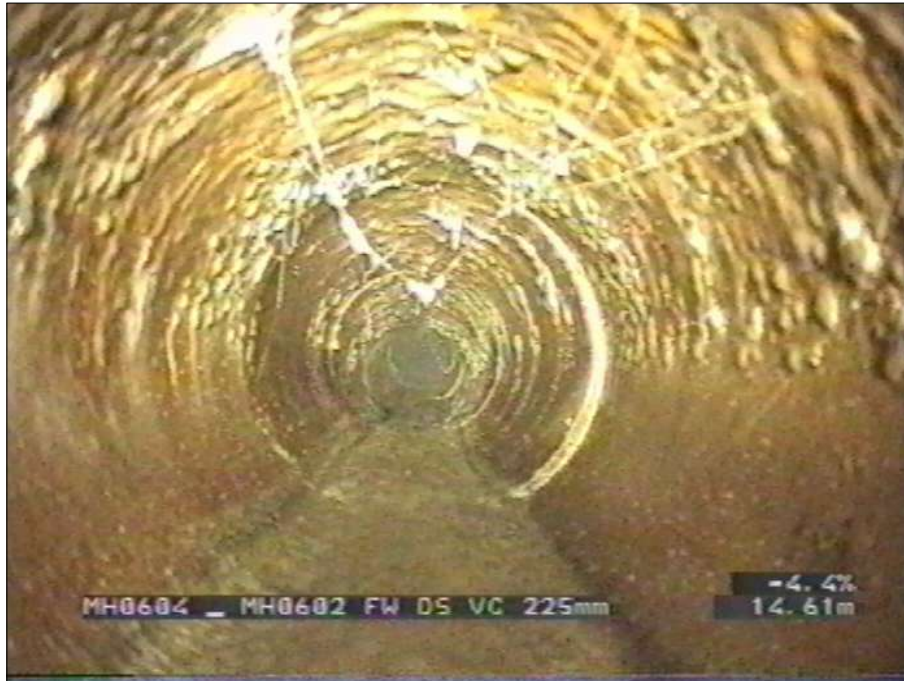
Photo: 3\_3a, Tape No.: 002, 23:21:29  
0m, Attached deposits, fouling from 09 to 03 o'clock 05 %  
cross-sectional area loss, Start

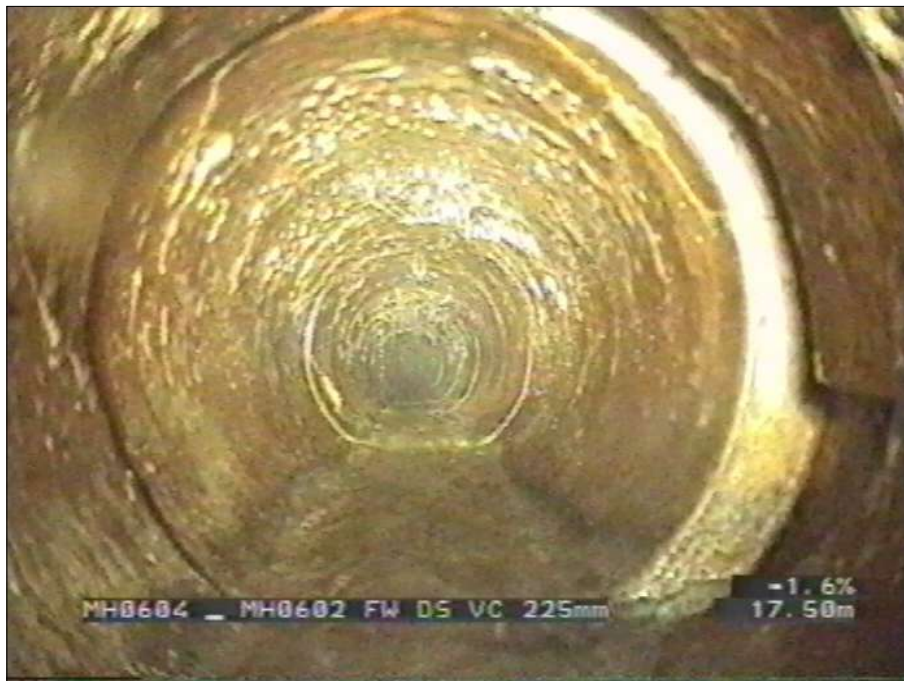
Photo: 5\_5a, Tape No.: 002, 23:23:36  
17.36m, Broken Pipe at joint from 04 to 06 o'clock

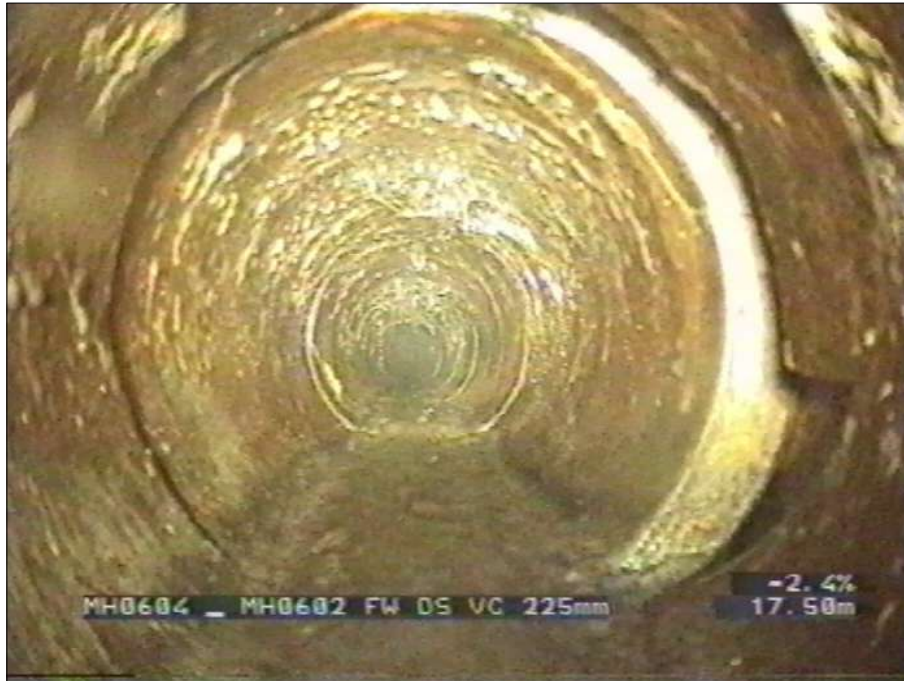
Photo: 5\_5b, Tape No.: 002, 23:23:36  
 17.36m, Broken Pipe at joint from 04 to 06 o'clock

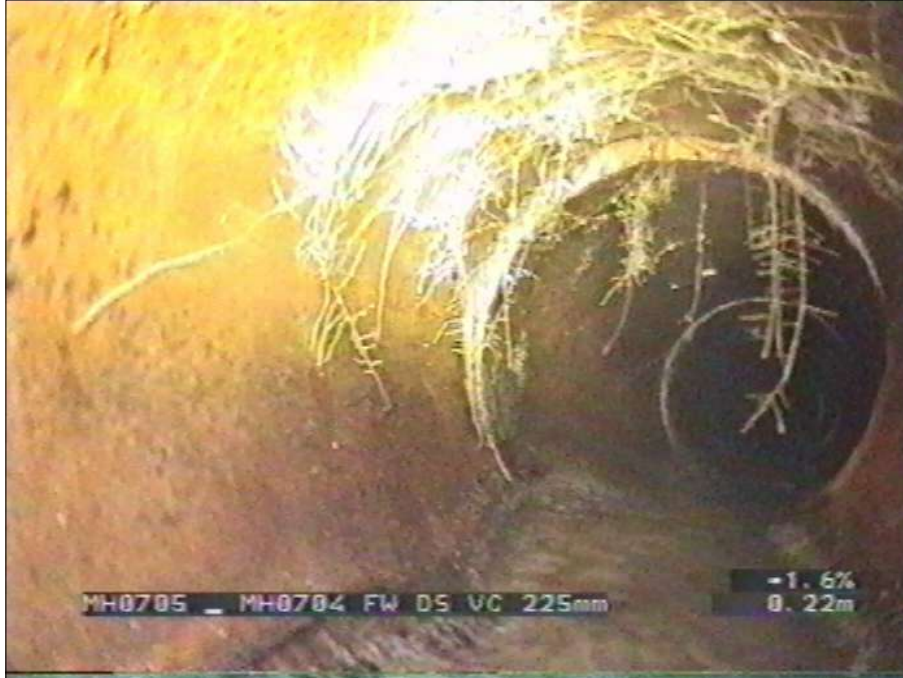
Photo: 15\_3a, Tape No.: 002, 23:36:20  
0.45m, Fine Roots

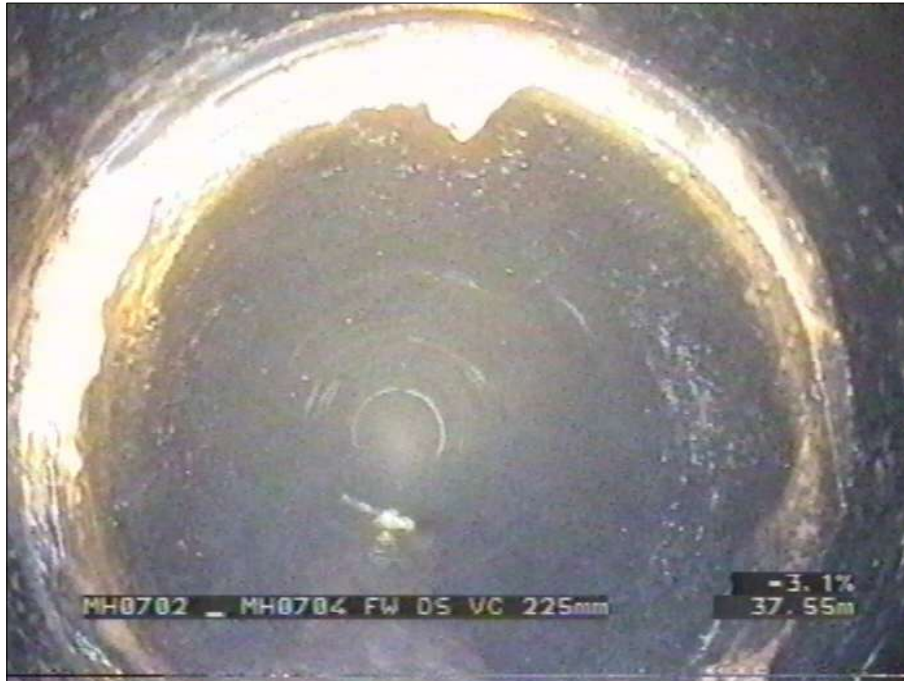
Photo: 58\_3a, Tape No.: 002, 23:53:49  
37.54m, Infiltration Dripping at 12 o'clock

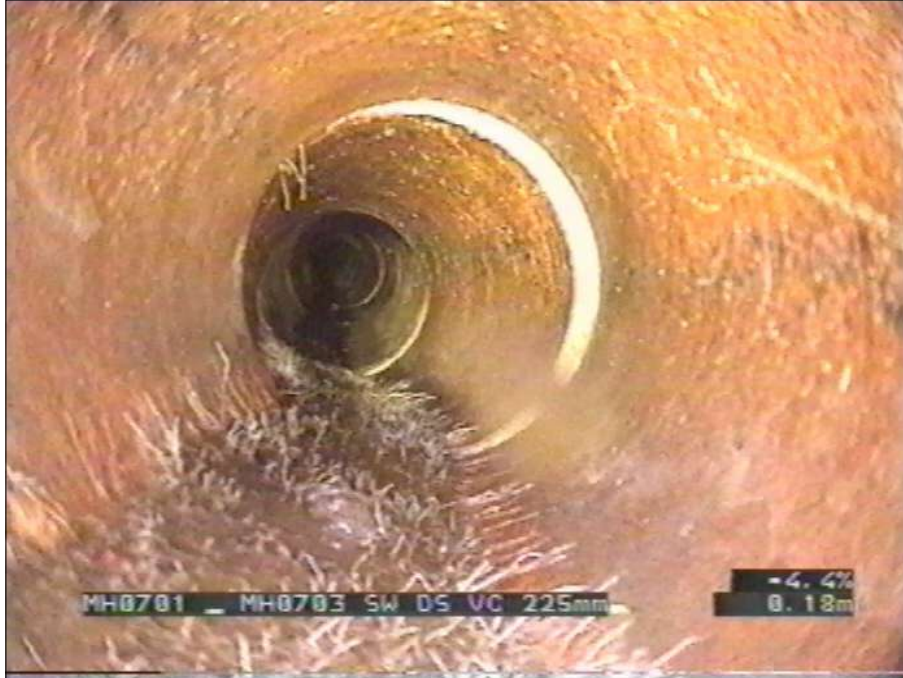
Photo: 8\_29555a, Tape No.: 002, 23:56:33  
0m, Fine Roots, Start

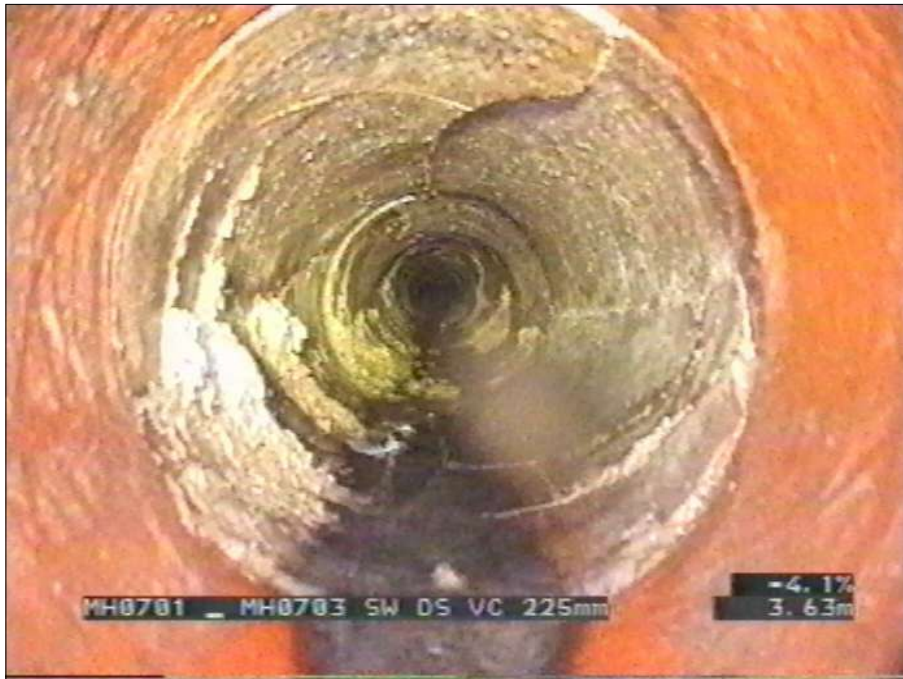
Photo: 8\_29559a, Tape No.: 002, 23:57:43  
3.76m, Fractures multiple from 10 to 06 o'clock

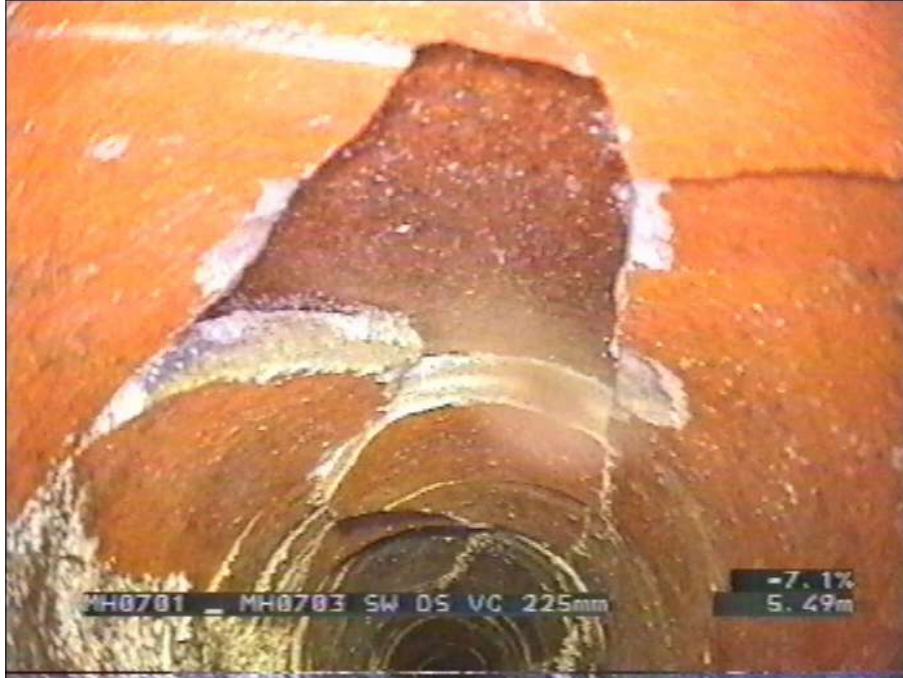
Photo: 8\_29563a, Tape No.: 002, 23:57:57

5.44m, Broken pipe from 11 to 01 o'clock Remark: Missing pipe

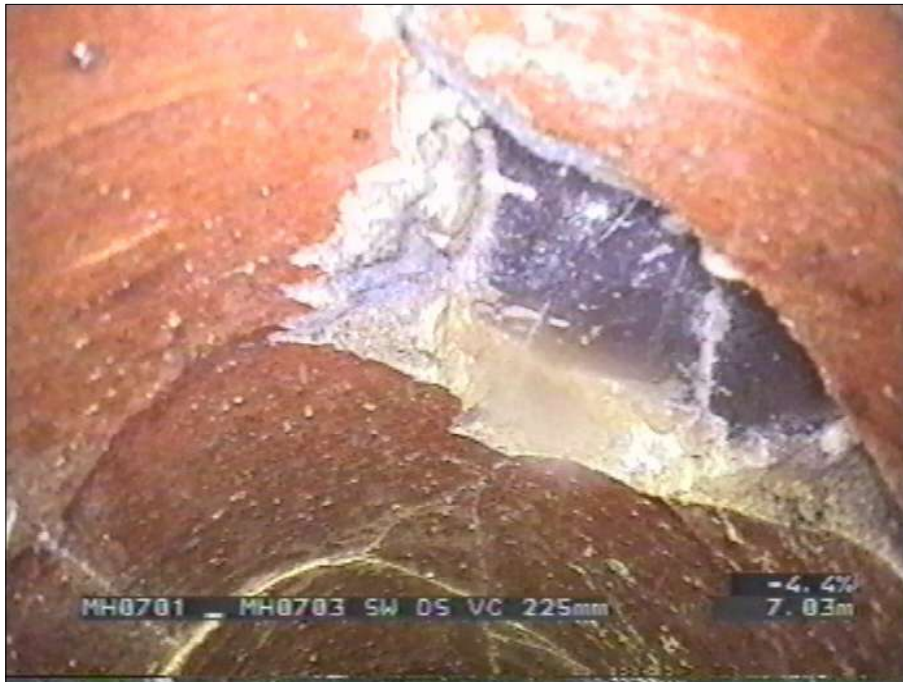
Photo: 8\_29567a, Tape No.: 002, 23:58:16

6.9m, Broken pipe from 11 to 02 o'clock Remark: Missing pipe

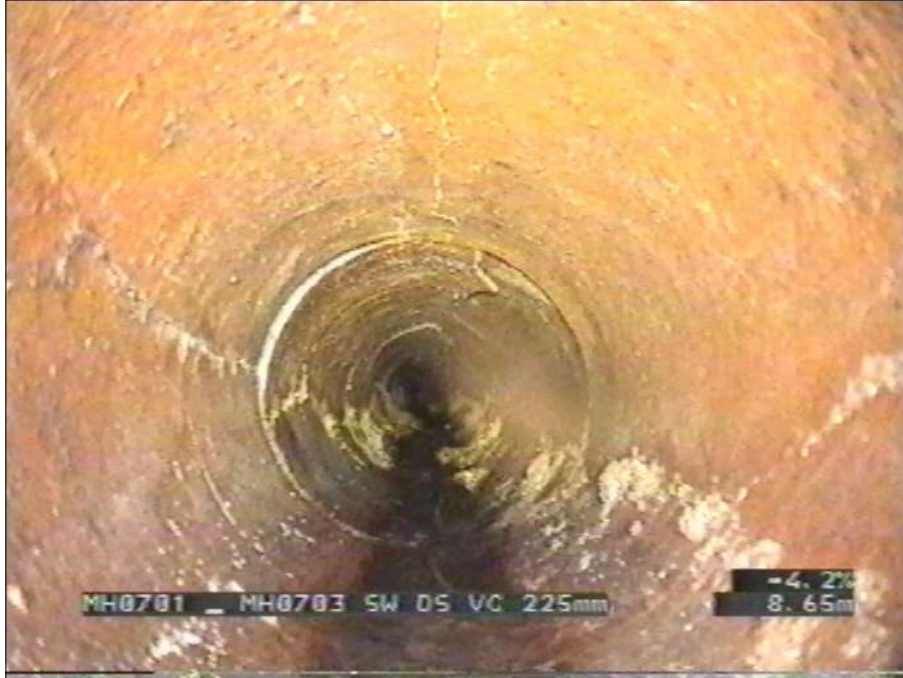
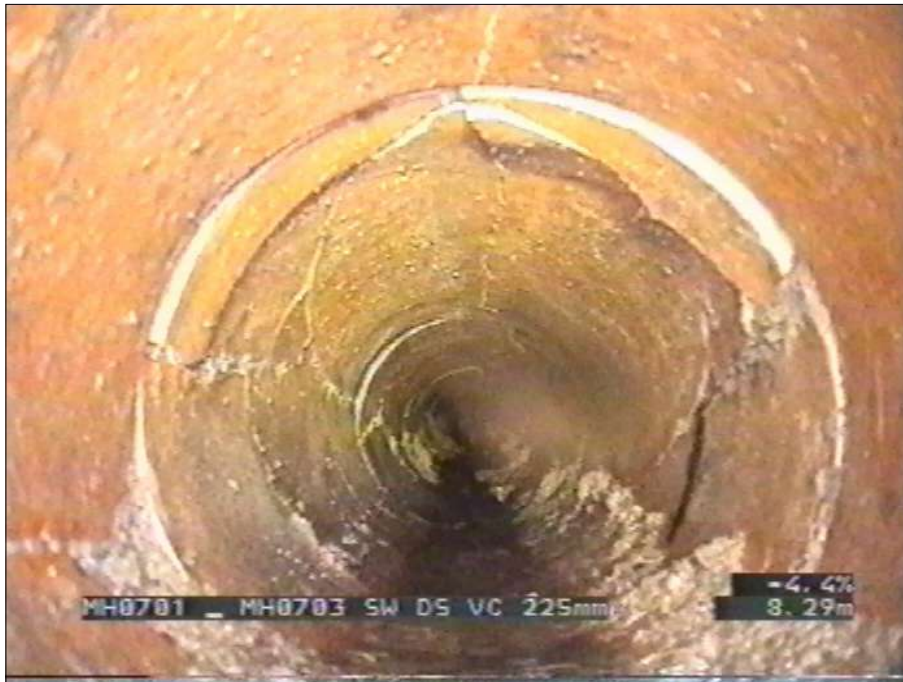
Photo: 8\_29569a, Tape No.: 002, 23:58:36  
8.42m, Broken Pipe at joint from 09 to 03 o'clock

Photo: 8\_29569b, Tape No.: 002, 23:58:36  
8.42m, Broken Pipe at joint from 09 to 03 o'clock

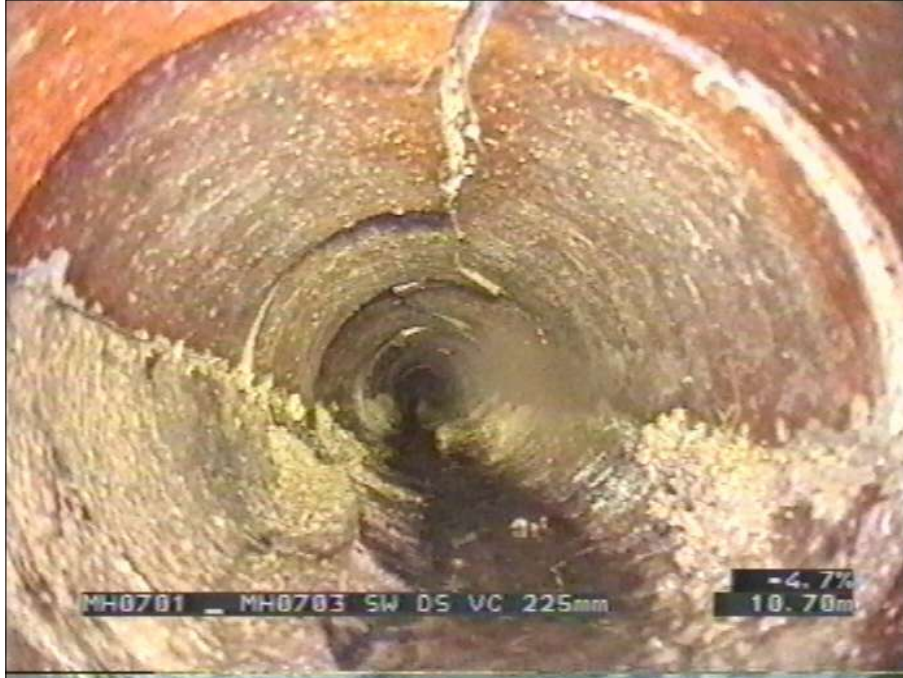
Photo: 8\_29574a, Tape No.: 002, 23:58:57  
10.76m, Broken pipe from 09 to 12 o'clock

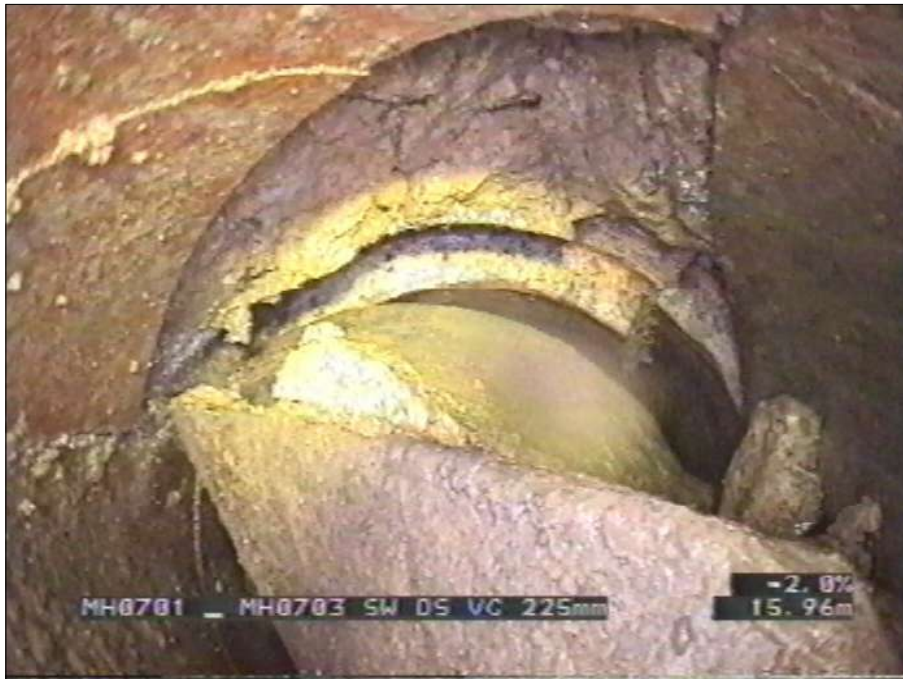
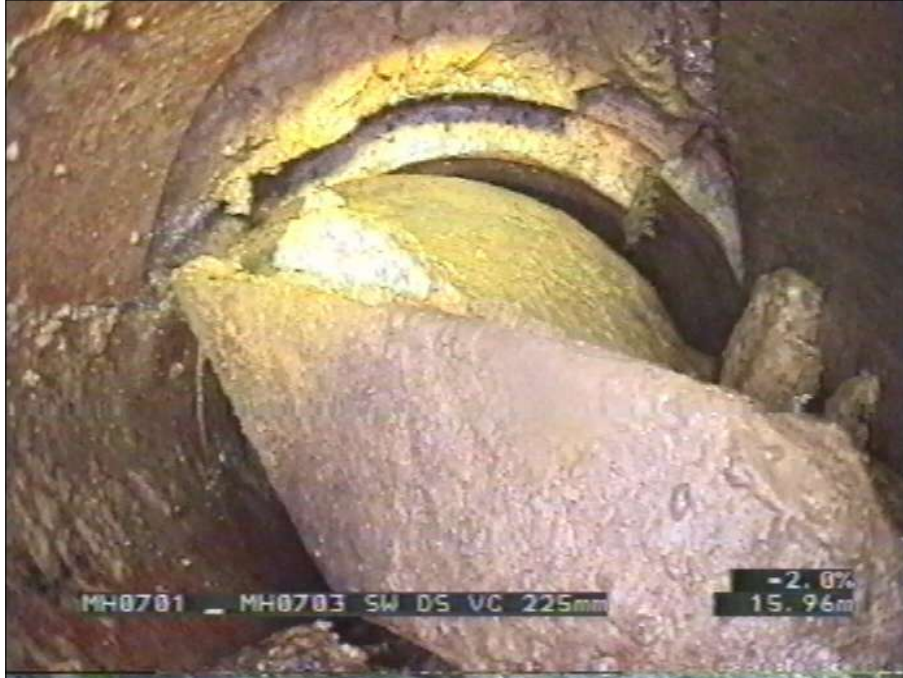
Photo: 8\_29582a, Tape No.: 002, 23:59:42  
15.96m, Hole in sewer from 09 to 03 o'clock Remark: obstruction  
broken pipe

Photo: 8\_29582b, Tape No.: 002, 23:59:42  
15.96m, Hole in sewer from 09 to 03 o'clock Remark: obstruction  
broken pipe
