| Grade Defect Report | | | | | | | | |

## REPORT INSPECTION

## CCTV Drainage Survey

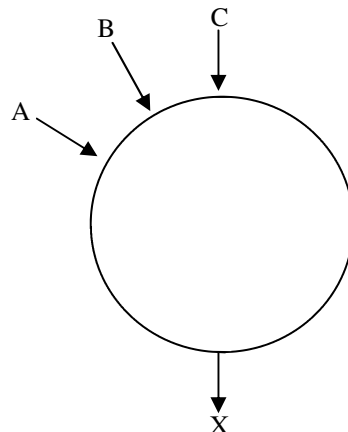
Remarks: Step Iron Broken

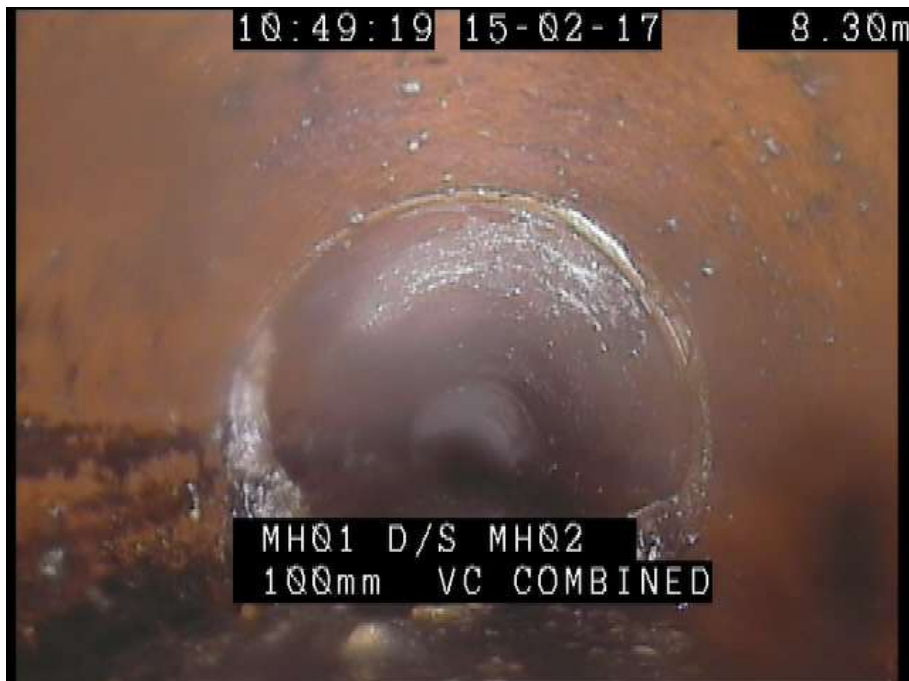
Photo: 1\_11A

8.3m, Settled deposits, fine, 15% cross-sectional area loss

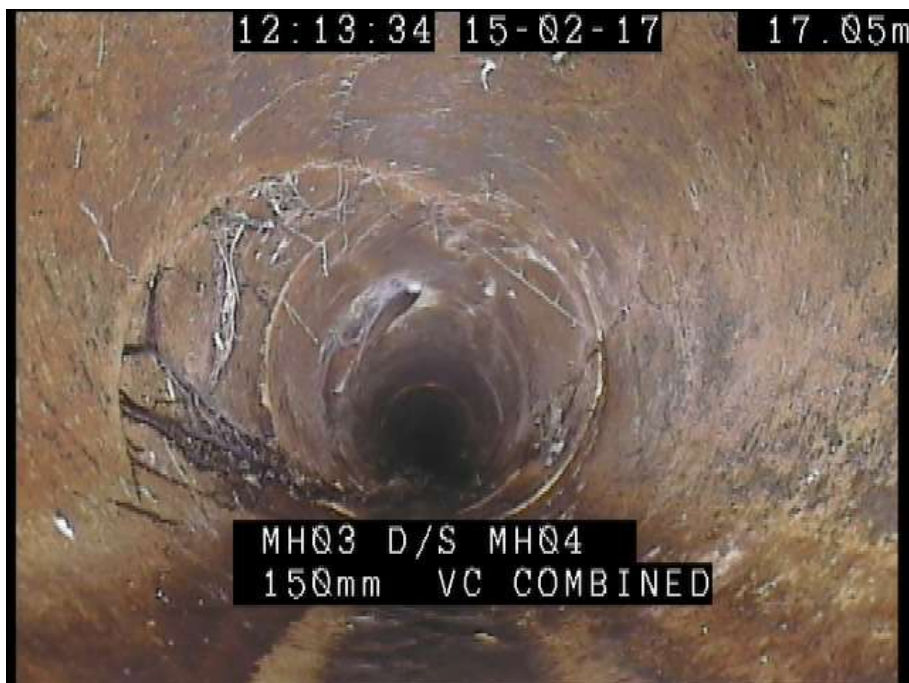
Photo: 4\_4A

| 1:500 | Position | Code | Observation | Grade | |
|---|---|---|---|---|---|
| | 17.15 | FC | Fracture, circumferential, from 8 to 3 o'clock | 3 | |

17.15m, Fracture, circumferential, from 8 to 3 o'clock

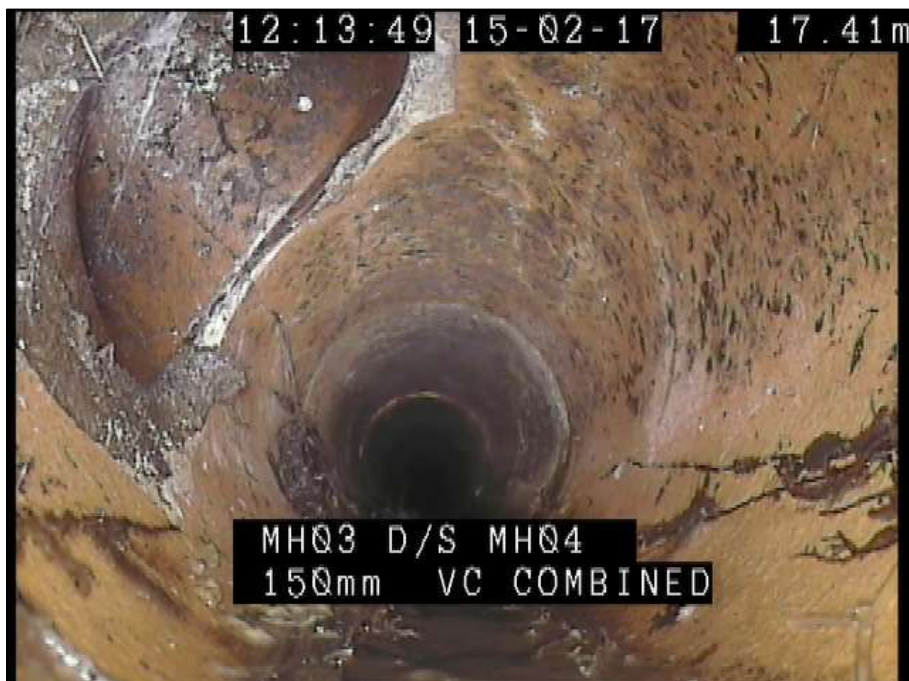
Photo: 4\_7A

| 1:500 | Position | Code | Observation | Grade | |
|---|---|---|---|---|---|
| | 17.40 | FL | Fracture, longitudinal, at 3 o'clock | 3 | |

17.4m, Fracture, longitudinal, at 3 o'clock

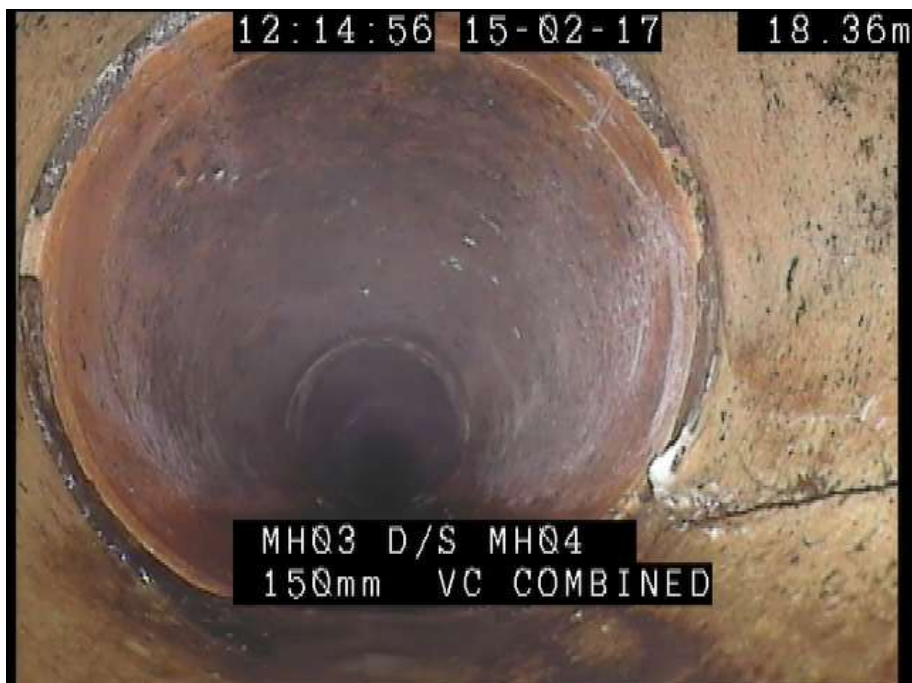
| 1:500 | Position | Code | Observation | Grade | |
|---|---|---|---|---|---|
| | 18.30 | FL | Fracture, longitudinal, at 4 o'clock | 3 | |

Photo: 4\_8A  
18.3m, Fracture, longitudinal, at 4 o'clock

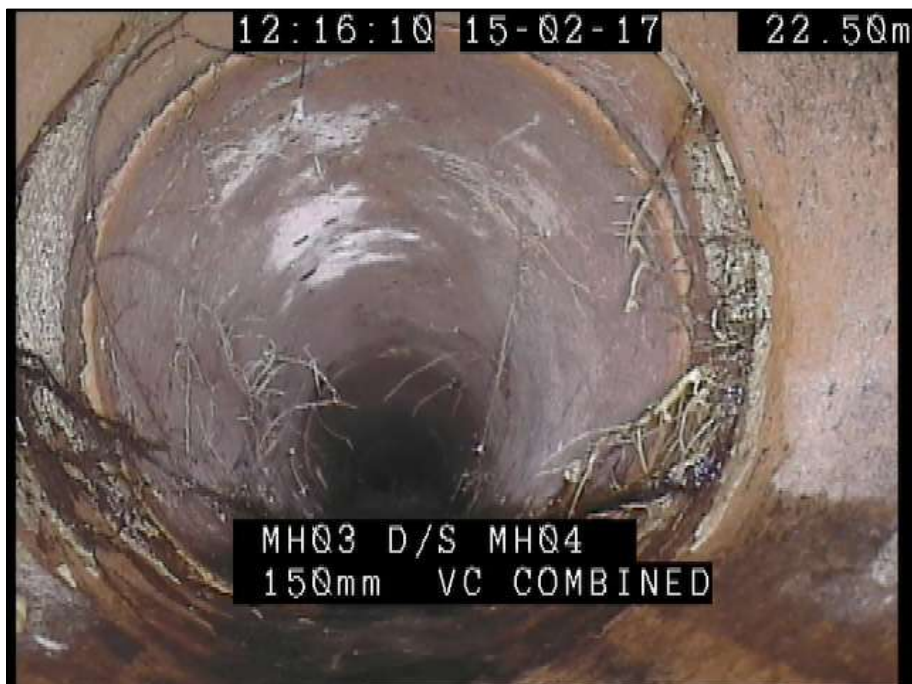
| 1:500 | Position | Code | Observation | Grade | |
|---|---|---|---|---|---|
| | 22.50 | FCJ | Fracture, circumferential at joint, from 7 to 5 o'clock | 3 | |

Photo: 4\_11A  
22.5m, Fracture, circumferential at joint, from 7 to 5 o'clock

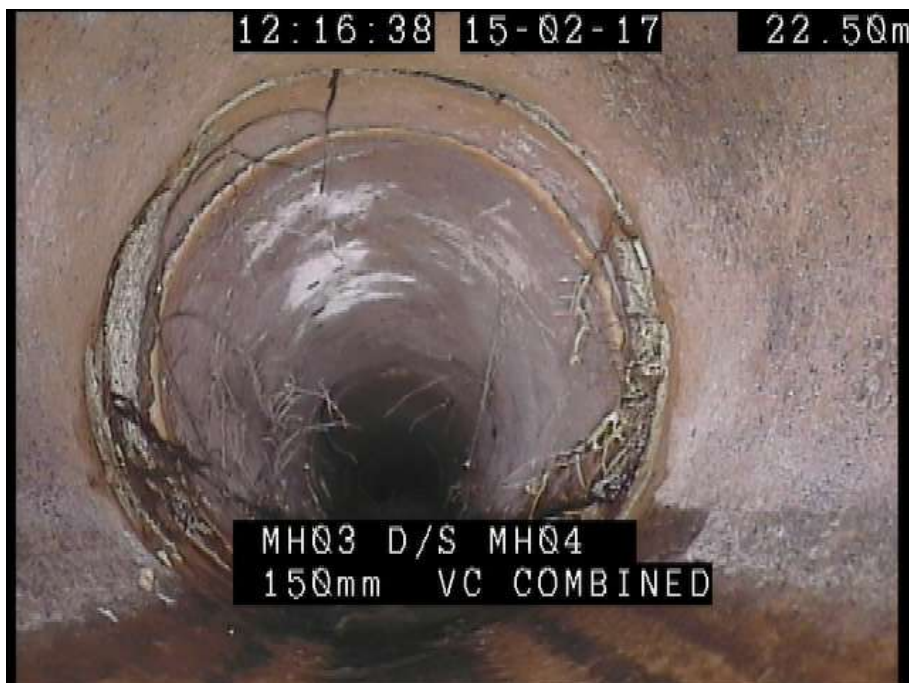
| 1:500 | Position | Code | Observation | Grade | |
|---|---|---|---|---|---|
| | 22.50 | FLJ | Fracture, longitudinal at joint, at 12 o'clock | 3 | |

Photo: 4\_12A  
22.5m, Fracture, longitudinal at joint, at 12 o'clock

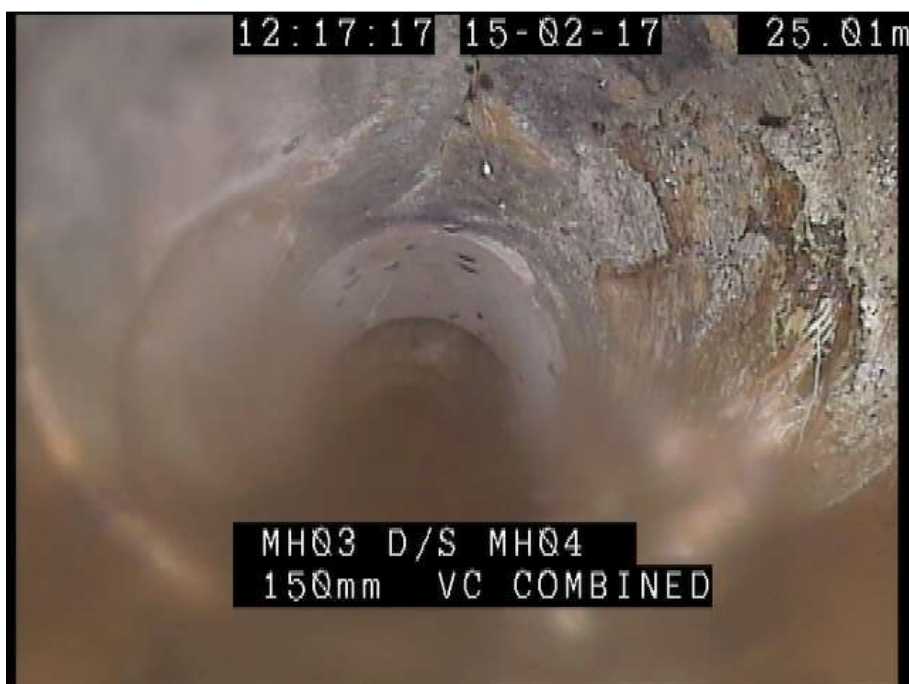
| 1:500 | Position | Code | Observation | Grade | |
|---|---|---|---|---|---|
| | 25.00 | FL | Fracture, longitudinal, at 12 o'clock | 3 | |

Photo: 4\_14A  
25m, Fracture, longitudinal, at 12 o'clock

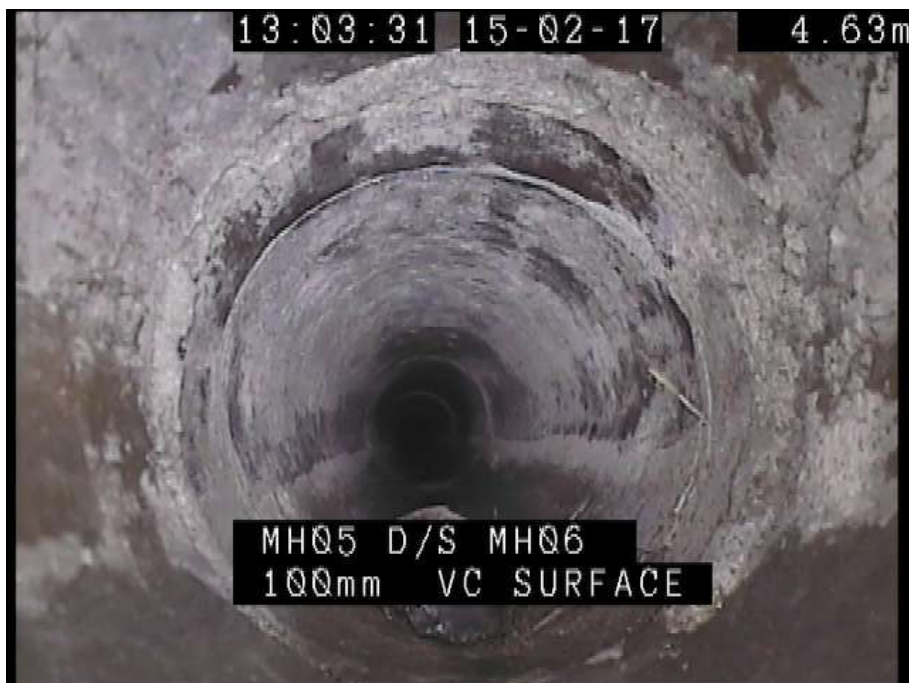
Photo: 7\_4A

| 1:500 | Position | Code | Observation | Grade |
|---|---|---|---|---|
| | 4.60 | FCJ | Fracture, circumferential at joint, from 7 to 5 o'clock | 3 |

4.6m, Fracture, circumferential at joint, from 7 to 5 o'clock

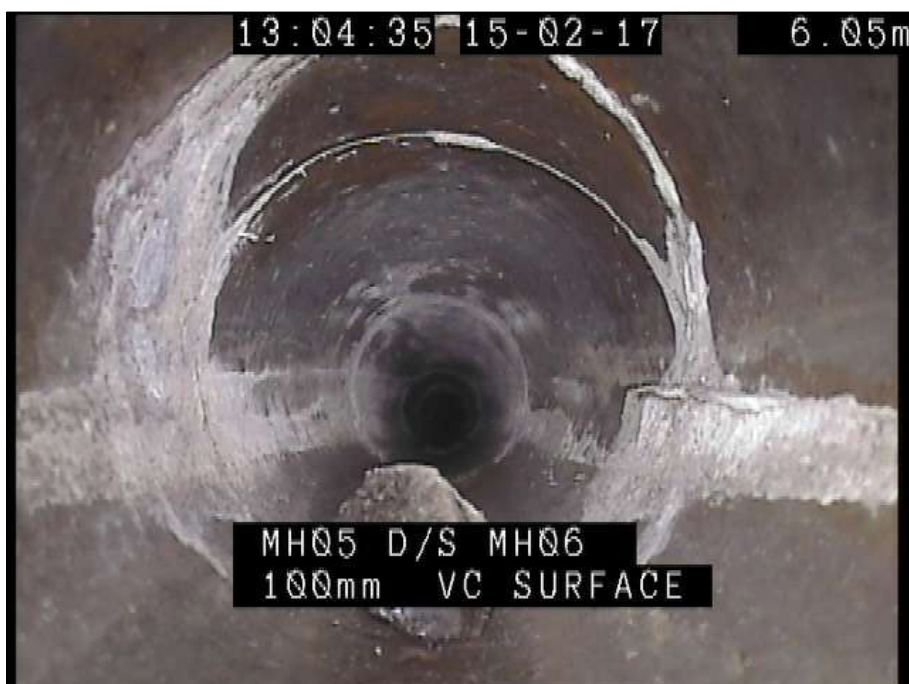
Photo: 7\_5A

| 1:500 | Position | Code | Observation | Grade |
|---|---|---|---|---|
| | 6.00 | FCJ | Fracture, circumferential at joint, from 10 to 3 o'clock | 3 |

6m, Fracture, circumferential at joint, from 10 to 3 o'clock

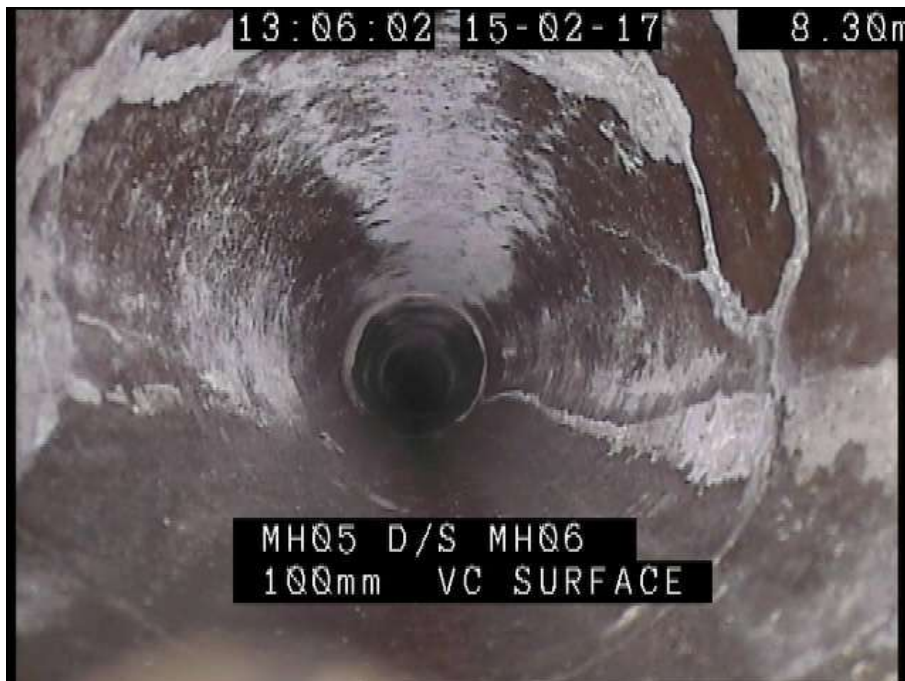
Photo: 7\_7A

| 1:500 | Position | Code | Observation | Grade |
|---|---|---|---|---|
| | 8.30 | FCJ | Fracture, circumferential at joint, from 9 to 3 o'clock | 3 |

8.3m, Fracture, circumferential at joint, from 9 to 3 o'clock

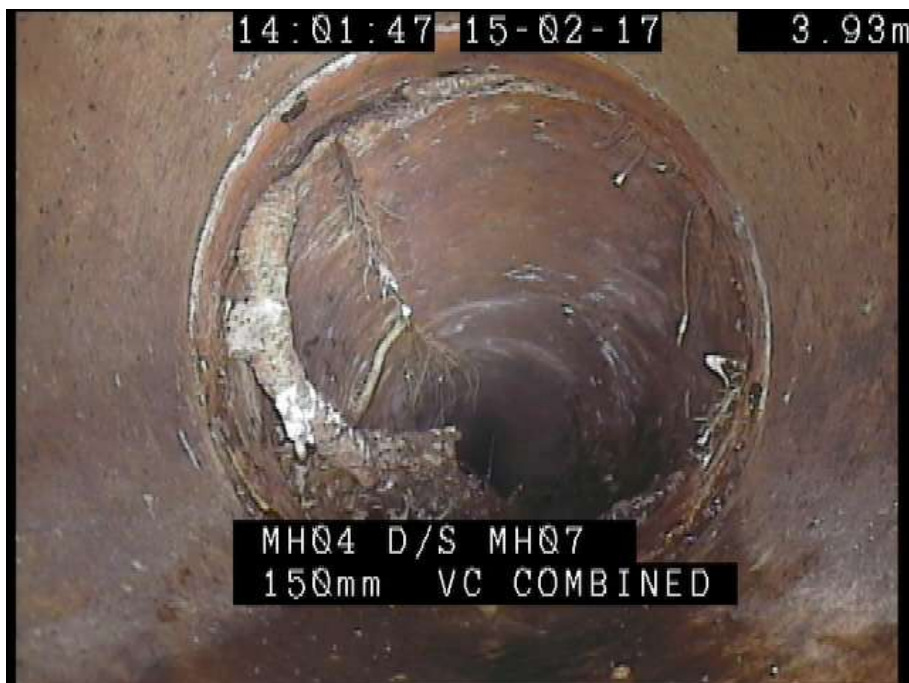
| 1:500 | Position | Code | Observation | Grade |
|---|---|---|---|---|
| | 3.90 | B | Broken pipe, from 7 to 5 o'clock | 4 |

Photo: 8\_7A  
3.9m, Roots, tap Remarks: From break

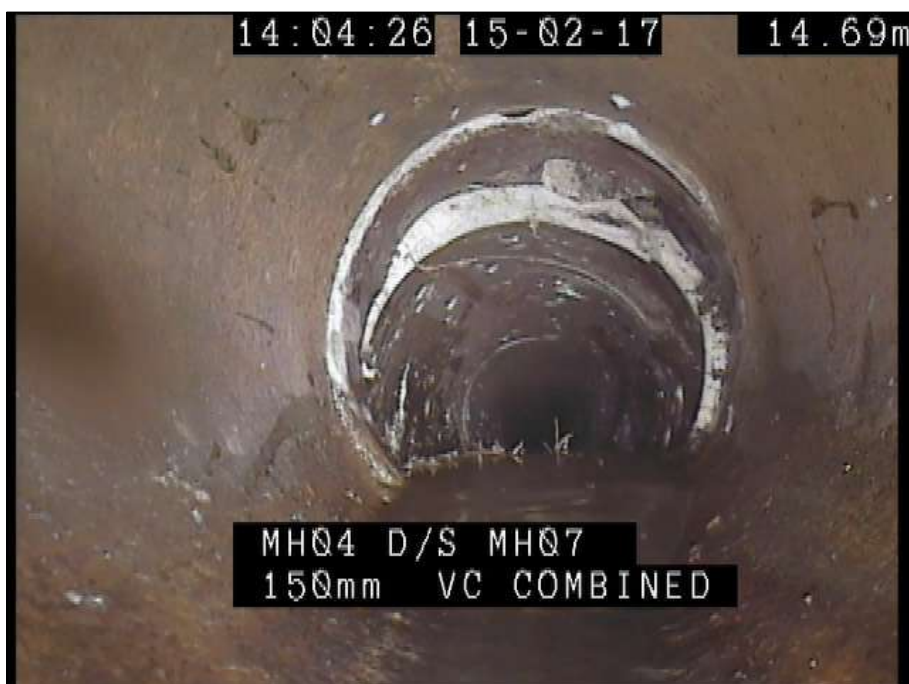
| 1:500 | Position | Code | Observation | Grade |
|---|---|---|---|---|
| | 14.60 | B | Broken pipe, from 7 to 5 o'clock | 4 |

Photo: 8\_12A  
14.6m, Broken pipe, from 7 to 5 o'clock

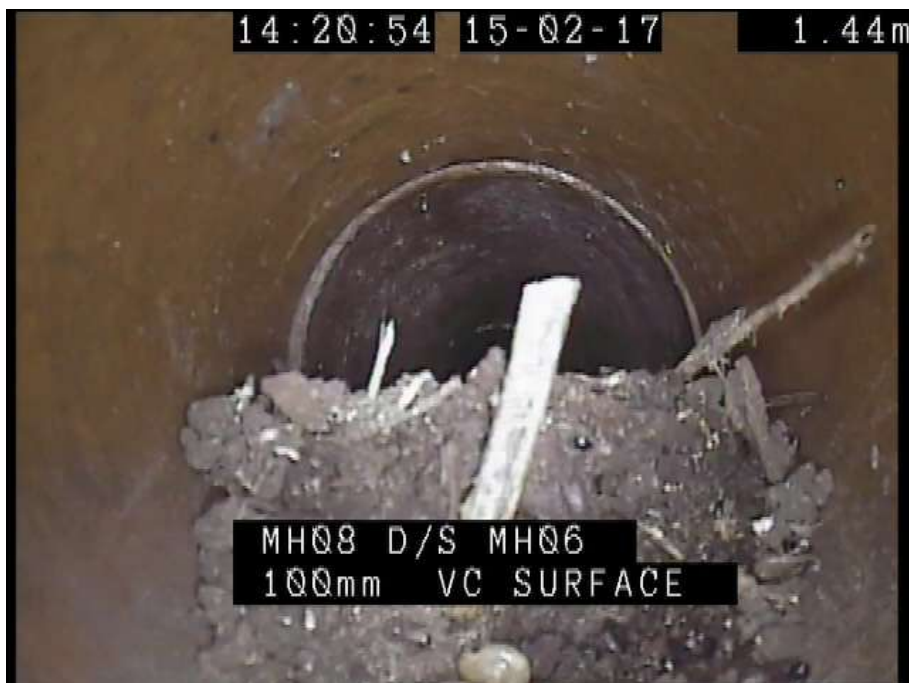
Photo: 9\_4A

1.4m, Settled deposits, fine, 30% cross-sectional area loss

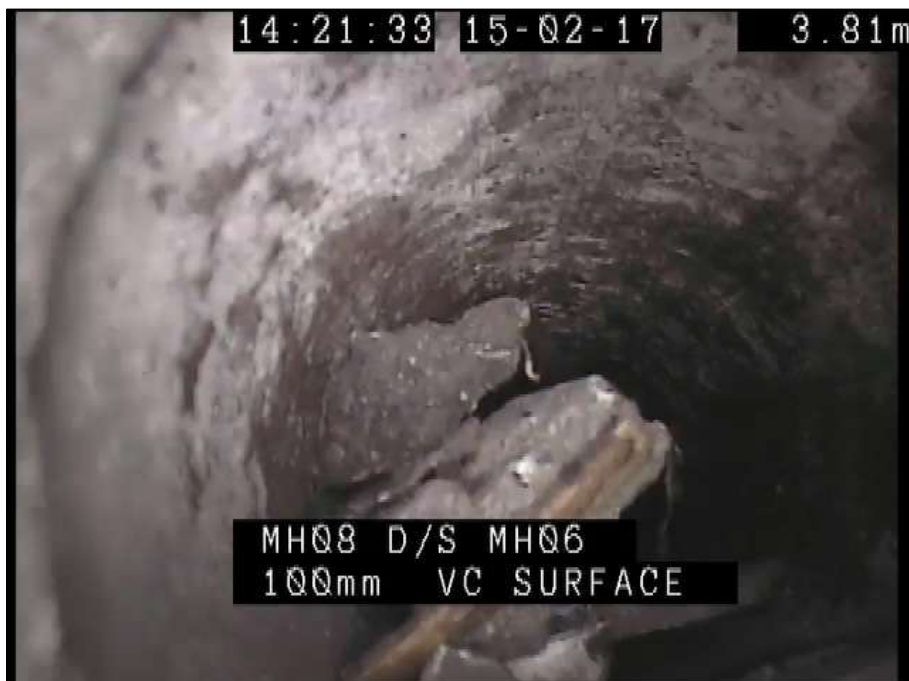
Photo: 9\_6A

3.81m, Settled deposits, coarse, 60% cross-sectional area loss  
(pushing)

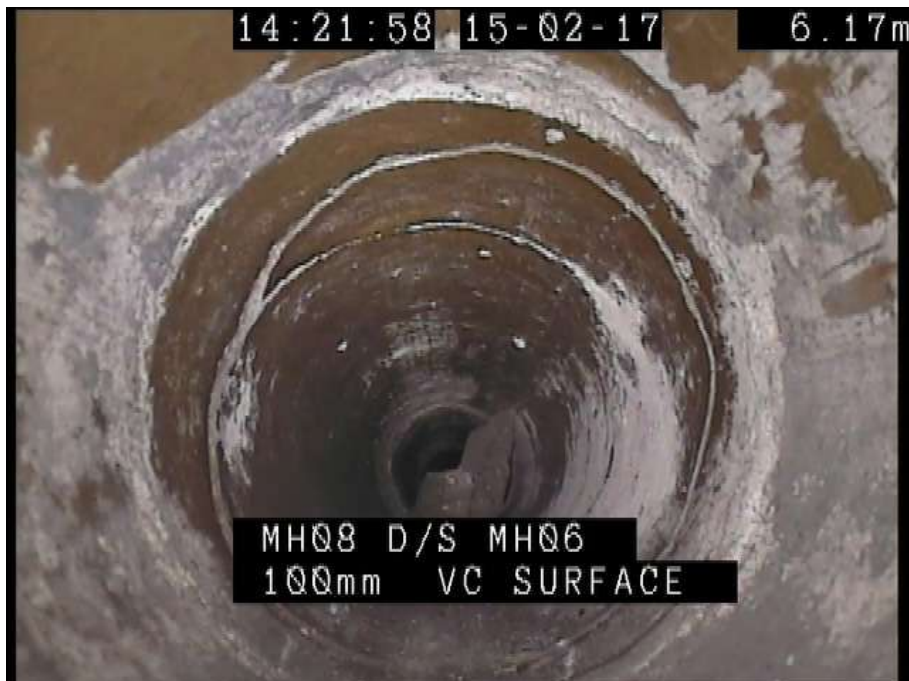
Photo: 9\_7A

| 1:500 | Position | Code | Observation | Grade | |
|---|---|---|---|---|---|
| | 6.17 | FC | Fracture, circumferential, from 12 to 12 o'clock | 3 | |

6.17m, Fracture, circumferential, from 12 to 12 o'clock

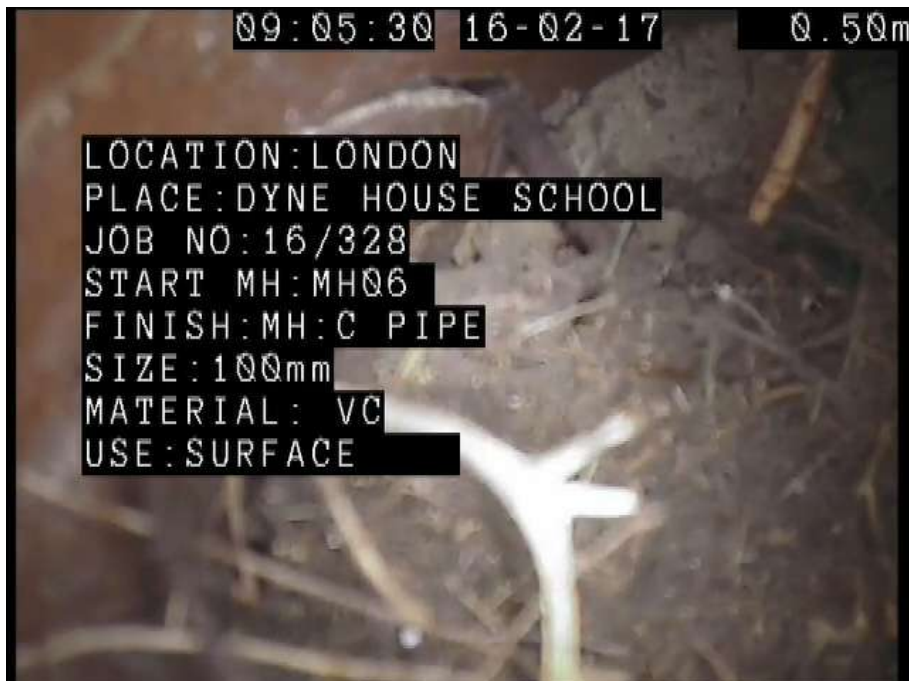
Photo: 11\_3A

0.5m, Settled deposits, coarse, 95% cross-sectional area loss

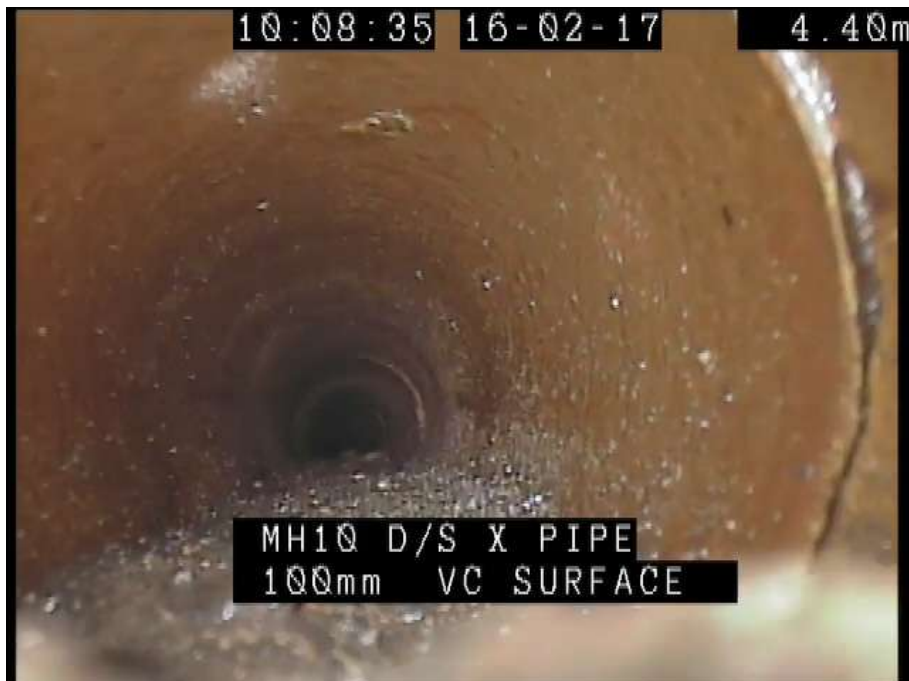
Photo: 13\_3A

4.4m, Settled deposits, fine, 20% cross-sectional area loss

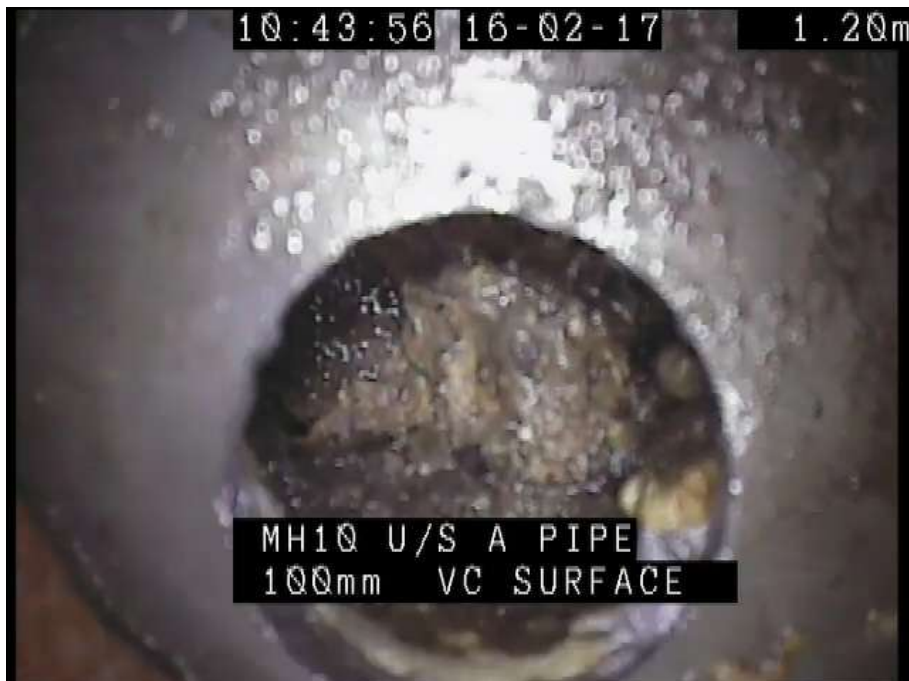
Photo: 14\_3A

1.2m, Dimension changes, 25mm high, 25mm wide

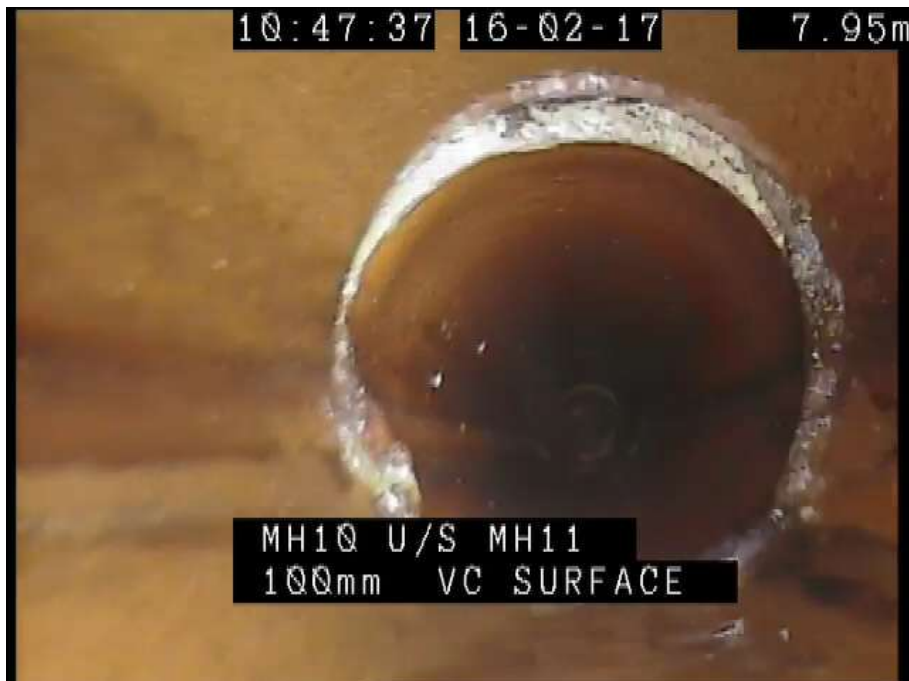
Photo: 15\_5A  
8.07m, Joint displaced, medium

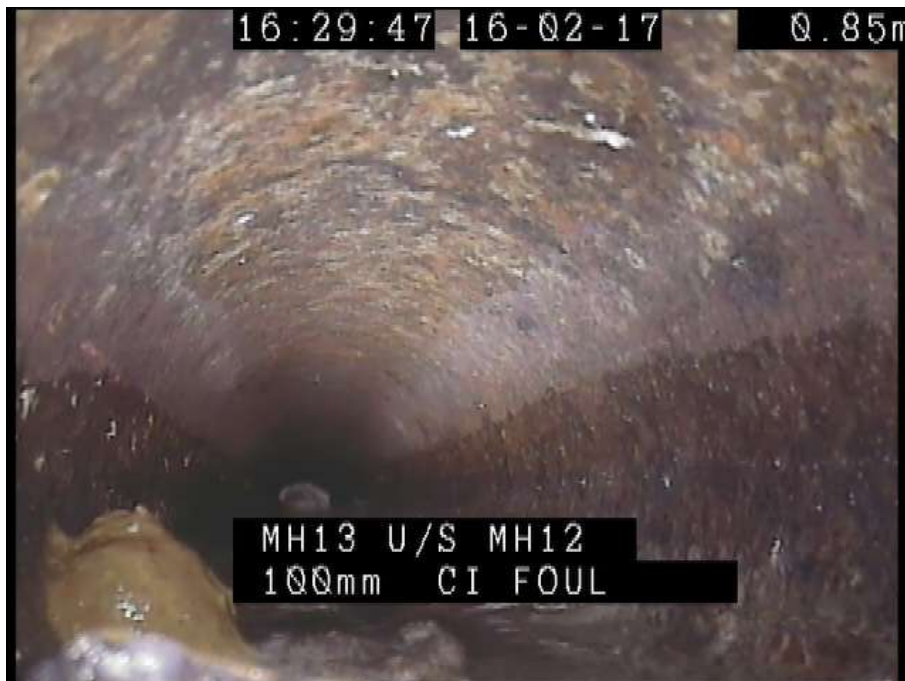
Photo: 17\_3A

0.85m, Settled deposits, fine, 10% cross-sectional area loss

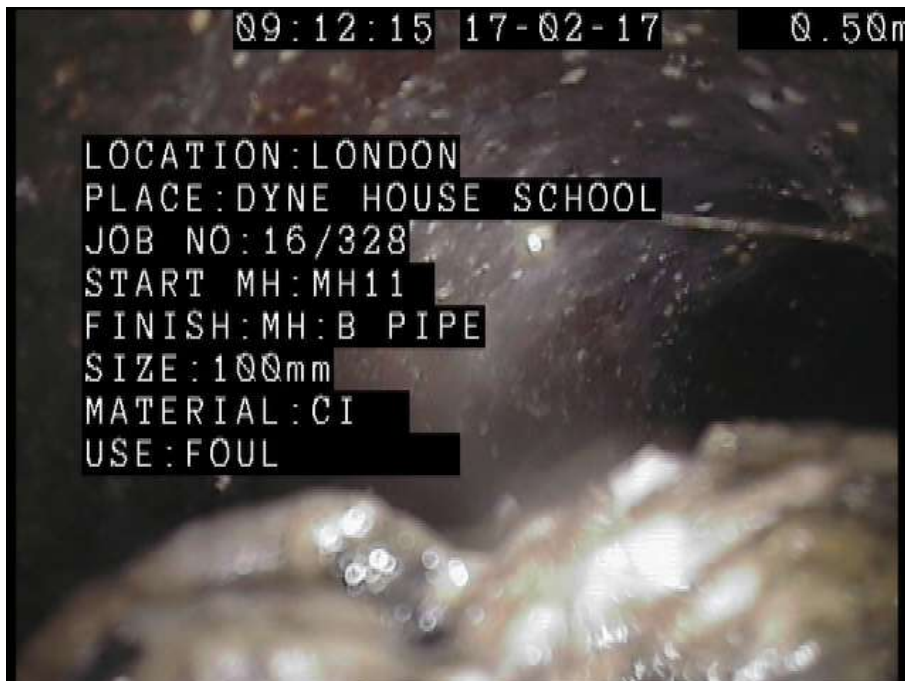
Photo: 23\_3A

0.5m, Settled deposits, other, 50% cross-sectional area loss

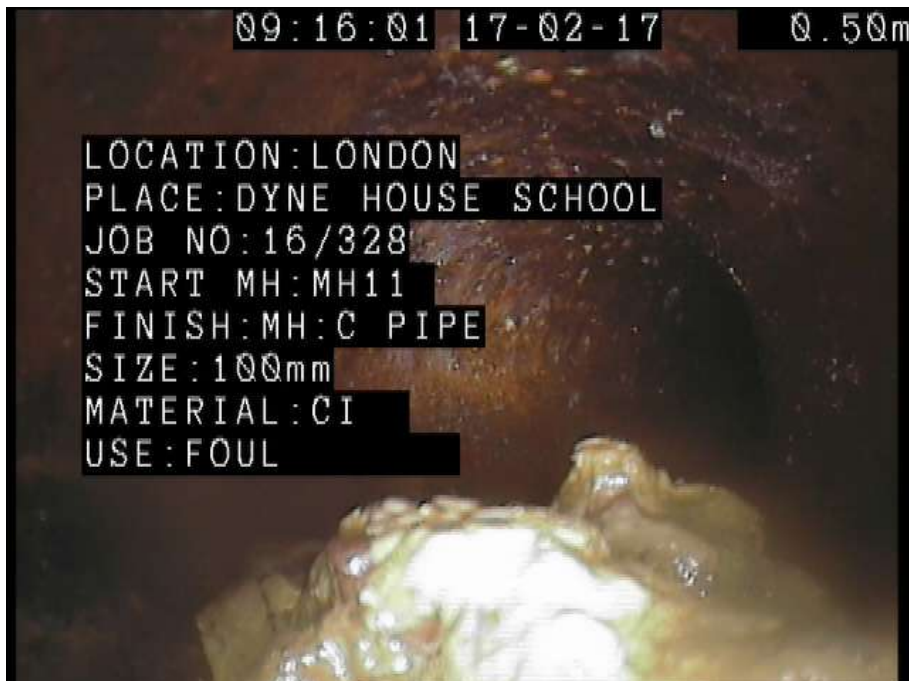
Photo: 24\_3A

0.5m, Settled deposits, other, 20% cross-sectional area loss

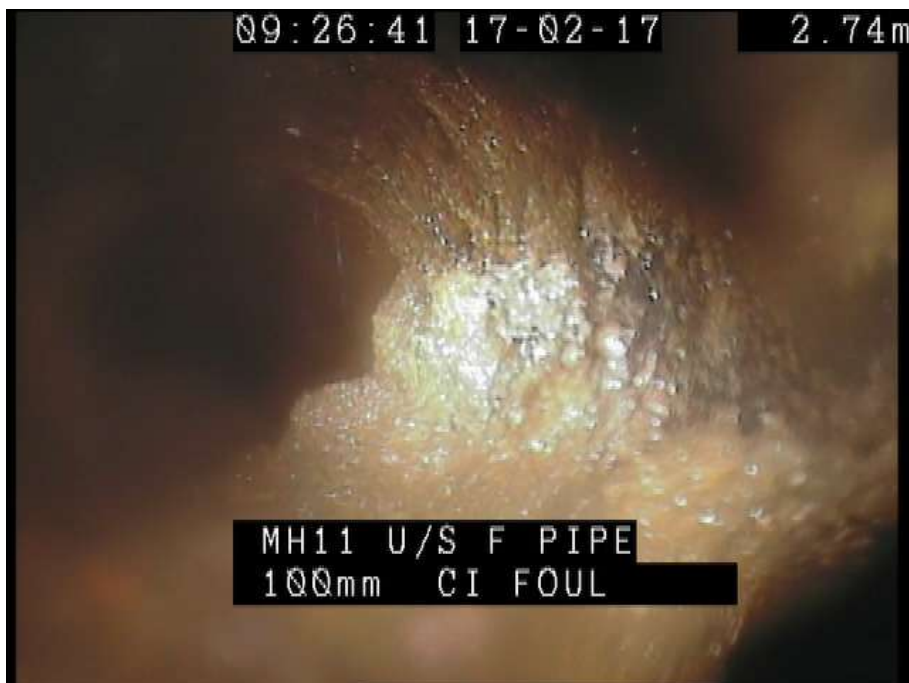
Photo: 27\_6A

2.74m, Settled deposits, fine, 25% cross-sectional area loss

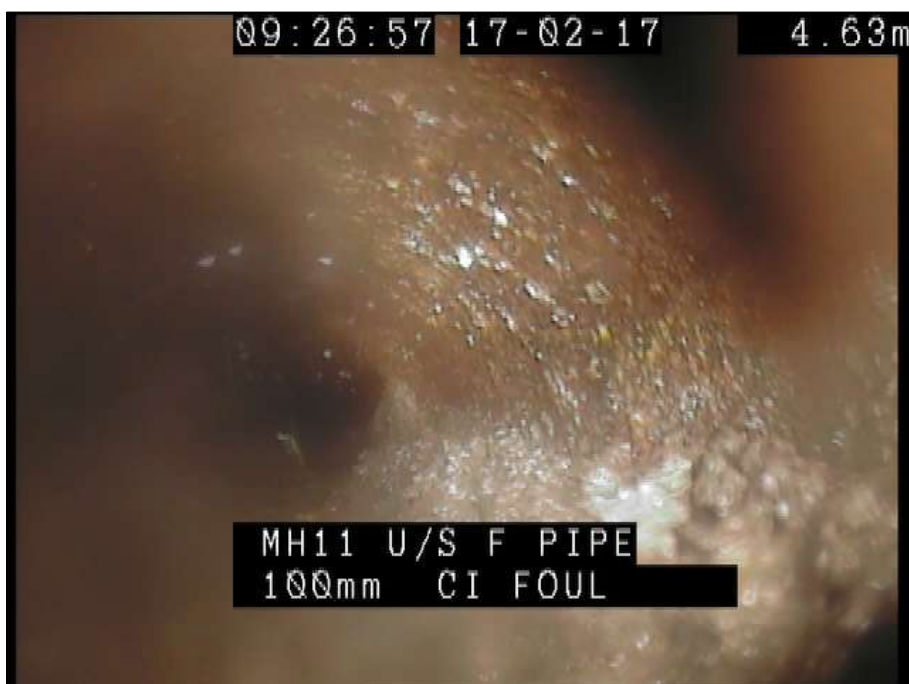
Photo: 27\_8A

4.63m, Settled deposits, fine, 50% cross-sectional area loss

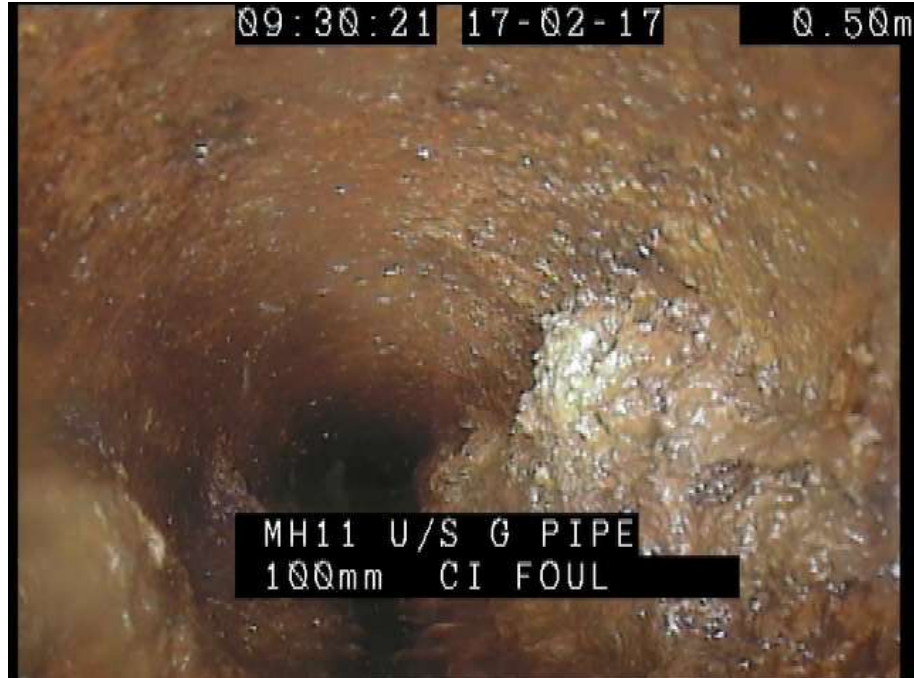
Photo: 28\_3A

0.5m, Settled deposits, fine, 20% cross-sectional area loss

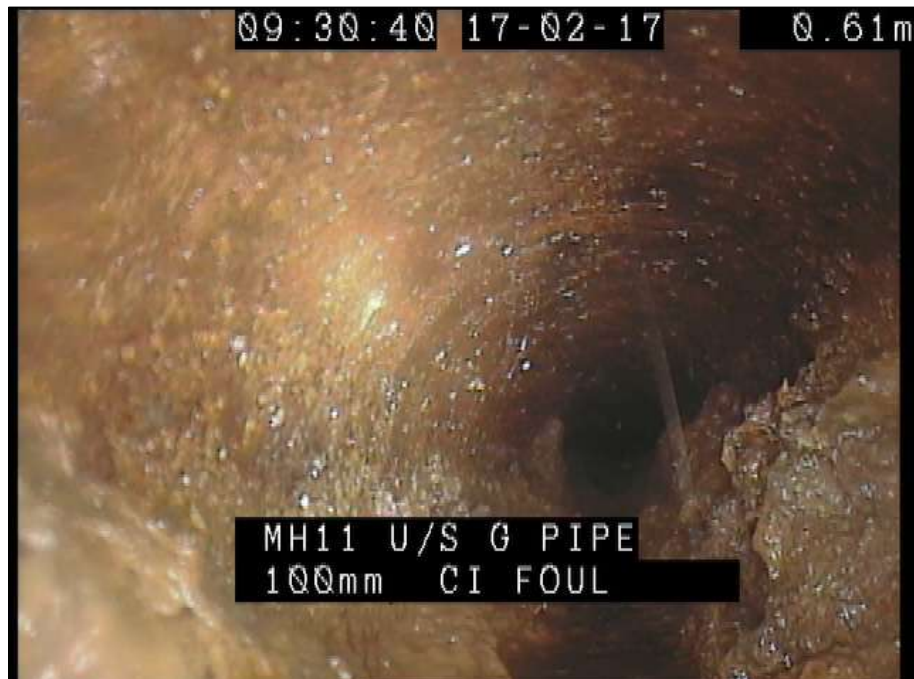
Photo: 28\_4A

0.61m, Attached deposits, encrustation, from 7 to 5 o'clock, 30% cross-sectional area loss  
Remarks: scale

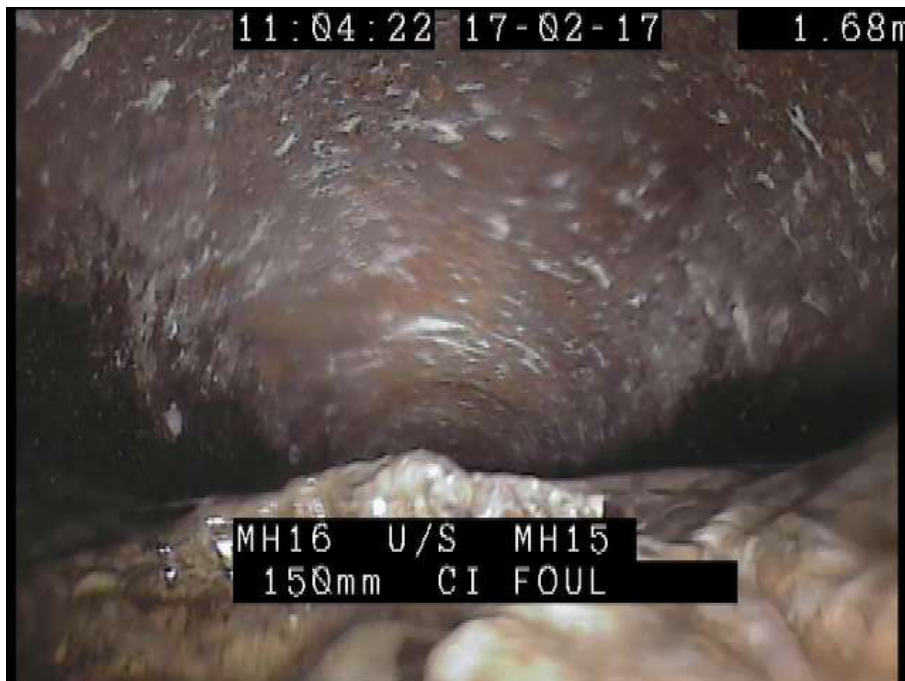
Photo: 30\_3A

1.68m, Settled deposits, other, 30% cross-sectional area loss

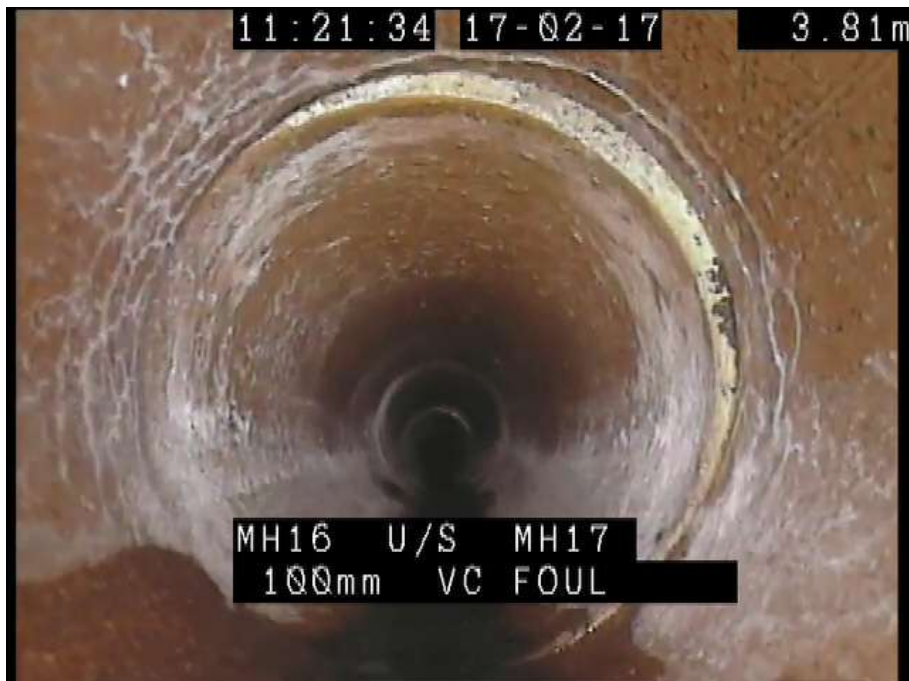
Photo: 33\_3A

3.82m, Cracks, multiple at joint, from 7 to 5 o'clock

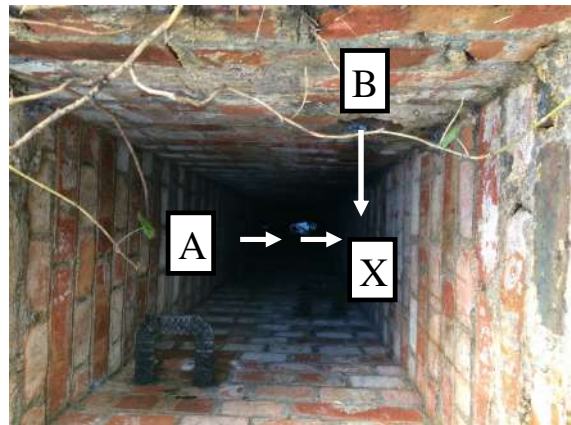
Remarks: Slab used as a cover

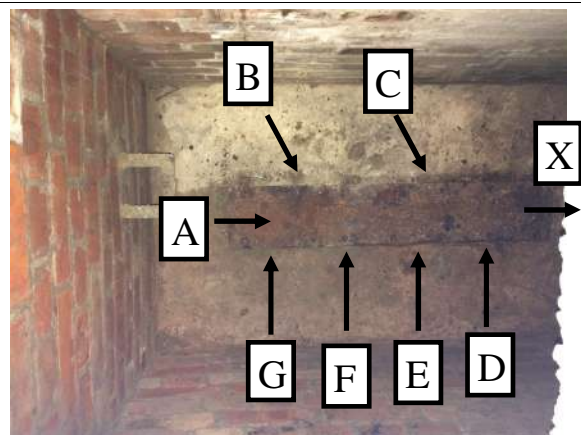
Remarks: Cover over invert, no bolts

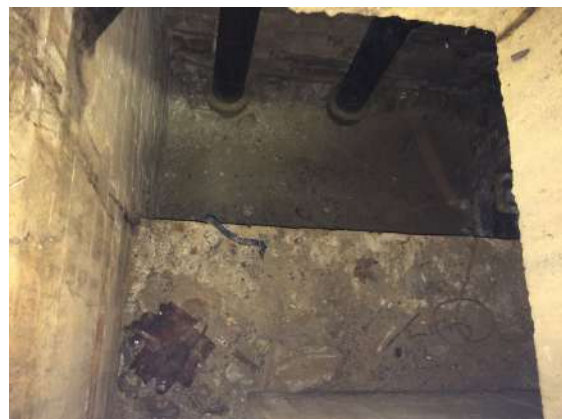
Remarks: Cast iron invert, Has a cast iron lid, nuts and bolts possibly need replacing.  
2 x CI external pipes into chamber.
