# ARBORICULTURAL ASSESSMENT REPORT

75 Upper Tollington Park, London, N4 4DD

**Client Ref:** 9667101

**Survey Date:** 12/10/2022

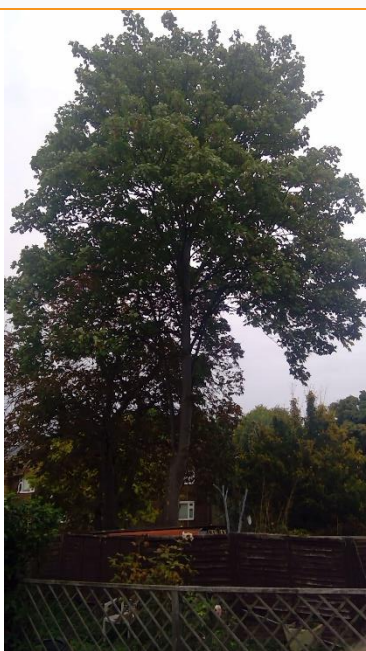
T1 - Sycamore

| Tree No | Common Name | Age Class | Condition | Height (m) | Crown Spread (m) | Stem diam. (mm) | Dist to bldg. (m) | Roots Implicated | Pruning history | Recommendation | Tree work constraints | Notes | Owner address | Owner |
|---|---|---|---|---|---|---|---|---|---|---|---|---|---|---|
| T1 | Sycamore | Semi-Mature | Fair | 11* | 8 | 280* | 14 | N | Subject to past management | Fell and treat stump with eco plugs (broadleaved) | Unknown ownership, limited parking | Largest tree within vicinity cracking is located at RHC | 79 Upper Tollington Park<br>London<br>N4 4DD | P3P |

| Tree No: | Species | Works Required |
|---|---|---|
| T1 | Sycamore | Fell and treat stump with eco plugs (broadleaved) |

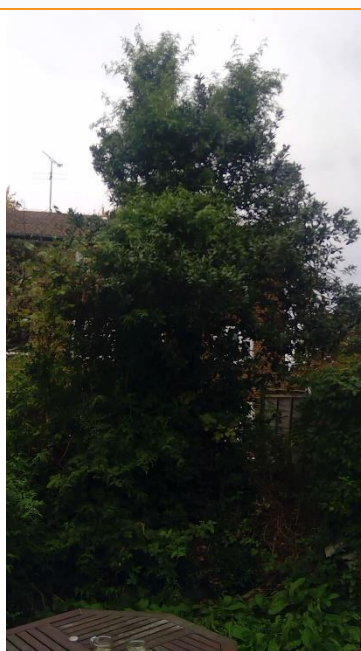
T2 - Holly

| Tree No | Common Name | Age Class | Condition | Height (m) | Crown Spread (m) | Stem diam. (mm) | Dist to bldg. (m) | Roots Implicated | Pruning history | Recommendation | Tree work constraints | Notes | Owner address | Owner |
|---|---|---|---|---|---|---|---|---|---|---|---|---|---|---|
| T2 | Holly | Semi-Mature | Fair | 6.4 | 3.35 | 120* | 10 | N | No significant past tree works | No work required | | Jasmine growth through crown | District land registry search required | UKN |

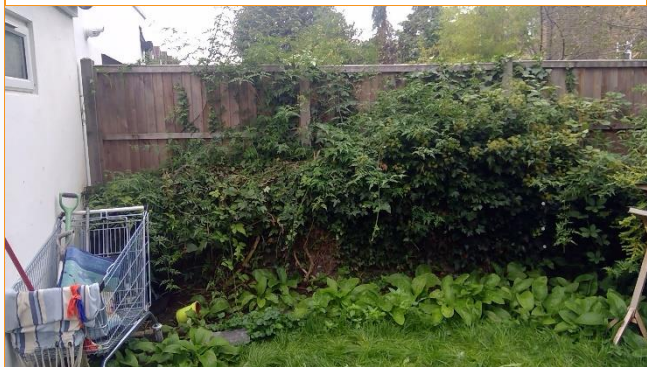
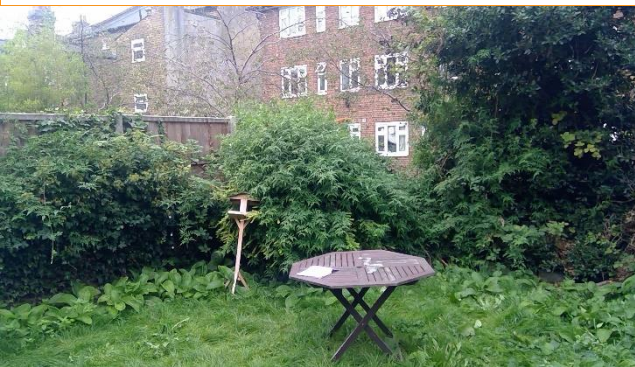
CG1 - Mixed species climbers

| Tree No | Common Name | Age Class | Condition | Height (m) | Crown Spread (m) | Stem diam. (mm) | Dist to bldg. (m) | Roots Implicated | Pruning history | Recommendation | Tree work constraints | Notes | Owner address | Owner |
|---|---|---|---|---|---|---|---|---|---|---|---|---|---|---|
| CG1 | Mixed species climbers | Semi-Mature | Fair | 2 | 1.0 | 20* | 0 | N | Unmanaged Jasmine and Ivy growing over fence line, T2 and S3 | Fell and treat Jasmine and Ivy stumps with eco plugs (broadleaved) | Access through policy holder house | | 75 Upper Tollington Park<br>London<br>N4 4DD | PH |

| Tree No: | Species | Works Required |
|---|---|---|
| CG1 | Mixed species climbers | Fell and treat Jasmine and Ivy stumps with eco plugs (broadleaved) |

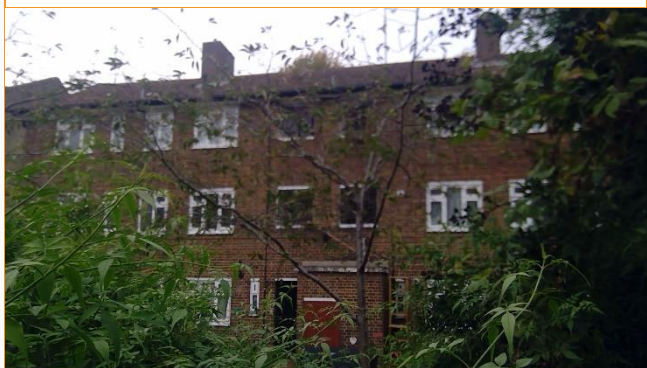
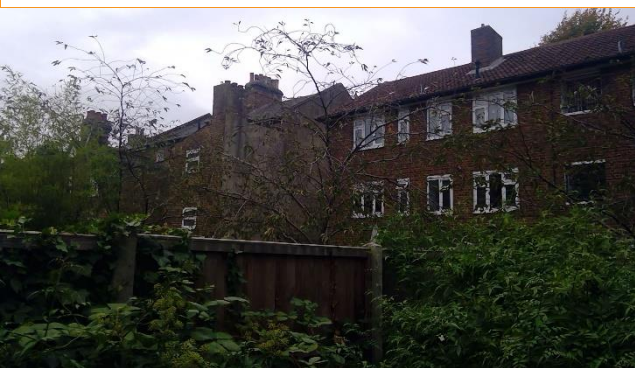
T3 - Wild cherry

| Tree No | Common Name | Age Class | Condition | Height (m) | Crown Spread (m) | Stem diam. (mm) | Dist to bldg. (m) | Roots Implicated | Pruning history | Recommendation | Tree work constraints | Notes | Owner address | Owner |
|---|---|---|---|---|---|---|---|---|---|---|---|---|---|---|
| T3 | Wild cherry | Young | Fair | 4.5 | 2.8 | 110* | 9 | N | No significant past tree works | No work required | | Prunus roots found but too Young and too far to implicate | District land registry search required | UKN |

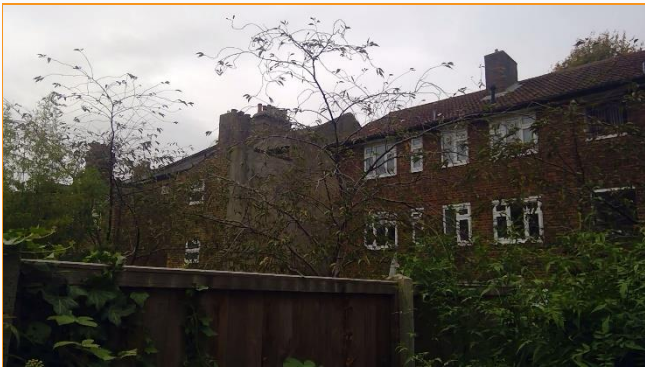
T4 - Wild cherry

| Tree No | Common Name | Age Class | Condition | Height (m) | Crown Spread (m) | Stem diam. (mm) | Dist to bldg. (m) | Roots Implicated | Pruning history | Recommendation | Tree work constraints | Notes | Owner address | Owner |
|---|---|---|---|---|---|---|---|---|---|---|---|---|---|---|
| T4 | Wild cherry | Young | Fair | 4.5 | 2.8 | 110* | 10.5 | N | No significant past tree works | No work required | | Prunus roots found but too young and too far to implicate. (Distance is to rear of property) | District land registry search required | UKN |

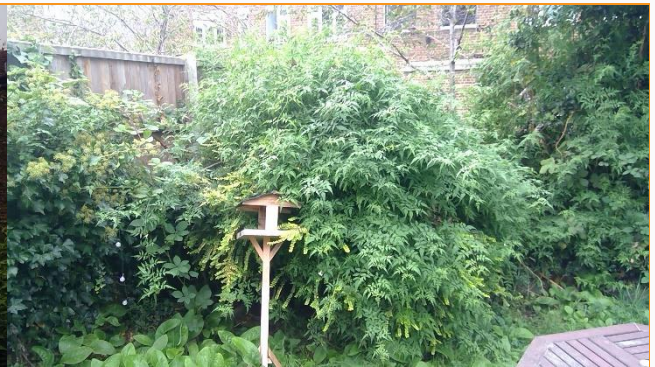
S3 - Honeysuckle

| Tree No | Common Name | Age Class | Condition | Height (m) | Crown Spread (m) | Stem diam. (mm) | Dist to bldg. (m) | Roots Implicated | Pruning history | Recommendation | Tree work constraints | Notes | Owner address | Owner |
|---|---|---|---|---|---|---|---|---|---|---|---|---|---|---|
| S3 | Honeysuckle | Young | Fair | 1.7 | 2 | 40 | 4.1 | N | Distance is to rear of property | No work required | | Covered in Jasmine (due for removal) | 75 Upper Tollington Park<br>London<br>N4 4DD | PH |
