REPORT ON TREE INSPECTION AT  
1 ST MARTIN'S TERRACE,  
16 PAGES LANE,  
LONDON N10 1QY.  
AUGUST 2022

**Arboricultural Solutions LLP**

**REPORT ON TREE INSPECTION AND DAMAGE TO BUILT STRUCTURES  
AT  
1 ST. MARTIN'S TERRACE  
16 PAGES LANE  
LONDON  
N10 1QY.**

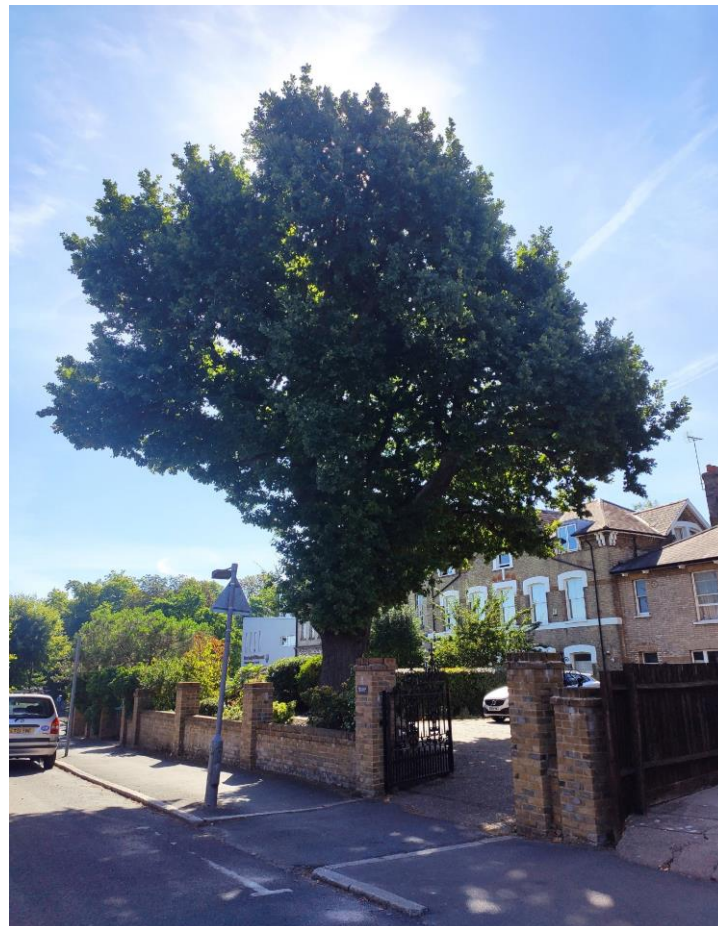
2.4.3. Tree 1 is single stemmed at ground level, located in a shrubbed on the front elevation of the property. It is mature in age and considered to be of average condition and normal vigour (refer to photograph 1 below). The tree has the following approximate dimensions; height 15.5 metres, crown spread to north 7.2, east 6.3, south 7.8 and west 6.0 metre and a trunk diameter of 1200mm.

2.4.4. The soil levels have been raised around the base of the tree to create the raised shrubbed planter, the base of the trunk and the buttress root flare were not visible. There is a partially occluded wound at ground level on the south side of the trunk and several small, occluded bark wounds around the base. However, there was no indication of basal decay or loose bark around the basal area and sounding around the base of the tree using a nylon mallet (Thor 710 400g) returned a solid sound.

**Photograph 1 showing tree 1 from west side in Pages Lane.**

2.4.6. The trunk is straight to the crown beak level at approximately 2.5 metres height. There has been some removal of large low limbs on the northeast side at approximately 2 metres height and there is a minor decay pocket in the pruning wound. There is epicormic growth on the trunk between

- Manage tree at approximately its current size by undertaking a crown reduction on a 3-year cycle. An application to undertake a crown reduction to the previous (and outermost) pruning points by removing approximately 1.5 metres branch length should be submitted to London Borough of Haringey for TPO consent.
- Whilst undertaking the crown reduction the scaffold limb on the south side at 2 metres should be assessed to establish the extent of any decay caused by Sulphur Polypore and this should be monitored as part of the cyclical crown management.
- Install a root barrier along party boundary between 1 St. Martins Terrace and 14 Page's Lane.
- Remove or reduce the area of concrete hard surfacing within the front garden of 1 St. Martin's Terrace.

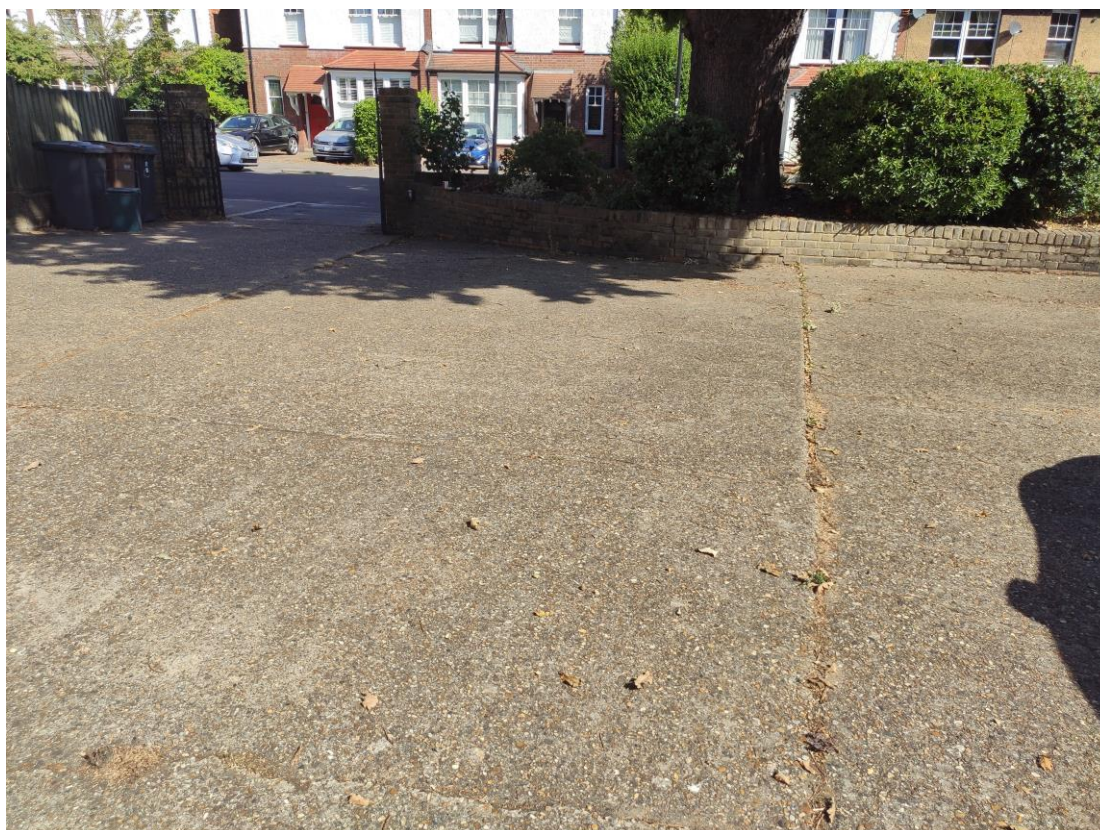
4.2.1. The concrete driveway and car parking area at the front of 1 St. Martin's Terrace measures approximately 13 x 10 metres and predates the conversion of the convent to residential housing. The slabs have lifted and rotated differentially resulting in raised vertical edges and cracking as shown in photograph 5 below.

**Photograph 5 showing lifting and rotation of concrete drive at 1 St. Martin's Terrace.**

5.2.2. Removing or reducing the size of the concrete parking area will allow rainwater to penetrate the underlying soils so reducing storm water run off and improving the rooting conditions for the Oak tree. The concrete could be completely removed and replaced using porous hard surfacing and a cellular raft system (such as Cellweb). Another option would be to reduce the area of the hard surfacing by removing the area of concrete closest to the house to allow the planted garden area to be extended. In addition, breaking up any retained concrete slabs and installing a topping layer of gravel would 'infill' any uneven areas and vertical trip hazards whilst increasing the rainwater penetration beneath the parking area.

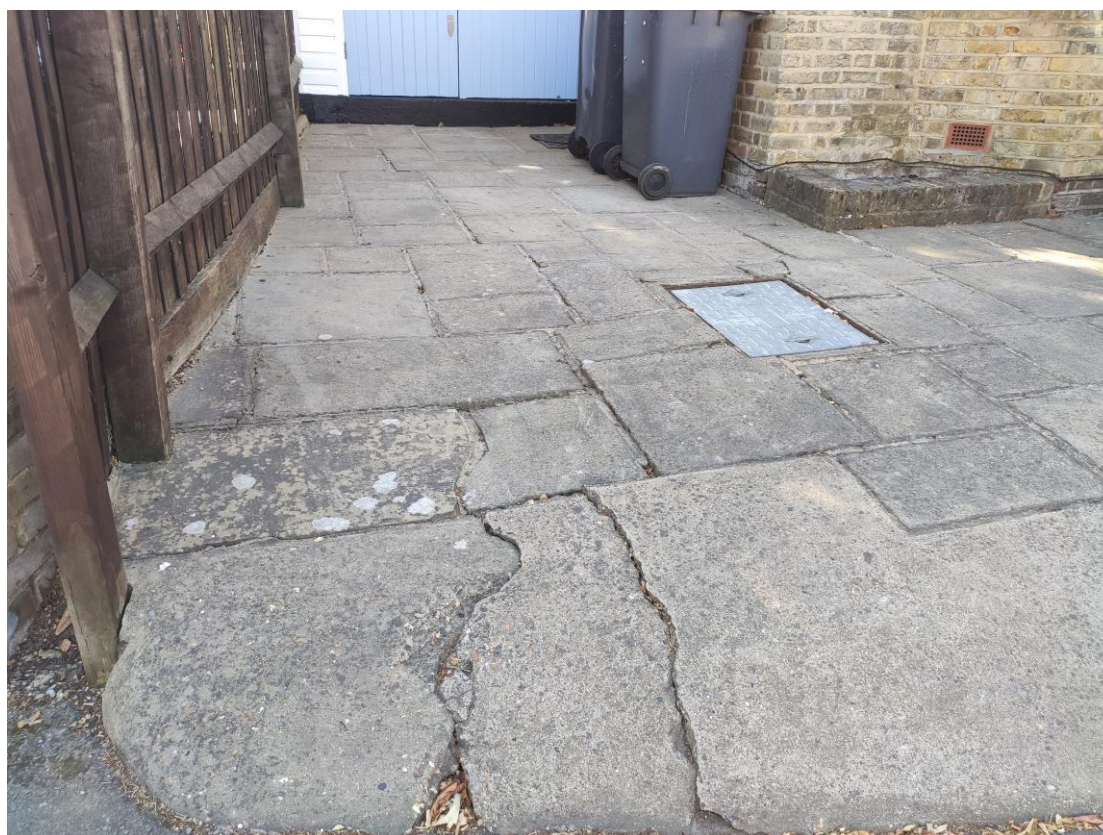
4.3.1. The front paved area and off-street parking within 14 Page's Lane is distorted around the inspection chamber and drains; and has sunk particularly on the eastern side adjacent to the party boundary (refer to photograph 6 below). In addition, there is cracking to the floor slab and tiling of the side extension.

**Photograph 6 showing distorted and sunken paving at 14 Page's Lane.**

6.1.2. The roots may be contributing to indirect damage to the neighbouring property due to the uptake of water close to the foundations.

5.2.3. **Install a Root Barrier:** A trench could be excavated along the party boundary between 1 St. Martins Terrace and 14 Pages Lane. The concrete slabs could be broken up using a pneumatic
