Site Photographs

St William

Clarendon Road Gasworks, Phase 3

6075

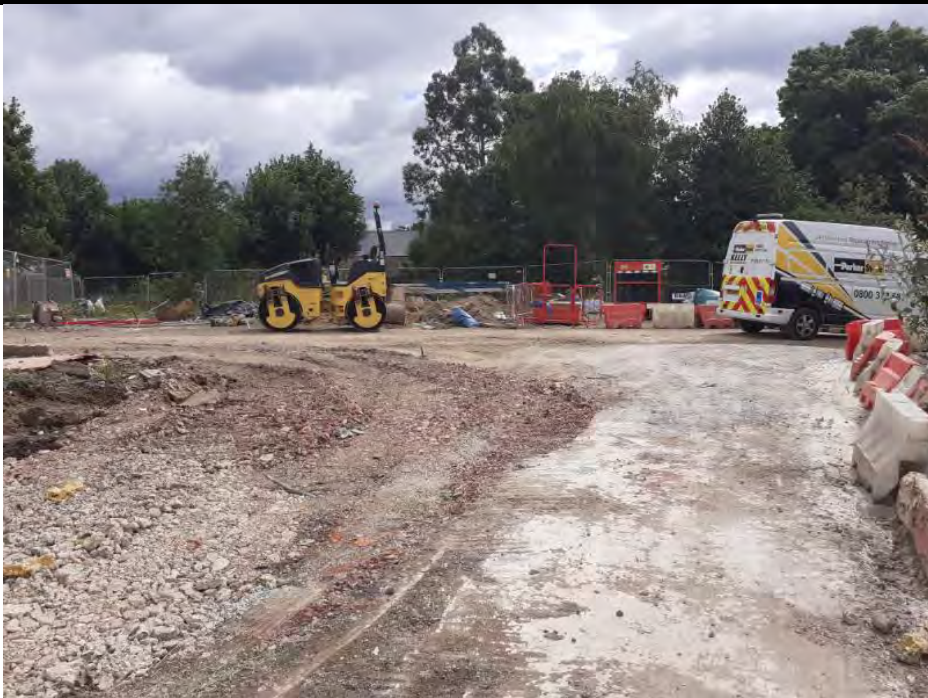
Photo: 1

Description: Crushed brickwork laid down and compacted to form ramp in the level change. Later scraped and formed into SP-0

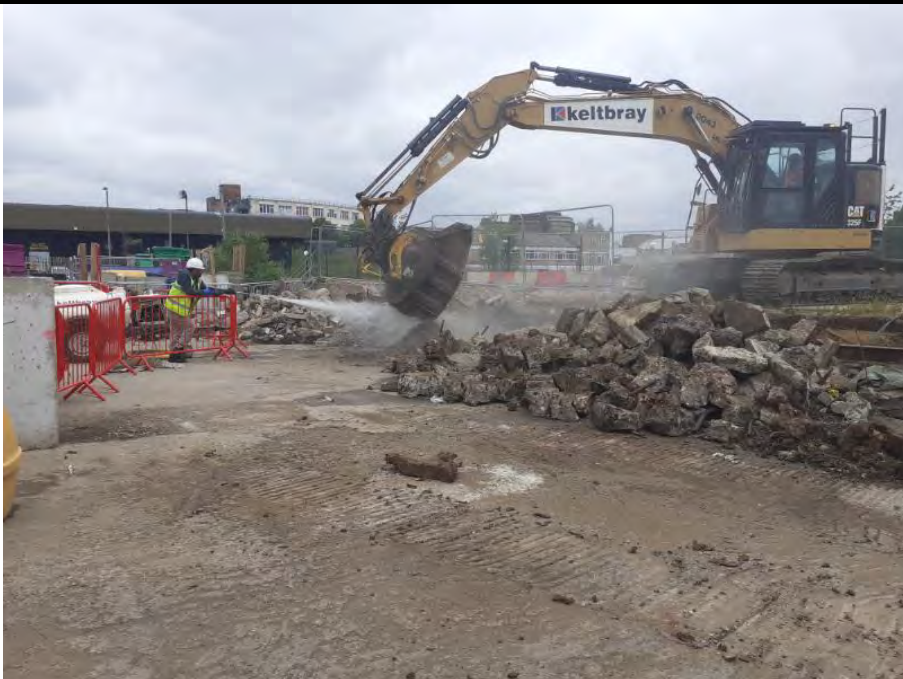
Photo: 2

Description: Stockpiling of concrete during breakout in Car Park, with jet wash for dust suppression.

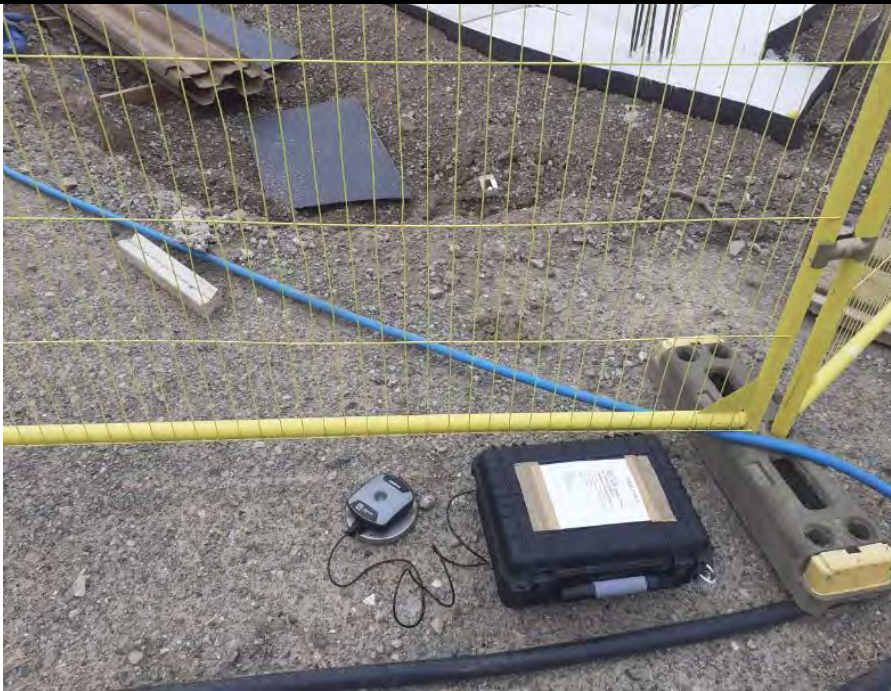
Photo: 3

Description: Set-up of vibration monitor 'Cadent Easement'.

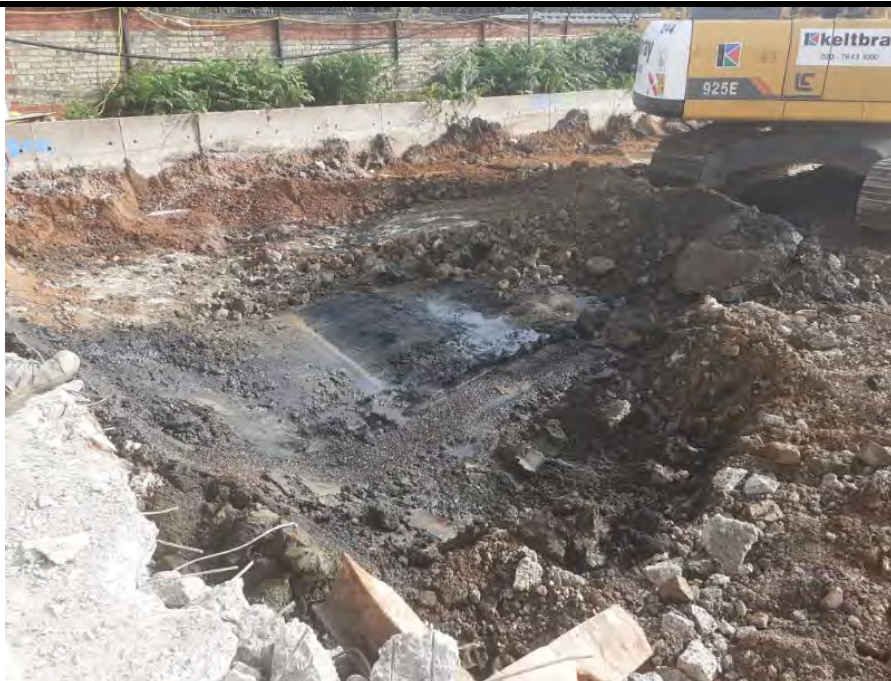
Photo: 4

Description: Breaking out of concrete and type 1 Made Ground in car park.

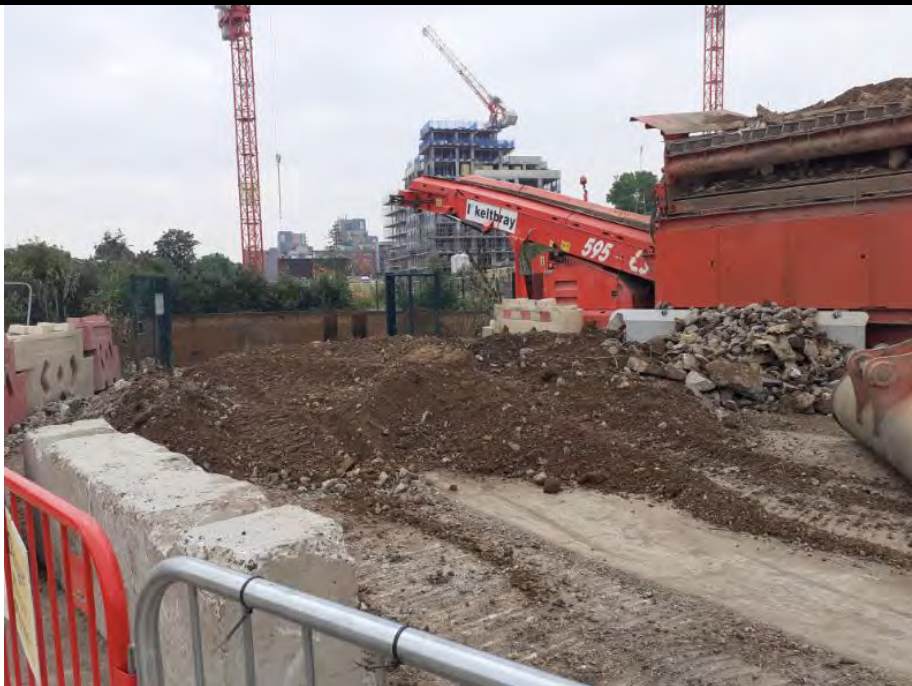
Photo: 5

Description: Material excavated from car park processed through screener. And stockpiled in GH1.

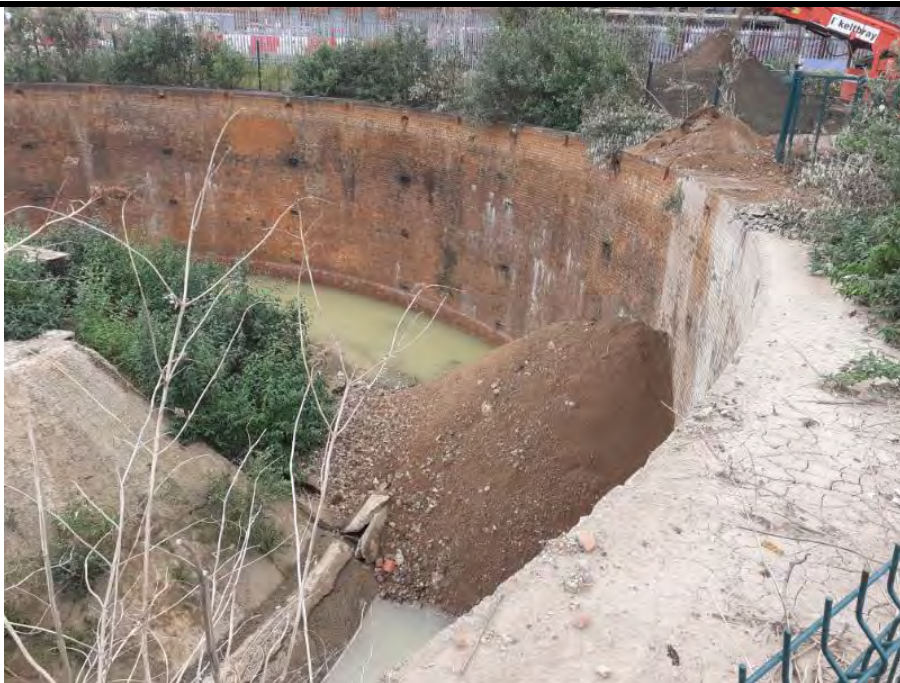
Photo: 6

Description: Formation of ramp using screened material from excavation in car park.

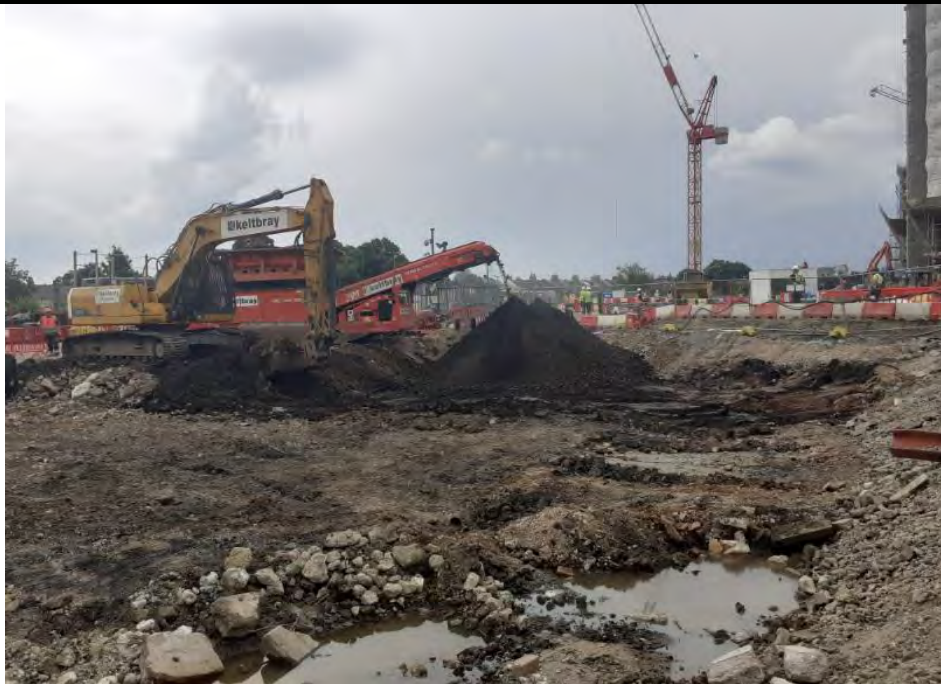
Photo: 7

Description: Screener active processing stockpile.

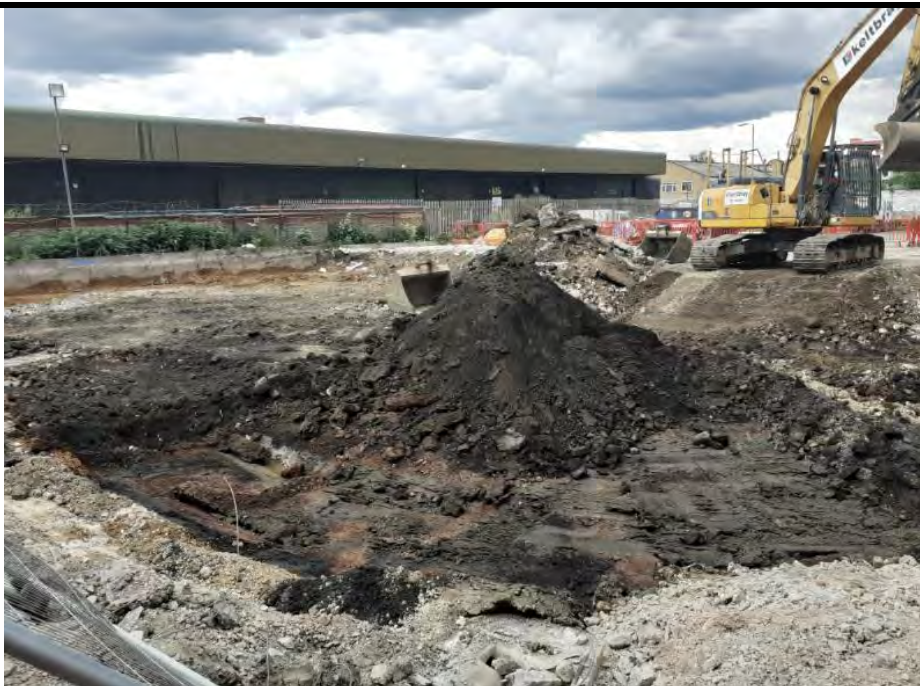
Photo: 8

Description: Break out and excavation of the car park.

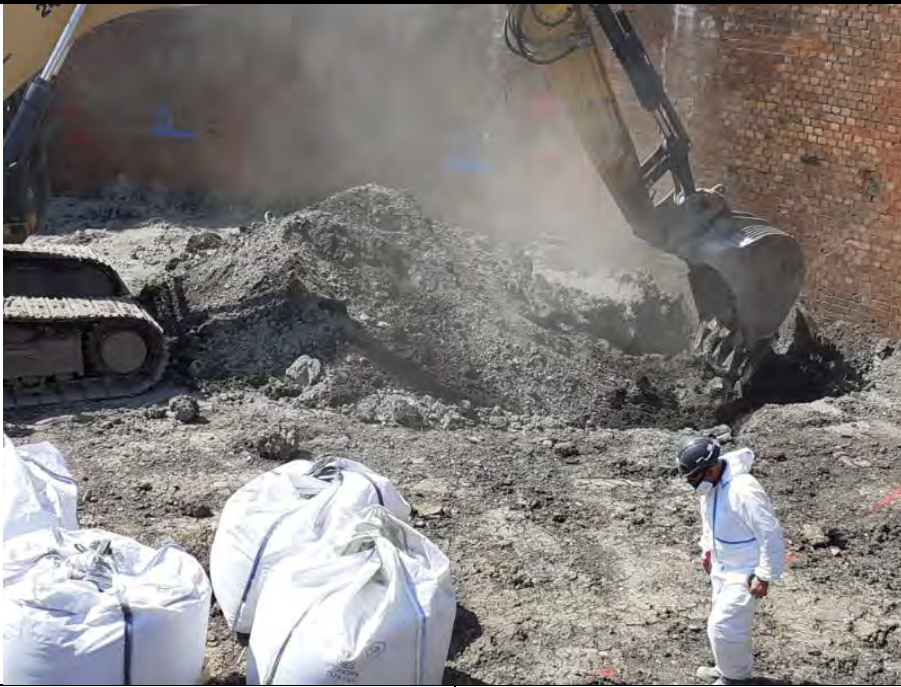
Photo: 9

Description: 5% wt CEM1 stabilisation in progress.

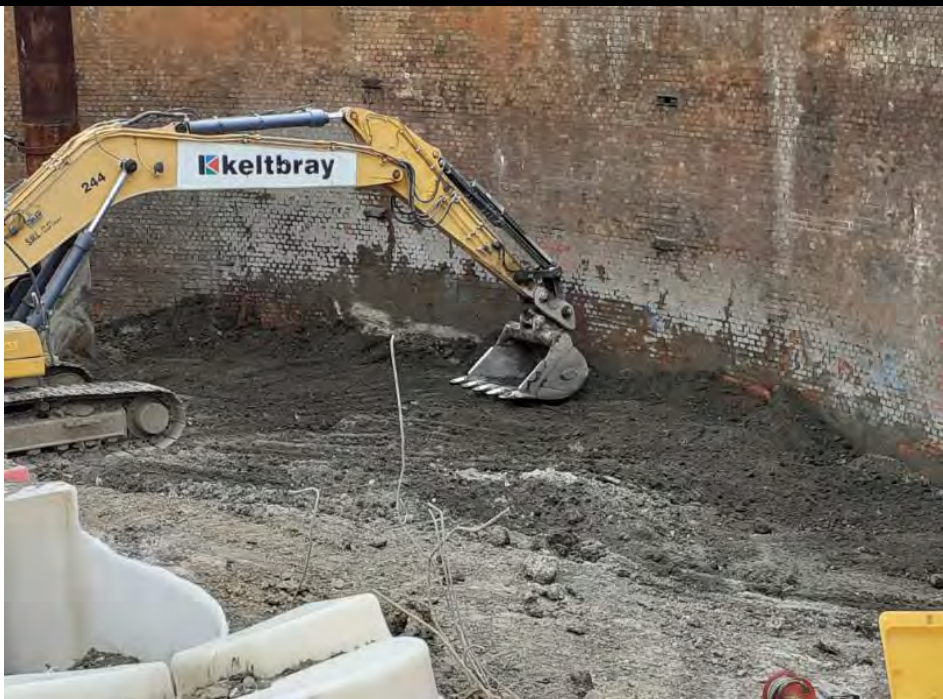
Photo: 10

Description: Placement of stockpiled material during backfill of GH1 prior to rolling.

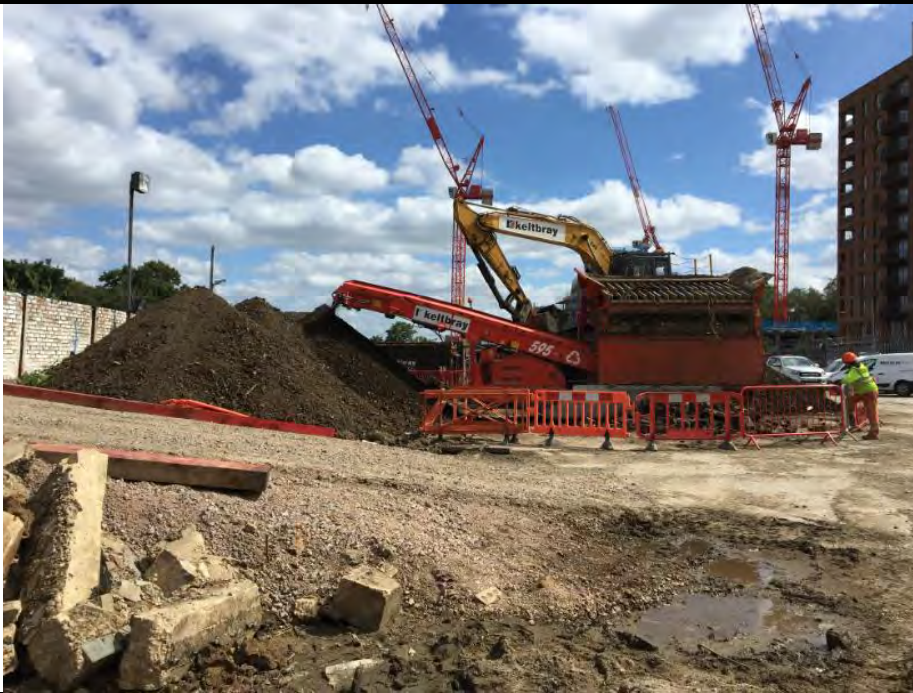
Photo: 12

Description: All material being excavated from car park screened and stockpiled on-site prior to reuse.

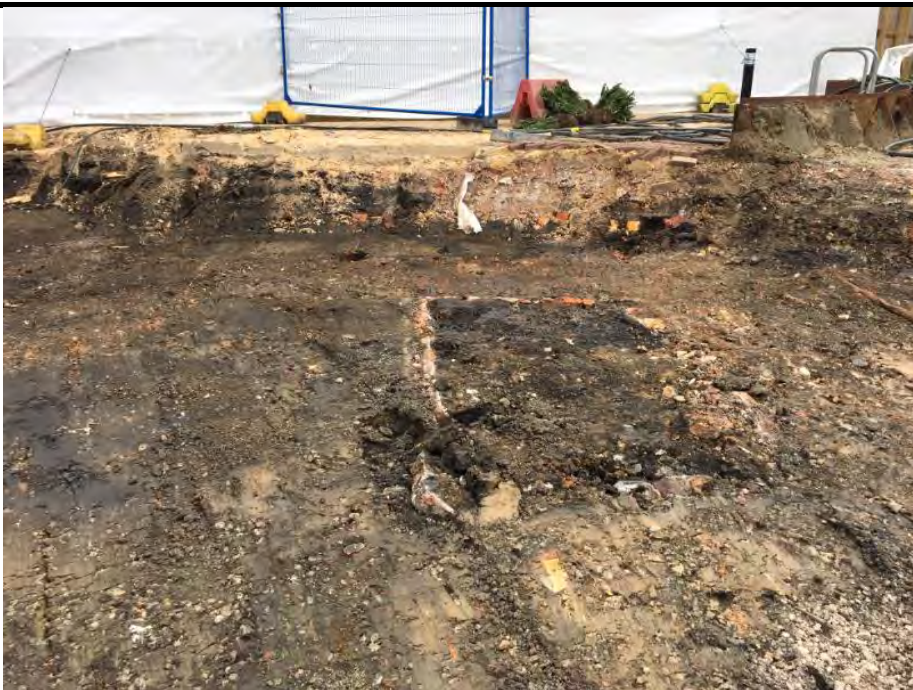
Photo: 13

Description: Tank hotspot located in Q2.

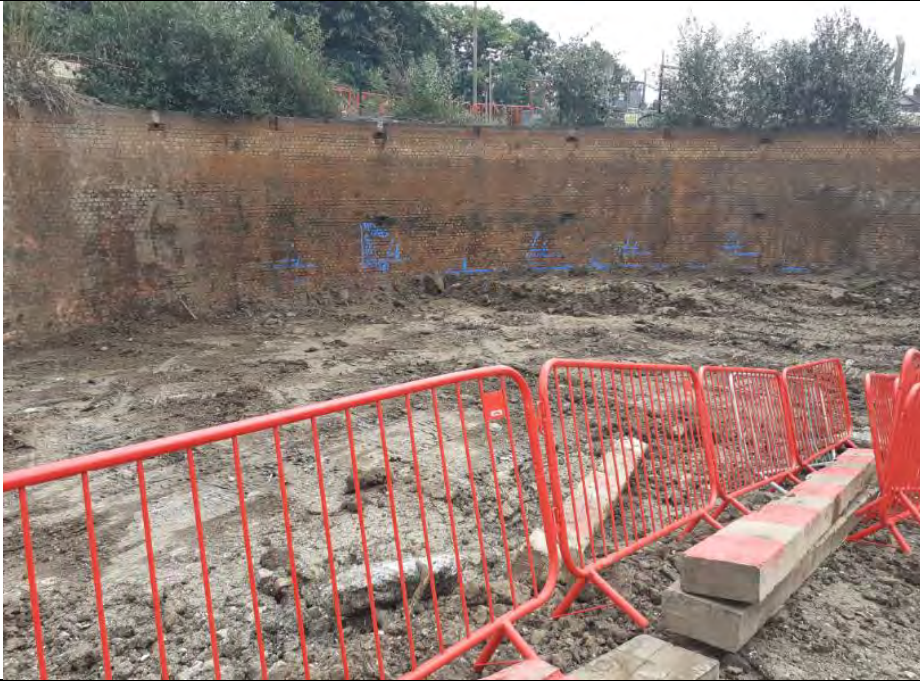
Photo: 14

Description: Continued process of backfilling in GH1. Depth levels marked on brick wall for reference.

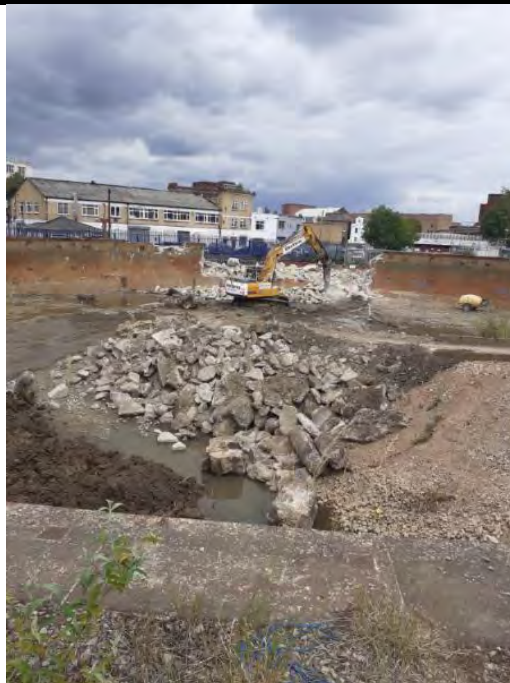
Photo: 15

Description: Concrete in GH3 being broken out and stockpiled prior to crushing in Gasholder 3.

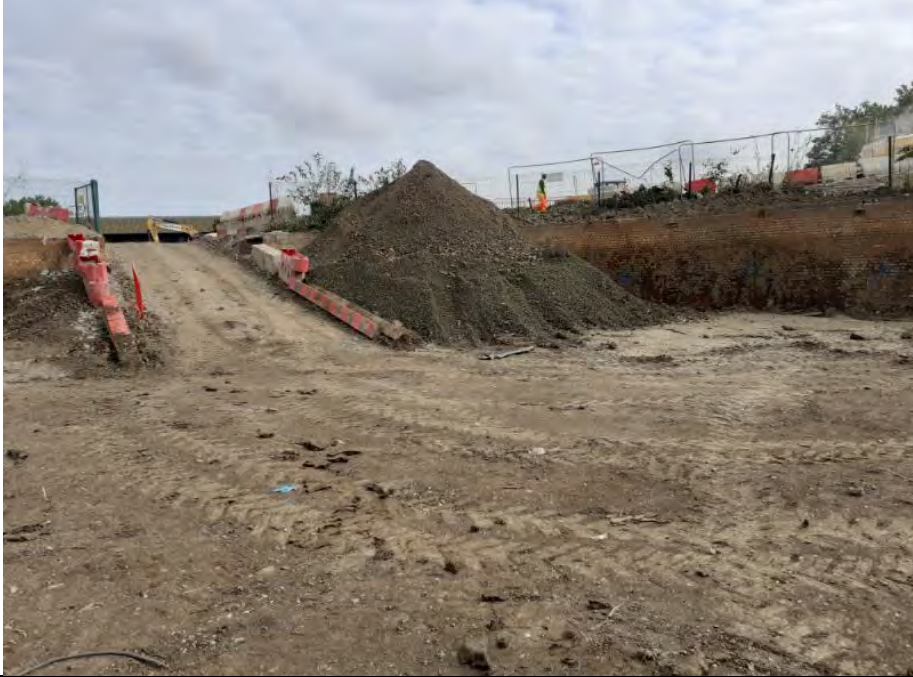
Photo: 16

Description: Processed material stockpiled in Gasholder 1 with 3m remaining until backfill complete.

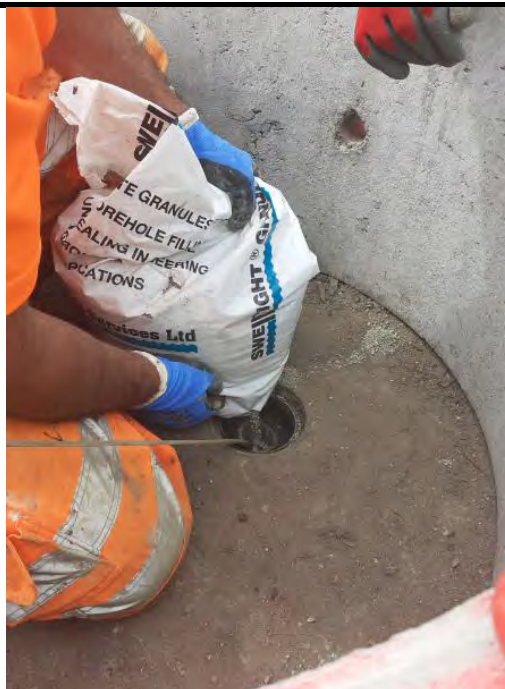
Photo: 17

Description: Decommissioning of borehole.

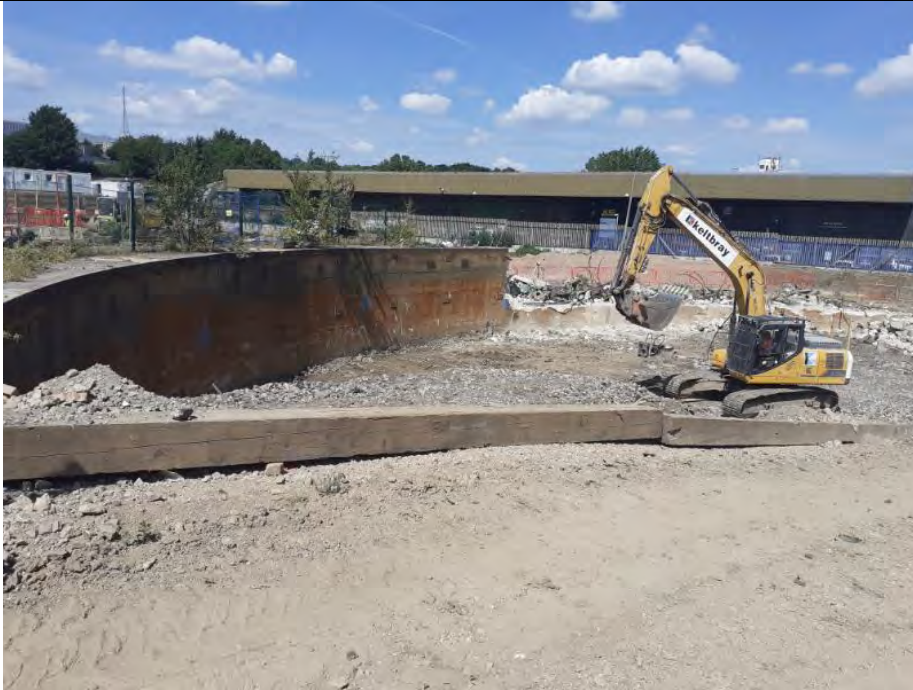
Photo: 18

Description: Breaking out wall in Gasholder 3 down to formation level.

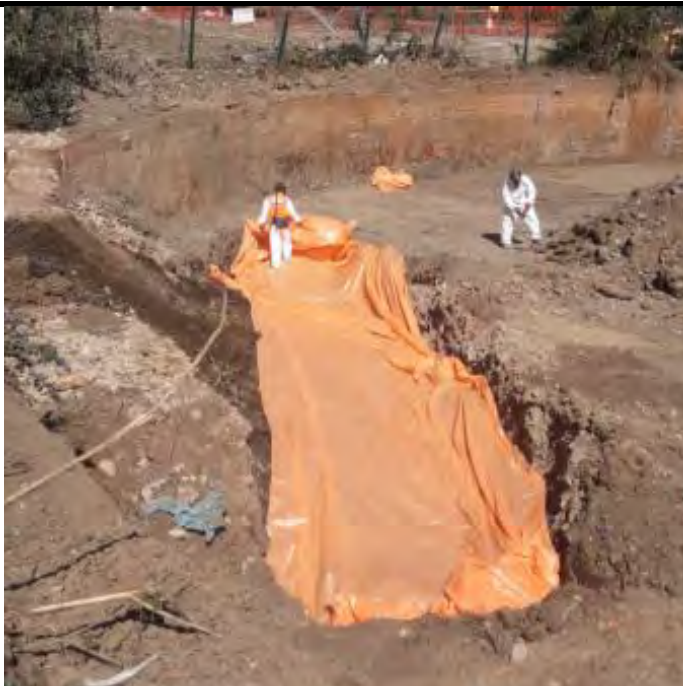
Photo: 19

Description: Asbestos hotspot during backfill. NNLW works.

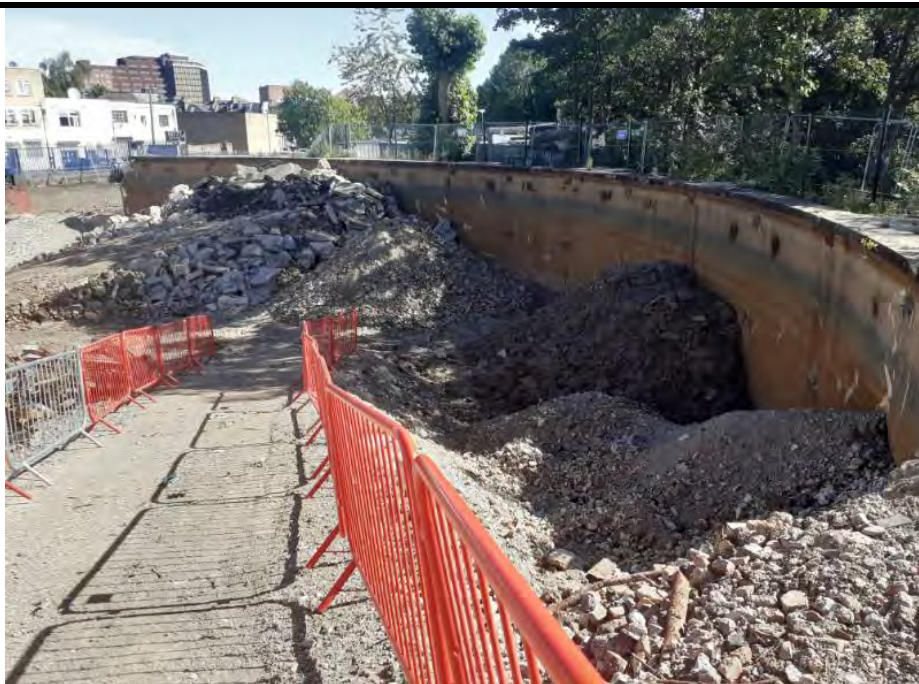
Photo: 20

Description: Initial stockpiling in GH3.  
Stockpiles awaiting screening, sampling and rolling.

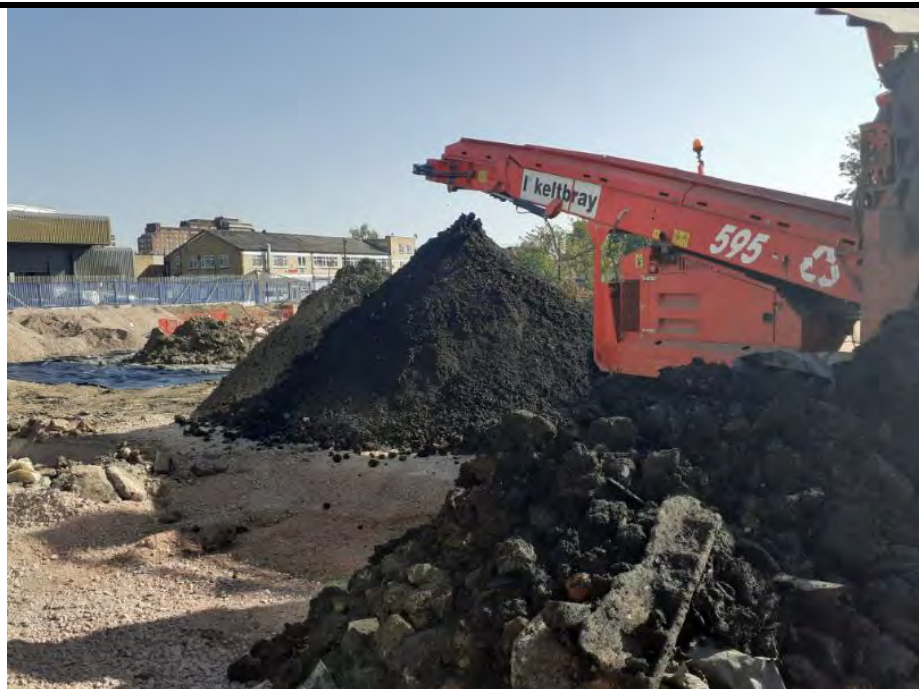
Photo: 21

Description: Material continued to be processed and being stockpiled in Gasholder 1.

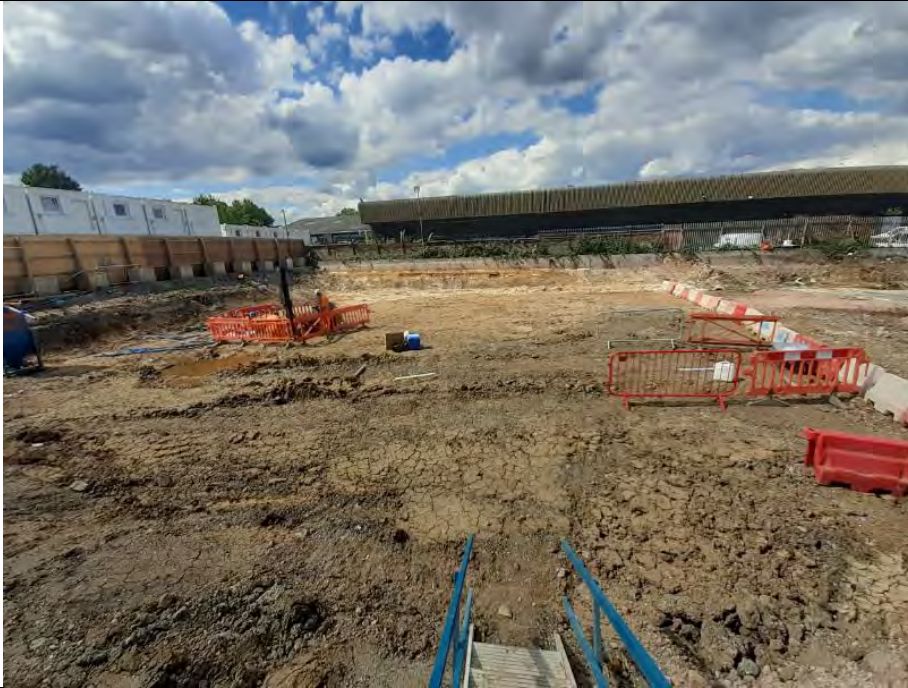
Photo: 22

Description: Further excavation of the car park and window sampling.

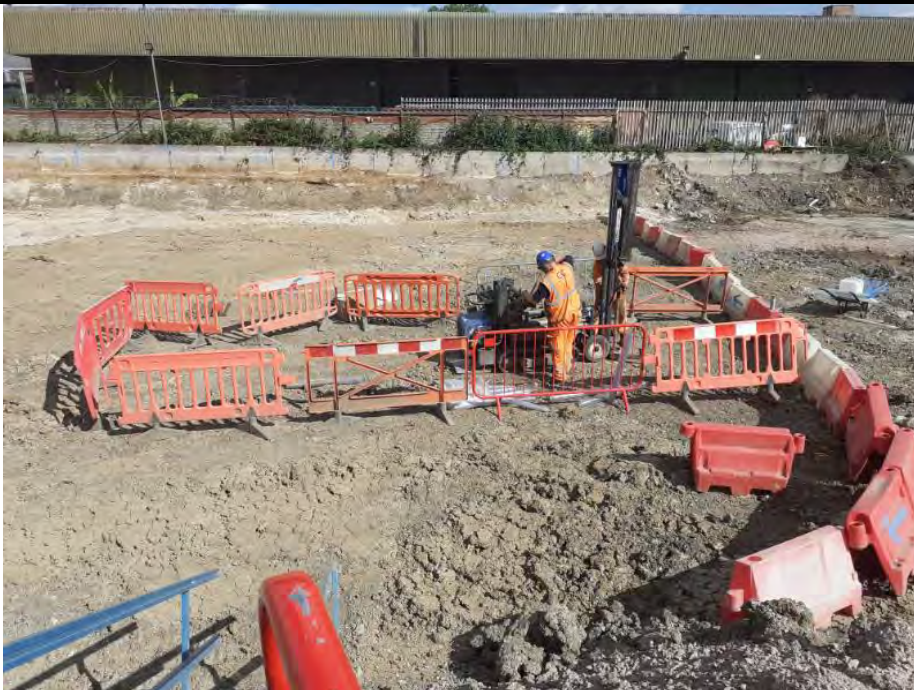
Photo: 23

Description: Window sampling in car park area.

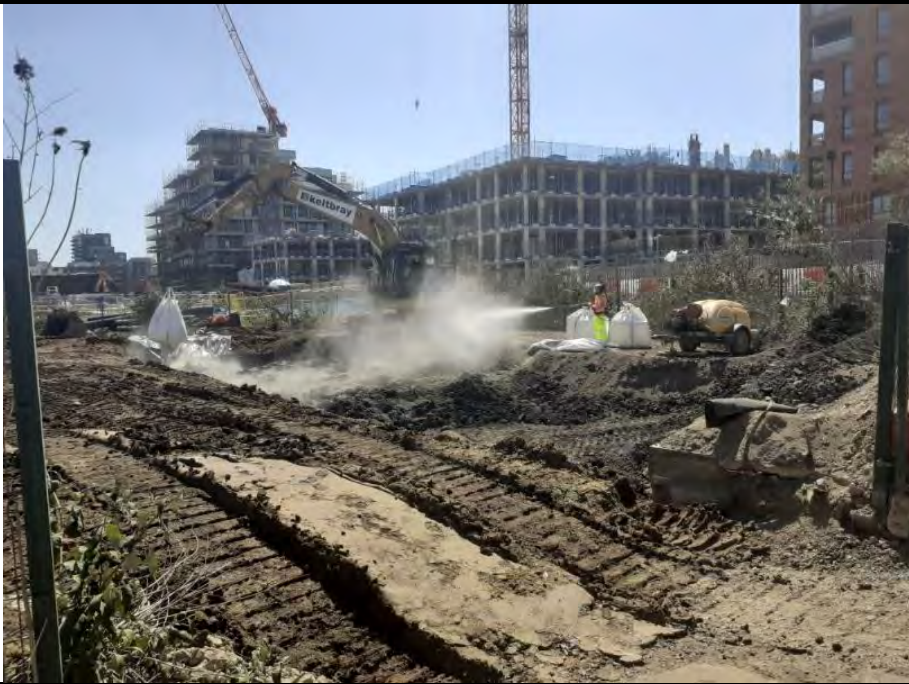
Photo: 24

Description: Continued backfill of Gasholder 1 with 5% wt CEM1 stabilisation and jet wash dust suppressant.

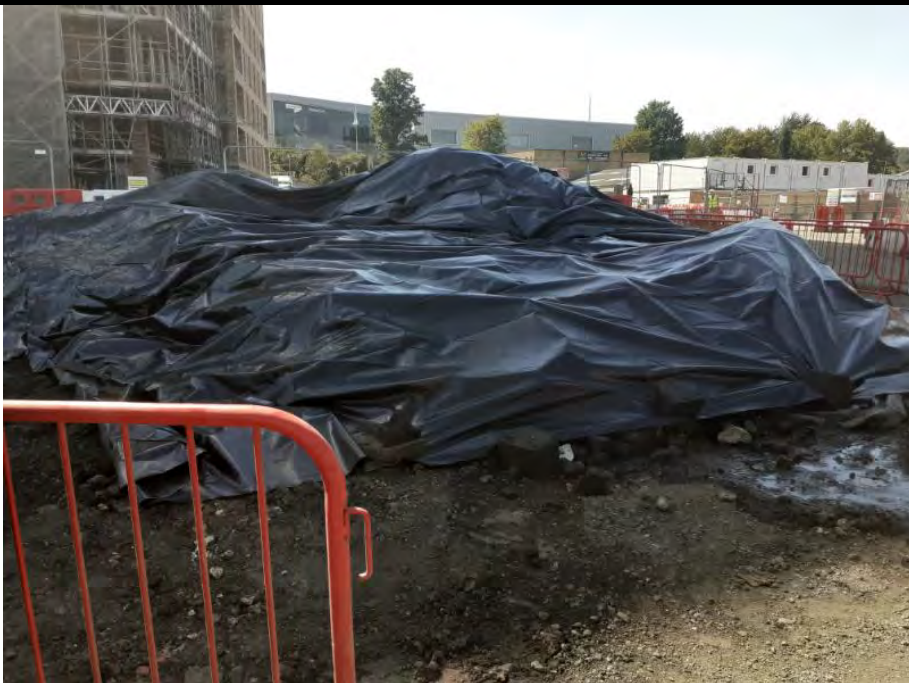
Photo: 25

Description: Stockpile covering to reduce odour.

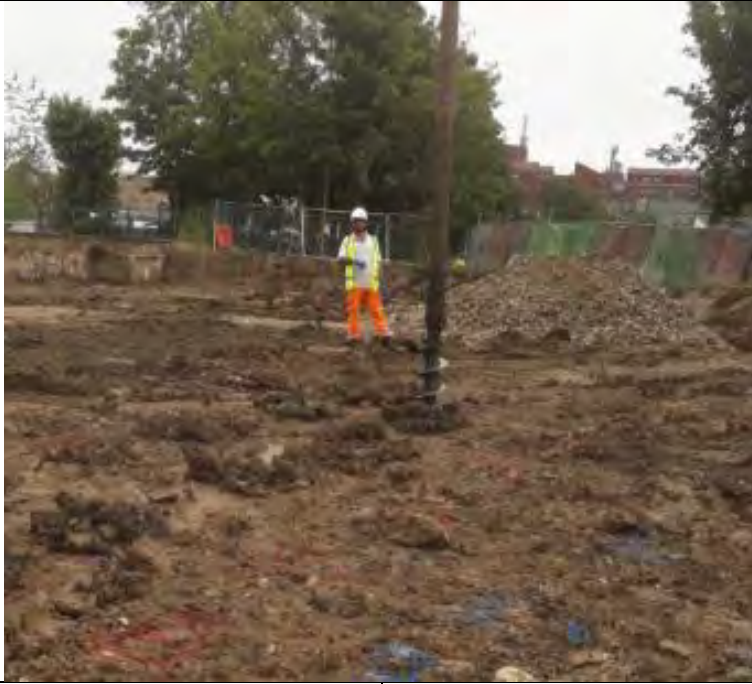
Photo: 26

Description: Pile probing activity.

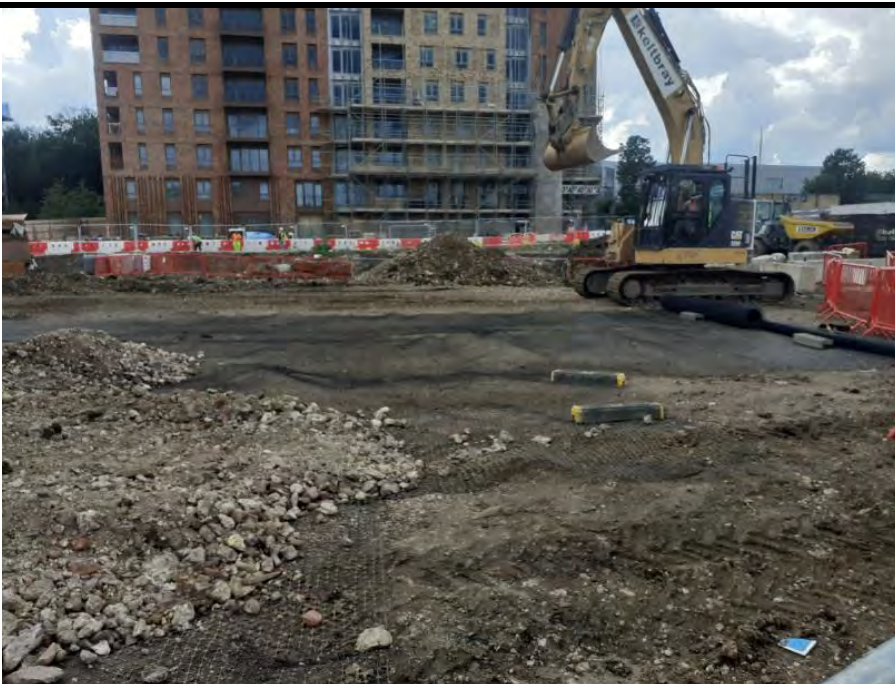
Photo: 27

Description: Installation of pile mat using site-won crushed material placed over 1 layer of geogrid.

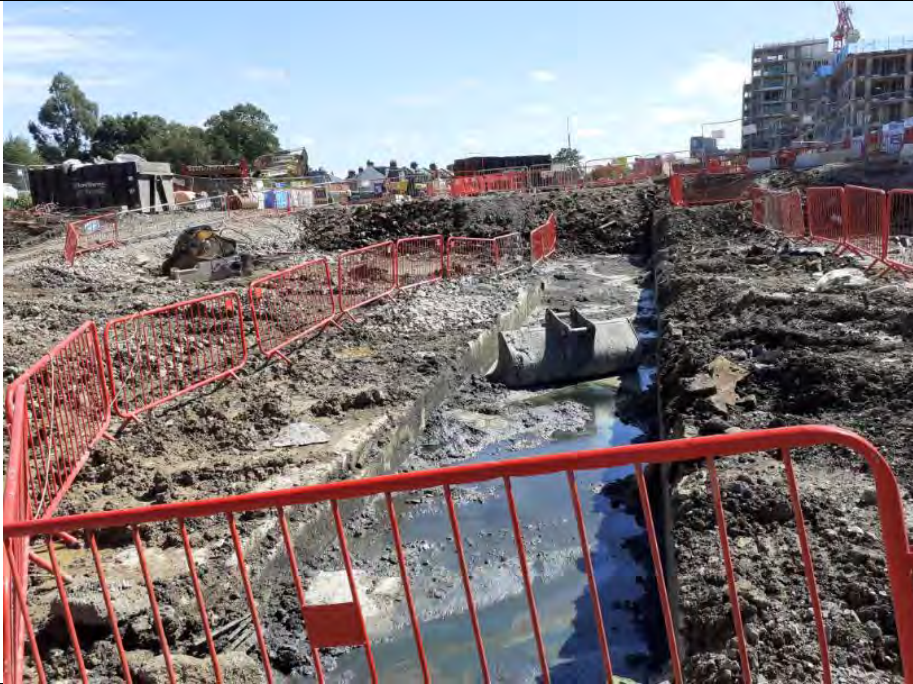
Photo: 28

Description: Excavation of hotspot in J9 North of Gasholder 1.

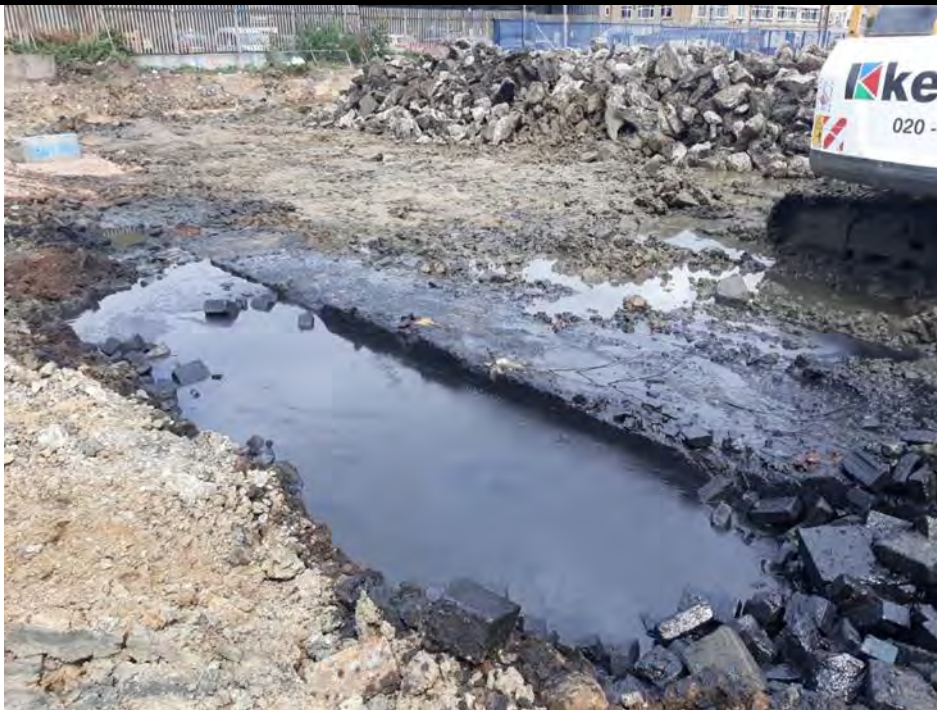
Photo: 29

Description: Initial uncovering of the contaminated trench.

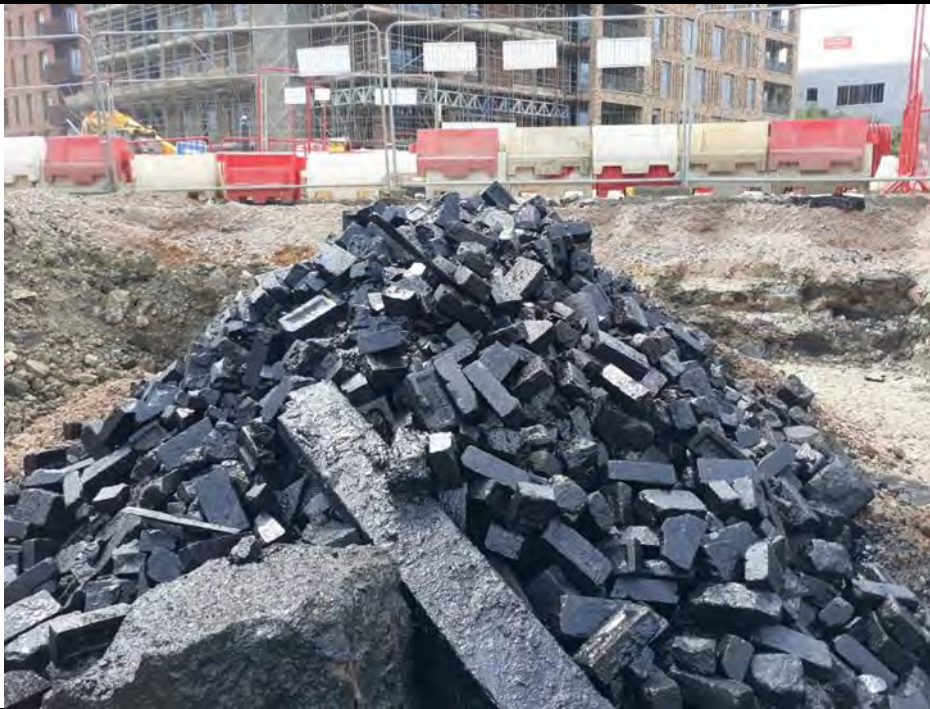
Photo: 30

Description: Brick fill material excavated from the trench. Stockpiled on plastic adjacent to source prior to screening and sampling.

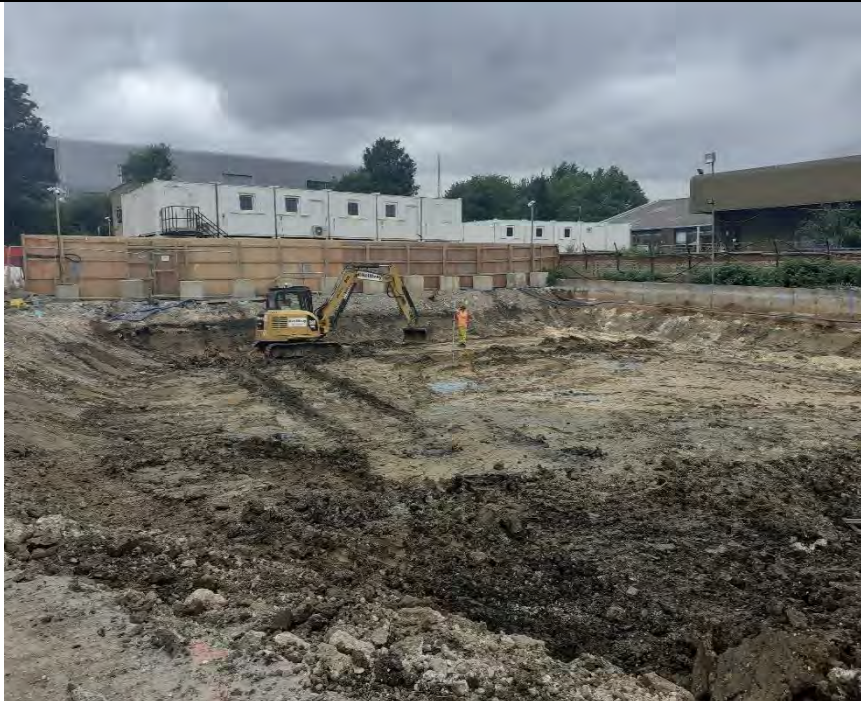
Photo: 31

Exposed Clay in I11 / H11, samples from this area exceeded the ammonium criteria

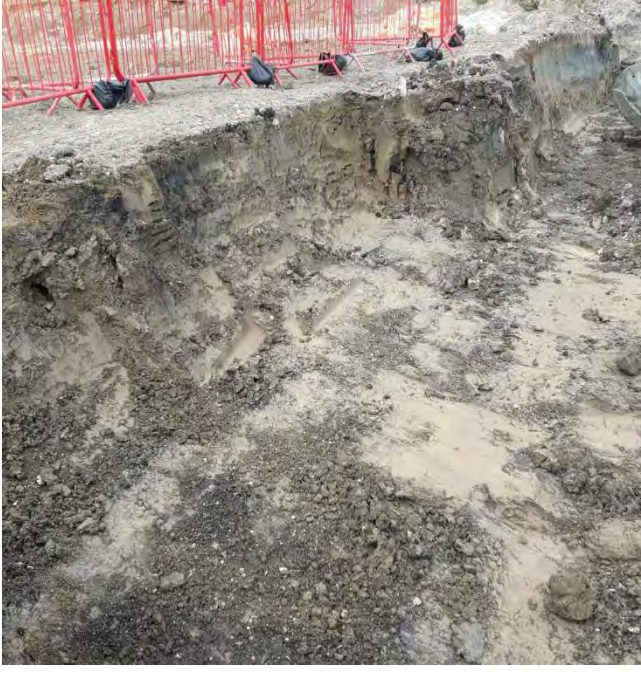
| Client: | Site Location: | Project Number: |
|---|---|---|
| Photo: 32 | Description: Trench following excavation. | |

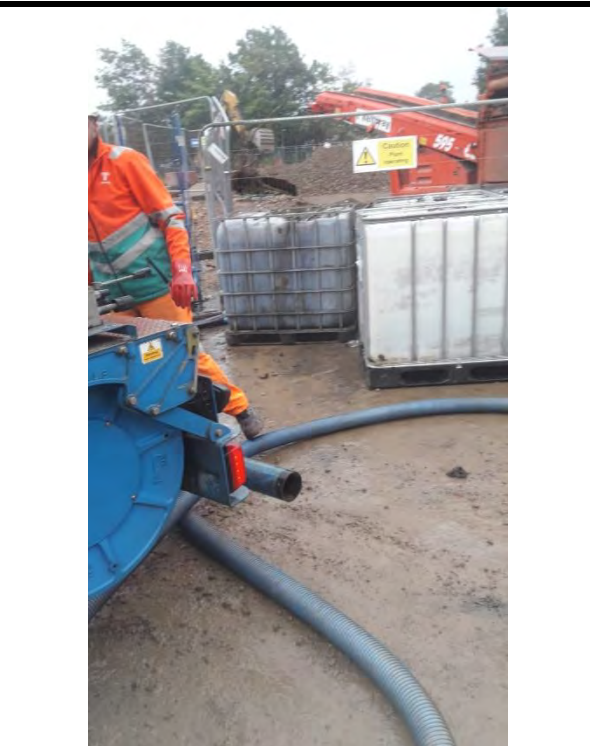
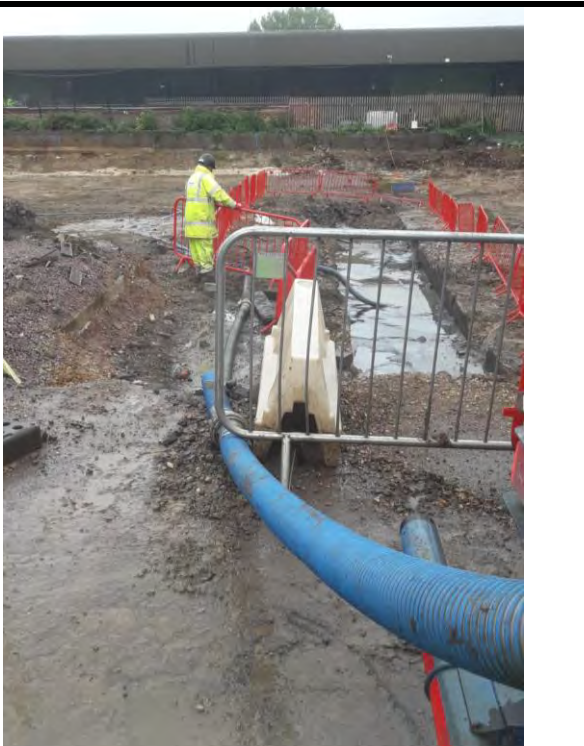
| Photo: 33 | Description: Vacuum extraction of contaminated water from the trench hotspot. |

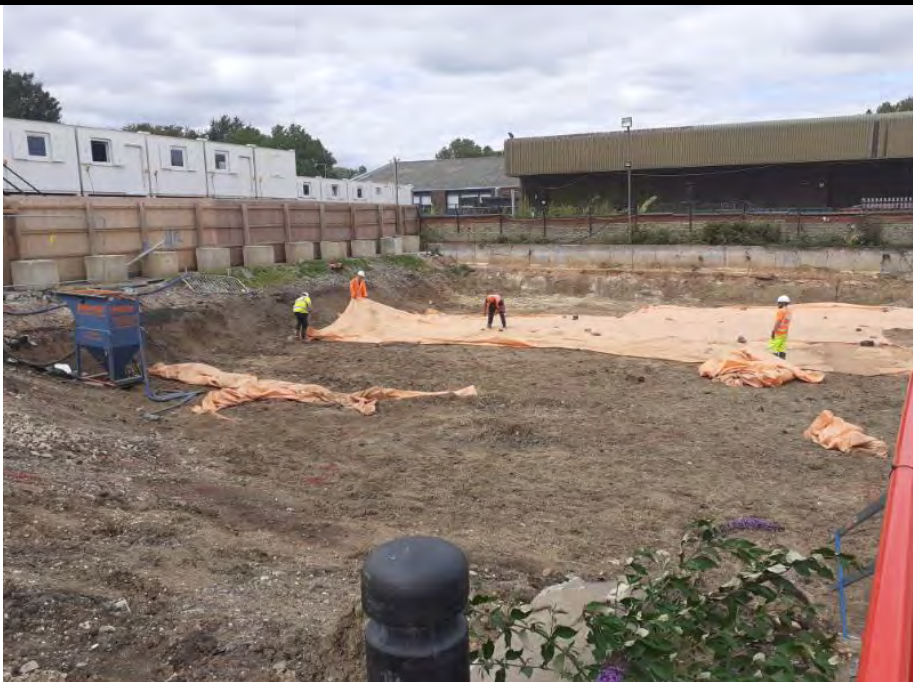
Photo: 34

Description: Placement of orange marker layer in Car Park.

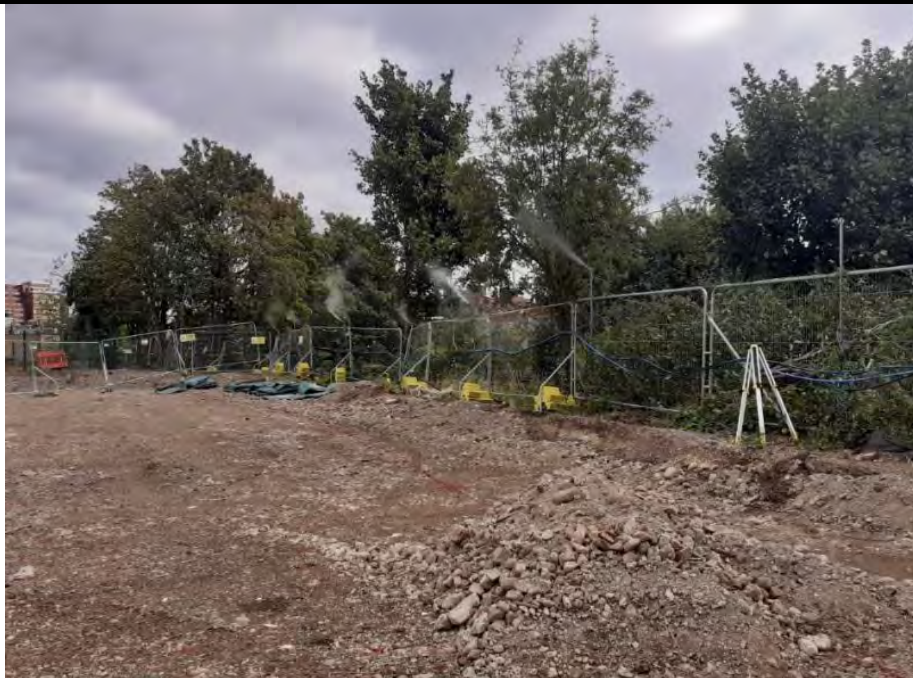
Photo: 35

Description: Dust suppression water jets on perimeter of site.

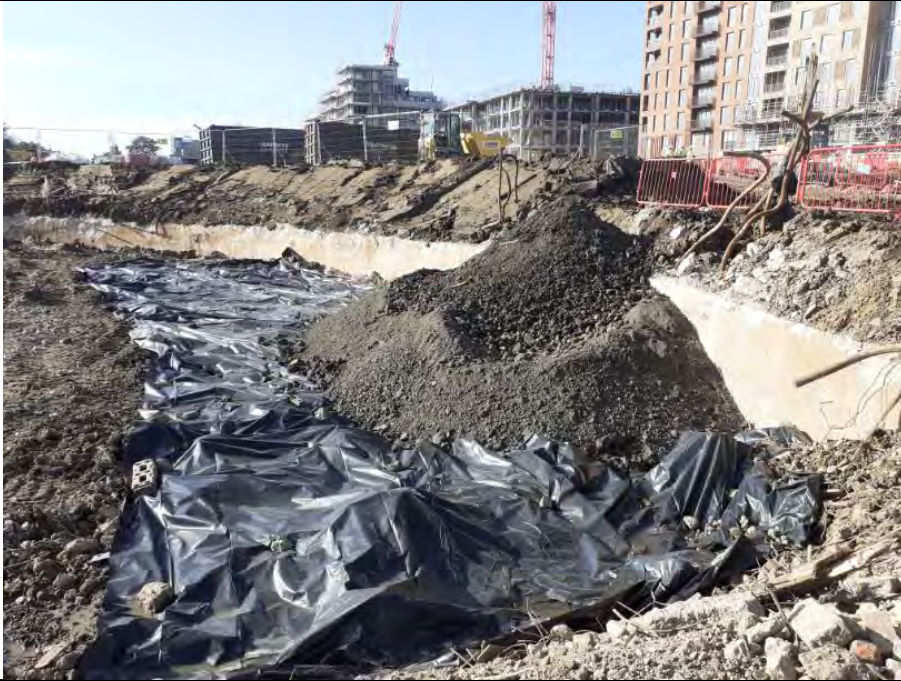
Photo: 36

Description: Placement of material onto black terram layer in Gasholder 3 prior to stabilisation.

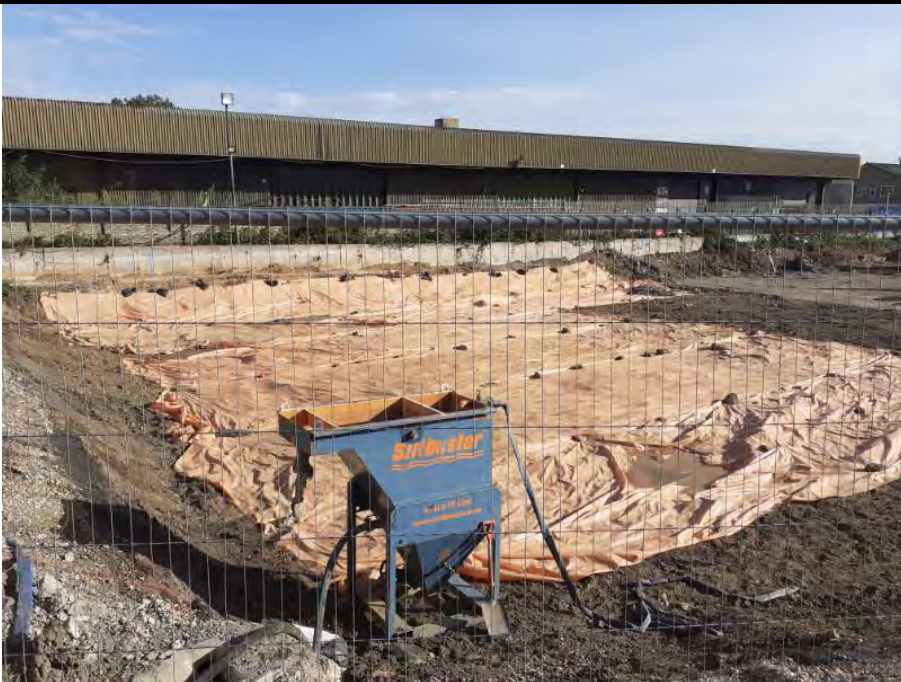
Photo: 37

Description: Placement of orange marker layer in car park. Siltbuster active and being used to treat water.

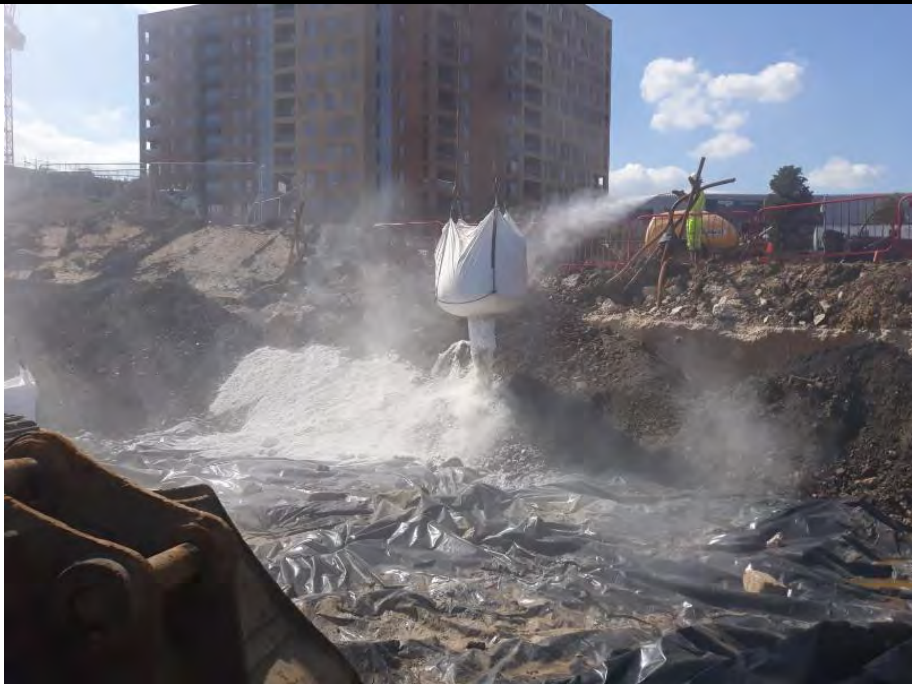
Photo: 38

Description: GGBS stabilisation with jet wash for dust suppression in Gasholder 3.
