Site Photographs

St William

Clarendon Road Gasworks, Phase 3

6075

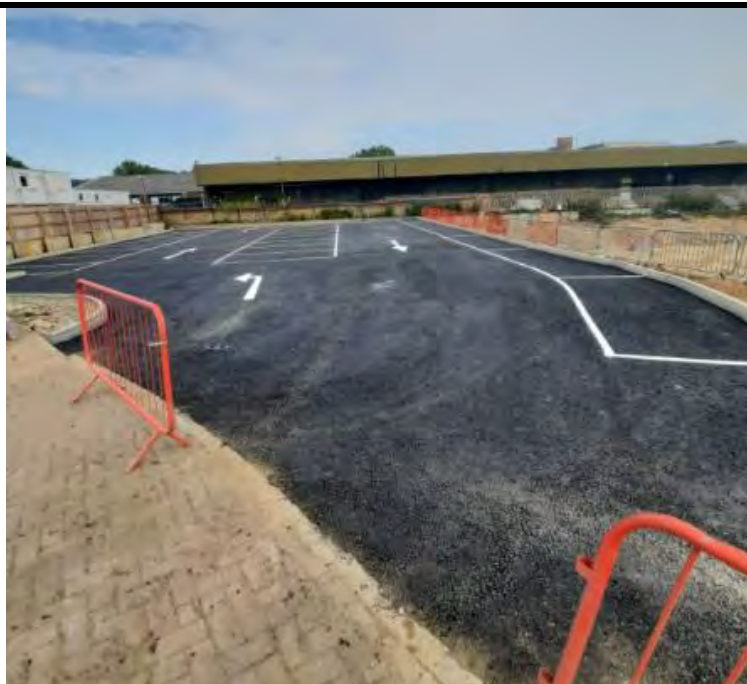
Photo: 39

Description: Installation of Car Park complete.

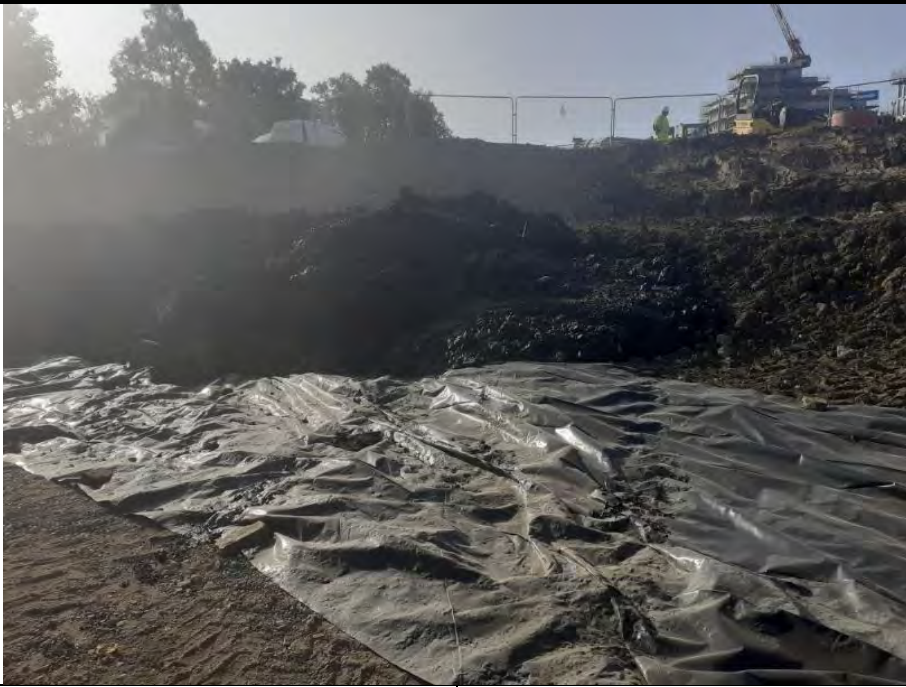
Photo: 40

Description: Stockpiling in Gasholder 3 to formation level using excavated material and site-won crushed concrete with stabilisation using cement and GGBS.

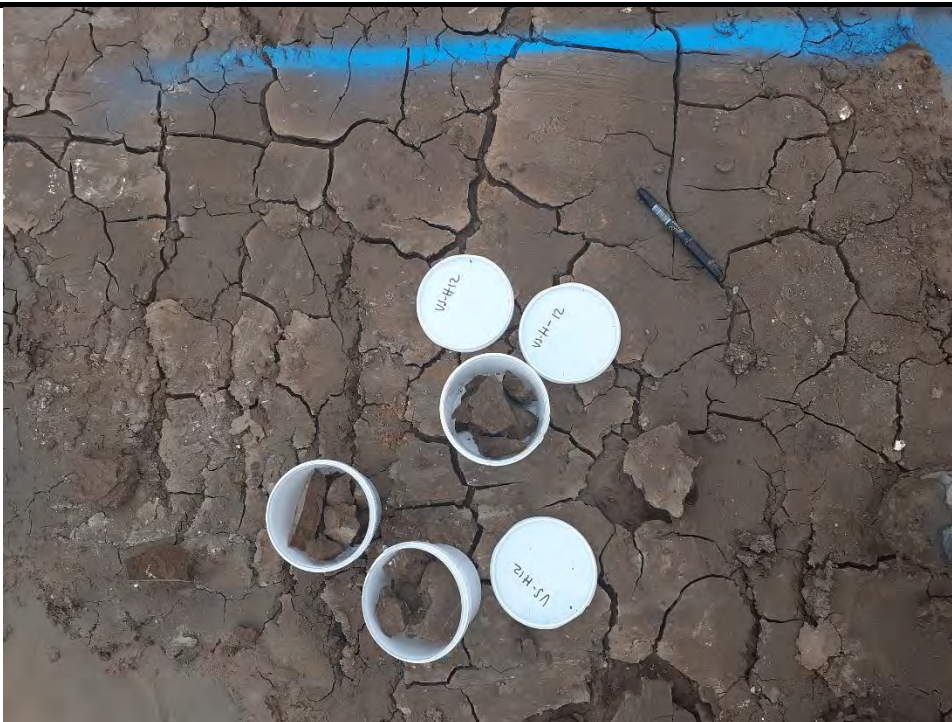
Photo: 41

Description: Validation sampling at formation level (H12).

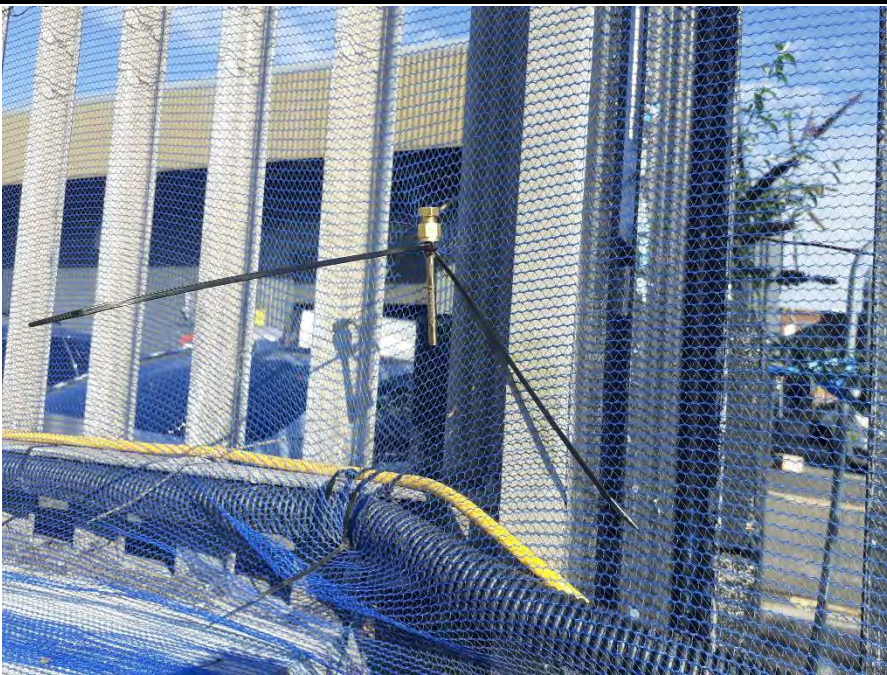
Photo: 42

Description: Tenax tube secured on boundary fencing at EMS 1.

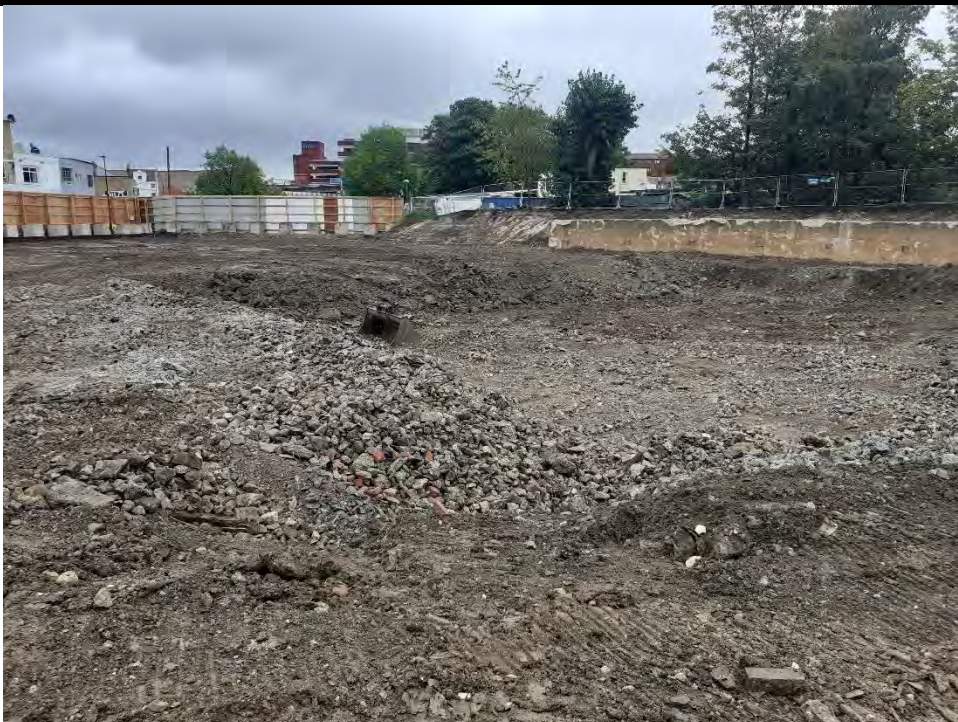
Photo: 43

Description: Final level backfill in GH3SP-40 and SP-38

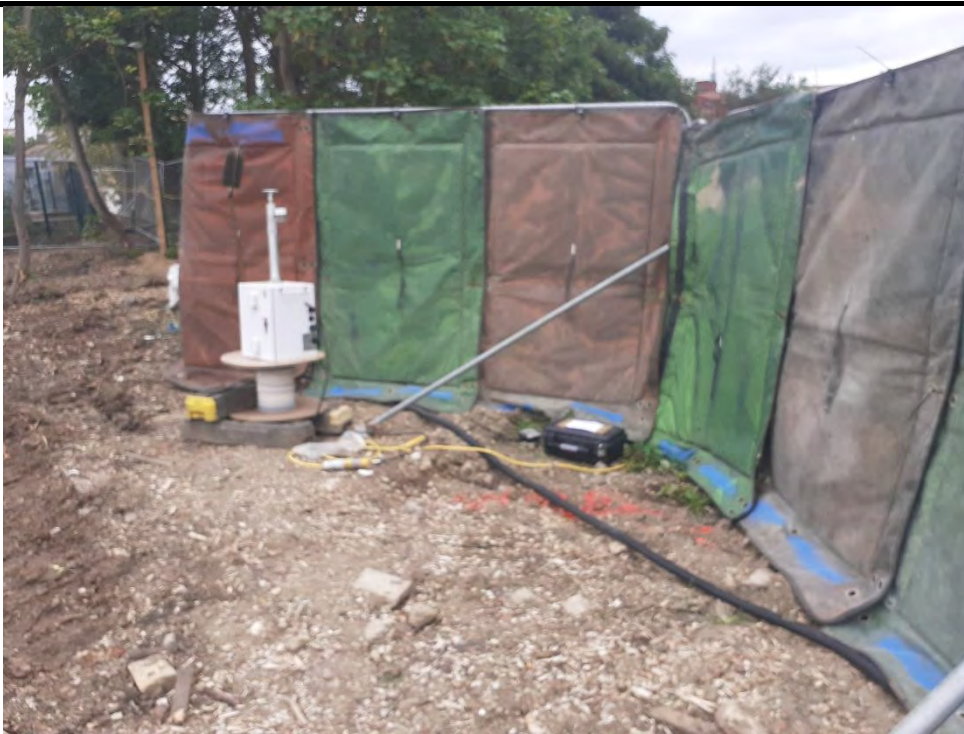
Photo: 44

Description: EMS2 monitoring point next to 'houses' sensitive receptor.

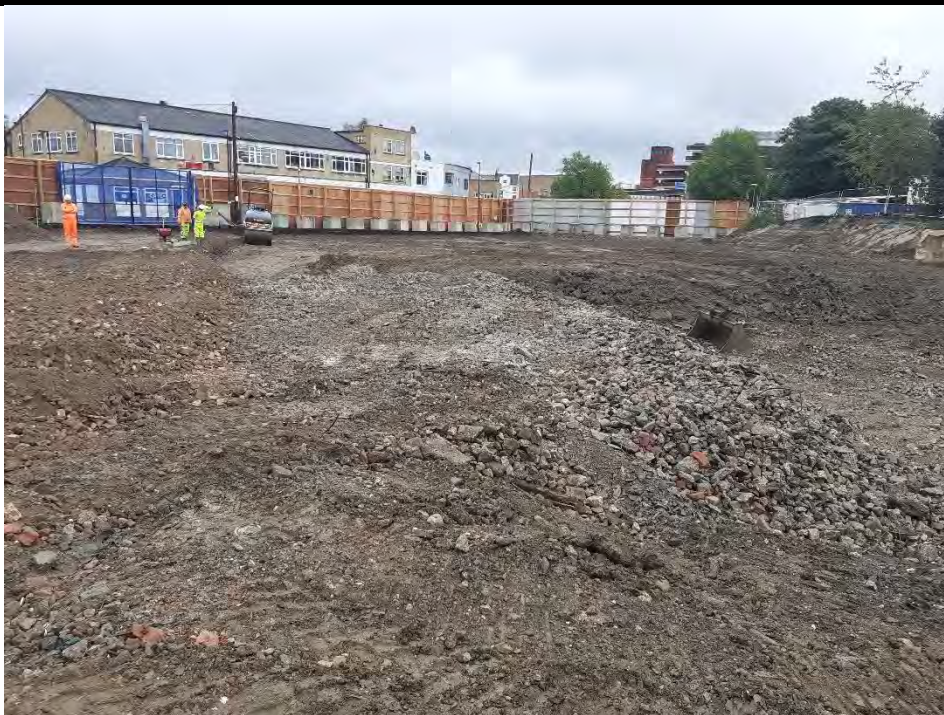
Photo: 45

Description: Haul road installation leading to Brook Road

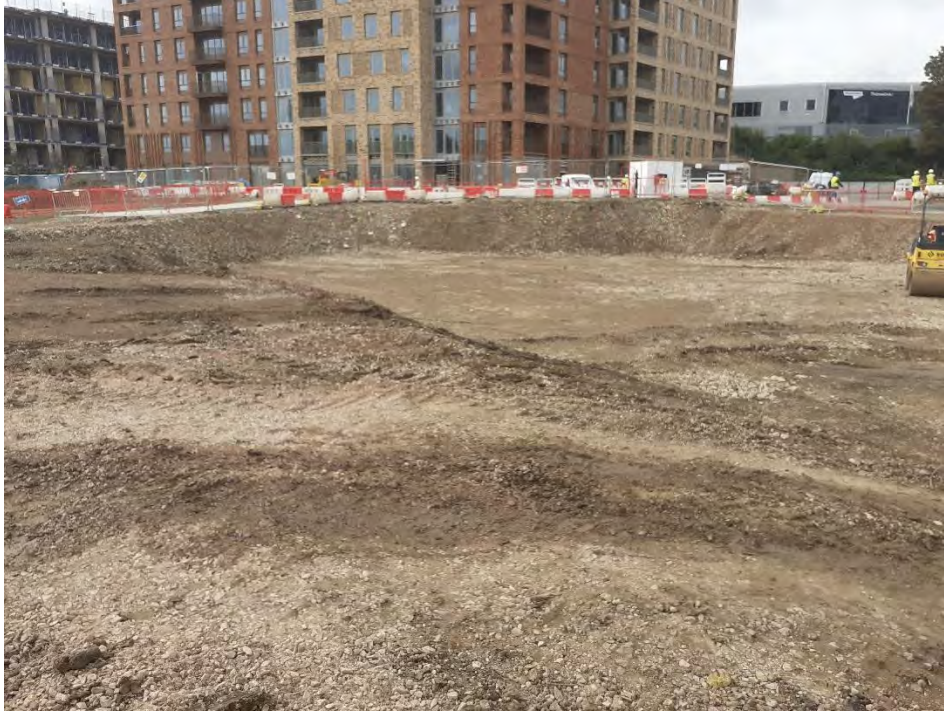
Photo: 46

Description: Haul road installation leading to Brook Road

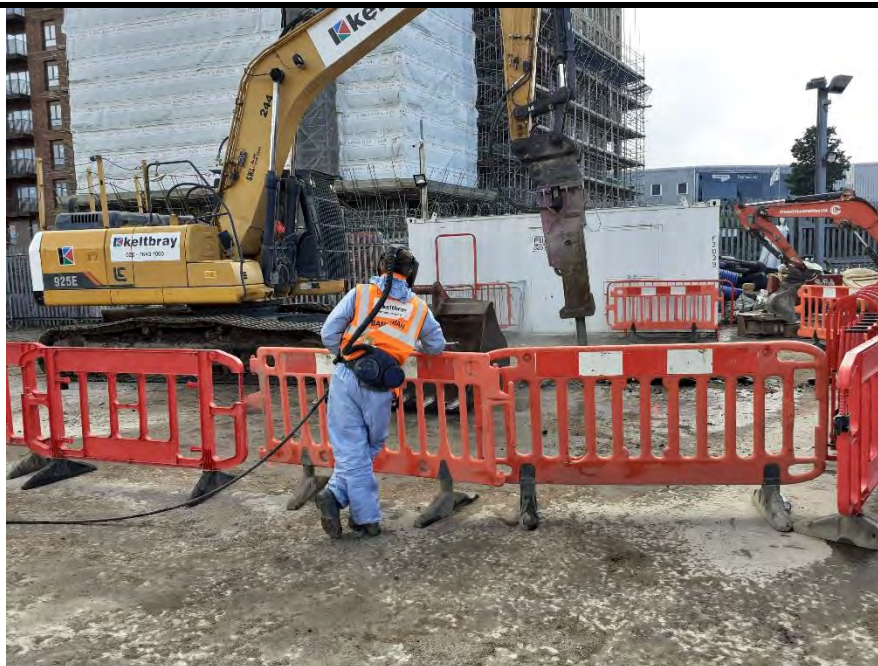
Photo: 47

Description: Excavation of TP424

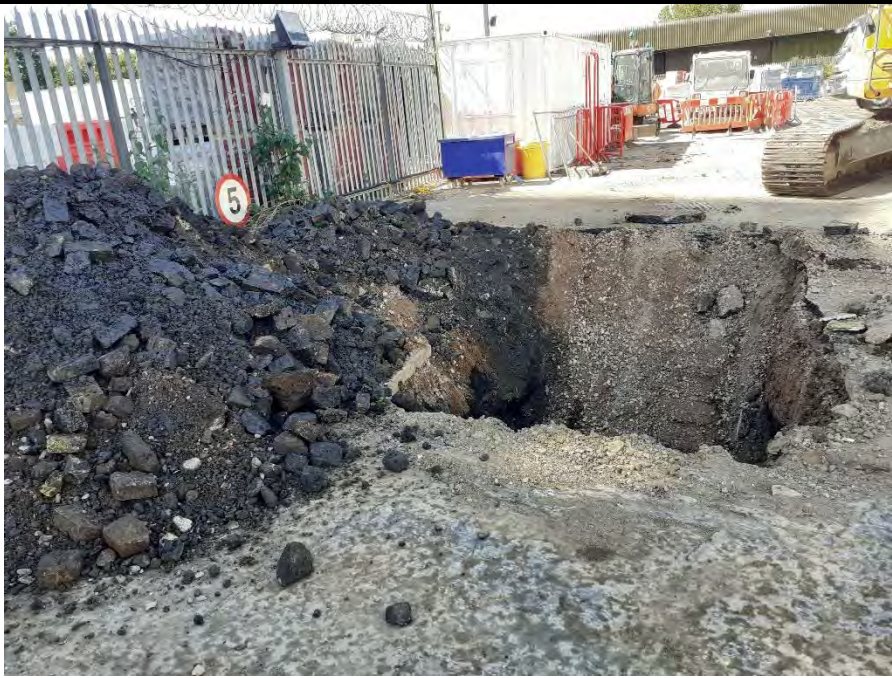
Photo: 48

Description: Excavation of TP419
