**Descriptive Report with Remarks and Observation Images**

**Site: Mary Neuer Road, Wood Green**

| Client:<br>St William | Location (Street Name):<br>Mary Neuer Road | City/Town/Village<br>Wood Green | Cust Job Ref. | Surveyors Name:<br>Ioan Zbandoc | Date:<br>21/05/2021 |

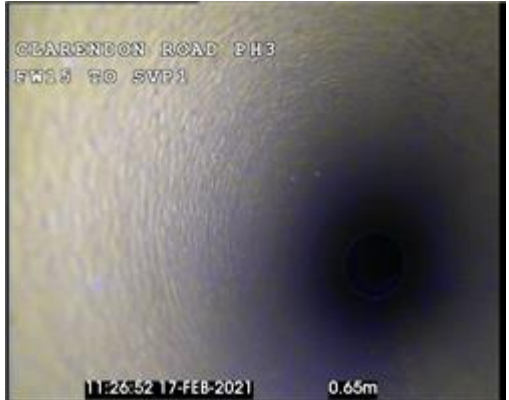
| Pos | Video Ref | Code | Description | Image |
|---|---|---|---|---|
| 00.60m | 0:00:04 | MCCI | Material of pipe changes to Cast Iron | Image Provided - Ref: 42_2<br> |

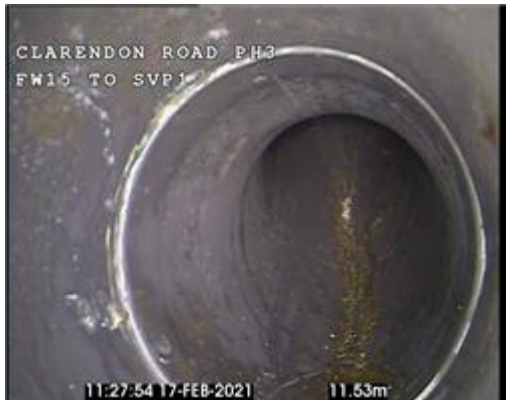
| Pos | Video Ref | Code | Description | Image |
|---|---|---|---|---|
| 11.60m | | OFF | Finish node type, outfall SVP1 | Image Provided - Ref: 42_9999<br> |

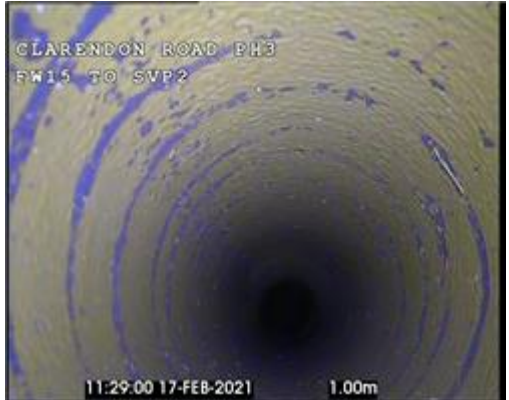
| Pos | Video Ref | Code | Description | Image |
|---|---|---|---|---|
| 00.80m | 0:00:06 | MCCI | Material of pipe changes to Cast Iron | Image Provided - Ref: 43_2<br> |

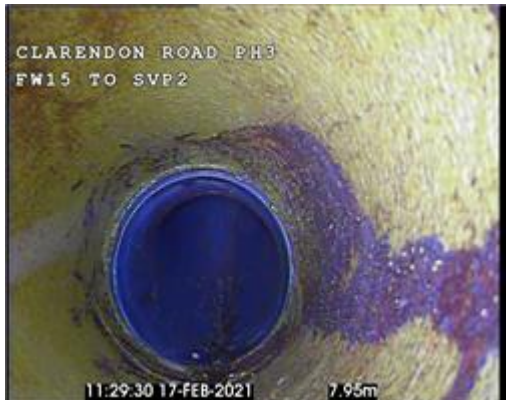
| Pos | Video Ref | Code | Description | Image |
|---|---|---|---|---|
| 08.20m | | OFF | Finish node type, outfall SVP2 | Image Provided - Ref: 43_9999<br> |

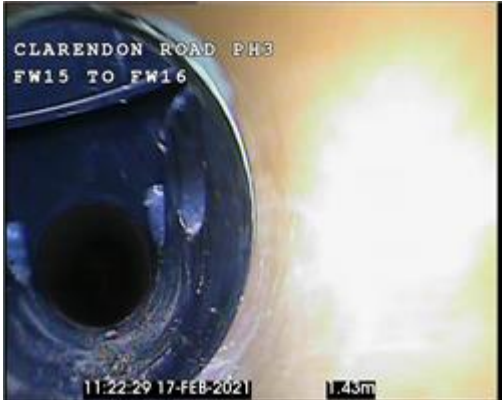
| Pos | Video Ref | Code | Description | Image |
|---|---|---|---|---|
| 01.70m | | MHF | Finish node type, manhole FW16 | <p>Image Provided - Ref: 44_9999</p> |

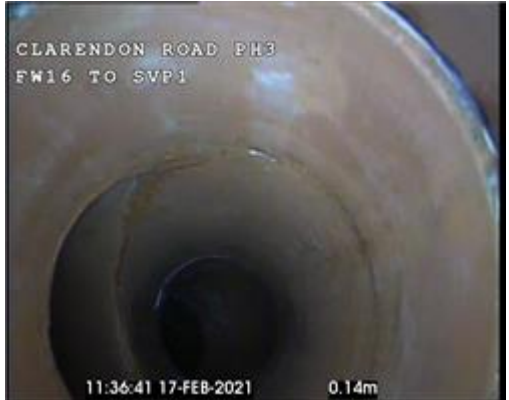
| Pos | Video Ref | Code | Description | Image |
|---|---|---|---|---|
| 00.20m | 0:00:02 | JN | Junction at 09 o'clock: 100mm Diameter | Image Provided - Ref: 45_2<br> |

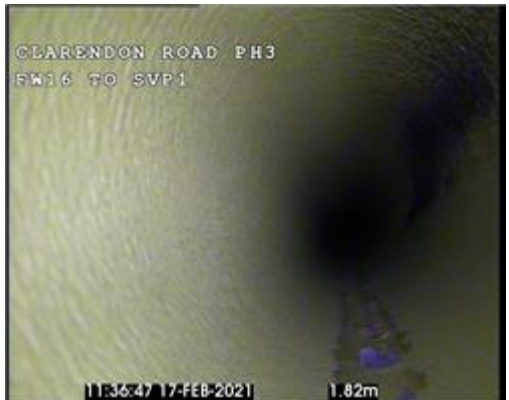
| Pos | Video Ref | Code | Description | Image |
|---|---|---|---|---|
| 01.60m | 0:00:08 | MCCI | Material of pipe changes to Cast Iron | Image Provided - Ref: 45_3<br> |

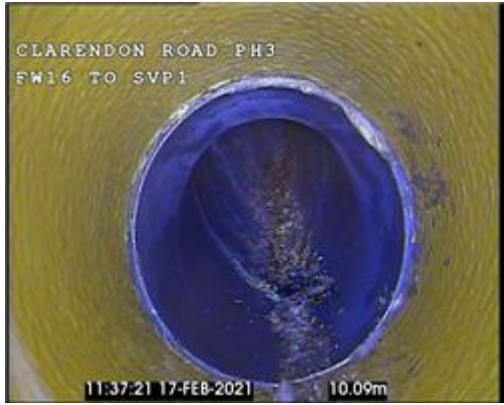
| Pos | Video Ref | Code | Description | Image |
|---|---|---|---|---|
| 10.20m | | OFF | Finish node type, outfall SVP1 | <p>Image Provided - Ref: 45_9999</p> |

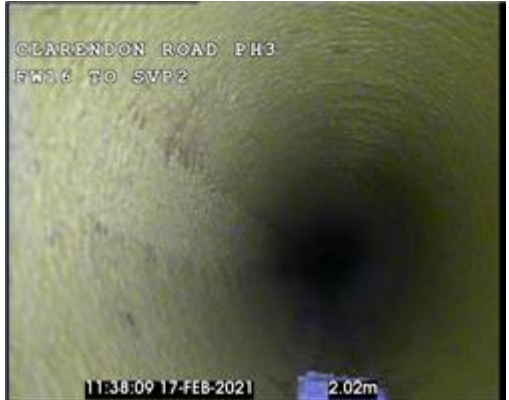
| Pos | Video Ref | Code | Description | Image |
|---|---|---|---|---|
| 01.70m | 0:00:06 | MCCI | Material of pipe changes to Cast Iron | Image Provided - Ref: 46_2<br> |

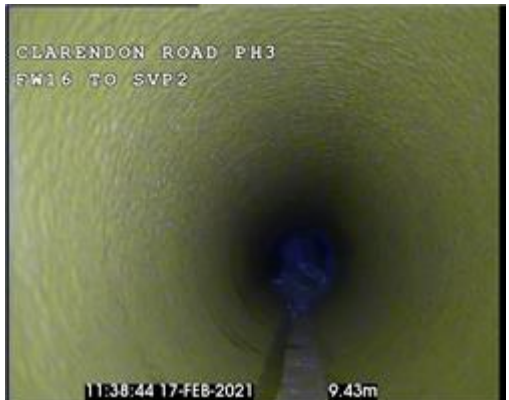
| Pos | Video Ref | Code | Description | Image |
|---|---|---|---|---|
| 10.20m | | OFF | Finish node type, outfall SVP2 | Image Provided - Ref: 46_9999<br> |

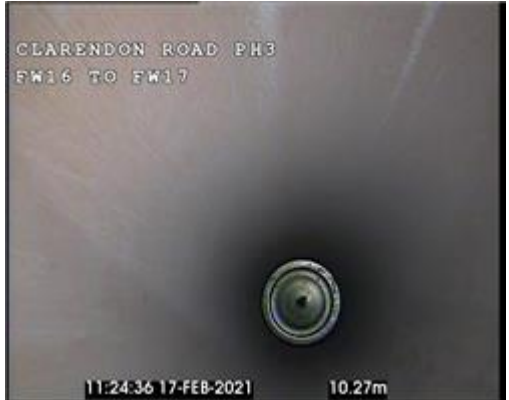
| Pos | Video Ref | Code | Description | Image |
|---|---|---|---|---|
| 11.00m | | SA | Survey abandoned Pipe not completed yet. | <p>Image Provided - Ref: 47_9999</p> |

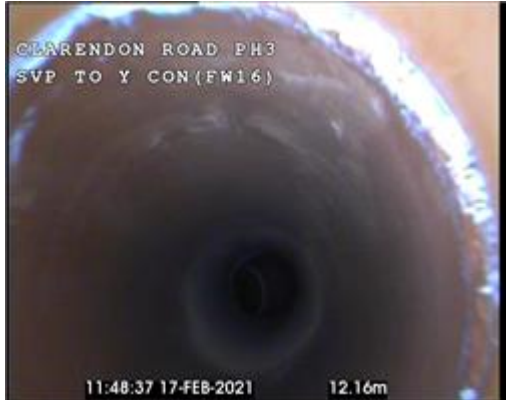
| Pos | Video Ref | Code | Description | Image |
|---|---|---|---|---|
| 12.10m | 0:00:44 | MCVC | Material of pipe changes to Vitrified Clay (i.e. all clayware) | Image Provided - Ref: 48_2<br> |

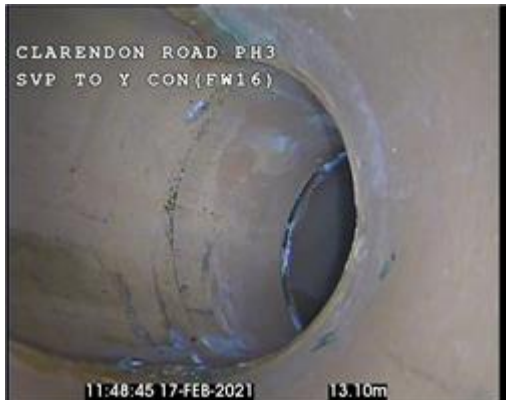
| Pos | Video Ref | Code | Description | Image |
|---|---|---|---|---|
| 13.10m | | WRF | Finish node type, major connection without manhole Y CON(FW16) | Image Provided - Ref: 48_9999<br> |

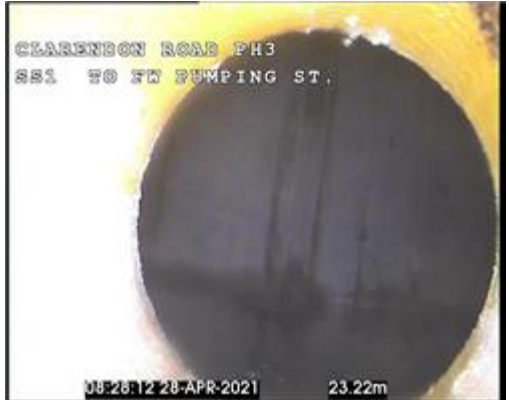
| Pos | Video Ref | Code | Description | Image |
|---|---|---|---|---|
| 23.20m | | OCF | Finish node type, other special<br>chamber<br>PUMP ST | Image Provided - Ref: 49_9999<br> |

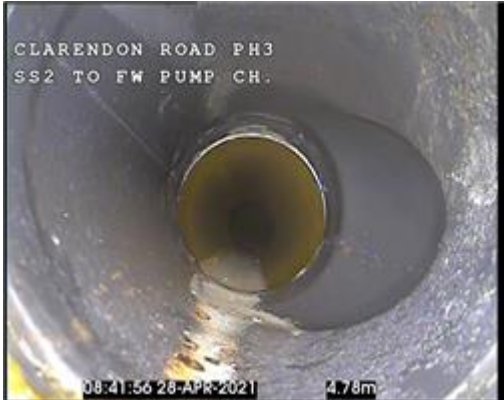
| Pos | Video Ref | Code | Description | Image |
|---|---|---|---|---|
| 04.80m | 0:00:33 | JN | Junction at 03 o'clock: 100mm Diameter | Image Provided - Ref: 50_2<br> |

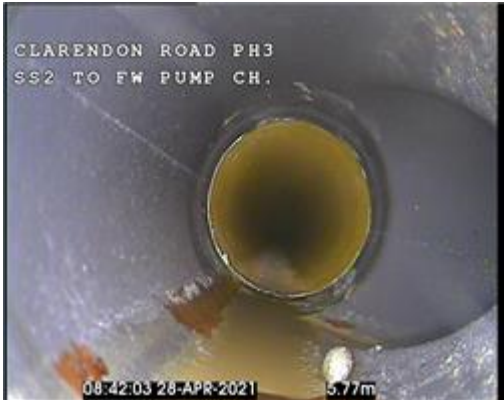
| Pos | Video Ref | Code | Description | Image |
|---|---|---|---|---|
| 05.80m | 0:00:41 | JN | Junction at 03 o'clock: 100mm Diameter | Image Provided - Ref: 50_3<br> |

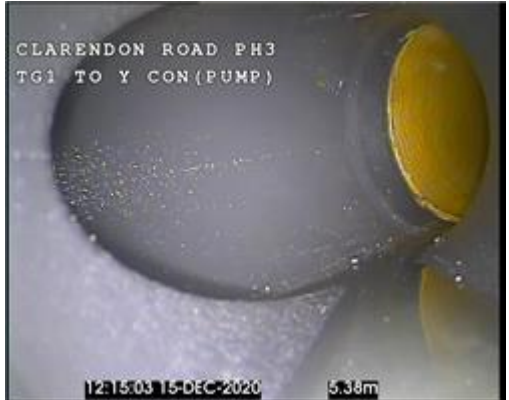
| Pos | Video Ref | Code | Description | Image |
|---|---|---|---|---|
| 05.40m | | WRF | Finish node type, major connection without manhole Y CON(PUMP ST) | Image Provided - Ref: 51_9999<br> |

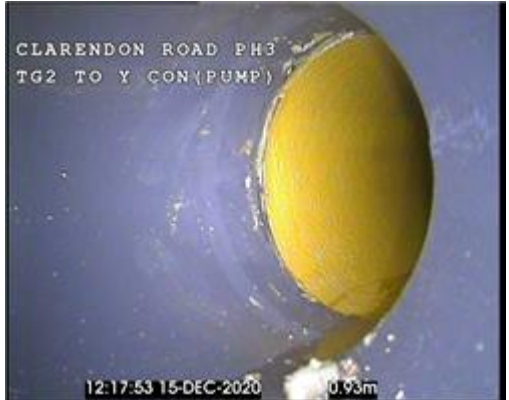
| Pos | Video Ref | Code | Description | Image |
|---|---|---|---|---|
| 01.20m | | WRF | Finish node type, major connection without manhole Y CON(PUMP ST) | Image Provided - Ref: 52_9999<br> |

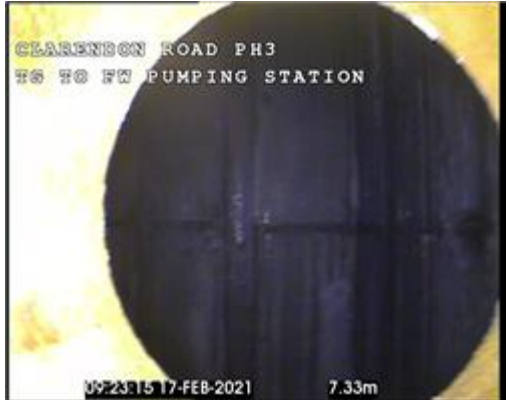
| Pos | Video Ref | Code | Description | Image |
|---|---|---|---|---|
| 07.70m | | OCF | Finish node type, other special chamber FW PUPM ST | Image Provided - Ref: 53_9999<br> |

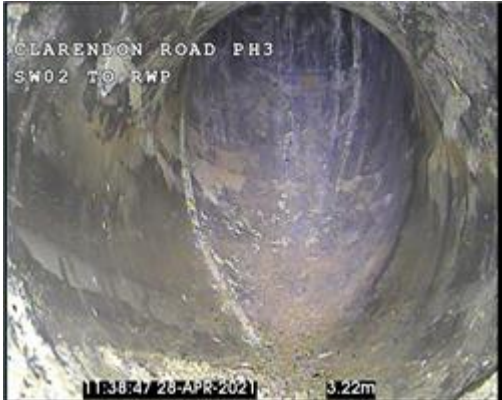
| Pos | Video Ref | Code | Description | Image |
|---|---|---|---|---|
| 03.20m | | OFF | Finish node type, outfall RWP | <p>Image Provided - Ref: 55_9999</p> |

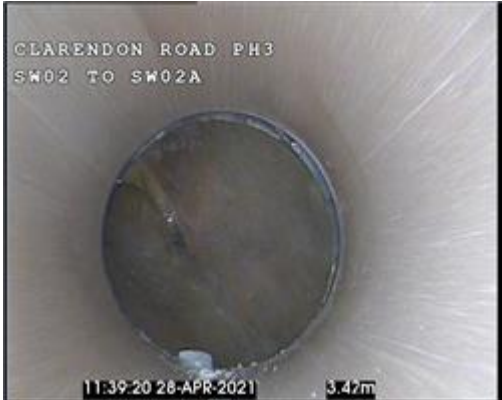
| Pos | Video Ref | Code | Description | Image |
|---|---|---|---|---|
| 04.00m | | SA | Survey abandoned SW02A not built yet | <p>Image Provided - Ref: 56_9999</p> |

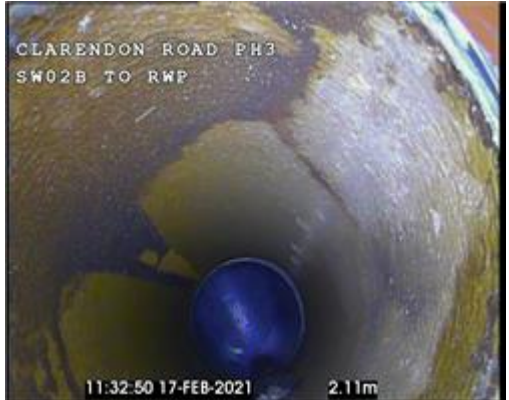
| Pos | Video Ref | Code | Description | Image |
|---|---|---|---|---|
| 02.00m | 0:00:08 | MCCI | Material of pipe changes to Cast Iron | <p>Image Provided - Ref: 57_2</p> |

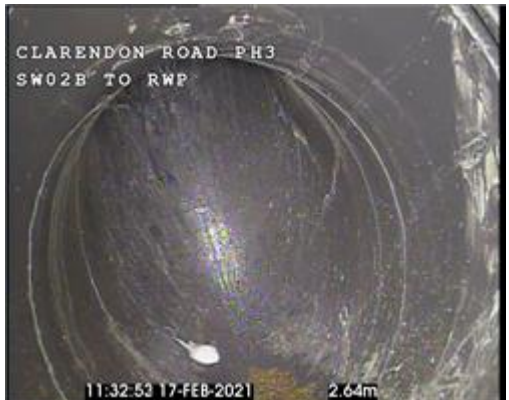
| Pos | Video Ref | Code | Description | Image |
|---|---|---|---|---|
| 02.70m | | OFF | Finish node type, outfall RWP | <p>Image Provided - Ref: 57_9999</p> |

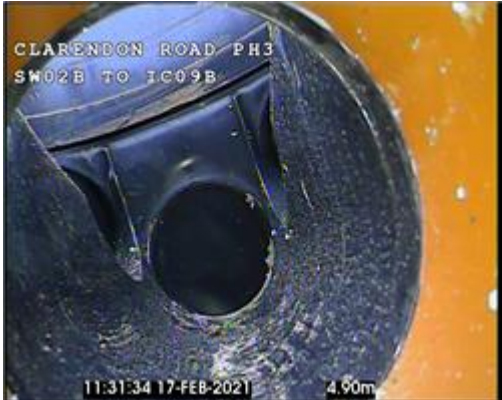
| Pos | Video Ref | Code | Description | Image |
|---|---|---|---|---|
| 05.00m | | MHF | Finish node type, manhole IC09B | <p>Image Provided - Ref: 58_9999</p> |

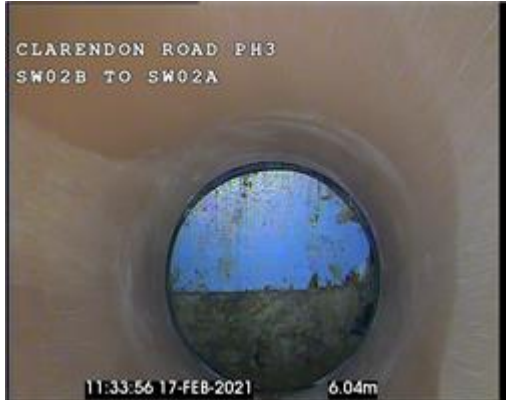
| Pos | Video Ref | Code | Description | Image |
|---|---|---|---|---|
| 06.50m | | SA | Survey abandoned SW02A not built yet | <p>Image Provided - Ref: 59_9999</p> |

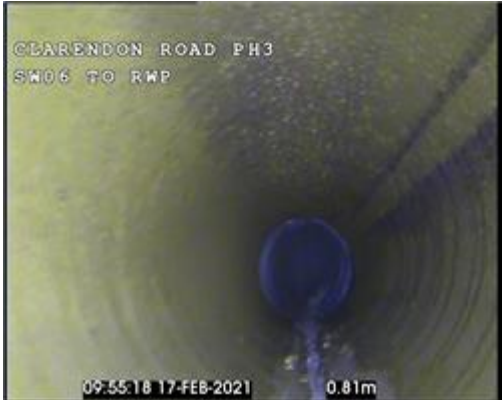
| Pos | Video Ref | Code | Description | Image |
|---|---|---|---|---|
| 00.60m | 0:00:05 | MCCI | Material of pipe changes to Cast Iron | <p>Image Provided - Ref: 60_2</p> |

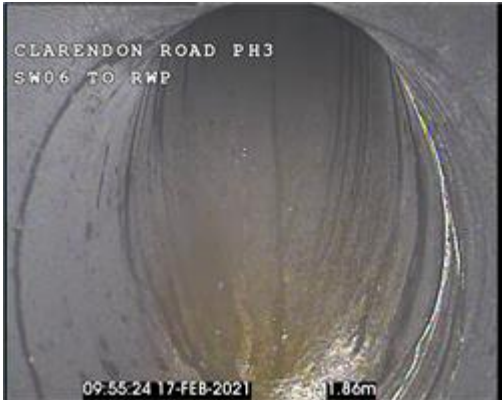
| Pos | Video Ref | Code | Description | Image |
|---|---|---|---|---|
| 01.80m | | OFF | Finish node type, outfall RWP | <p>Image Provided - Ref: 60_9999</p> |

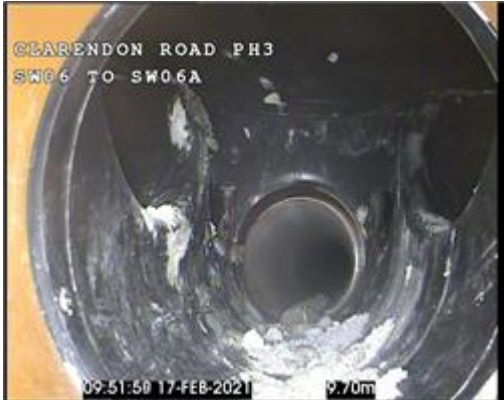
| Pos | Video Ref | Code | Description | Image |
|---|---|---|---|---|
| 09.80m | | MHF | Finish node type, manhole SW06A | Image Provided - Ref: 61_9999<br> |

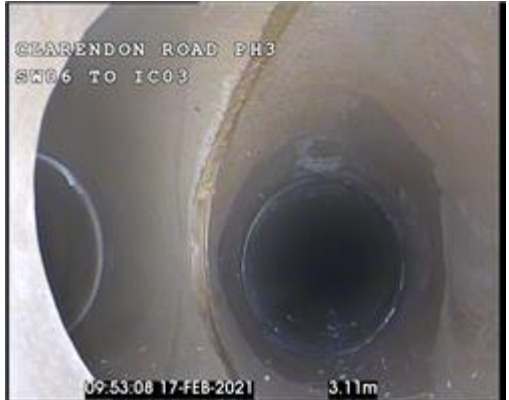
| Pos | Video Ref | Code | Description | Image |
|---|---|---|---|---|
| 03.10m | 0:00:24 | JN | Junction at 09 o'clock: 150mm Diameter | Image Provided - Ref: 62_2<br> |

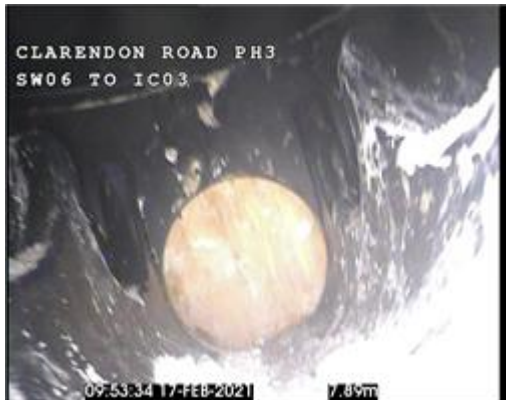
| Pos | Video Ref | Code | Description | Image |
|---|---|---|---|---|
| 07.80m | | MHF | Finish node type, manhole SW07 | Image Provided - Ref: 62_9999<br> |

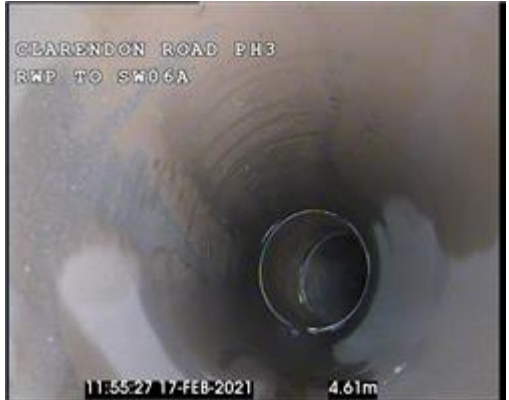
| Pos | Video Ref | Code | Description | Image |
|---|---|---|---|---|
| 04.60m | 0:00:16 | MCCI | Material of pipe changes to Cast Iron | Image Provided - Ref: 89_2<br> |

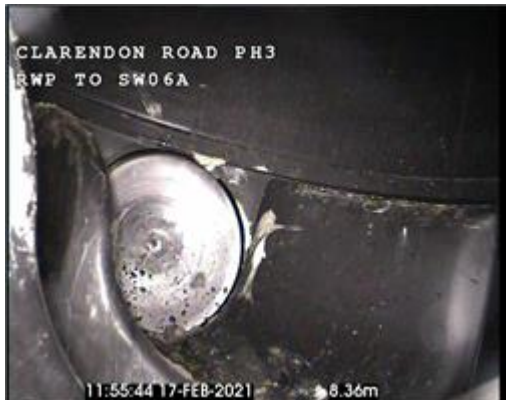
| Pos | Video Ref | Code | Description | Image |
|---|---|---|---|---|
| 08.40m | | MHF | Finish node type, manhole SW06A | Image Provided - Ref: 89_9999<br> |

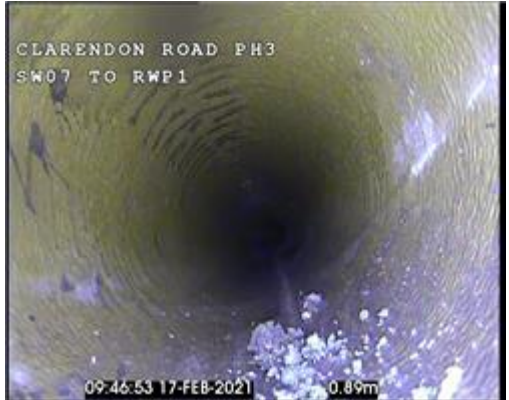
| Pos | Video Ref | Code | Description | Image |
|---|---|---|---|---|
| 00.70m | 0:00:04 | MCCI | Material of pipe changes to Cast Iron | Image Provided - Ref: 63_2<br> A photograph looking down a pipe. The text 'CLARENDON ROAD PH3 SW07 TO RWP1' is visible in the upper left. A timestamp '09:46:53 17-FEB-2021' and a distance marker '0.89m' are at the bottom. |

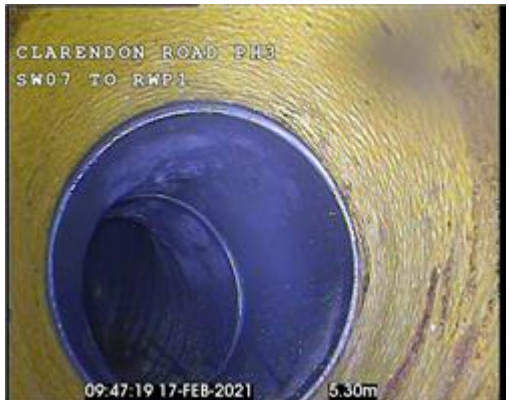
| Pos | Video Ref | Code | Description | Image |
|---|---|---|---|---|
| 05.30m | | OFF | Finish node type, outfall RWP1 | Image Provided - Ref: 63_9999<br> A photograph of a large circular pipe opening. The text 'CLARENDON ROAD PH3 SW07 TO RWP1' is visible in the upper left. A timestamp '09:47:19 17-FEB-2021' and a distance marker '5.30m' are at the bottom. |

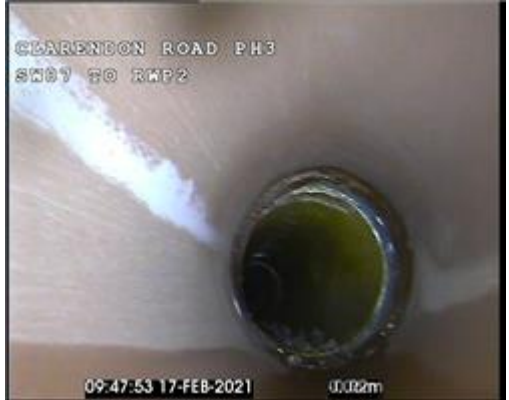
| Pos | Video Ref | Code | Description | Image |
|---|---|---|---|---|
| 00.00m | | MH | Start node type, manhole SW07 | Image Provided - Ref: 64_0<br> A close-up photograph of a circular manhole opening. The interior of the manhole is dark, and the surrounding concrete structure is visible. Text overlay: CLARENDON ROAD PH3 SW07 TO RWP2. Timestamp: 09:47:53 17-FEB-2021. Depth: 0.002m. |

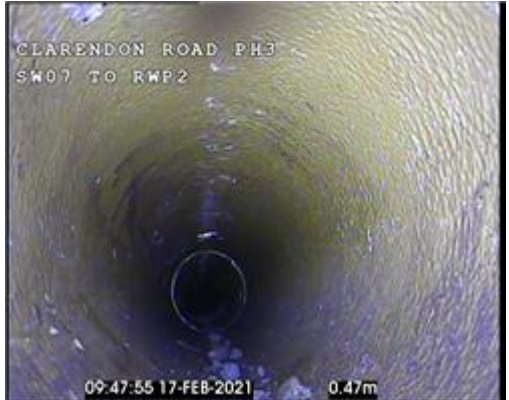
| Pos | Video Ref | Code | Description | Image |
|---|---|---|---|---|
| 00.60m | 0:00:04 | MCCI | Material of pipe changes to Cast Iron | Image Provided - Ref: 64_2<br> A photograph looking down a pipe. The pipe walls are made of cast iron and show some rust and debris. Text overlay: CLARENDON ROAD PH3 SW07 TO RWP2. Timestamp: 09:47:55 17-FEB-2021. Depth: 0.47m. |

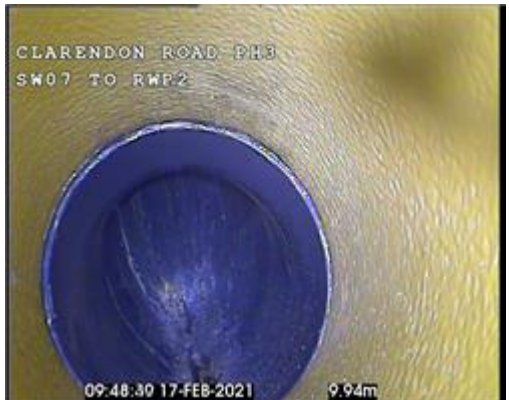
| Pos | Video Ref | Code | Description | Image |
|---|---|---|---|---|
| 10.10m | | OFF | Finish node type, outfall RWP2 | Image Provided - Ref: 64_9999<br> A photograph of a large, circular outfall pipe. The pipe is dark blue/black and surrounded by a concrete structure. Text overlay: CLARENDON ROAD PH3 SW07 TO RWP2. Timestamp: 09:48:30 17-FEB-2021. Depth: 9.94m. |

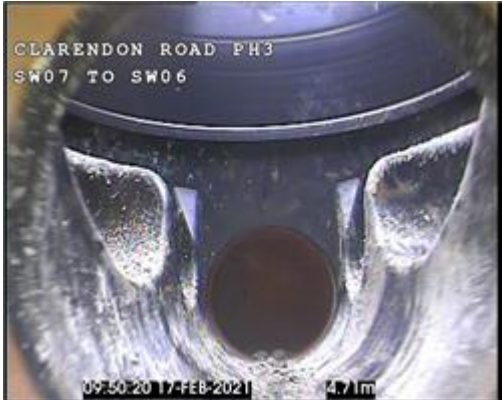
| Pos | Video Ref | Code | Description | Image |
|---|---|---|---|---|
| 04.80m | | MHF | Finish node type, manhole SW06 | <p>Image Provided - Ref: 65_9999</p> |

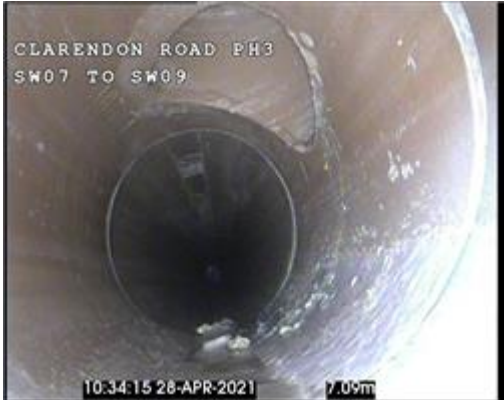
| Pos | Video Ref | Code | Description | Image |
|---|---|---|---|---|
| 07.20m | 0:00:32 | JN | Junction at 12 o'clock: 150mm Diameter | Image Provided - Ref: 66_2<br> |

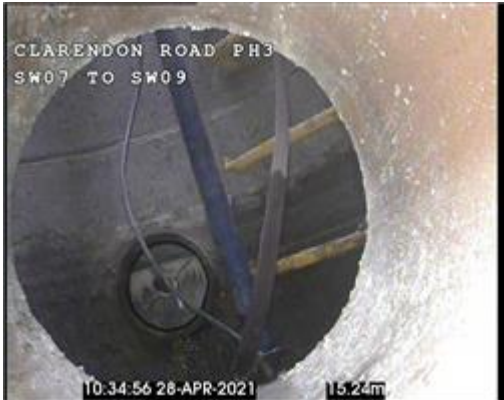
| Pos | Video Ref | Code | Description | Image |
|---|---|---|---|---|
| 15.50m | | MHF | Finish node type, manhole SW09 Catchpit | Image Provided - Ref: 66_9999<br> |

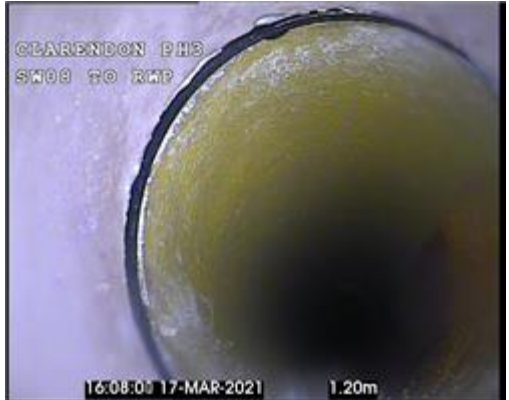
| Pos | Video Ref | Code | Description | Image |
|---|---|---|---|---|
| 01.30m | 0:00:10 | MCCI | Material of pipe changes to Cast Iron | Image Provided - Ref: 67_2<br> |

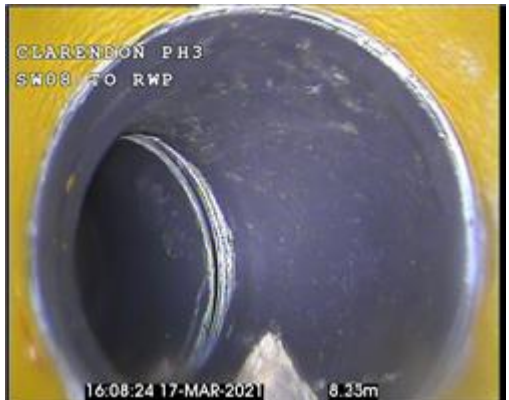
| Pos | Video Ref | Code | Description | Image |
|---|---|---|---|---|
| 08.60m | | OFF | Finish node type, outfall RWP | Image Provided - Ref: 67_9999<br> |

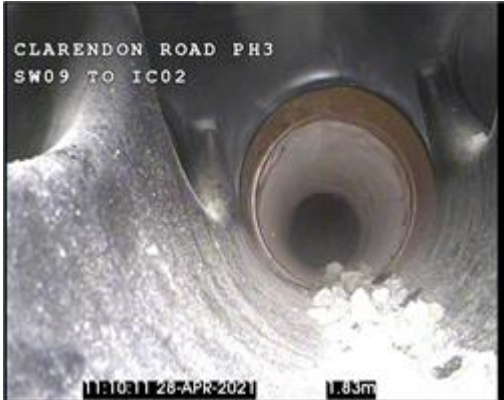
| Pos | Video Ref | Code | Description | Image |
|---|---|---|---|---|
| 01.60m | | MHF | Finish node type, manhole IC02A | <p>Image Provided - Ref: 69_9999</p> |

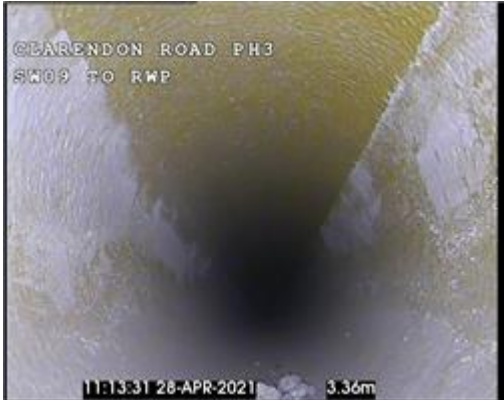
| Pos | Video Ref | Code | Description | Image |
|---|---|---|---|---|
| 03.30m | 0:00:17 | MCCI | Material of pipe changes to Cast Iron | Image Provided - Ref: 70_2<br> |

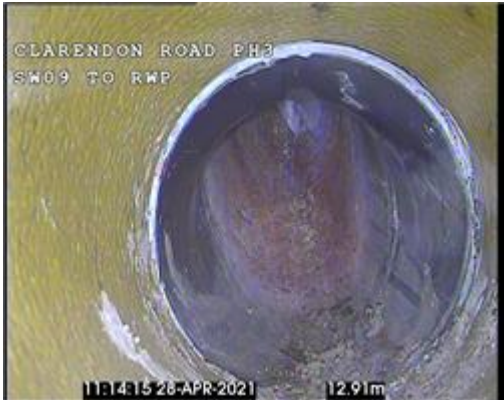
| Pos | Video Ref | Code | Description | Image |
|---|---|---|---|---|
| 12.80m | | OFF | Finish node type, outfall RWP | Image Provided - Ref: 70_9999<br> |

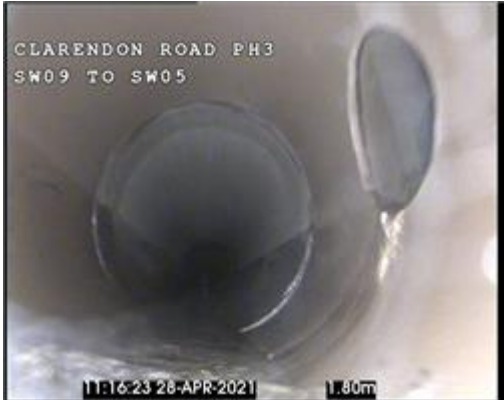
| Pos | Video Ref | Code | Description | Image |
|---|---|---|---|---|
| 01.90m | 0:00:10 | JN | Junction at 03 o'clock: 100mm Diameter | Image Provided - Ref: 71_2<br> |

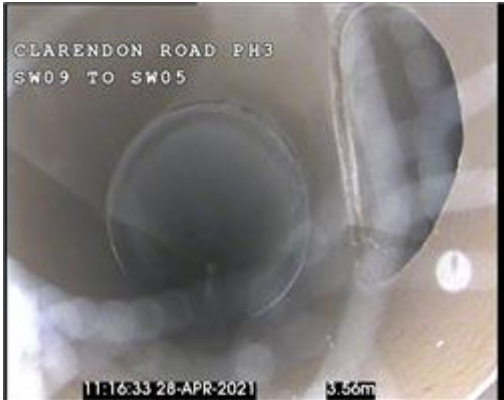
| Pos | Video Ref | Code | Description | Image |
|---|---|---|---|---|
| 03.60m | 0:00:21 | JN | Junction at 03 o'clock: 150mm Diameter | Image Provided - Ref: 71_3<br> |

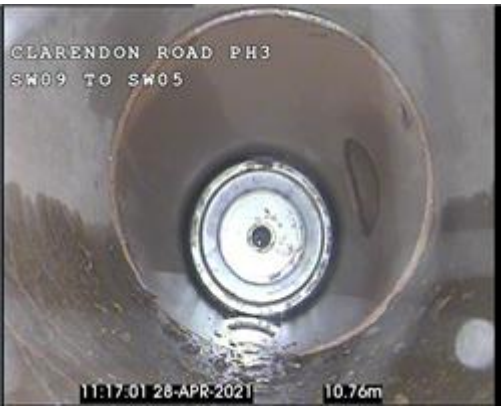
| Pos | Video Ref | Code | Description | Image |
|---|---|---|---|---|
| 11.10m | | SA | Survey abandoned<br>SW05 not built yet | <p>Image Provided - Ref: 71_9999</p> |

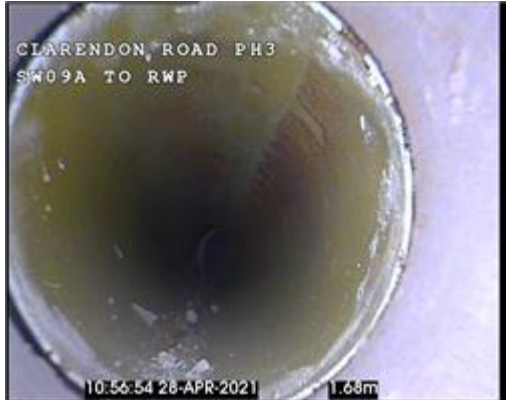
| Pos | Video Ref | Code | Description | Image |
|---|---|---|---|---|
| 01.70m | 0:00:11 | MCCI | Material of pipe changes to Cast Iron | Image Provided - Ref: 72_2<br> |

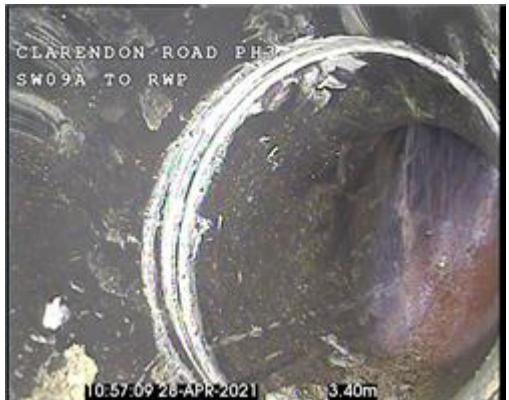
| Pos | Video Ref | Code | Description | Image |
|---|---|---|---|---|
| 03.40m | | OFF | Finish node type, outfall RWP | Image Provided - Ref: 72_9999<br> |

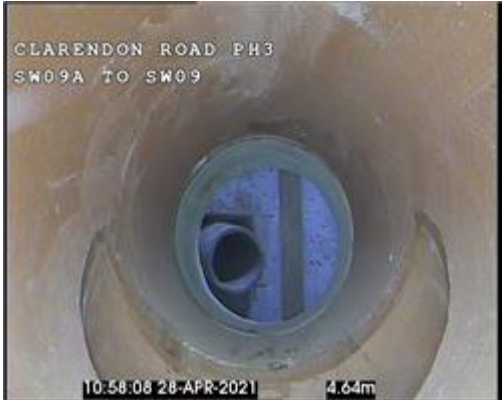
| Pos | Video Ref | Code | Description | Image |
|---|---|---|---|---|
| 04.60m | | MHF | Finish node type, manhole SW09 Backdrop | <p>Image Provided - Ref: 73_9999</p> |

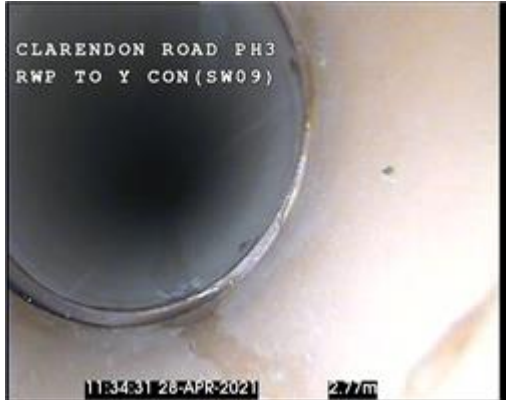
| Pos | Video Ref | Code | Description | Image |
|---|---|---|---|---|
| 02.70m | 0:00:13 | MCVC | Material of pipe changes to Vitrified Clay (i.e. all clayware) | Image Provided - Ref: 90_2<br> |

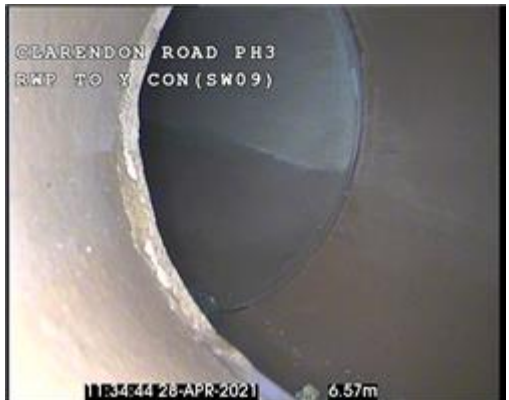
| Pos | Video Ref | Code | Description | Image |
|---|---|---|---|---|
| 06.60m | | WRF | Finish node type, major connection without manhole Y CON(SW09) | Image Provided - Ref: 90_9999<br> |

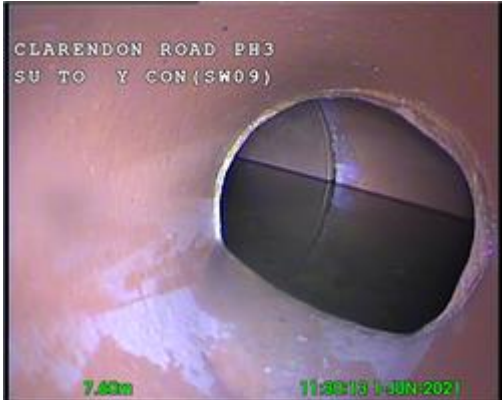
| Pos | Video Ref | Code | Description | Image |
|---|---|---|---|---|
| 07.70m | | WRF | Finish node type, major connection without manhole Y CON(SW09) | <p>Image Provided - Ref: 91_9999</p> |

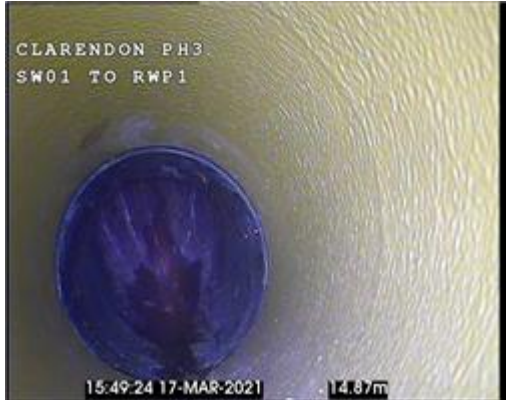
| Pos | Video Ref | Code | Description | Image |
|---|---|---|---|---|
| 14.90m | | OFF | Finish node type, outfall RWP1 | Image Provided - Ref: 74_9999<br> |

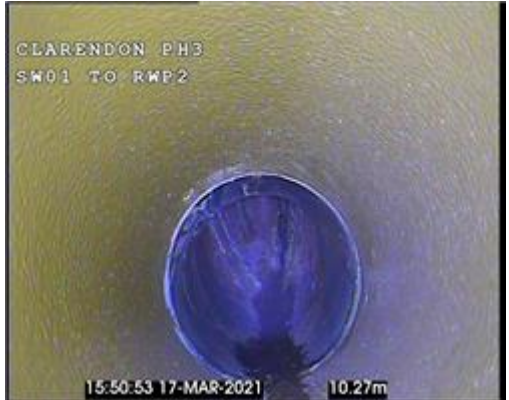
| Pos | Video Ref | Code | Description | Image |
|---|---|---|---|---|
| 10.30m | | OFF | Finish node type, outfall RWP2 | Image Provided - Ref: 75_9999<br> |

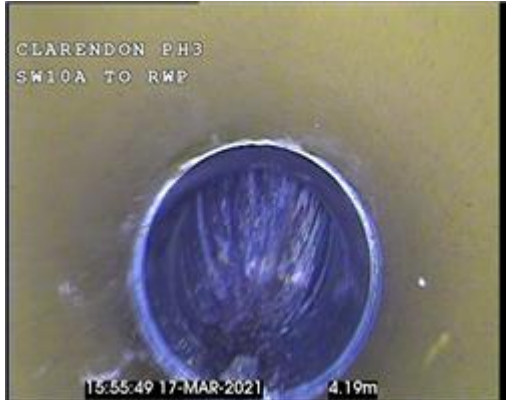
| Pos | Video Ref | Code | Description | Image |
|---|---|---|---|---|
| 04.40m | | OFF | Finish node type, outfall RWP | <p>Image Provided - Ref: 76_9999</p> |

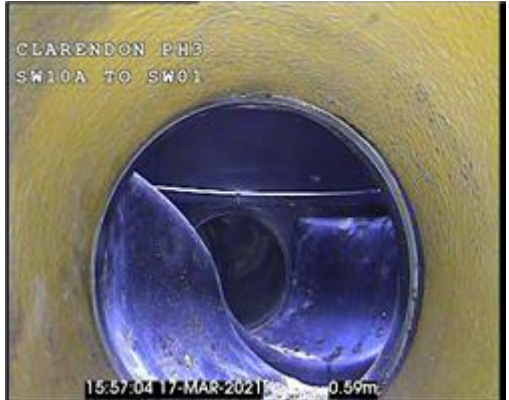
| Pos | Video Ref | Code | Description | Image |
|---|---|---|---|---|
| 01.00m | | MHF | Finish node type, manhole SW10 | Image Provided - Ref: 77_9999<br> |

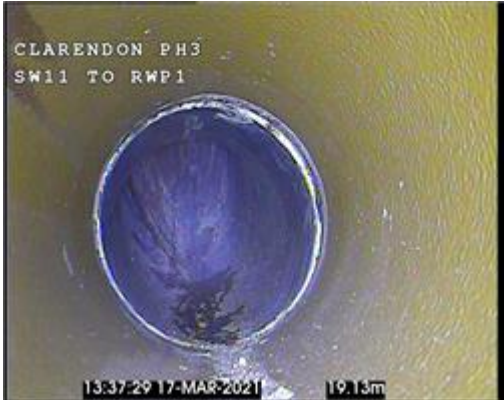
| Pos | Video Ref | Code | Description | Image |
|---|---|---|---|---|
| 19.30m | | OFF | Finish node type, outfall RWP1 | Image Provided - Ref: 78_9999<br> |

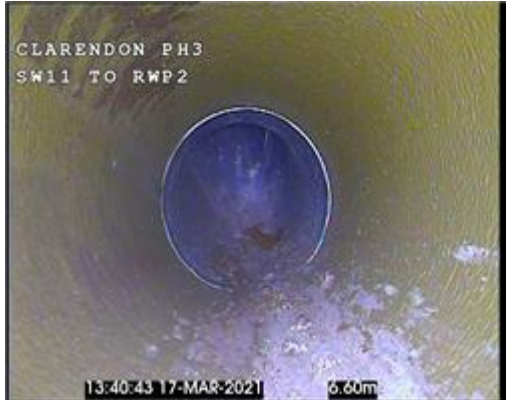
| Pos | Video Ref | Code | Description | Image |
|---|---|---|---|---|
| 06.60m | | OFF | Finish node type, outfall RWP2 | <p>Image Provided - Ref: 79_9999</p> |

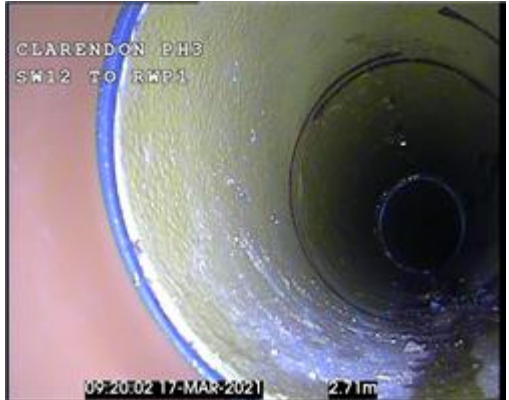
| Pos | Video Ref | Code | Description | Image |
|---|---|---|---|---|
| 02.70m | 0:00:24 | MCCI | Material of pipe changes to Cast Iron | Image Provided - Ref: 80_2<br> |

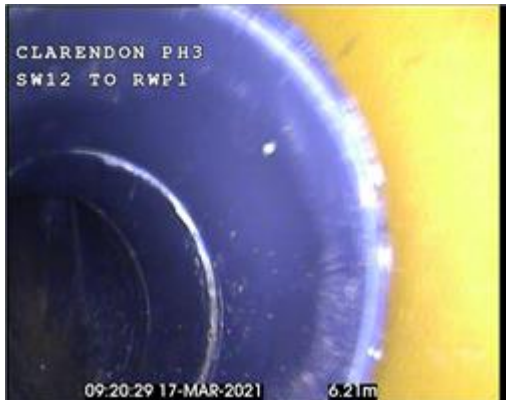
| Pos | Video Ref | Code | Description | Image |
|---|---|---|---|---|
| 06.60m | | OFF | Finish node type, outfall RWP1 | Image Provided - Ref: 80_9999<br> |

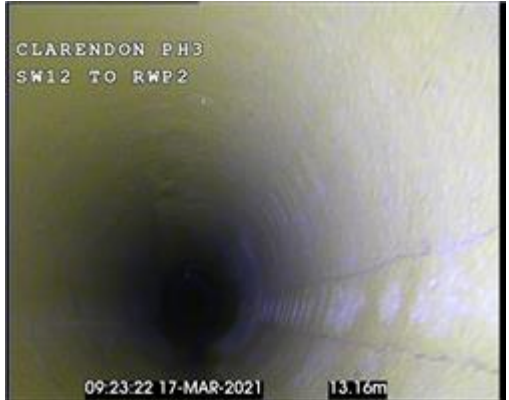
| Pos | Video Ref | Code | Description | Image |
|---|---|---|---|---|
| 19.40m | | OFF | Finish node type, outfall RWP2 | Image Provided - Ref: 81_9999<br> |

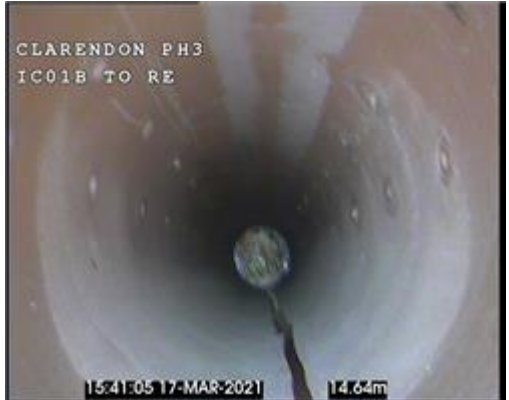
| Pos | Video Ref | Code | Description | Image |
|---|---|---|---|---|
| 13.10m | | REF | Finish node type, rodding eye RE | <p>Image Provided - Ref: 82_9999</p> |

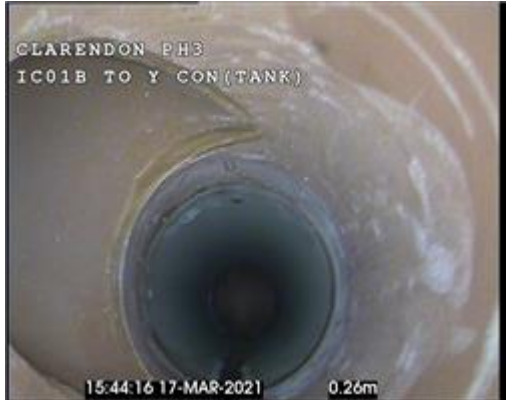
| Pos | Video Ref | Code | Description | Image |
|---|---|---|---|---|
| 00.30m | 0:00:03 | JN | Junction at 09 o'clock: 100mm Diameter | Image Provided - Ref: 83_2<br> |

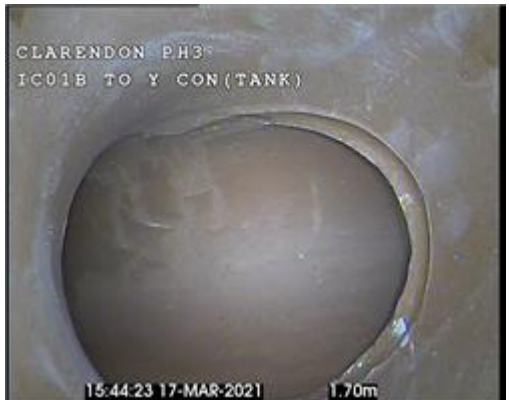
| Pos | Video Ref | Code | Description | Image |
|---|---|---|---|---|
| 01.70m | | WRF | Finish node type, major connection without manhole Y CON(TANK) | Image Provided - Ref: 83_9999<br> |

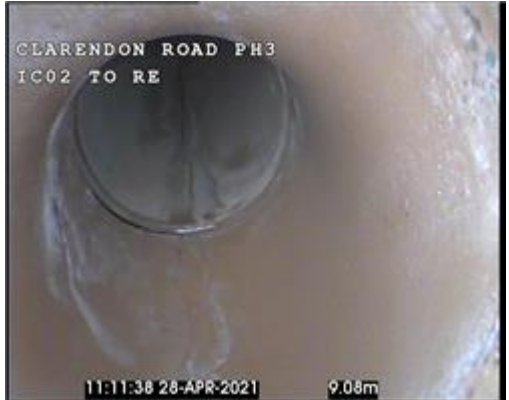
| Pos | Video Ref | Code | Description | Image |
|---|---|---|---|---|
| 09.60m | | REF | Finish node type, rodding eye RE | Image Provided - Ref: 84_9999<br> |

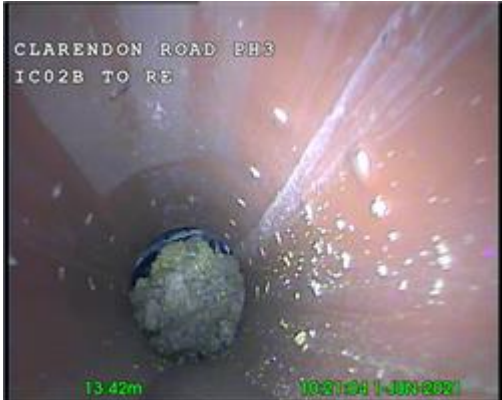
| Pos | Video Ref | Code | Description | Image |
|---|---|---|---|---|
| 13.70m | | SA | Survey abandoned RE not installed yet | Image Provided - Ref: 85_9999<br> |

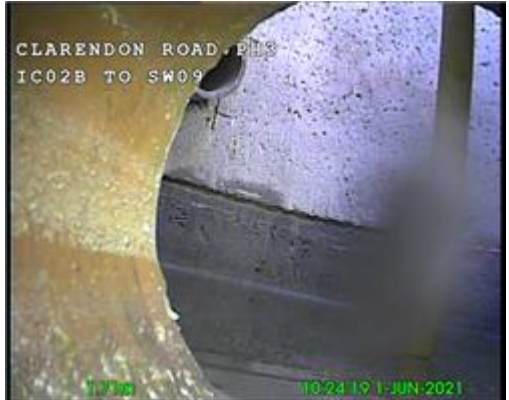
| Pos | Video Ref | Code | Description | Image |
|---|---|---|---|---|
| 01.80m | | MHF | Finish node type, manhole SW09 | <p>Image Provided - Ref: 86_9999</p> |

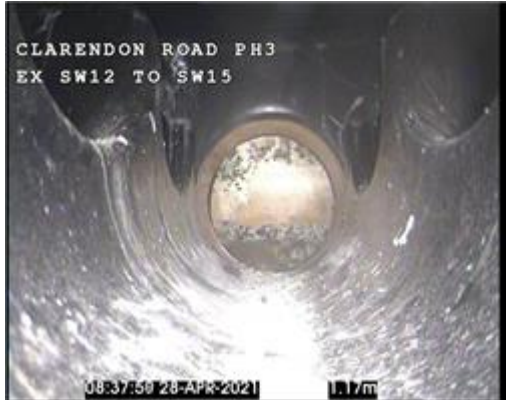
| Pos | Video Ref | Code | Description | Image |
|---|---|---|---|---|
| 01.10m | | MHF | Finish node type, manhole<br>SW15 | Image Provided - Ref: 88_9999<br> |
