# GEOSHIELD Verification Report

GCL - Clarendon Road PHASE 3

AREA SURVEYED: Block D1 Slab - Pour 1.

DATE: 10/12/2020

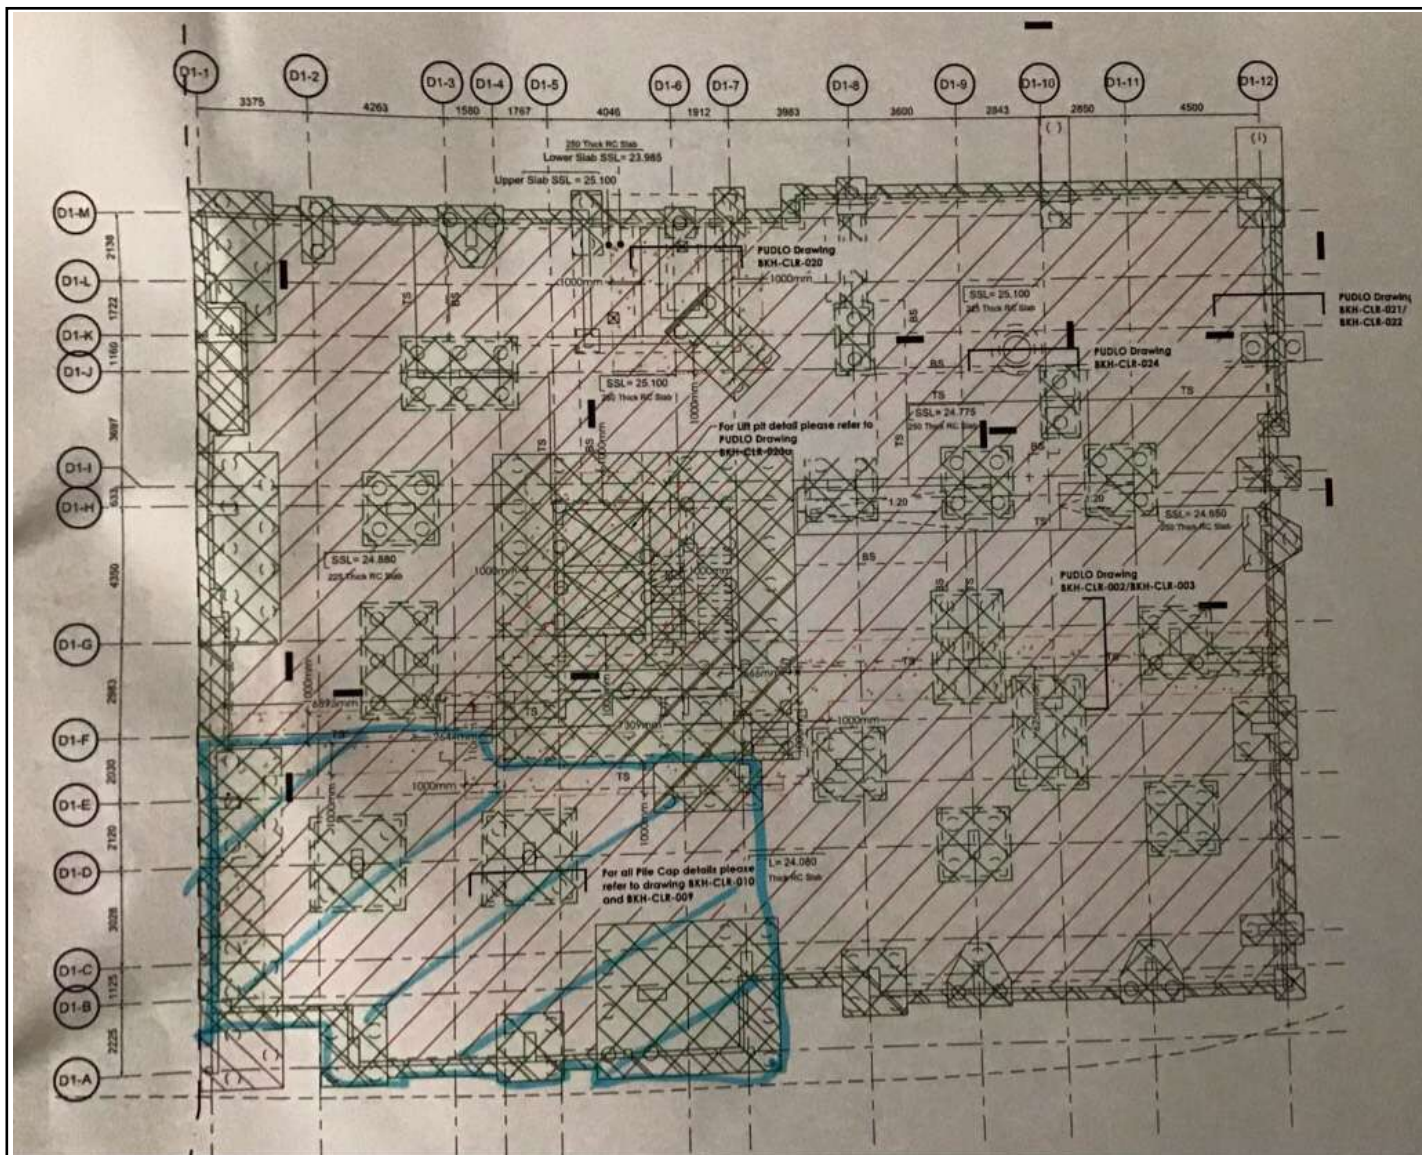
The layout above highlighted in blue shows Block D1 - Pour 1 (50% complete)

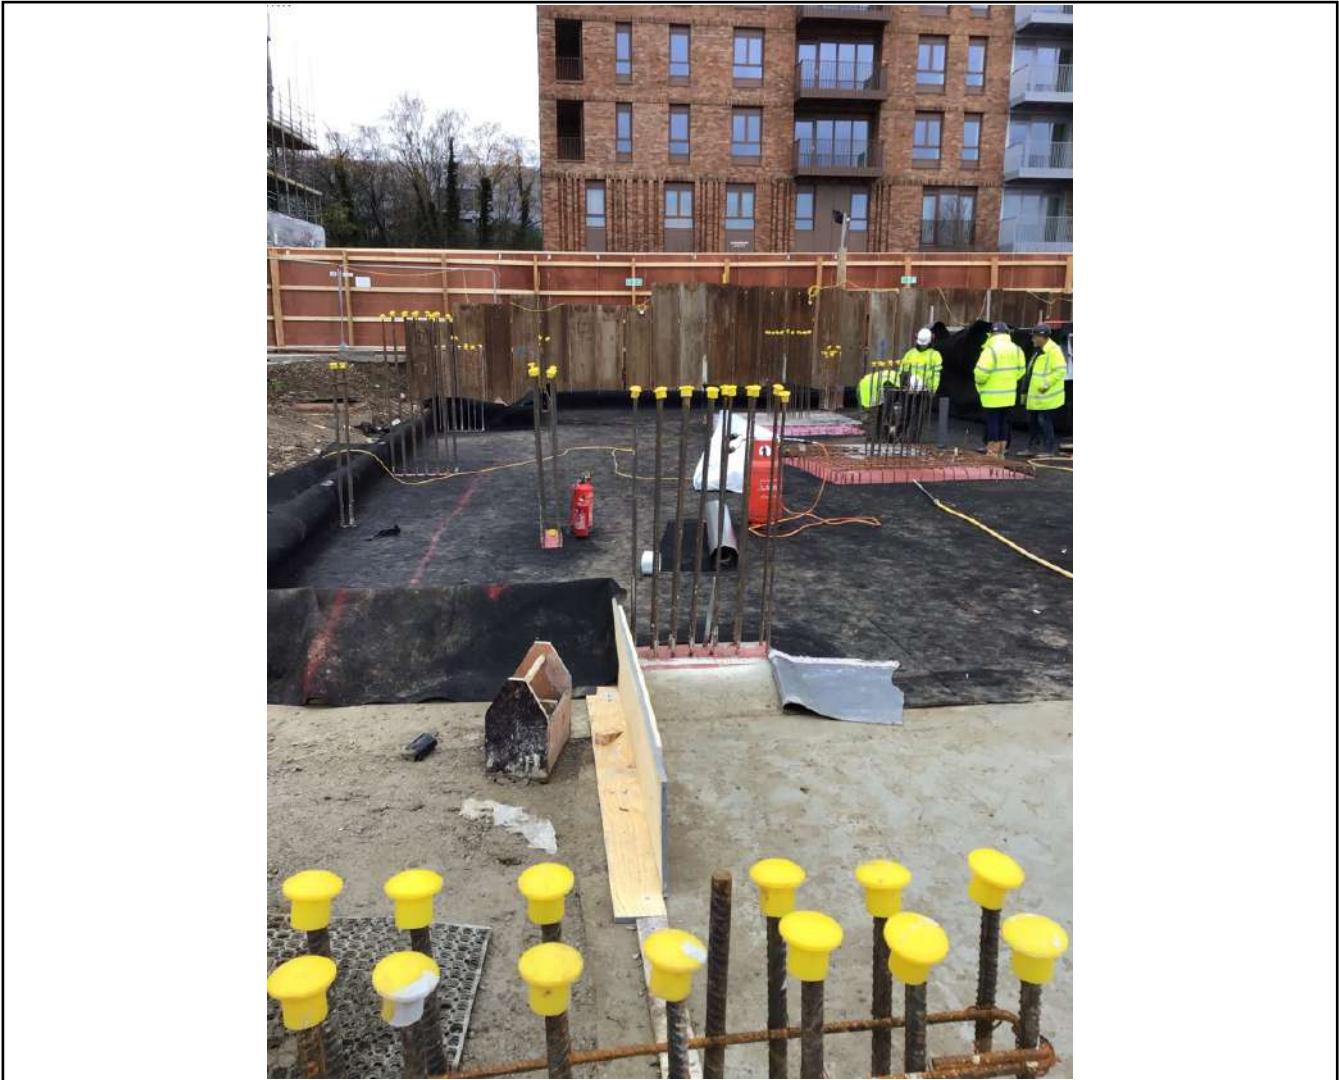
The photograph above shows an overview of the installation of the

Pudlo GP Ultra+ Gas Barrier to D1 Slab - Pour 1 (50% complete).

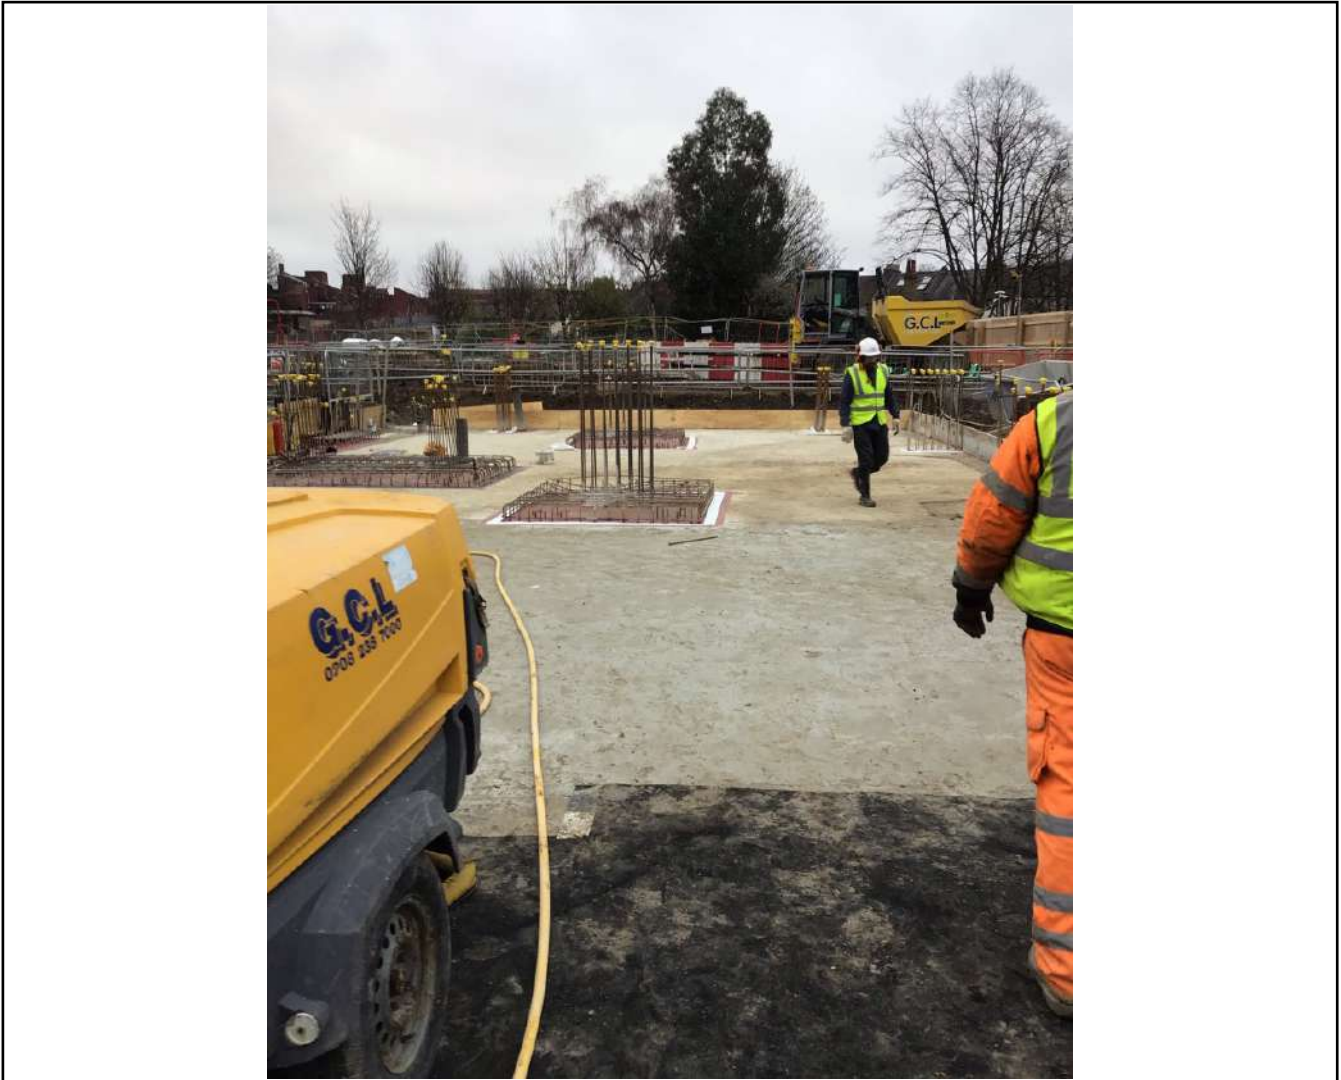
The photograph above shows an overview of the remaining (50%) of the

D1 Slab - Pour 1, where the installation is yet to be completed.

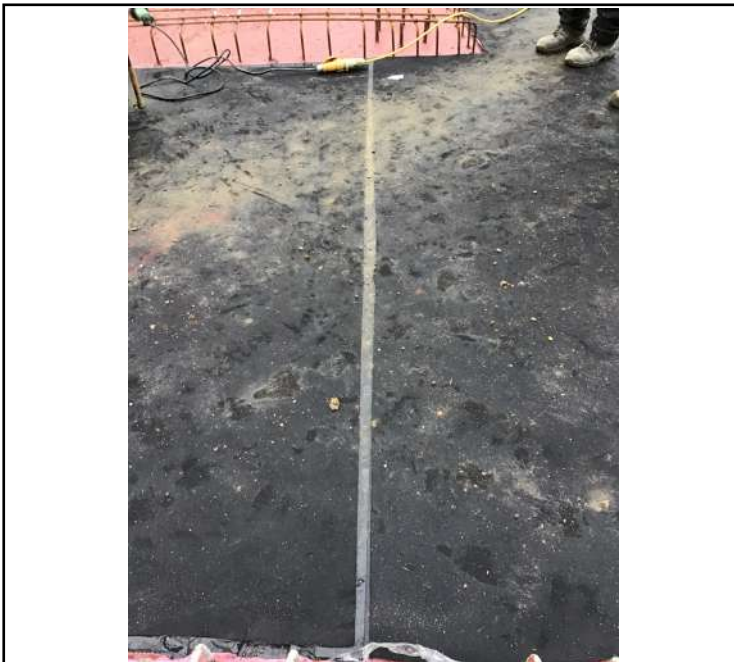
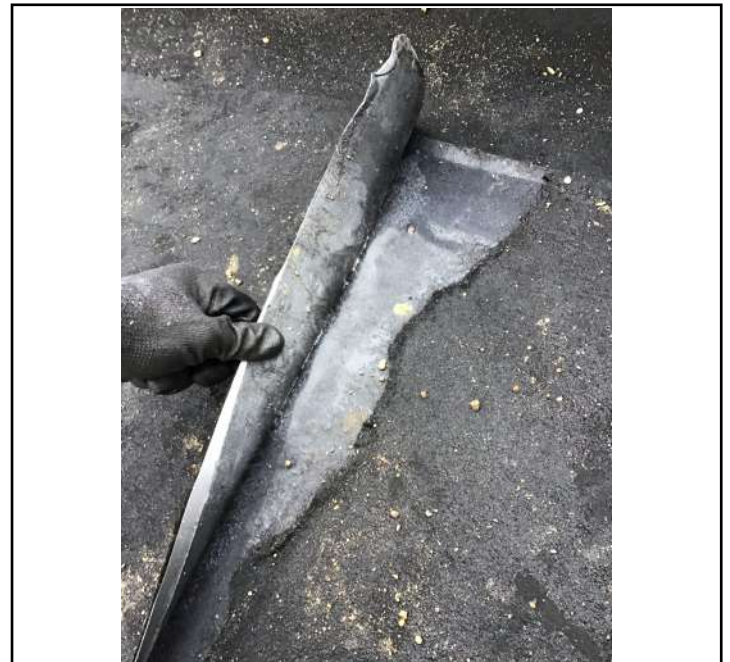
LOCATION/GRID LINE: Block D1 Slab - Pour 1 (50%).

NOTES: Incorrect sealing of lap joints.

The first photograph below shows an overview of a lap joint, found within the area verified during this visit. The second photograph below shows a pick and probe test to the pictured lap joint.

During the pick and probe test, it was identified that the sealing of lap joints had been taped, and not welded. This is not to manufacturers specification.

| Date | Nr | Remediation Description | Y/N |
|---|---|---|---|
| 10/12/2020 | 004 | 1. Incorrect sealing of lap joints in membrane - taped not welded. | |

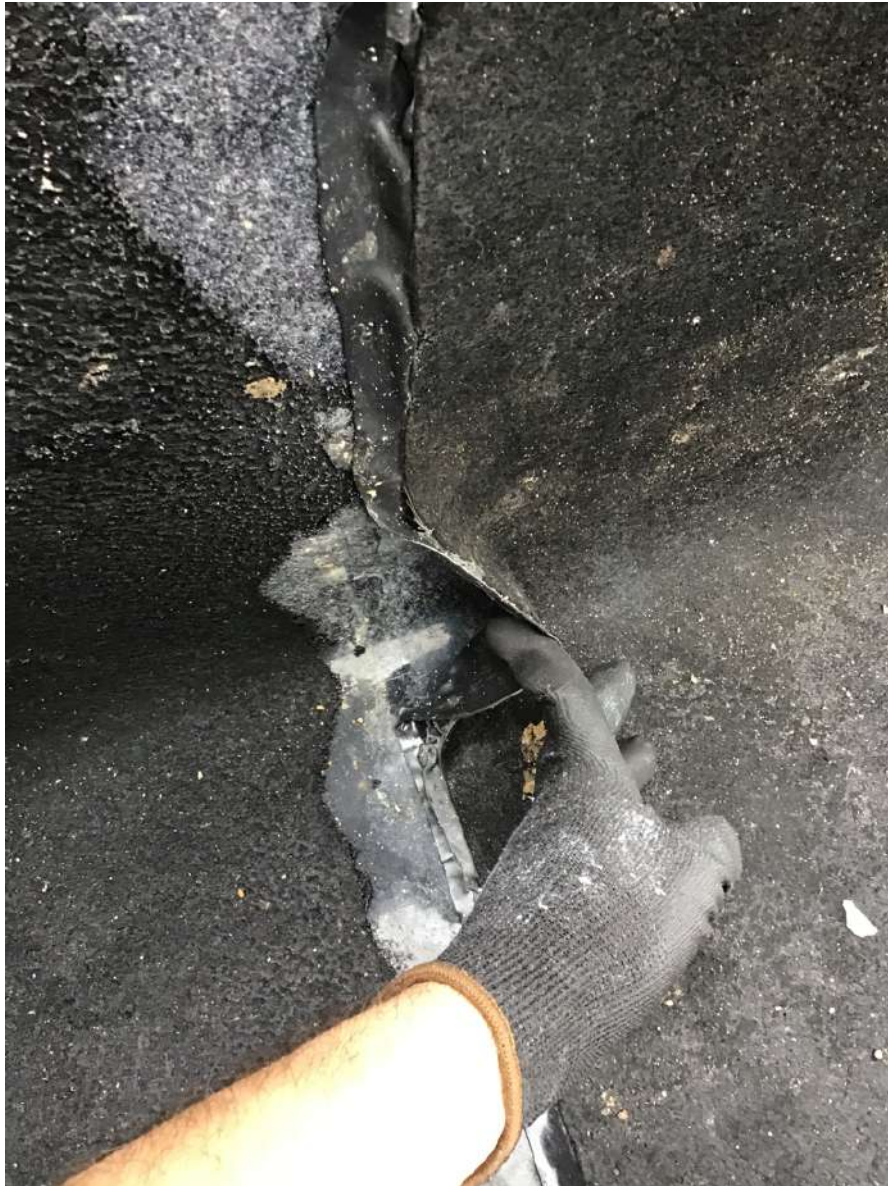
The photograph above shows a separate fault found within the sealing of lap joints.

Not only had the installers used the wrong method to seal the lap joints, there was also holes in the joints present, as pictured above.

This is deemed a failed visit, and the same area will need to be re-inspected.

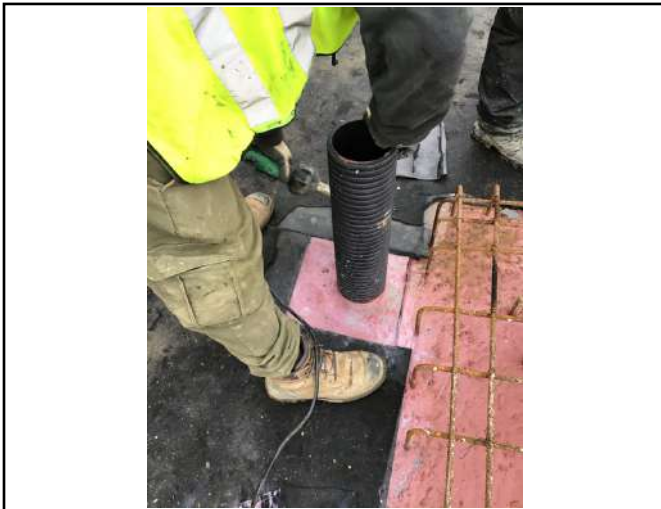
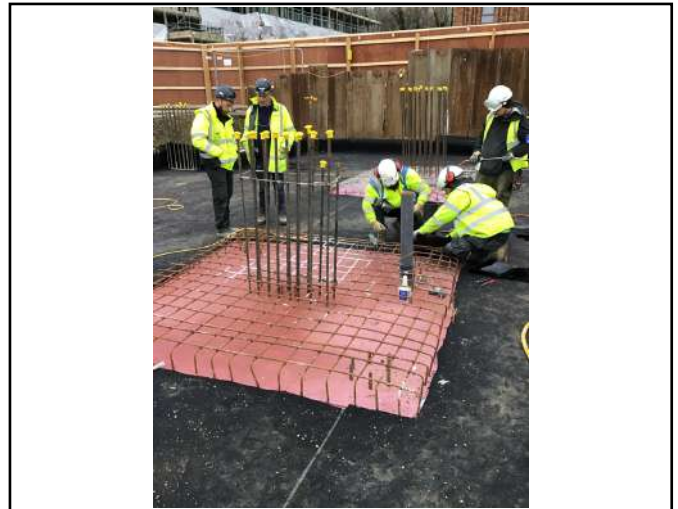
LOCATION/GRID LINE: Block D1 Slab - Pour 1.

NOTES: Incomplete sealing of pipe penetrations.

The first photograph below shows a pipe penetration that was found unsealed during today's inspection visit. This was along with another two unsealed pipe penetrations.

The second photograph above shows a toolbox talk demonstration being carried out to the installers, demonstrating how to correctly seal the pipe penetration, as per manufacturers specification and design details.

| Date | Nr | Remediation Description | Y/N |
|---|---|---|---|
| | | 2. 3 x pipe penetrations not sealed. | |

All pipe penetrations will need to be sealed and re-verified during the next inspection visit to site.

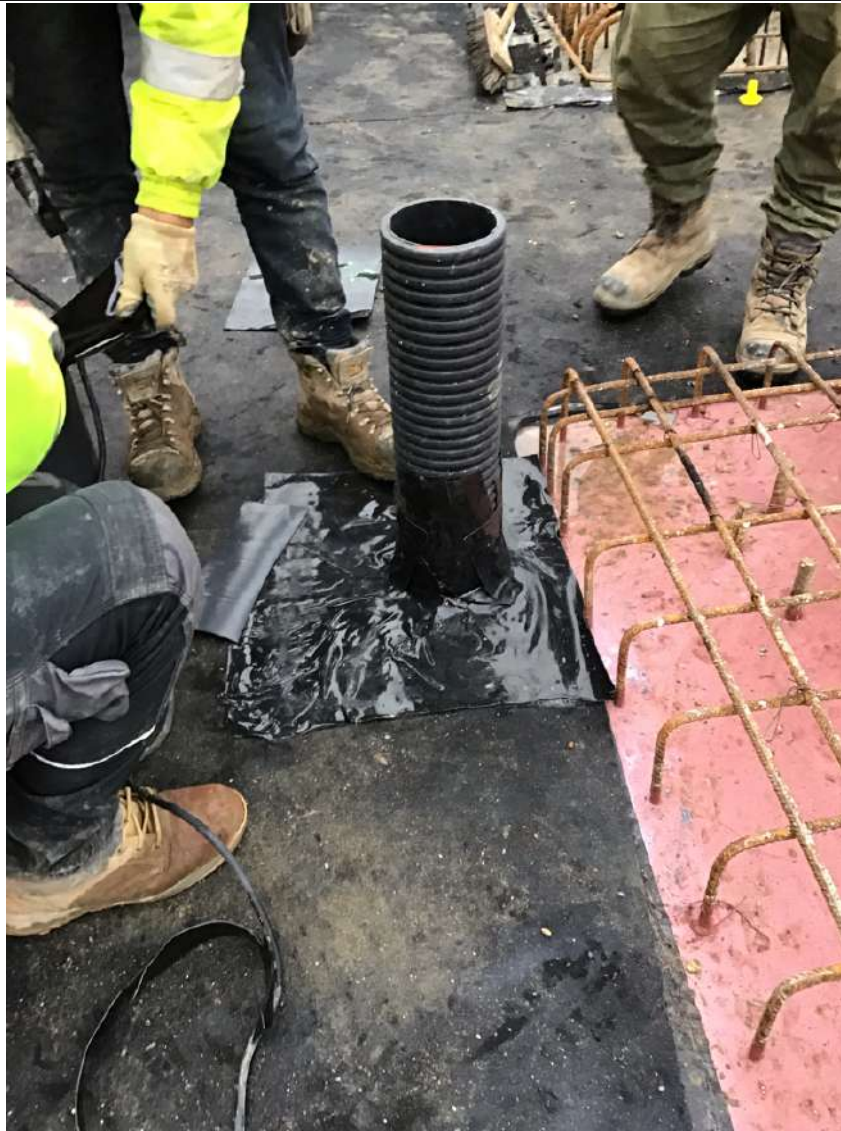
The photograph above shows where the installers have now correctly sealed the aforementioned pipe penetration, after a short toolbox talk demonstration provided to the installers, by Geosheild. All pipe penetrations will need to be sealed as per manufacturers specification, and then re-inspected during the next visit.

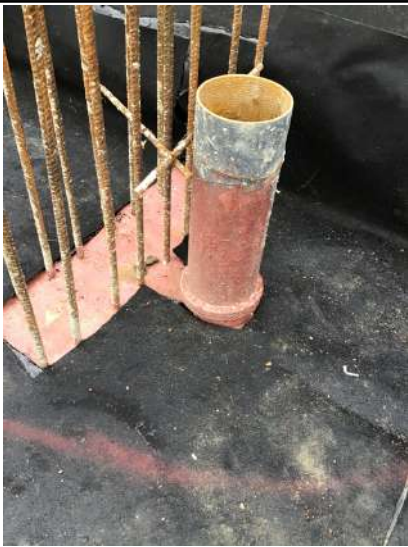
Unsealed pipe penetration.

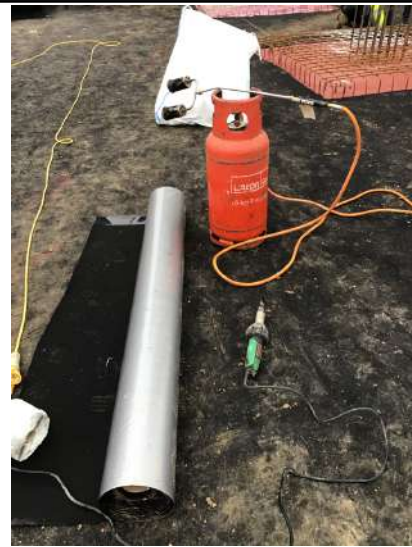
Hot air tools used.

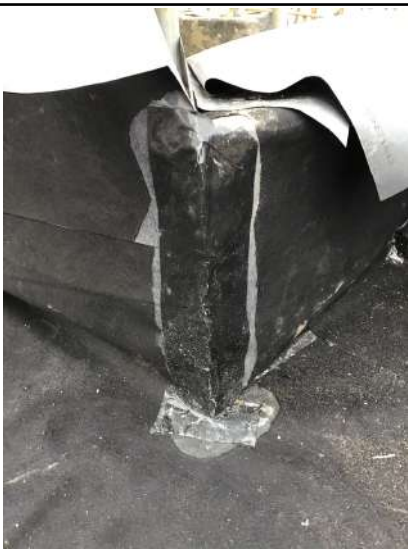
Corner detailing completed.

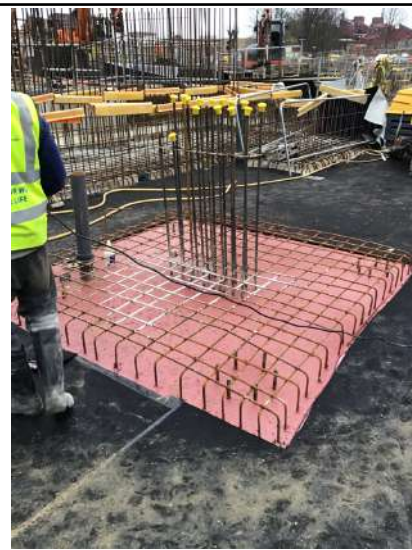
Large pile cap sealed.
