## Verification Report

GCL - Clarendon Road PHASE 3

AREA SURVEYED: Block D1 Slab - Pour 1. (2nd visit for this area).

DATE: 12/01/2021

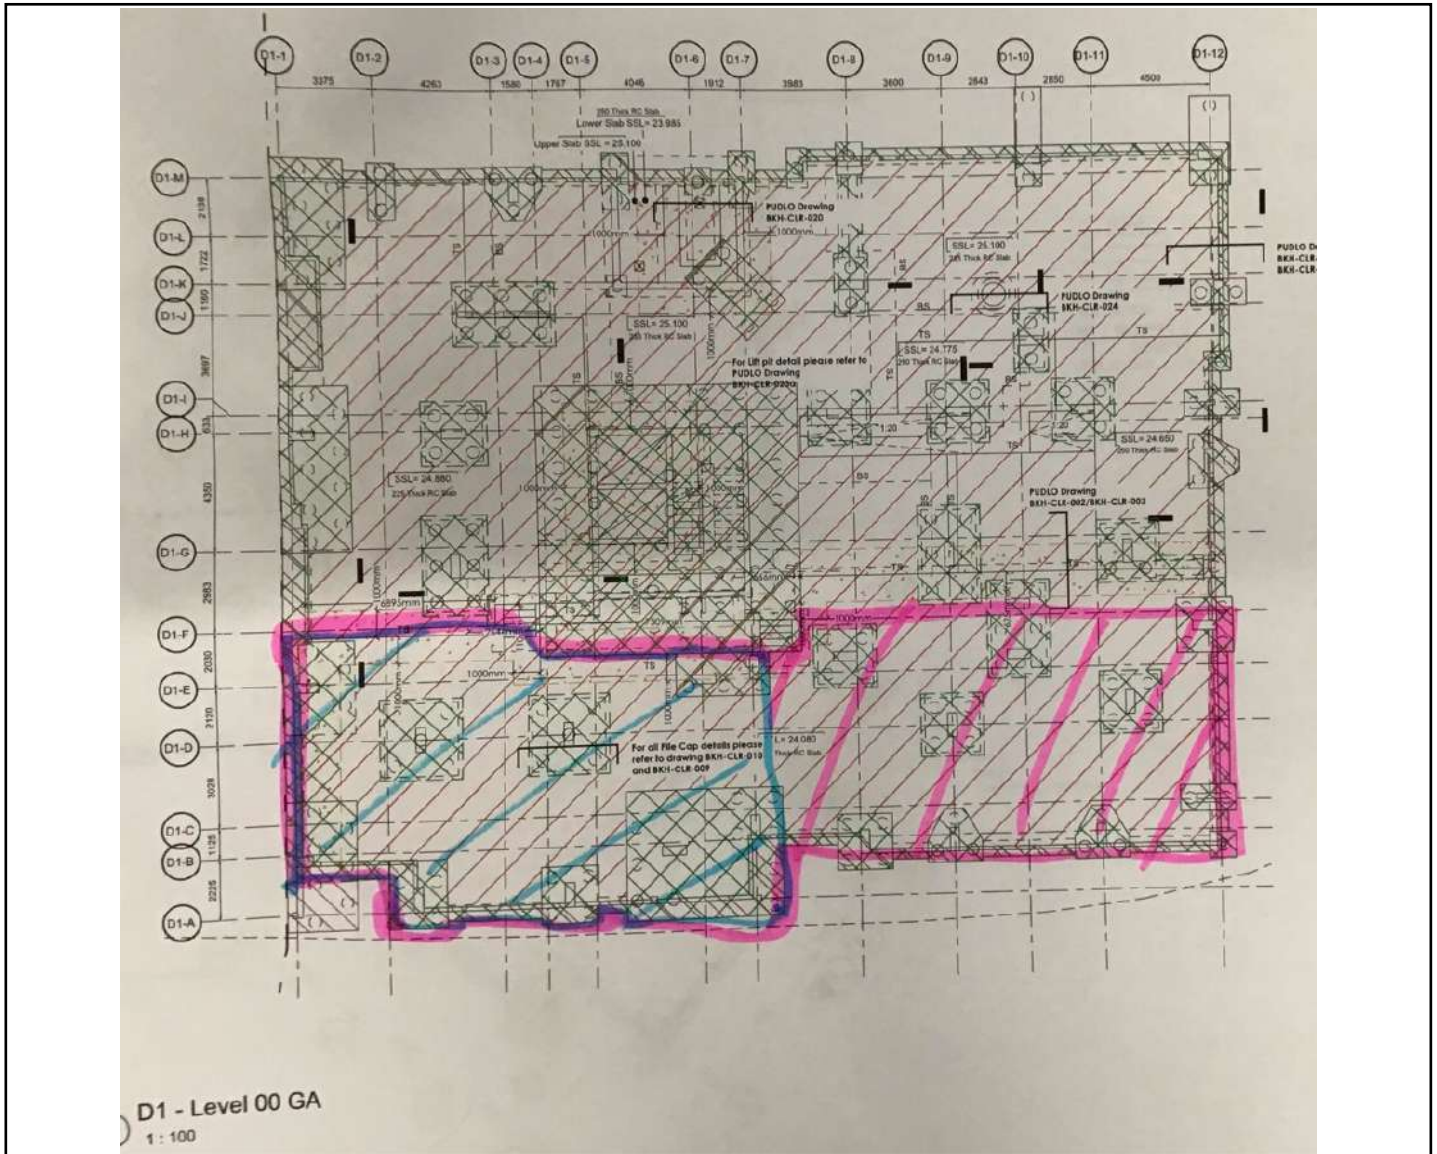
The layout above highlighted in pink shows Block D1 - Pour 1 (Base installation only)

which was verified during this inspection visit.

This is the second time this area has been inspected due to the faults found previously

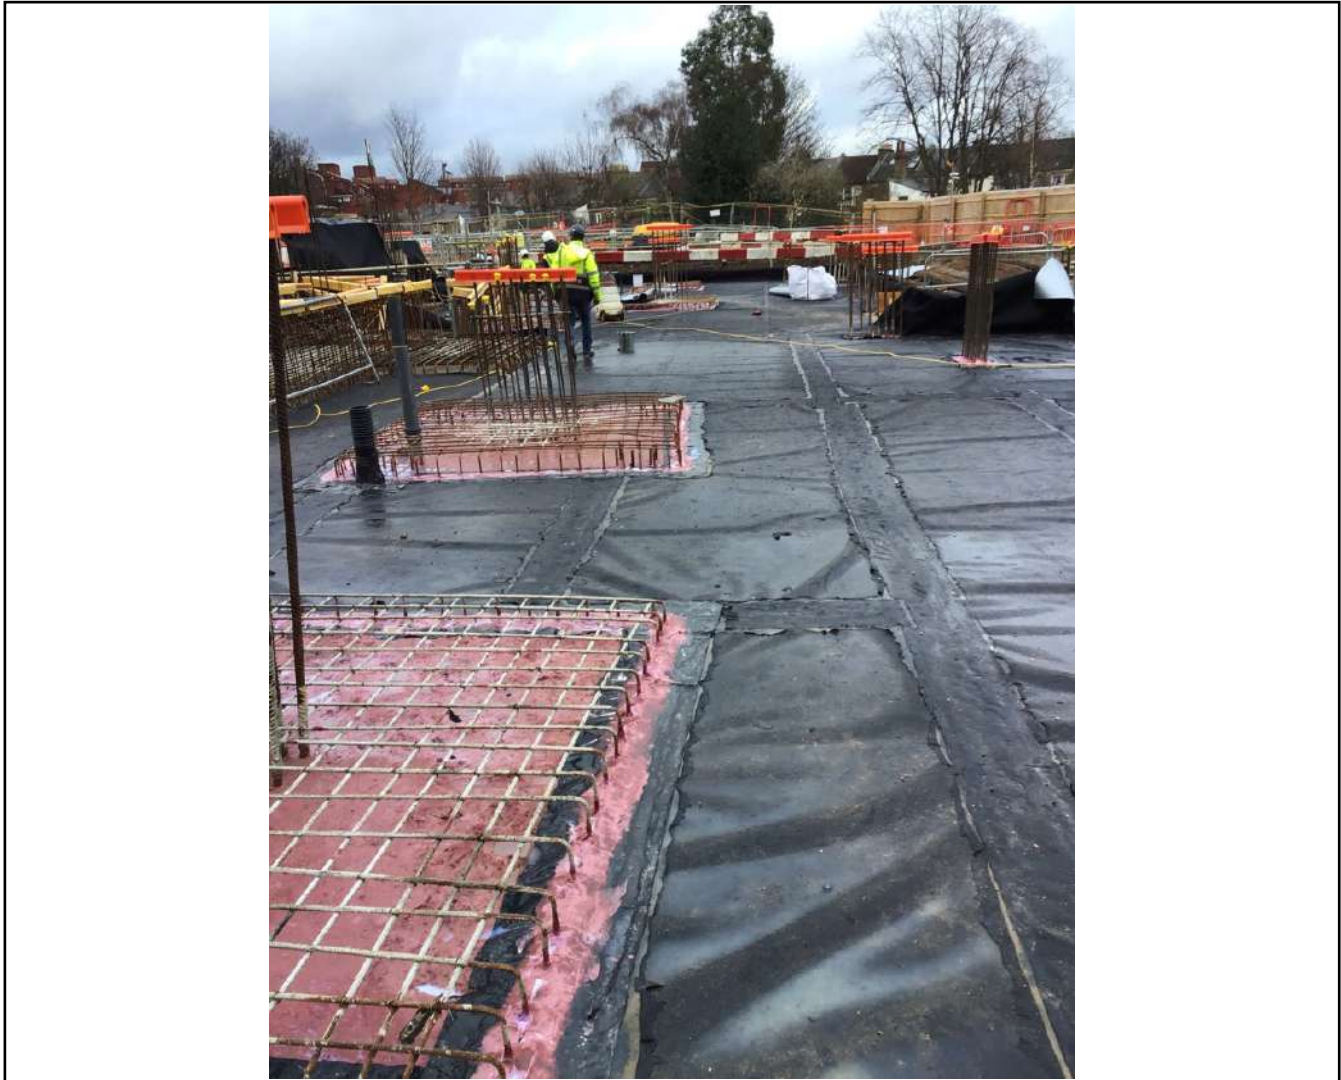
The photograph above shows an overview of the installation of the

Pudlo GP Ultra+ Gas Barrier to D1 Slab - Pour 1 (base installation only).

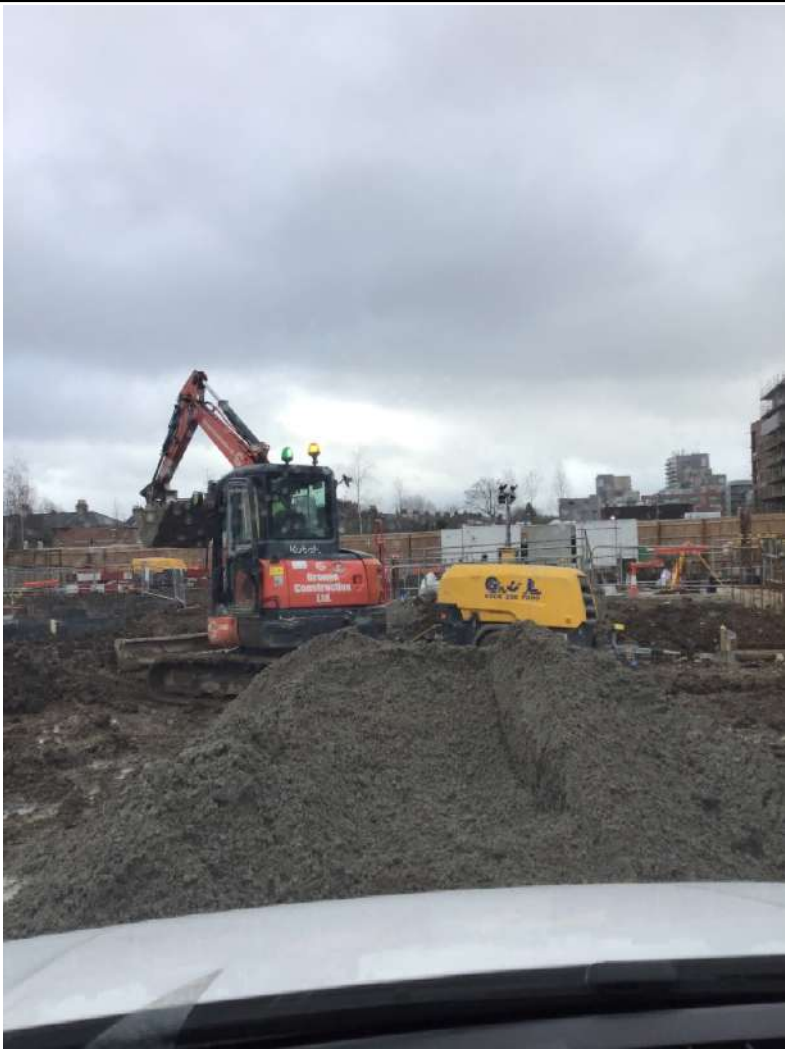
RESTRICTIONS AND LIMITATIONS: Restricted access to area of works.

The photograph below shows the restricted access present, during today's inspection visit. This meant that air lance integrity testing could not be carried out to the welded lap joints. A thorough visual, pick and probe test was however carried out.

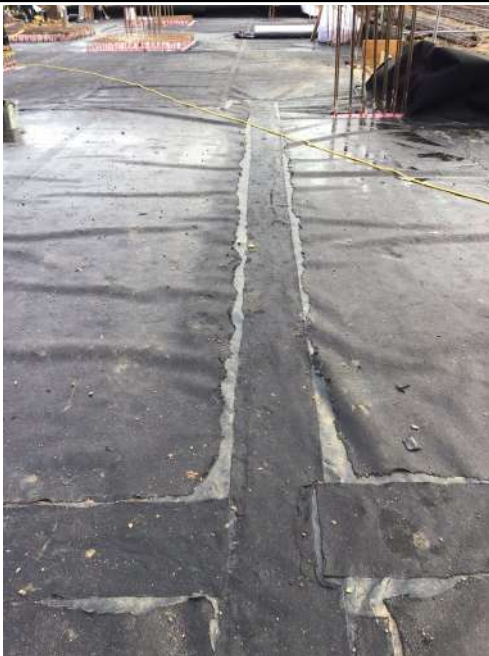
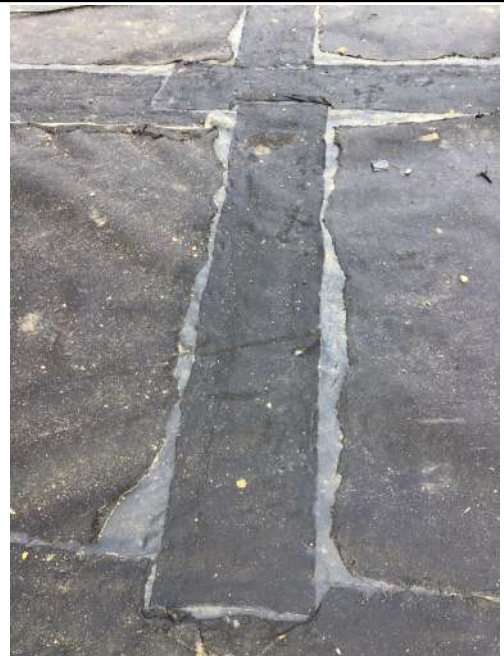
The first photograph below shows an overview of some examples of welded lap joints, which have been verified during this inspection visit. The installers have now correctly sealed the lap joints, as per the design details and manufacturers specification.

The lap joints were previously taped, which is not as per the detail.

All lap joints have now been welded and sealed correctly.

All laps of the Pudlo GP Ultra+ Gas Barrier have now been correctly sealed and remediated, as per the request during visit four.

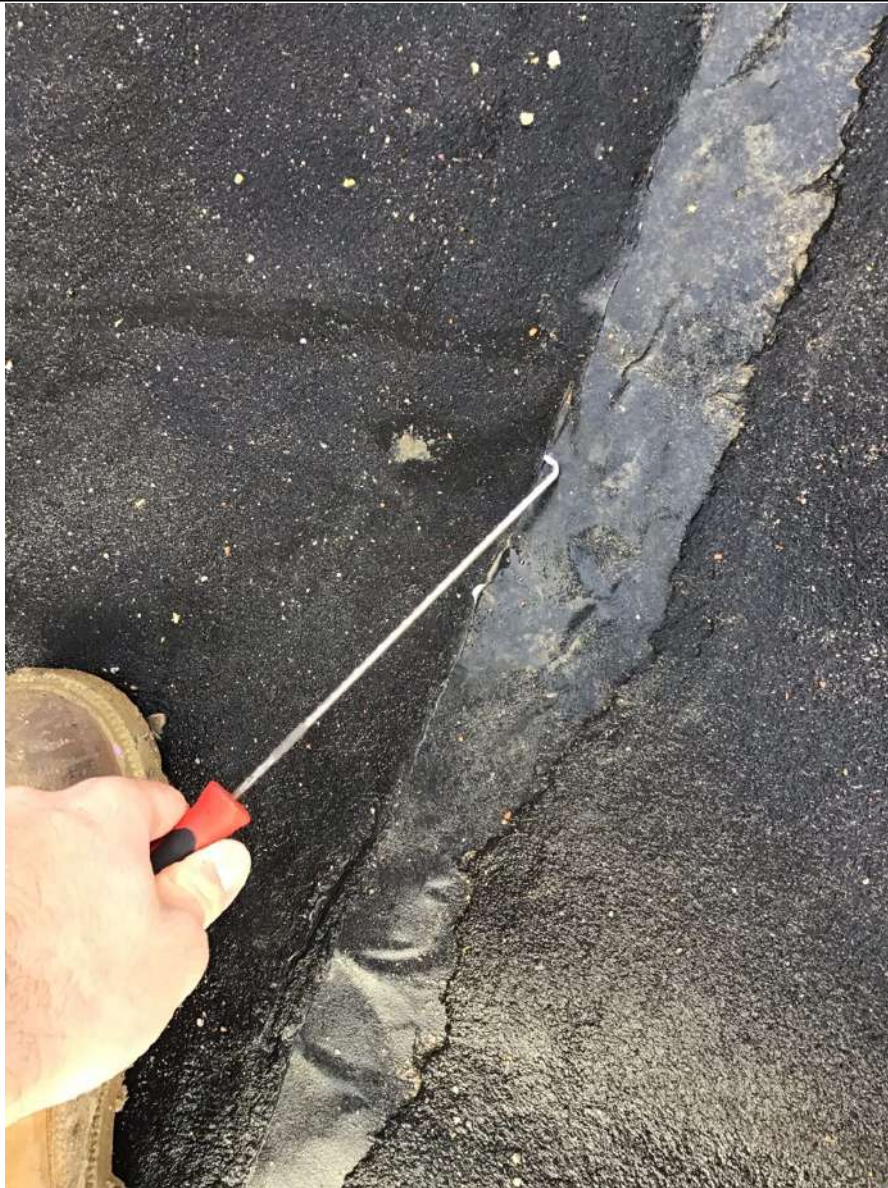
The photograph above demonstrates a pick and probe test being carried out to a welded lap joint within the area verified during this visit.

Air lance integrity testing could not be carried out during this visit, due to the restricted access to the area - see limitation page.

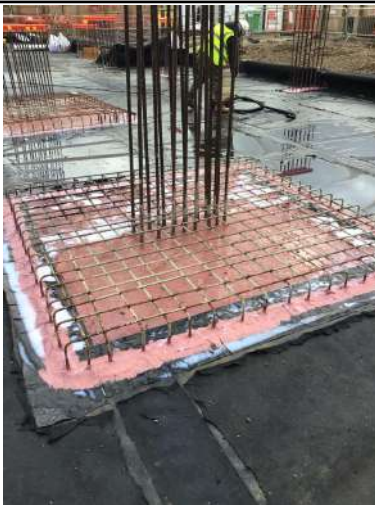
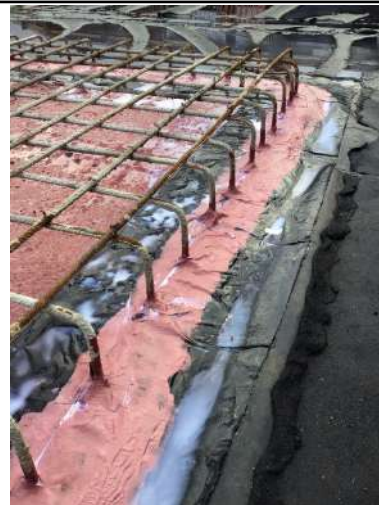
The first photograph below shows an overview photograph of two examples, where the installers have sealed the Pudlo GP+ Ultra, to the Pile caps. The pile caps have also been sealed using Pudlo liquid gas membrane, as per the design details.

The second photograph above shows a close up view of the termination and sealing detail, present between the membrane and pile caps. The detail for this has been updated, and completed during this visit. The installers have taped the membrane to the painted pile cap, using Pudlo EXT Tape, and sealed the individual steel rebars, again using the Pudlo liquid gas membrane.

Complete pile caps have now been sealed as per the revised detail. The installers have sealed onto the pile cap a minimum of 150mm, and sealed the steel rebars using double sided butyl tape and gas resistant liquid membrane.

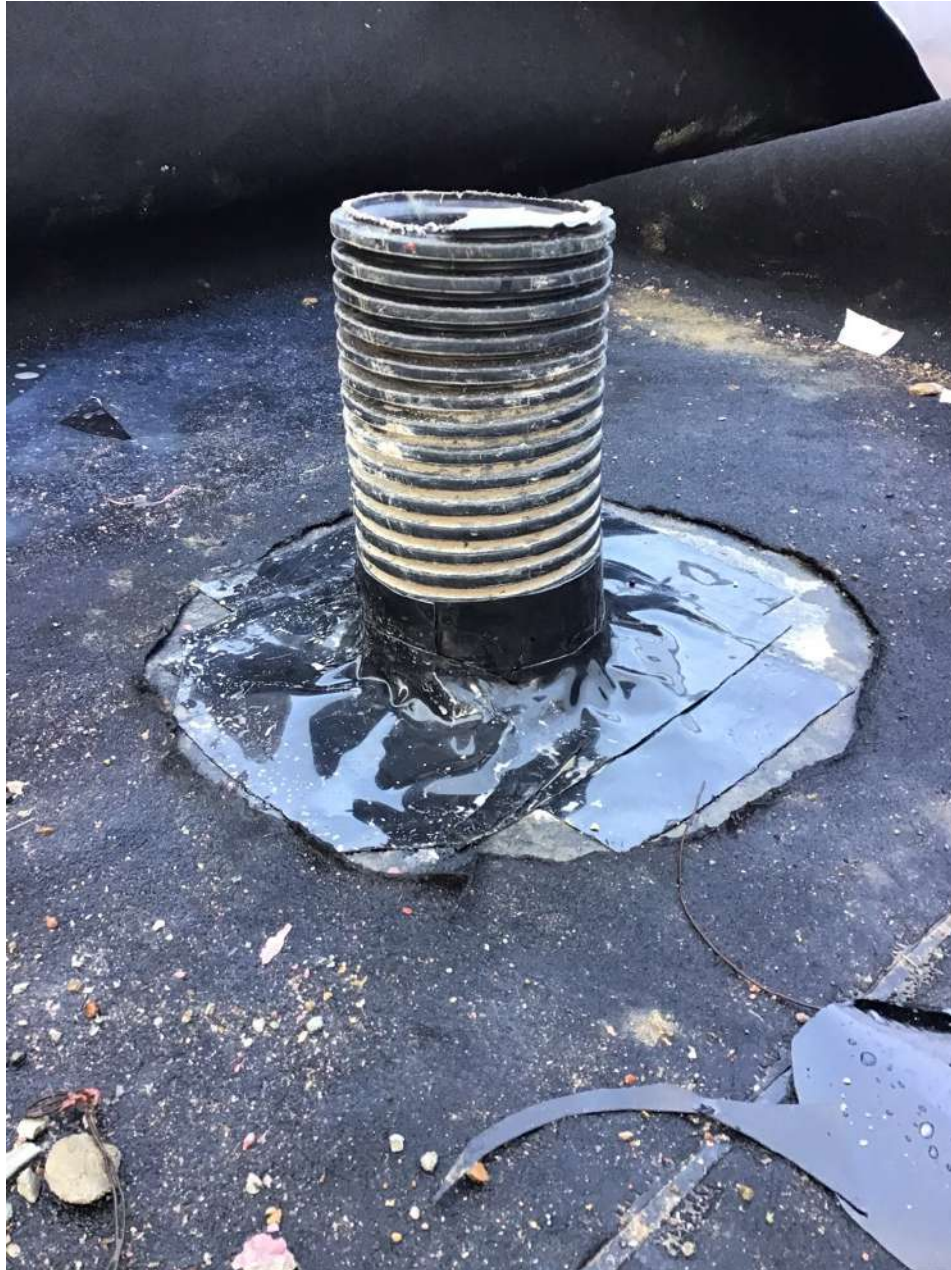
The photograph above portrays a sealed pipe penetration, located within the verified area. This pipe penetration has been sealed to manufacturers specification.

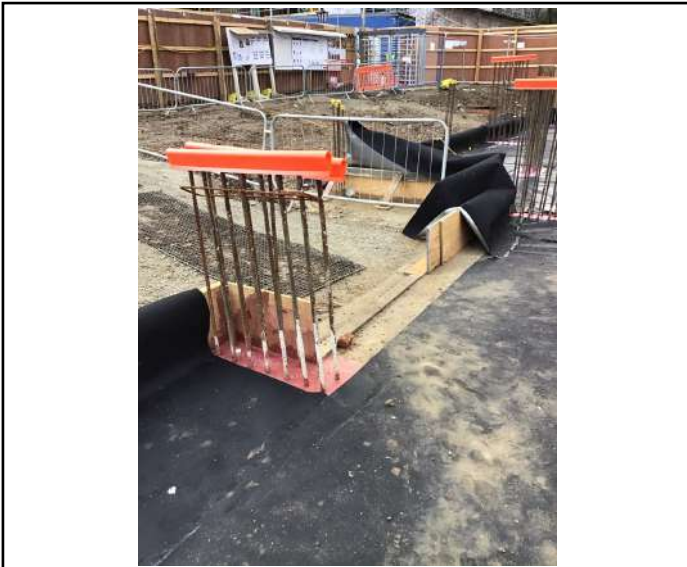
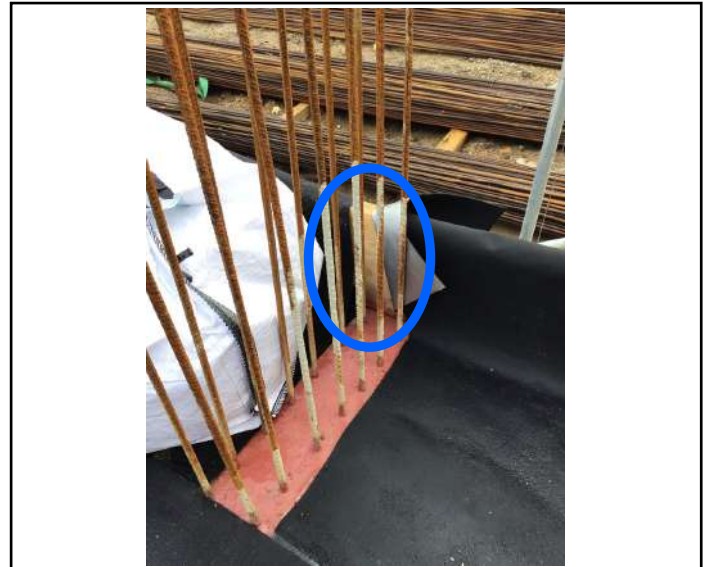
The two photographs below show examples of incomplete works, which haven't been possible to verify during today's visit. These works will need to be completed, and verified during the next visit, again to achieve sign off for this area.

The first photograph shows an access route for the area verified, the shutter will need to be erected, to allow the installers to lap and finish the membrane. The second photograph shows an incomplete pile cap, with a unsealed joint in the membrane.

| Date | Nr | Remediation Description | Y/N |
|---|---|---|---|
| 12/01/2021 | 006 | 1. Some pile caps incomplete as per the detail for sealing. | |

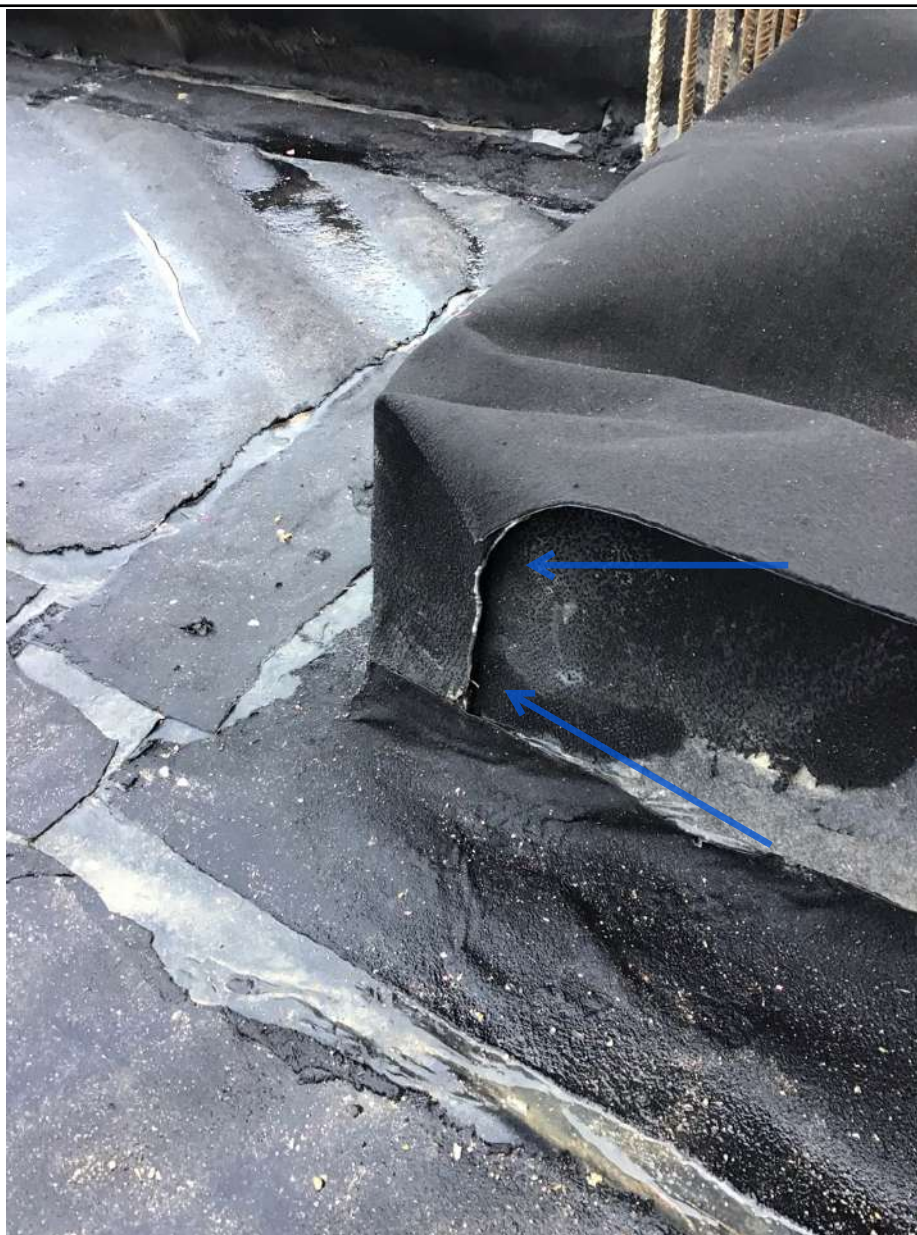
The photograph above shows a close up view of an incomplete corner detail, that needs to be sealed and verified, in order to achieve sign off completion for this area.

| Date | Nr | Remediation Description | Y/N |
|---|---|---|---|
| | | 3. Corner details not sealed due to access required to the area. | |

All details such as pipe penetrations and corners have also been sealed correctly, however some corner details are yet to be sealed due to access required to area.

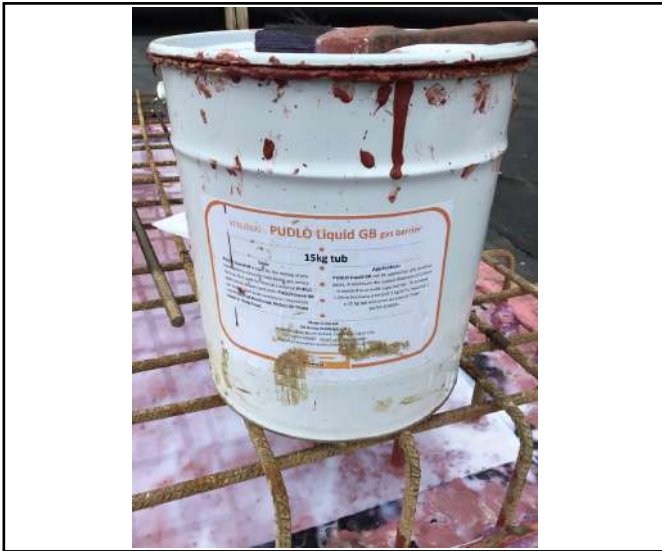
Pudlo liquid gas barrier applied  
to all pile caps.

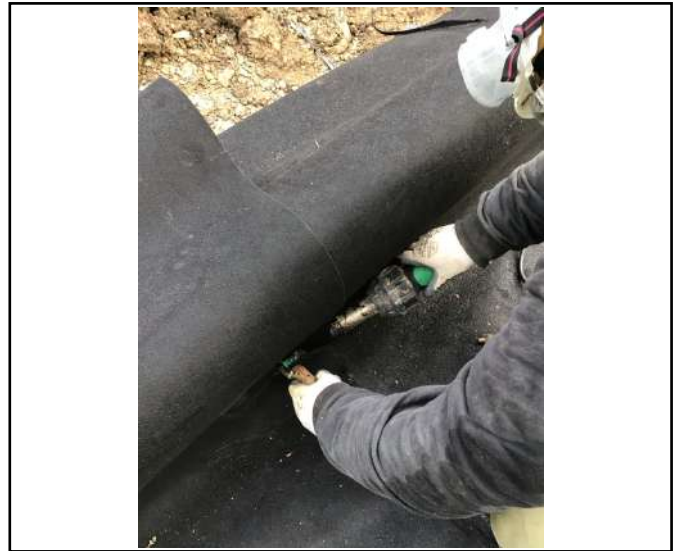
Installer welding a lap joint using  
hot air leister and roller.

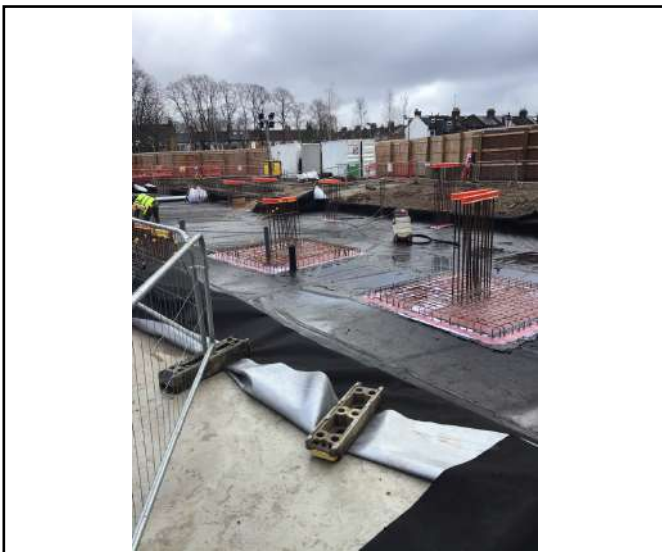
Overview photograph example showing  
area verified during this visit.

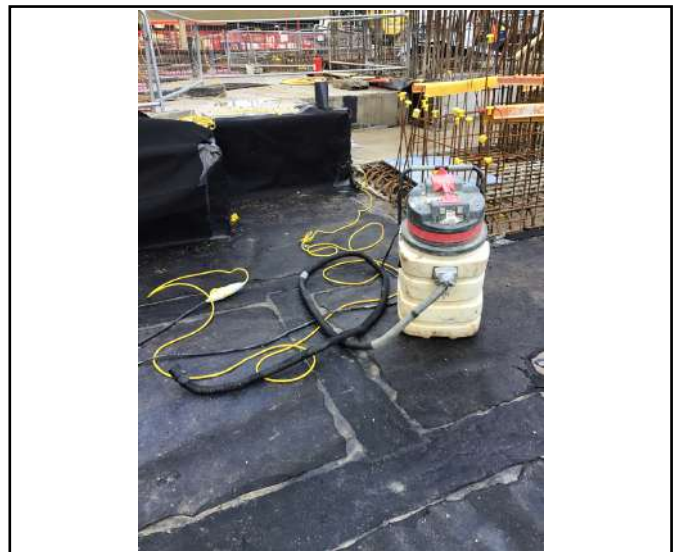
Water hoover used to dry areas.
